JRC2015-5793

## TRACKING OF SPALL DETERIORATION ON TAPERED ROLLER BEARINGS

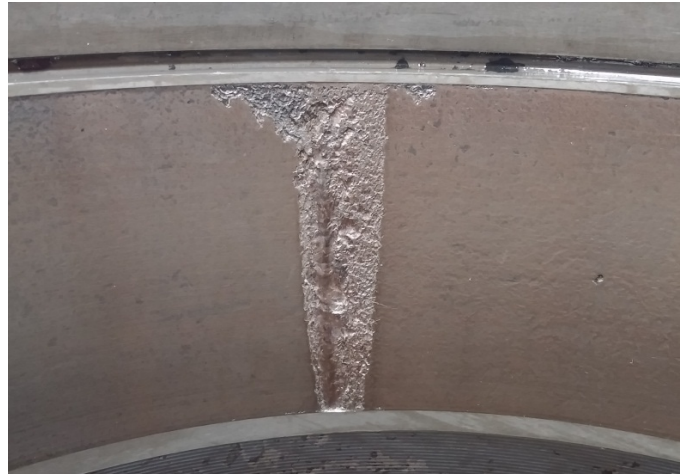
Subsequent to stopping the tester and pressing off the bearings, Bearing 3 was disassembled after running a total of 63,678 miles. Visual inspection of Bearing 3 revealed deterioration of Spall 1 (depicted in Figure 5), which was previously discovered during the second teardown inspection.

After only 12,258 miles of additional operation, the spall had expanded along the entire width of the raceway for a total spall area of about 1.050 in.<sup>2</sup>; i.e., the spall grew in size six times its original area.

Figure 5: Photograph of degradation of the existing spall found on Test Cup A after running an additional 12,258 miles – 3<sup>rd</sup> Teardown

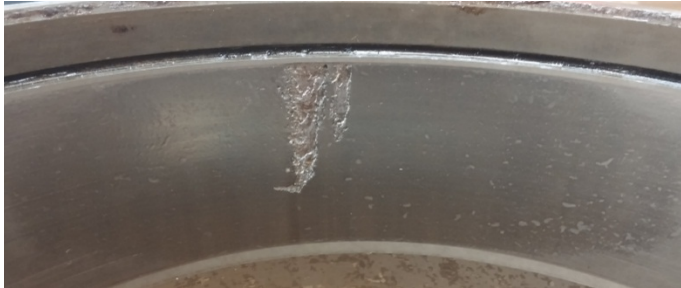
Following teardown, visual inspection of Bearing 3 revealed noticeable deterioration of the existing spall previously discovered on the IB raceway of Test Cup B, as can be seen in Figure 9. The spall has grown in size and it is accompanied by numerous indentations along the width of the raceway. The spall size is now approximately 2.600 in.<sup>2</sup>, which means that the initial spall that developed on Test Cup B has grown four times its original size after running an additional 10,757 miles.

Figure 9: Photograph of the deterioration of the existing spall discovered on Test Cup B of Bearing 3 after running an additional 10,757 miles – 6<sup>th</sup> Teardown

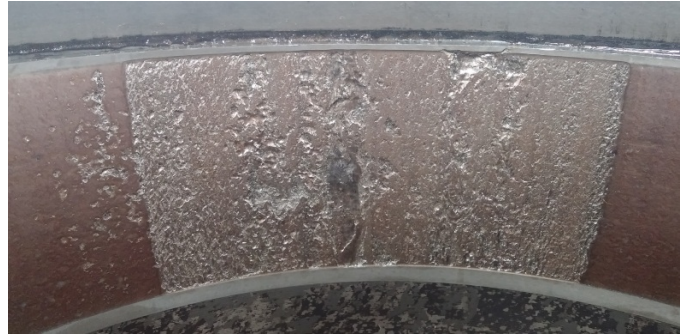
After running a total of 250,059 miles, Bearing 3 (Test Cup C) exhibited further signs of deterioration, which prompted a tenth teardown. Upon disassembly and inspection of Bearing 3 (formerly Bearing 2), it was observed that the spall deterioration was drastic, as pictured in Figure 13. The degraded spall encompassed nearly half of the loaded region of the IB raceway of Test Cup C. The total spall area measured roughly 8.986 in.<sup>2</sup>, which means that this spall grew about 2.2 times its size from the previous teardown after 27,802 miles of operation, and approximately 4.8 times its original size (8<sup>th</sup> teardown) in the span of 35,607 miles of operation. Based on the severity of the spall, and since the bearing reached the 250,000 milestone, it was removed from this service life test and was replaced by another ultrasonically scanned test cup

Figure 13: Photograph of the extensive spall degradation of the existing spall found on Test Cup C (Bearing 3) after running an additional 27,802 miles of operation – 10<sup>th</sup> Teardown
