# Service Life Testing of Railroad Bearings with Known Subsurface Inclusions: Detected with Advanced Ultrasonic Technology

C.M. Tarawneh<sup>1</sup>, J.A. Turner<sup>2</sup>, L. Koester<sup>2</sup> and B.M. Wilson<sup>3</sup>

## Abstract

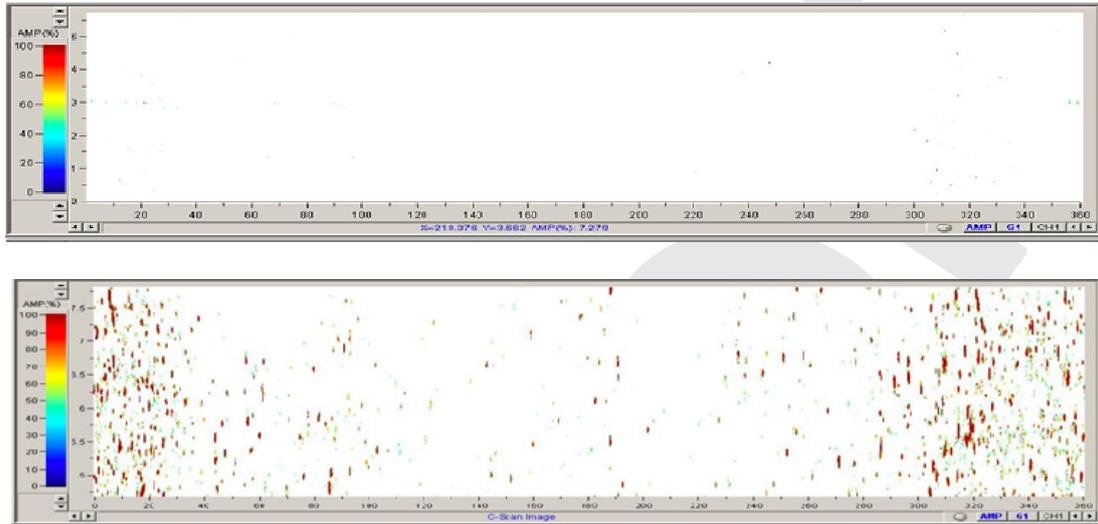
of the bulk material. As an example, two C-scans of certified ‘Bearing Quality Steel’ are shown in Figure 1. Clearly these two steels would perform very differently if or when they were manufactured into bearings.

Figure 1: C-scans of two bearing steels which have both been certified and rated as ‘Bearing Quality’ based on microscopic rating methods

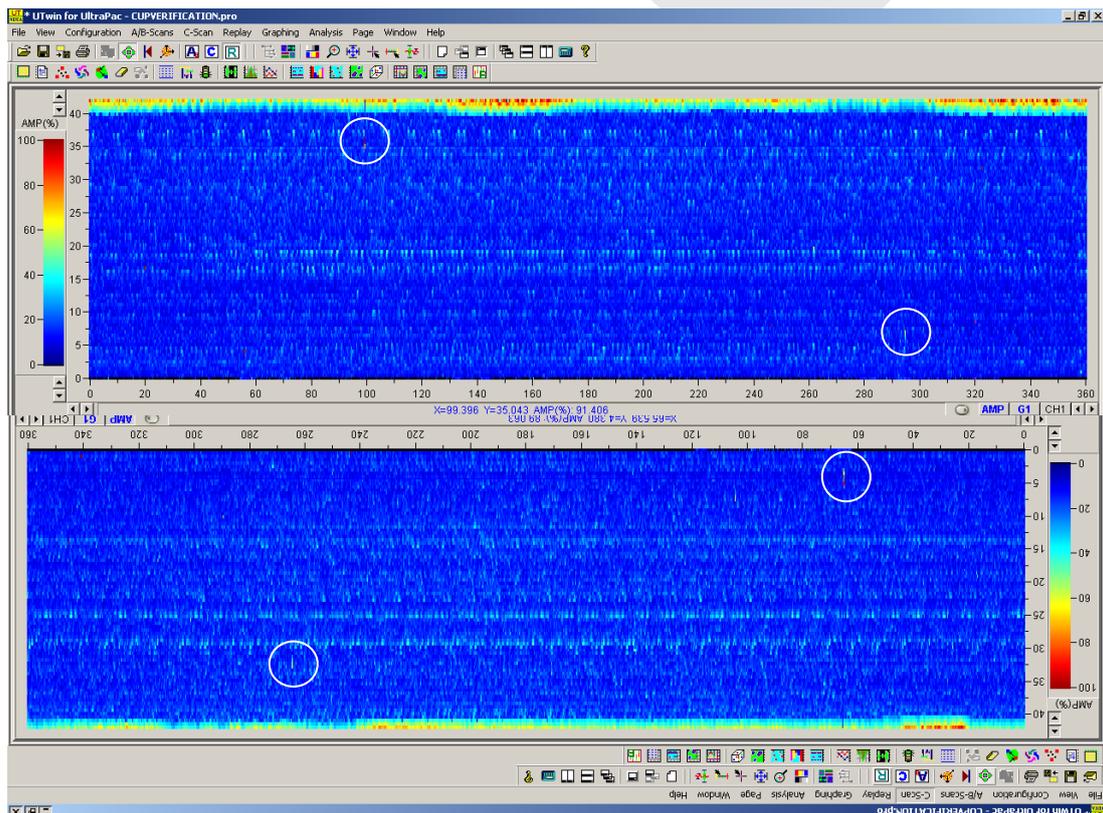
Figure 3 is a representative scan image from the UNL ultrasonic surface wave scanning system (degrees and mm) for Test Cup C. The high amplitude indications along the top and bottom of the UNL scan image should be ignored as they represent the edges of the raceways. Finally, it should be noted that clean (defect-free) cups were used in the service life testing of cones with subsurface inclusions, and clean cones were used in the service life testing of cups with near-raceway inclusions. The latter was done in an effort to isolate the chance of premature failure to the bearing components that contain subsurface inclusions in the raceways. Rollers and other bearing components were not inspected for subsurface inclusions. In total, eight cones (inner rings) and three cups (outer rings) were used to carry out two consecutive service life tests utilizing the dynamic four-bearing test rig at the University of Texas-Pan American (UTPA). For brevity, the work presented here will mainly focus on the service life testing performed on the bearing cups as the earlier study conducted on the bearing cones has been published elsewhere [13]. However, a summary of the main results from the service life testing of cones (inner rings) is also provided.

Figure 3: A scan image of the inspection performed on Test Cup C which indicates the presence of four distinct sub-surface inclusions on the inboard (top) and outboard (bottom) raceways [Refer to Table 1]

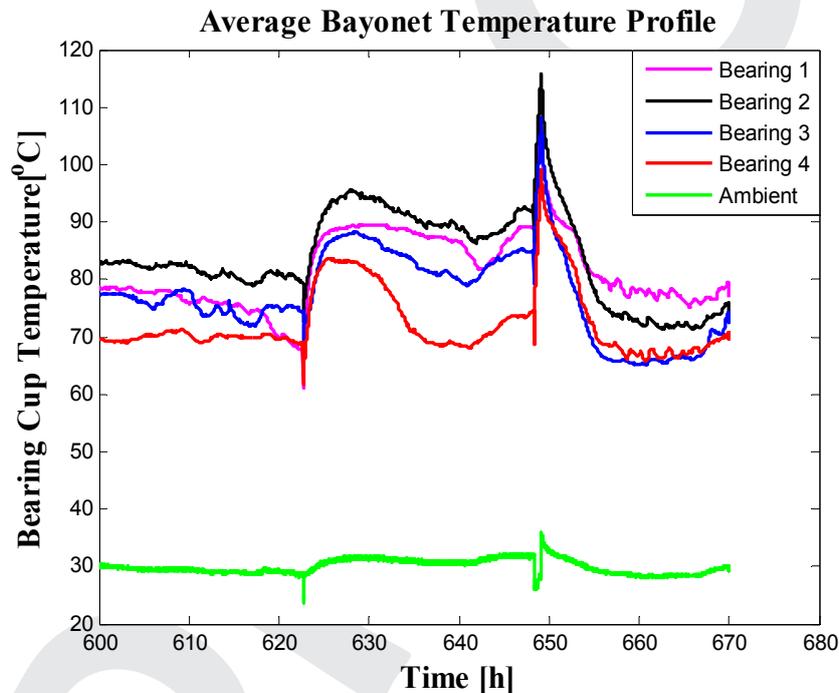
Figure 6: Average temperature profiles of all four bearings prior to the first teardown

Here the temperature profiles are shown because temperature is the primary identifier for degrading bearings in the railroad industry. Alternative methods based on the vibration signature, such as tracking of the vibration energy of a bearing, have been shown to be more effective in certain cases [14], yet this method is not established in the industry. Vibration events usually precede temperature fluctuations, especially when defects develop within the bearing. In this case, after 114,294 km (71,019 mi) of operation, an increase in the vibration energy of Bearing 3 was observed. Consequently, the bearing tester was stopped after running 115,799

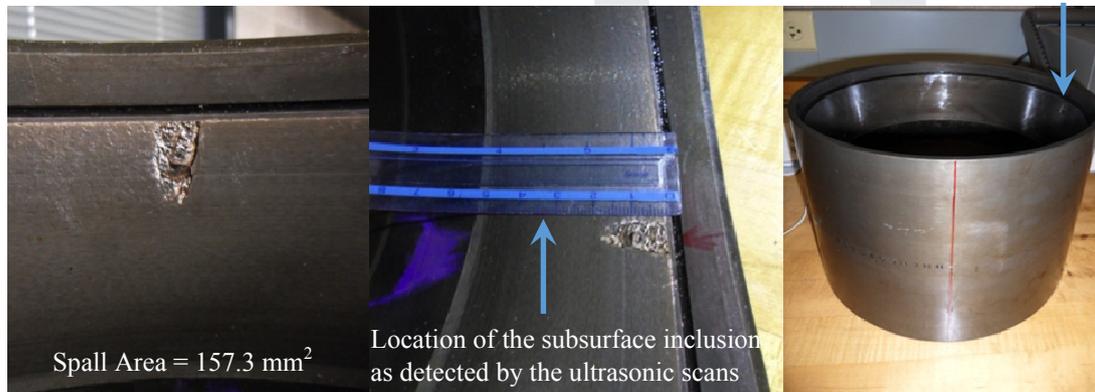
Upon teardown and inspection of the bearings, a spall was found on the cup outboard (OB) raceway of Bearing 3 (Test Cup C). The spall was located at  $\theta = 264^\circ$ , which matched the  $\theta$  for one of the subsurface indications on the outboard (OB) raceway as detected by the ultrasonic surface wave scans. However, the spall initiated at the top of the raceway ( $z < 20$  mm) and is approximately 16.05 mm long and 9.80 mm wide ( $0.632 \times 0.386$  in.), as shown in Figure 7, a location different from the subsurface inclusion detected at  $z = 32.7$  mm (see Table 1). This spall formed after only 115,799 km (71,954 mi) of bearing operation at 85 mph and 125% load.

Figure 7: Photographs of the first cup spall that developed on Bearing 3 (Test Cup C) – Teardown 1

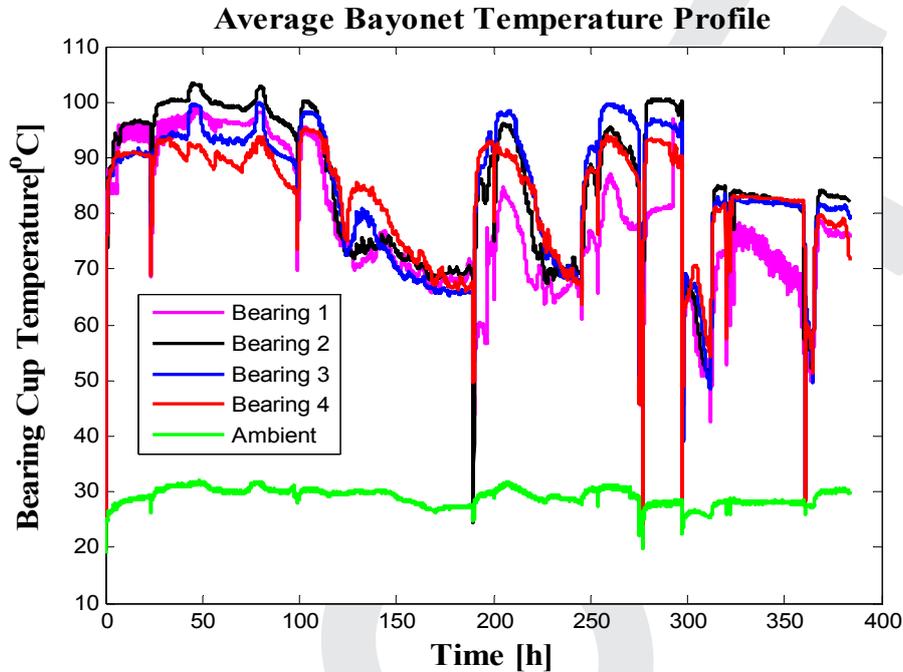
Upon continuation of the service life test, temperature and vibration of all four bearings were closely monitored. The large temperature increases and decreases seen in Figure 8 are a direct consequence of sudden changes in load or short period test stoppages. Bearing temperatures varied greatly throughout the experiment; Bearing 2 (Test Cup C), previously Bearing 3, occasionally displayed temperatures

higher than the other three bearings, including the last ten hours of the experiment. Moreover, the vibration energy of Bearing 2 exhibited a discernible increase after running for 118,897 km (73,879 mi). Consequently, the bearing tester was stopped after a total of 238,260 km (148,048 mi) of operation to perform a second teardown and inspection of all bearings.

Figure 8: Average temperature profiles of all four bearings after the first teardown and prior to the second teardown

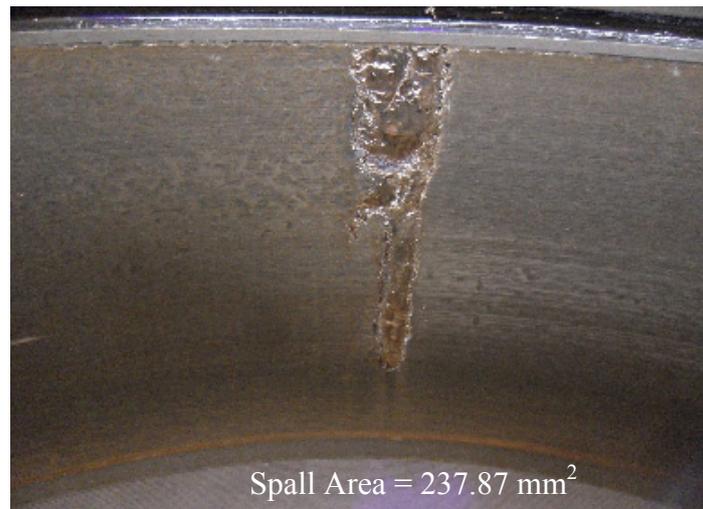
Upon teardown and inspection of the test bearings, the existing spall on Bearing 2 (Test Cup C) was found to have deteriorated significantly. The spall, located at  $\theta = 264^\circ$ , now had a maximum length of 36.42 mm and a maximum width of 9.39 mm, which constitutes an increase in the spall area from 157.3 mm<sup>2</sup> in the first teardown to 237.87 mm<sup>2</sup> in the second teardown. The new spall length now coincides with the subsurface inclusion location ( $z = 32.7$  mm, see Table 1). An important observation from the deteriorated spall, shown in Figure 9, is that the initial spall area is deeper into the raceway than that of the spall growth area. This result is not surprising given the fact that the initial spall developed while under maximum load, whereas, the deterioration occurred with the spall positioned in the unloaded region of the outer ring (cup).

Figure 9: Photograph of the cup spall on Bearing 2 (Test Cup C) after deterioration – Teardown 2

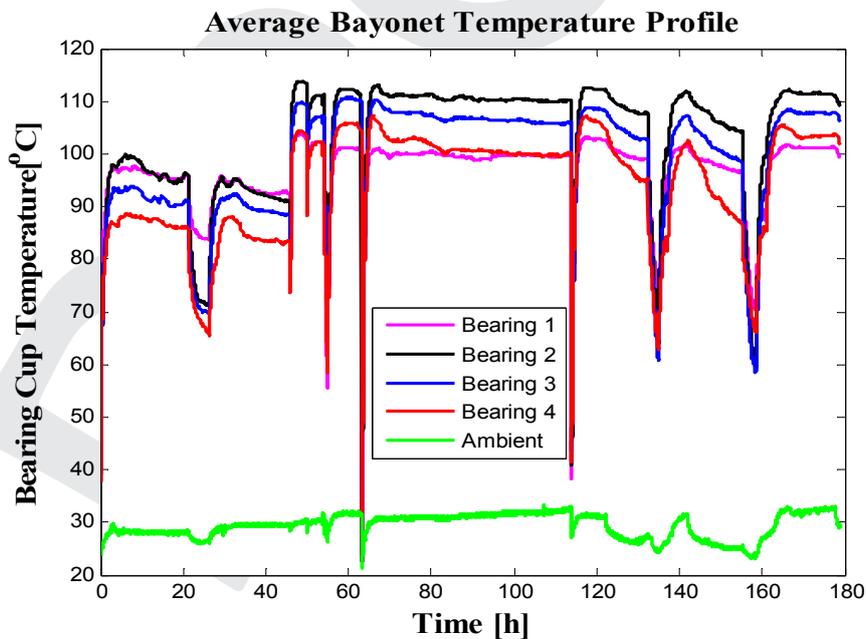
Upon continuation of the service life test, it was noticed that the temperature of the defective Bearing 2 (Test Cup C) was now consistently higher than the defect-free bearings, as can be seen in Figure 10. Furthermore, shortly after the test was resumed for an additional 20,500 km (12,738 mi), a significant increase in the vibration energy of Bearing 2 was detected, suggesting further deterioration of the existing spall. Consequently, the bearing tester was stopped after a total of 262,604 km (163,174.5 mi) of operation to carry out a third teardown and inspection of all test bearings.

Figure 10: Average temperature profiles of all four bearings after the second teardown and prior to the third teardown

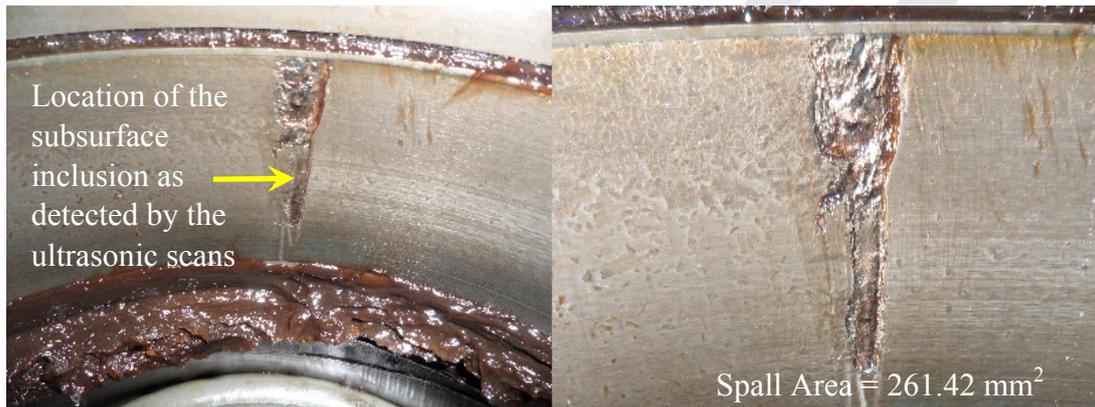
Upon teardown and visual inspection of the bearings, the existing spall on Bearing 2 (Test Cup C) was found to have deteriorated further. While the maximum length and width of the spall remained the same as in the second teardown, the wider region of the spall increased in length, thus, changing the total area of the spall from 237.87 mm<sup>2</sup> to 261.42 mm<sup>2</sup>, as shown in Figure 11.

Figure 11: Photographs of the cup spall on Bearing 2 (Test Cup C) after second sign of deterioration – Teardown 3

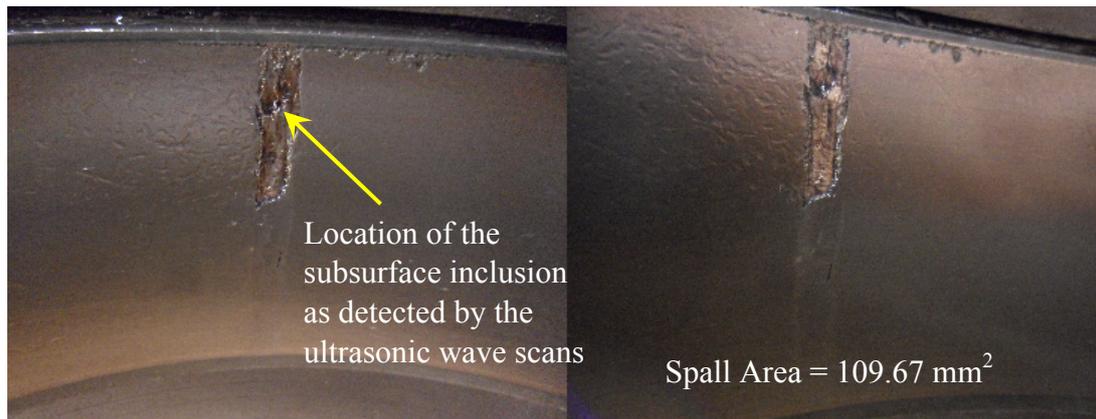
Upon teardown and visual inspection of the bearings, a new spall was found on the inboard (IB) cup raceway of Bearing 2 (Test Cup C). The new spall was located at  $\theta = 295^\circ$ , which matched the  $\theta$  for one of the near-surface inclusions on the IB raceway as detected by the ultrasonic surface wave scans (see Table 1). The spall was approximately 20.85 mm long and 5.26 mm wide (0.821 × 0.207 in.), as shown in Figure 12, and coincided perfectly with the subsurface inclusion detected at  $z = 6.4$  mm.

Figure 12: Photographs of the second cup spall that developed on Bearing 2 (Test Cup C) – Teardown 4

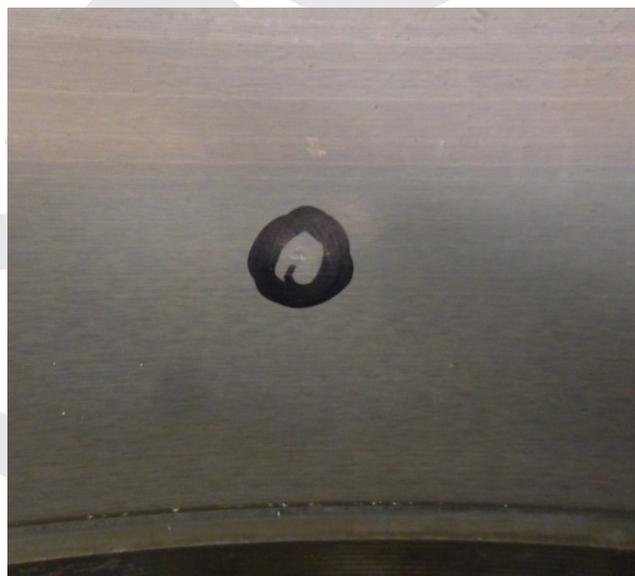
Upon close inspection of Bearing 3 (Test Cup B), the initial stages of spall formation were observed at the exact location of the near-surface inclusion detected by the ultrasonic wave scans (see Table 1). The size of the defect was very small at this stage, as shown in Figure 13. The bearing was reassembled and mounted onto the axle with the spall location placed directly under the region of maximum load (top hemisphere, 12 o'clock). The bearing/axle assembly setup was identical to that used prior to the fourth teardown. The test was resumed again and Bearings 2 and 3 were closely monitored.

Figure 13: Photograph of the initial stage of cup spall formation on Bearing 3 (Test Cup B) – Teardown 4

Upon inspection of Bearing 3, the region of the cup raceway which exhibited an initial stage of spall formation (see Figure 13) remained unchanged from the

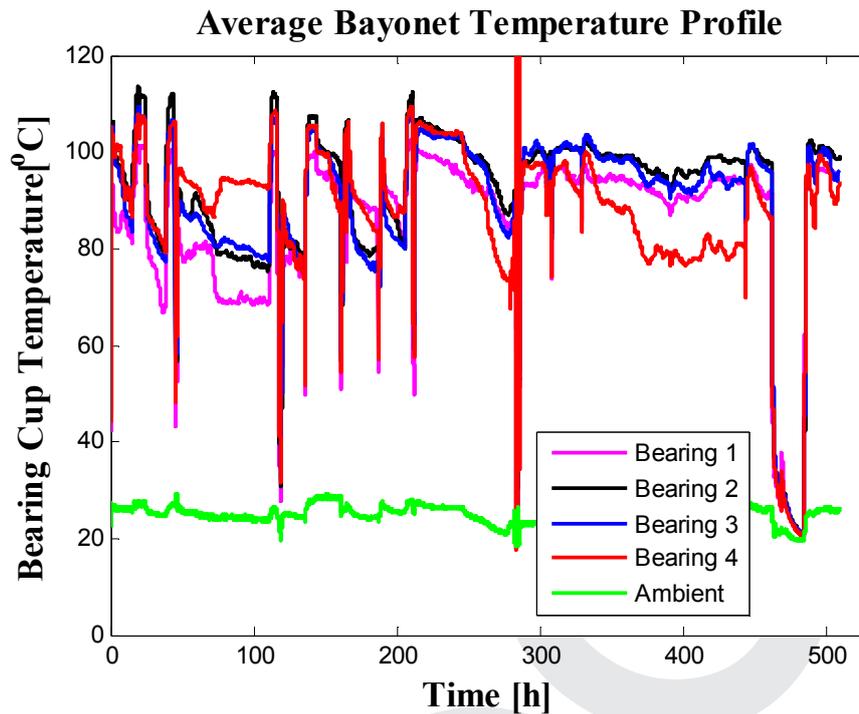
Following the fourth teardown, the bearings were run past the 402,336 km (250,000 mi) milestone completing 420,729 km (261,429 mi) of total service. The bearing temperature profiles for the last 515 hours of testing are provided in Figure 14. Note that bearing operating temperatures rarely dropped below 70°C. Similar to the temperature profiles shown previously, sudden temperature drops and increases are a consequence of short duration stops followed by restarts. The temperatures of Bearings 2 and 3 ran consistently hot and remained close to 100°C levels. However, what raised concerns was the fact that the temperature of Bearing 4 (Test Cup A) started approaching the same levels of Bearings 2 and 3 over the last 24 hours of the test coupled with a significant increase in its vibration energy.

Figure 14: Average temperature profiles of all four bearings after the fourth teardown and prior to the fifth and final teardown

The increase in the vibration energy of Bearing 4 (Test Cup A) was detected after 415,394 km (258,114 mi) of operation. A similar increase in energy was also observed in Bearing 3 (Test Cup B). The latter behaviour coupled with the visible increase in the temperature of Bearing 4 and the fact that the total test mileage exceeded the 402,336 km (250,000 mi) milestone prompted the fifth and final teardown and inspection of all four bearings involved in this service life test.

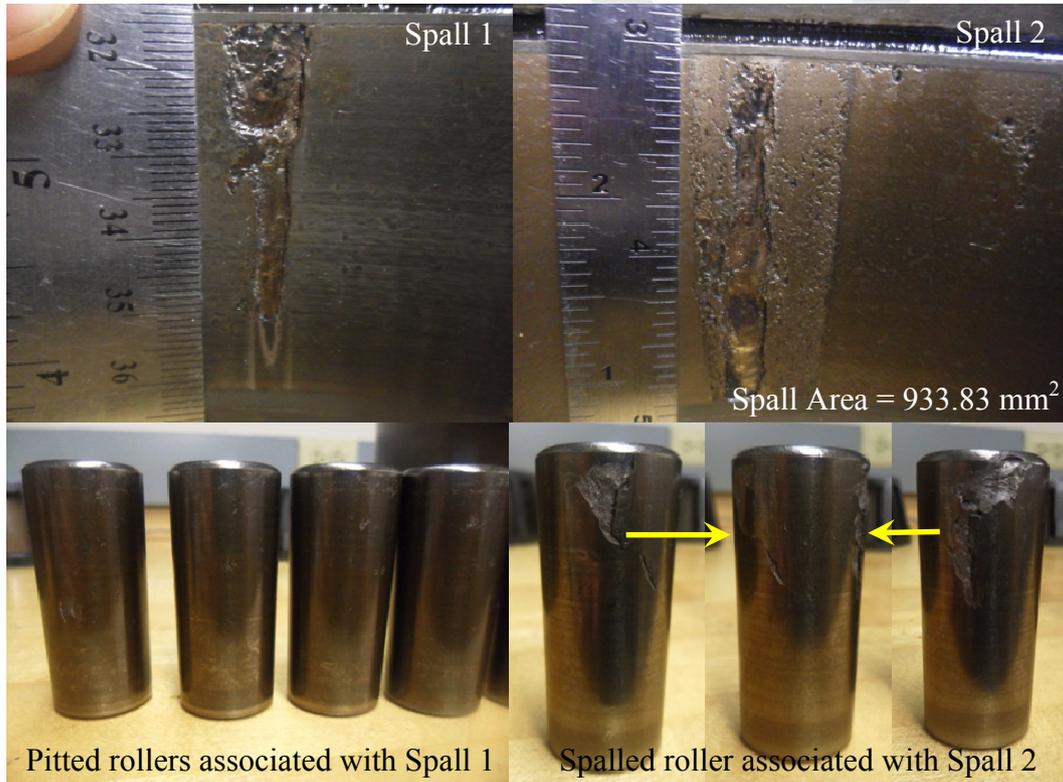
Two main observations were made upon inspection of this bearing; the area of the second cup spall (Spall 2) increased significantly to  $933.83 \text{ mm}^2$ , which corresponds to a length of 48.26 mm and a width of 19.35 mm ( $1.9 \times 0.762 \text{ in.}$ ), as shown in Figure 15. By comparing it to the size of this spall from the previous teardown ( $109.67 \text{ mm}^2$ ), Spall 2 grew eight and a half times its original area in approximately 117,285 km (72,878 mi) of operation. Moreover, one of the rollers on the cone assembly corresponding to the cup raceway containing Spall 2 was found to have formed two significant spalls, as shown in Figure 15. It was also observed that the majority of the rollers on both cone assemblies of Bearing 2 exhibit signs of minor pitting, probably resulting from the small pieces of steel coming off the spalled raceways and roller. The area of Spall 1 did not experience any noticeable increase in size, which is not surprising considering this spall was positioned in the unloaded region (bottom hemisphere, 6 o'clock) of the bearing as opposed to Spall 2 which was placed directly under the maximum load region (top hemisphere, 12 o'clock).

Figure 15: Photographs of Spall 1 (left) and Spall 2 (right) on Bearing 2 (Test Cup C) and the condition of the associated rollers upon final inspection – Teardown 5

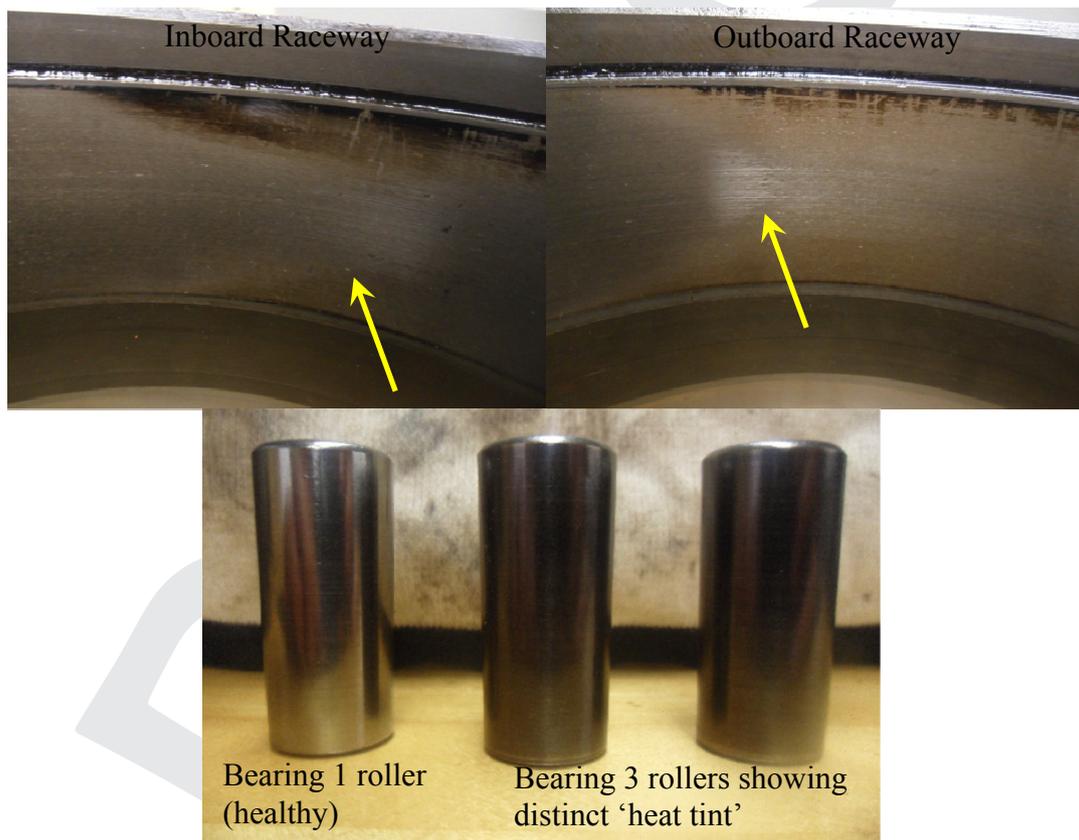
previous teardown, and no other spalls were found on the cup raceways. However, the vibration energy of this particular bearing was relatively high compared to that of a defect-free (healthy) bearing (Bearing 1). Moreover, the operating temperature of this bearing was among the highest for the majority of the service life test. A closer look at the rollers of both cone assemblies from this bearing revealed an abnormal discoloration resembling a distinct heat tint (see Figure 16) likely caused by the excessive heat generation within this bearing. This behavior is typical of temperature-trended bearings in which the high levels of vibration energy within the bearing tend to induce frequent roller misalignment, which in turn causes some of these rollers to be caught misaligned as they enter the loaded region of the bearing, thus, generating excessive frictional heating through roller skidding [15]. The aforementioned statement is further validated by the irregular wear patterns visible on both cup raceways of Bearing 3, seen in Figure 16. The figure also demonstrates the roller discoloration observed in the rollers of Bearing 3. The first roller on the left, seen in Figure 16, is a roller from the defect-free (healthy) Bearing 1 which ran the same exact distance as the two rollers on the right, which were taken from the two cone assemblies of Bearing 3.

Figure 16: Photographs showing the irregular wear patterns on the inboard and outboard raceways of Bearing 3 (Test Cup B) and a comparison of a roller from Bearing 1 (Healthy) and two rollers from Bearing 3 to demonstrate the “heat tint” discoloration – Teardown 5

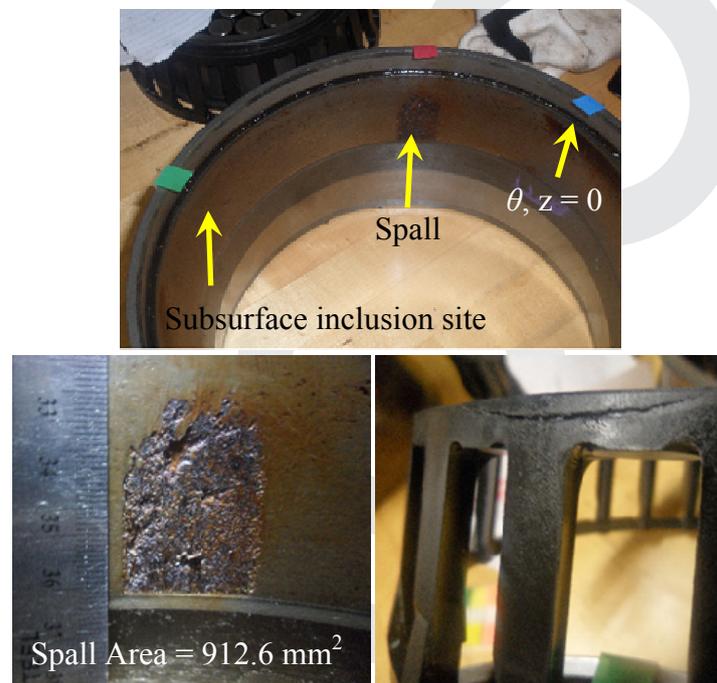
Upon teardown and inspection of Bearing 4, a large spall was found on the inboard (IB) cup raceway. The spall was located at  $\theta = 310^\circ$  as indicated in Figure 17, which did not match the  $\theta$  for the subsurface inclusion on the IB raceway as detected by the ultrasonic surface wave scans ( $\theta = 244.1^\circ$ ). The chosen origin ( $\theta = 0^\circ$ ) in the ultrasonic surface wave scans is shown in Figure 17, and the angle  $\theta$  is measured clockwise from the origin for the IB raceway. The spall size is approximately 36.00 mm long and 25.35 mm wide ( $1.417 \times 0.998$  in.), as seen in Figure 17. More importantly, the spall developed and reached its final area of  $912.6 \text{ mm}^2$  ( $1.414 \text{ in}^2$ ) within only 5,335 km (3,315 mi) of operation. Furthermore, a closer inspection of the cone assemblies revealed that the polyamide cage corresponding to the spalled raceway formed a substantial crack, as shown in Figure 17.

Figure 17: Pictures of the cup spall that developed on Bearing 4 (Test Cup A) and the associated cage damage – Teardown 5

Note that the ultrasonic surface wave scans are sensitive to near-surface inclusions within  $200 \mu\text{m}$  from the surface. The spall that initiated in Bearing 4 was possibly caused by an inclusion that was deeper than the scanned region. For future work, the depth of the scans from the surface needs to be adjusted to capture relevant inclusions that might be a little deeper beyond the Hertzian contact stress region ( $\sim 200 \mu\text{m}$ ). Nonetheless, the rate at which the spall developed and deteriorated in such a short period of operation is yet another example of the importance of steel cleanliness, and underscores the need to use ultrasonic surface wave scans as a quality control tool. The results of the service life tests performed on the ultrasonically scanned cups (outer rings) and cones (inner rings) are summarized in Table 4 and Table 5, respectively.
