SERVICE LIFE TESTING OF RAILROAD BEARINGS WITH KNOWN SUBSURFACE INCLUSIONS DETECTED WITH ADVANCED ULTRASONIC TECHNOLOGY

Railways 2014

C.M. Tarawneh¹, J.A. Turner², L. Koester², B.M. Wilson³

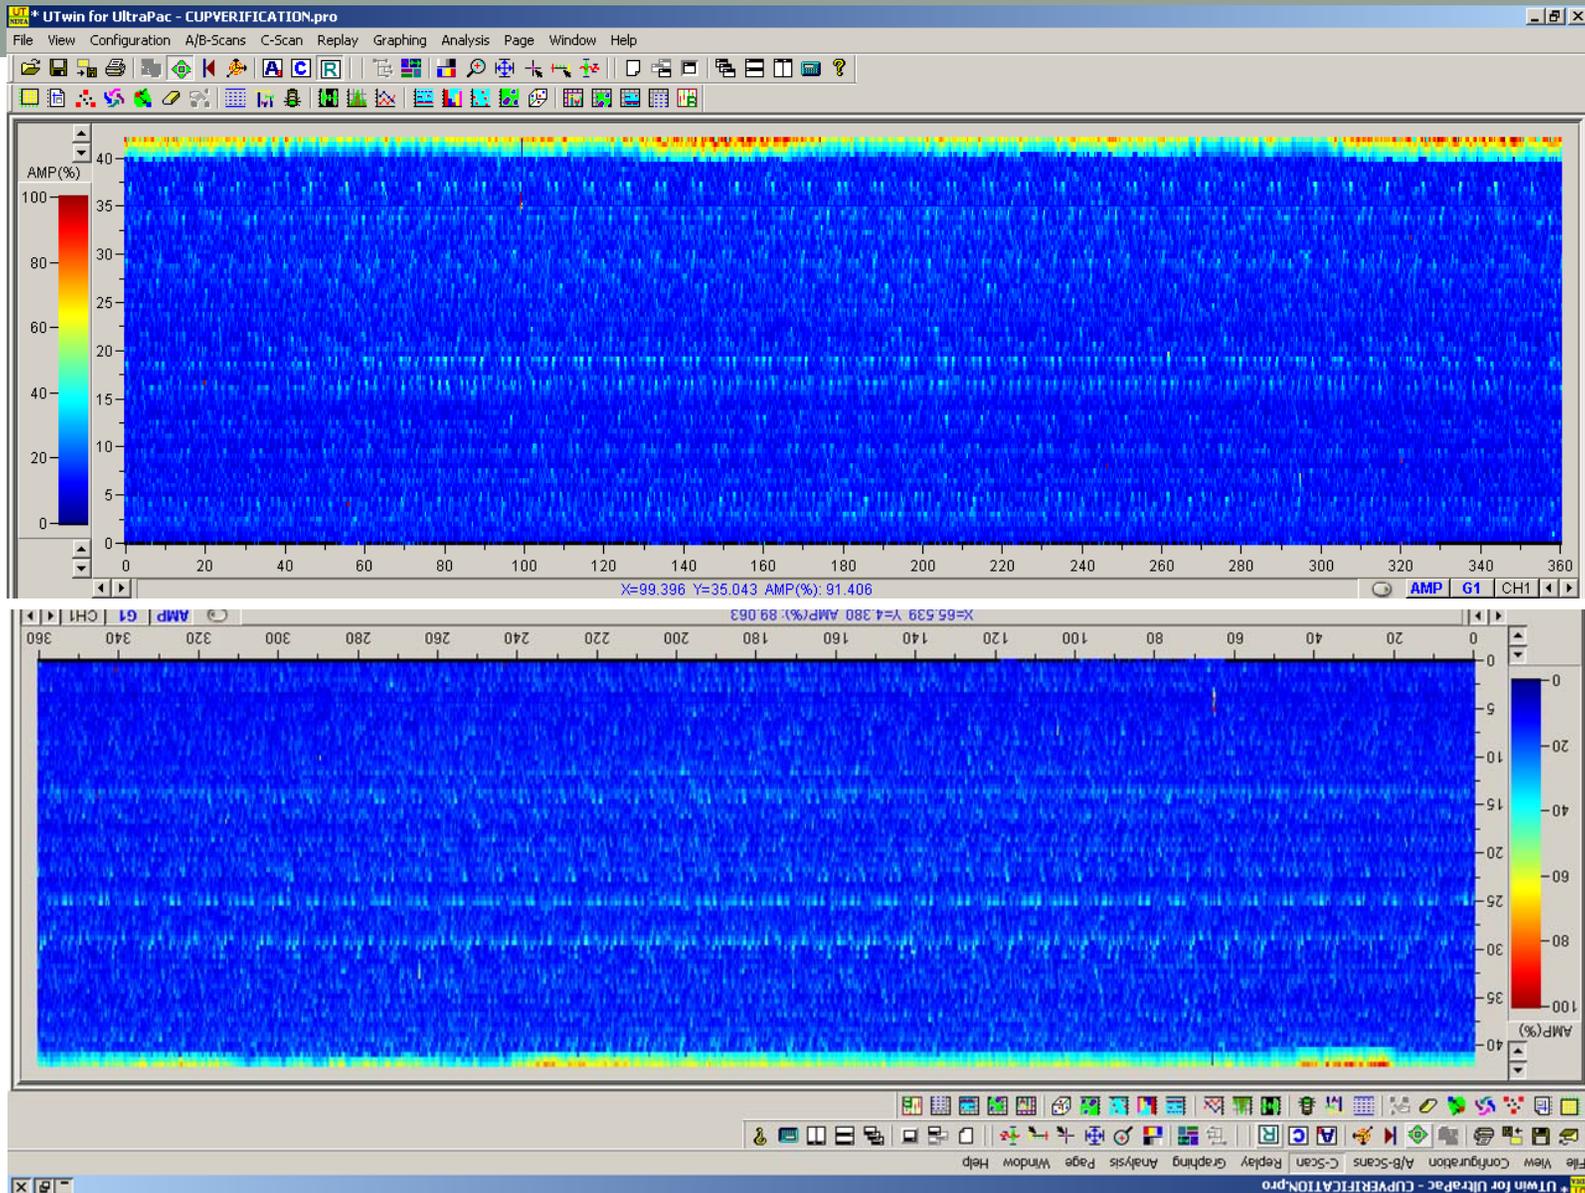
Figure 4: A scan image of the inspection performed on Test Cup C which indicates the presence of four distinct sub-surface inclusions on the inboard (top) and outboard (bottom) raceways

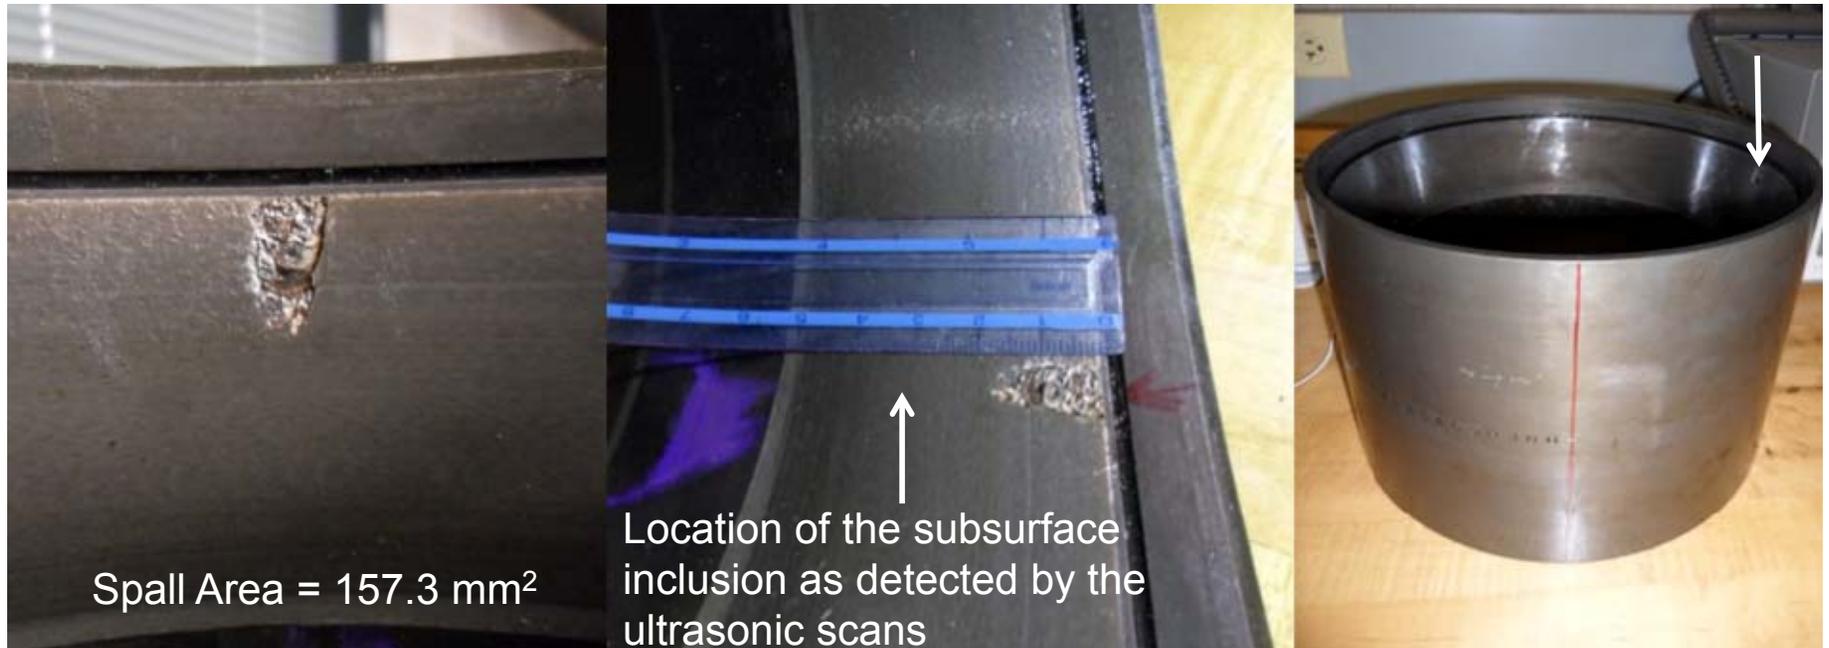
- Spall found Bearing 3 (Test Cup C)
 - Cup outboard (OB) raceway
 - $\theta = 264^\circ$ (matched θ from Table 1)
 - Top of raceway ($z < 20$ mm)
 - 16.05 mm long and 9.80 mm wide (0.632 × 0.386 in.)
- Subsurface inclusion detected at $z = 32.7$ mm (Table 1)
- Spall formed after 115,799 km (71,954 mi) at 85 mph and 125% load.

Figure 8: Photographs of the first cup spall that developed on Bearing 3 (Test Cup C) – Teardown 1

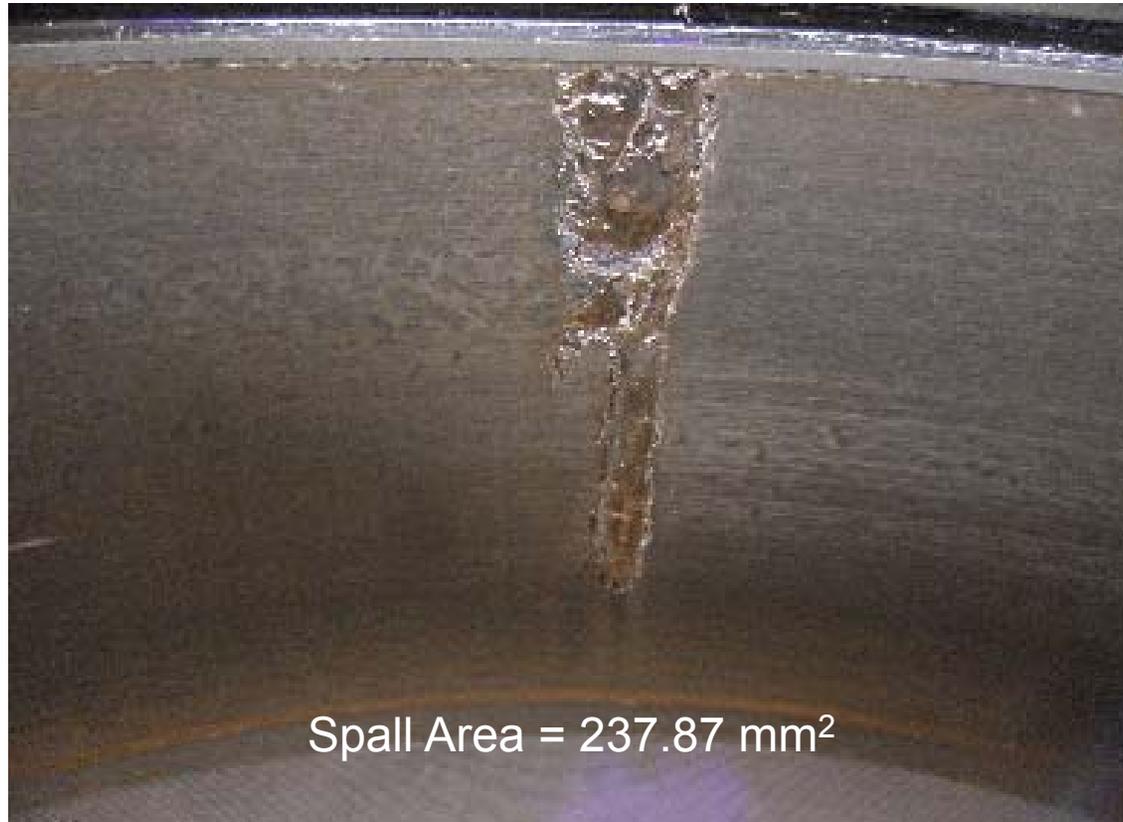
- Deterioration of existing spall on Bearing 2 (Test Cup C)
 - $\theta = 264^\circ$
 - Size increased to a maximum length of 36.42 mm and a maximum width of 9.39 mm
 - Area increased from 157.3 mm² (first teardown) to 237.87 mm² (second teardown)
- New spall length coincides with subsurface inclusion location ($z = 32.7$ mm, Table 1)

Figure 10: Photograph of the cup spall on Bearing 2 (Test Cup C) after deterioration – Teardown 2

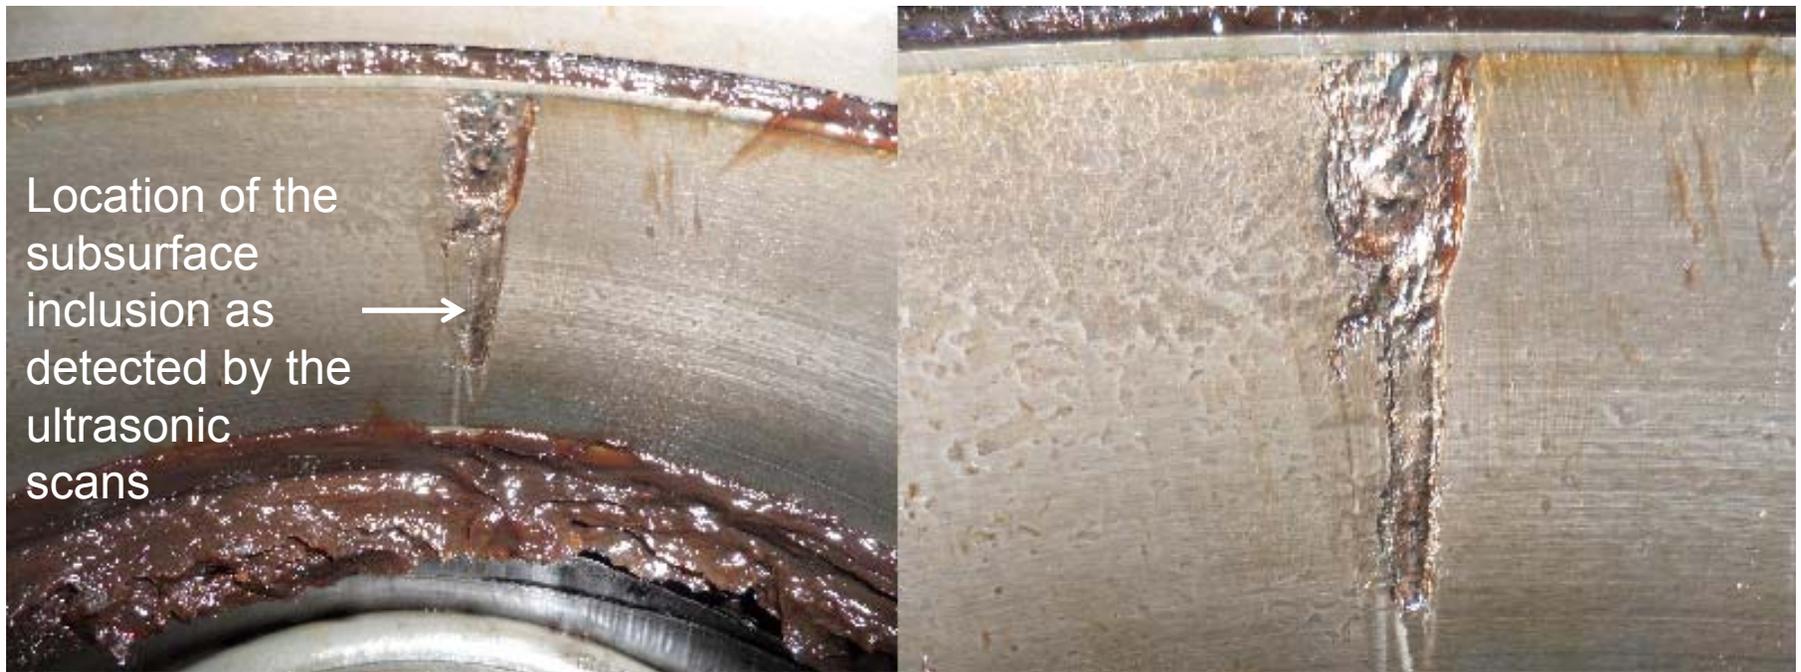
- Further deterioration of the existing spall on Bearing 2 (Test Cup C) was discovered.
 - Maximum length and width remained the same as in the second teardown.
 - Wider region of spall increased in length.
 - Total area changed from 237.87 mm² to 261.42 mm²

Figure 12: Photographs of the cup spall on Bearing 2 (Test Cup C) after second sign of deterioration – Teardown 3

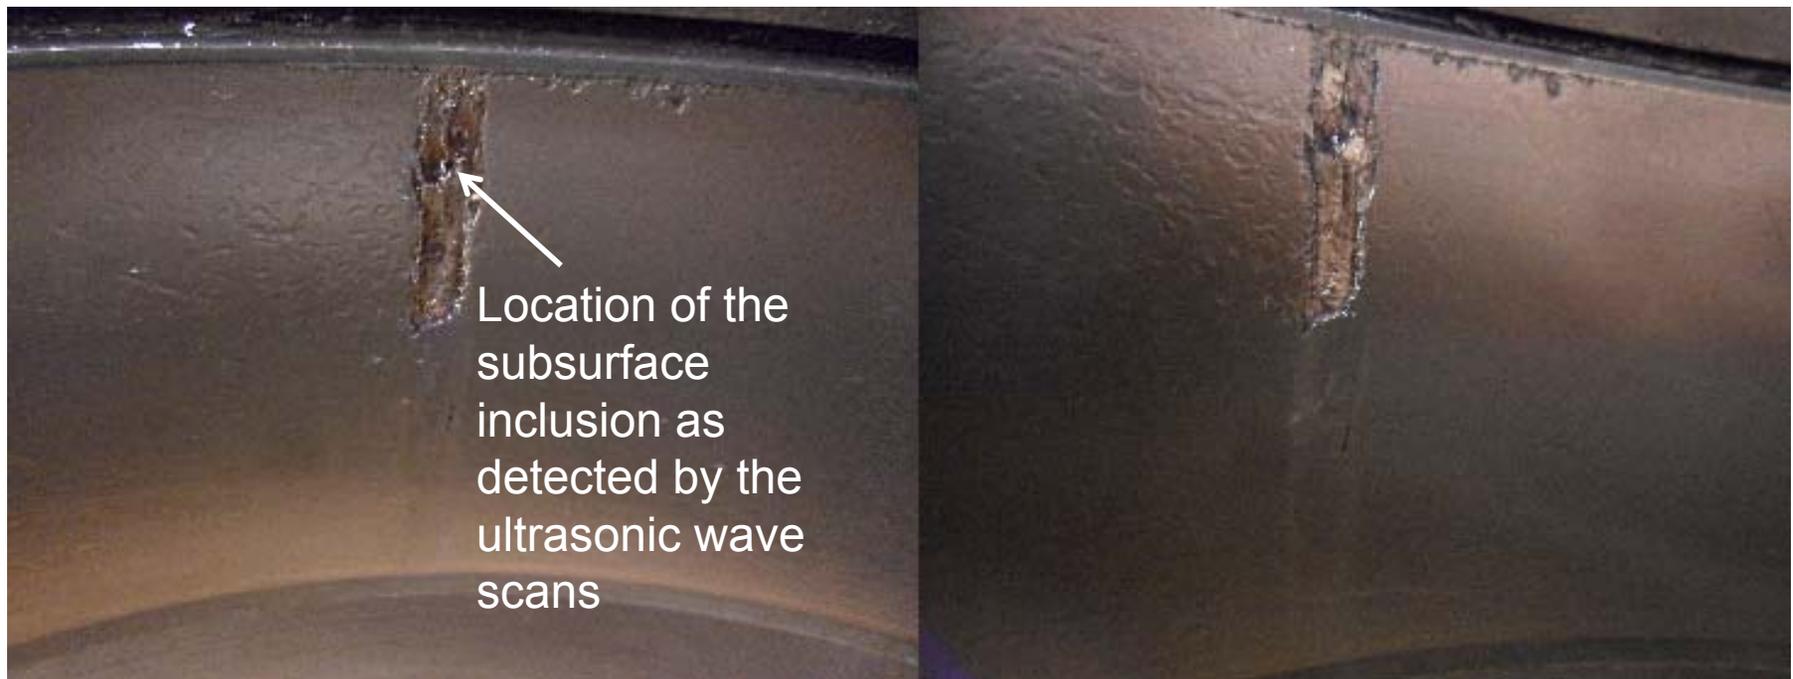
- New spall discovered on Bearing 2 (Test Cup C)
 - Inboard (IB) cup raceway
 - $\theta = 295^\circ$ (matched θ from Table 1)
 - Approx. 20.85 mm long and 5.26 mm wide (0.821 × 0.207 in)
 - $z = 6.4$ mm (coincident to z from Table 1)

Figure 13: Photographs of the second cup spall that developed on Bearing 2 (Test Cup C) – Teardown 4

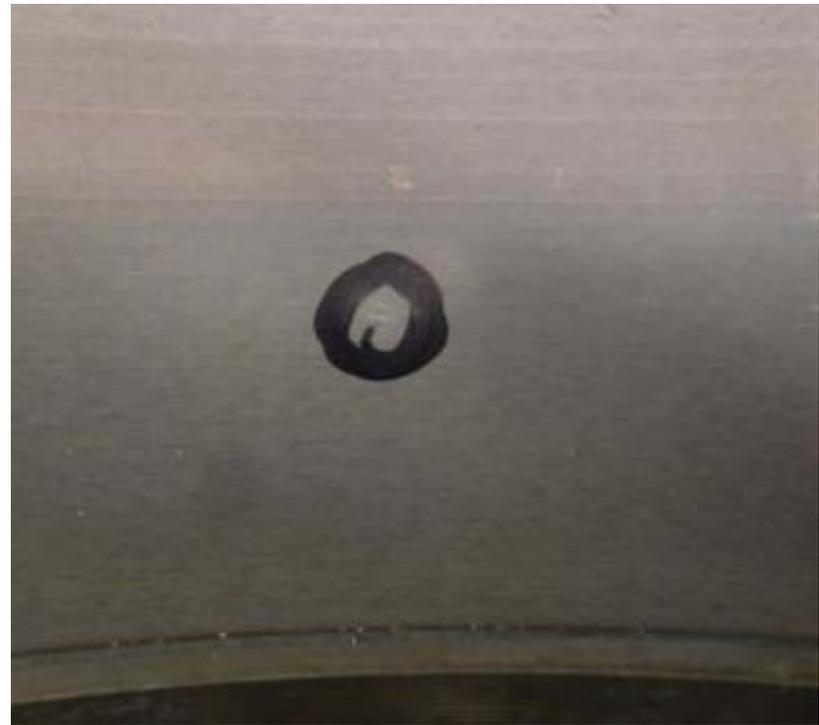
- Initial stages of spall formation on Bearing 3 (Test Cup B)
- Location of near-surface inclusion matching location from ultrasonic wave scans (Table 1)
- Spall location placed directly under maximum load region.

Figure 14: Photograph of the initial stage of cup spall formation on Bearing 3 (Test Cup B) – Teardown 4

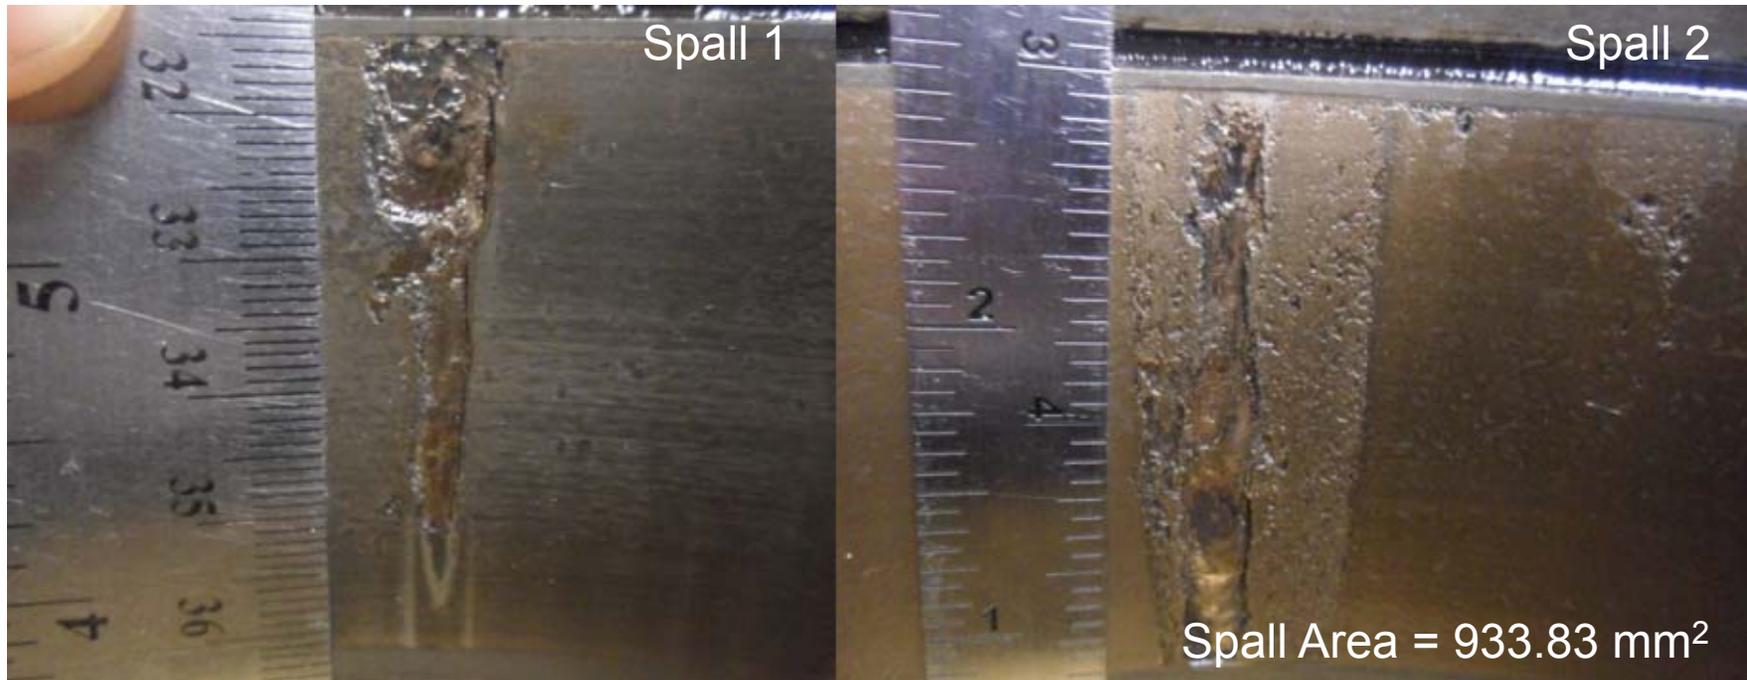
Figure 16: Photographs of Spall 1 (left) and Spall 2 (right) on Bearing 2 (Test Cup C) – Teardown 5

- Significant increase in area of second cup spall (Spall 2).
 - Length of 48.26 mm and a width of 19.35 mm (1.9 × 0.762 in)
 - Area increased from 109.67 mm² to 933.83 mm²
 - Spall 2 grew 8.5 times its original area
 - 117,285 km (72,878 mi)
- Corresponding roller to Spall 2 found to have two spalls (Figure 17).
- Rollers on both cone assemblies exhibited pitting.
- No noticeable increase in size of Spall 1.
 - Positioned in unloaded zone, unlike Spall 2

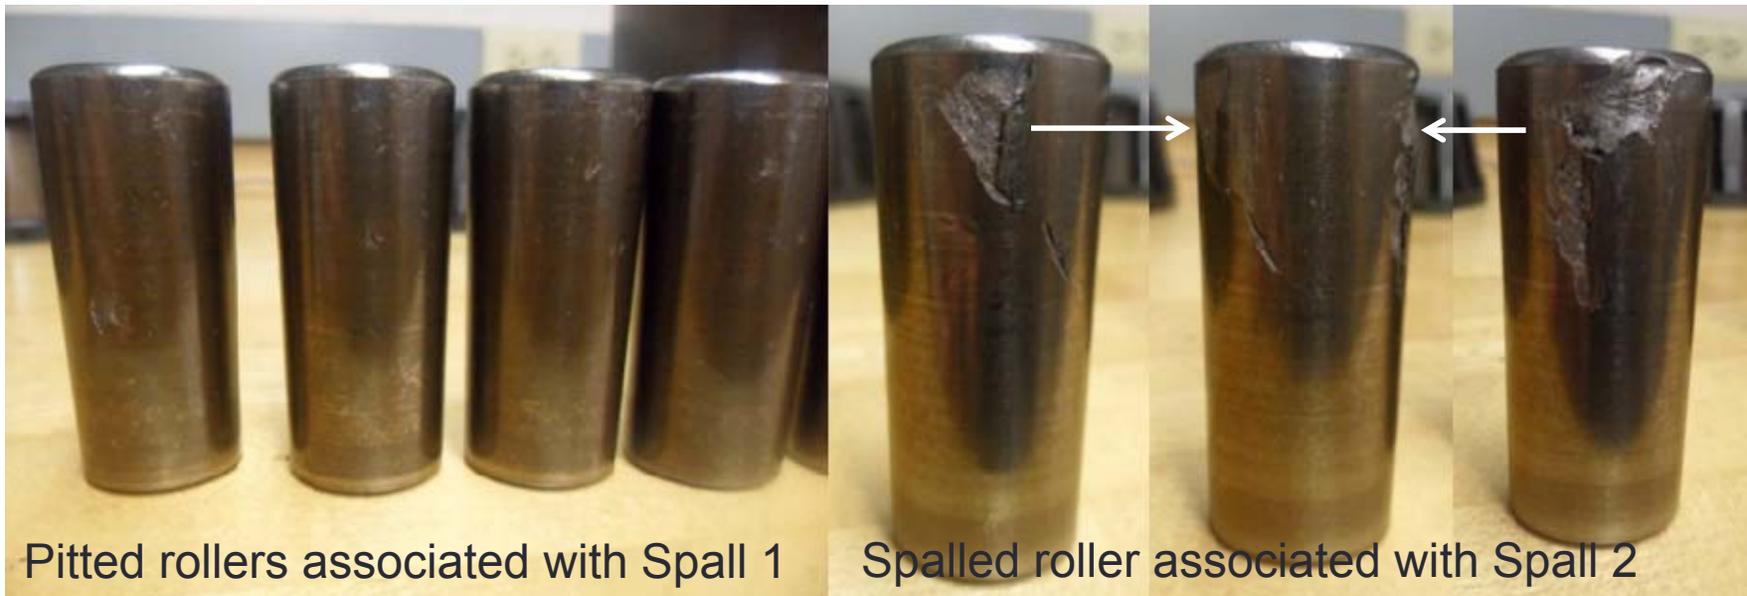
Figure 17: Photographs of the condition of the associated rollers with Spall 1 (left) and Spall 2 (right) of Bearing 2 (Test Cup C) upon final inspection – Teardown 5

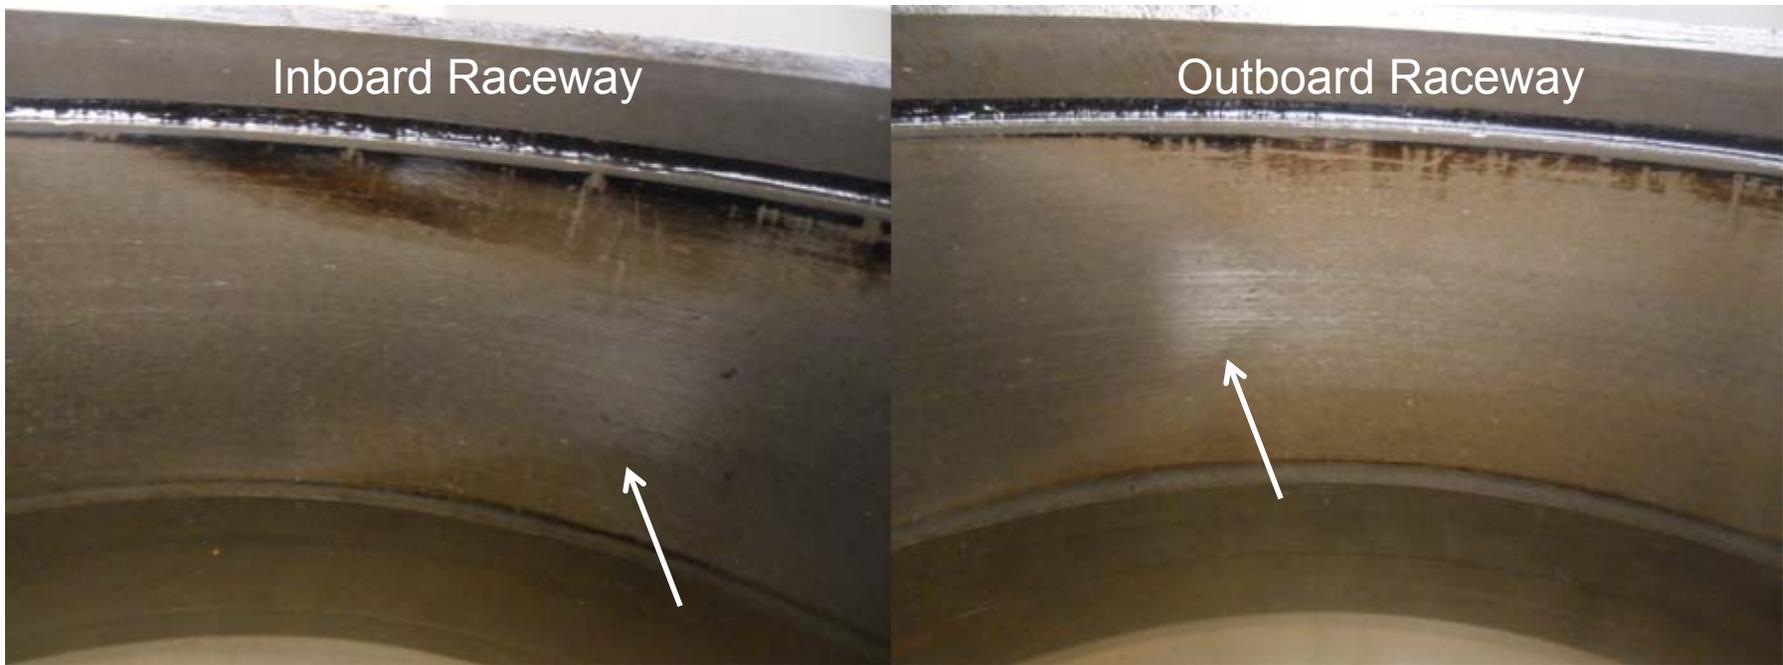
Figure 18: Photographs showing the irregular wear patterns on the inboard and outboard raceways of Bearing 3 (Test Cup B) – Teardown 5

- No change in initial stage of spall formation (Figure 14) from previous teardown.
- High vibration energy compared to Bearing 1 (defect-free bearing).
- One of the highest operating temperatures.
- Abnormal discoloration of rollers similar to a distinct heat tint (Figure 19).
- Irregular wear patterns visible on both cup raceways (Figure 18).

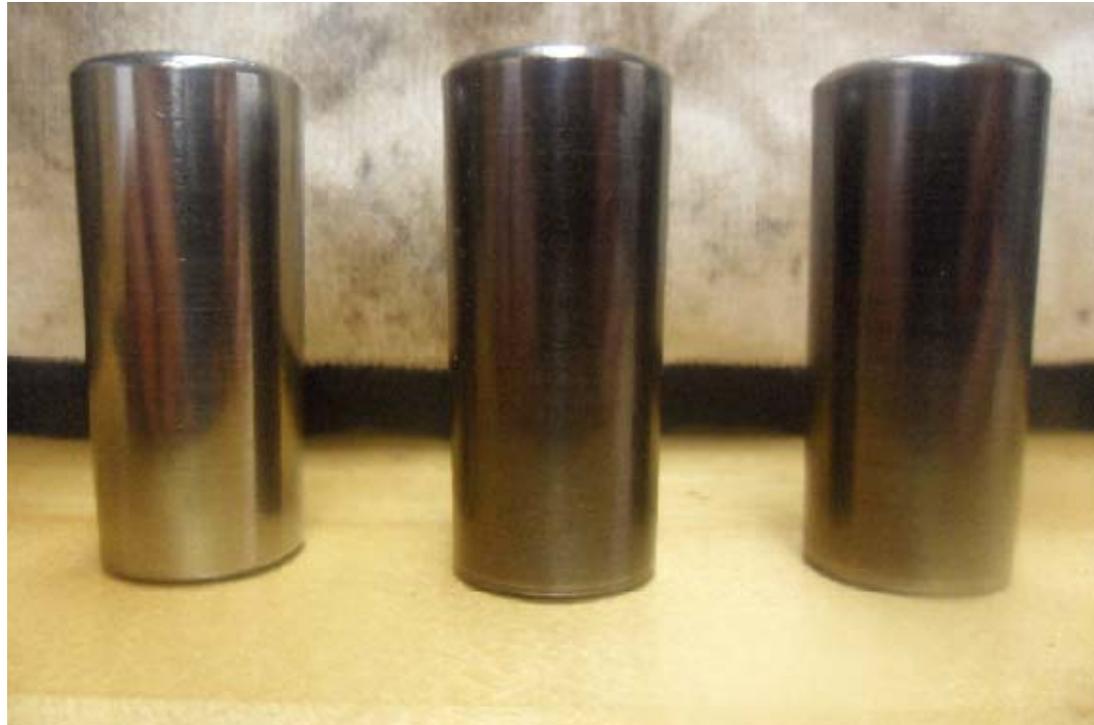
Figure 19: Photograph of a comparison of a roller from Bearing 1 (Healthy) and two rollers Bearing 3 to demonstrate the “heat tint” discoloration – Teardown 5

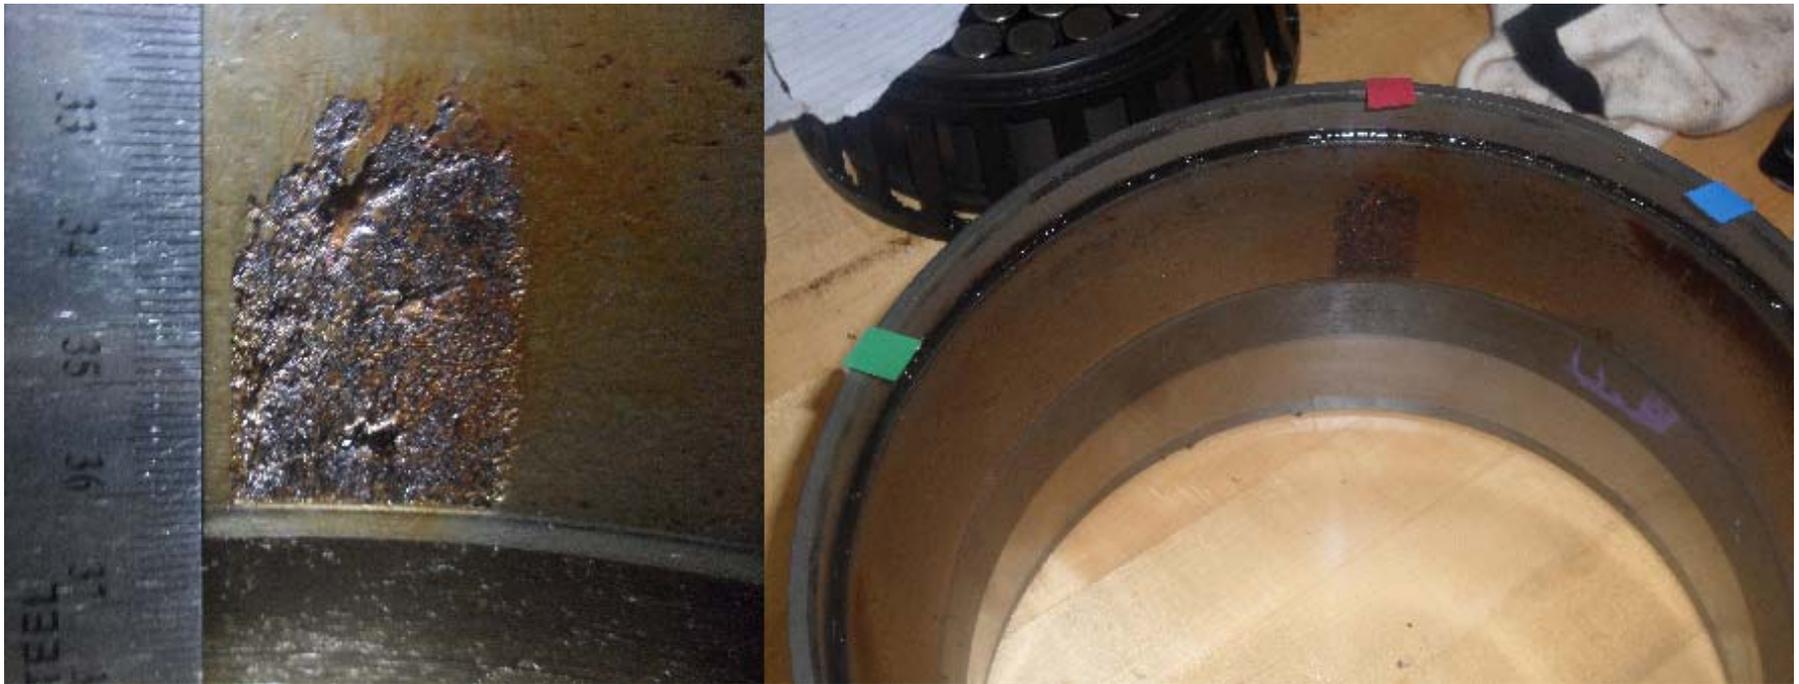
Figure 20: Pictures of the cup spall that developed on Bearing 4 (Test Cup A) – Teardown 5

- Inspection of Bearing 4 revealed a large cup spall
 - Inboard (IB) cup raceway
 - $\theta = 310^\circ \neq 244.1^\circ$ (Table 1)
 - Approx. 36.00 mm long and 25.35 mm wide (1.417 × 0.998 in.)
 - Reached an area of 912.6 mm² (1.414 in²) within 5,335 km (3,315 mi) of operation
- Polyamide cage corresponding to spalled raceway formed a large crack (Figure 21).

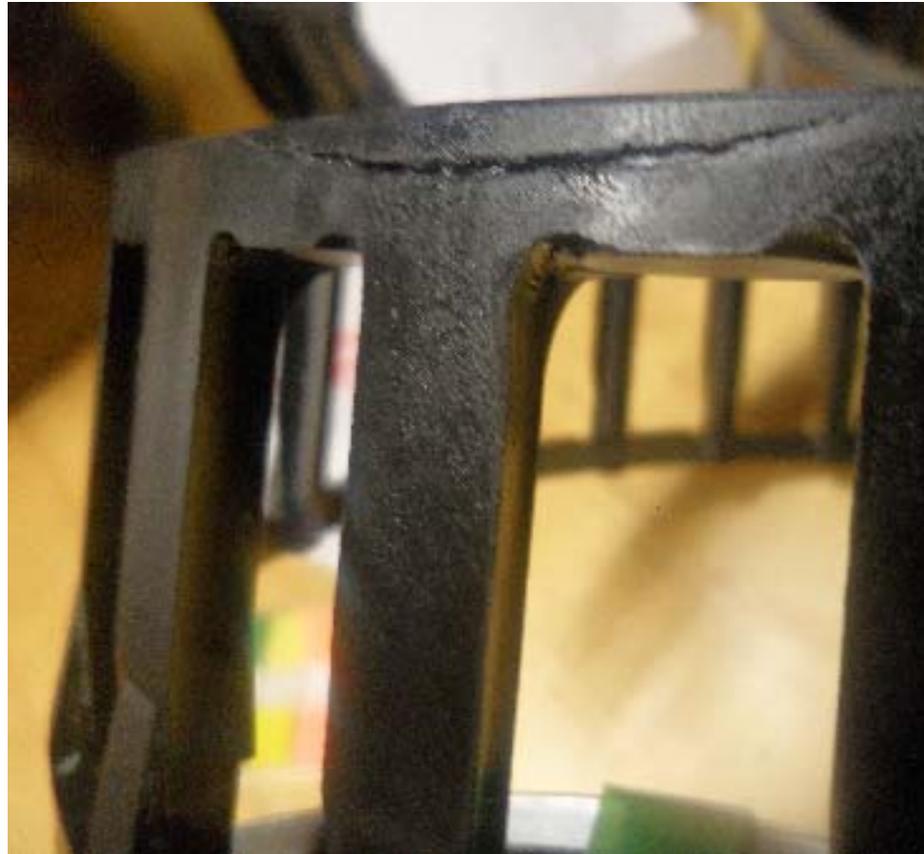
Figure 21: Photograph of the associated cage damage due to the cup spall on Bearing 4 (Test Cup A) – Teardown 5
