Effect of Long-Term Inactivity on Railcar Bearings – Year 1

A Report on Research Sponsored by

University Transportation Center for Railway Safety (UTCRS)

September 2024

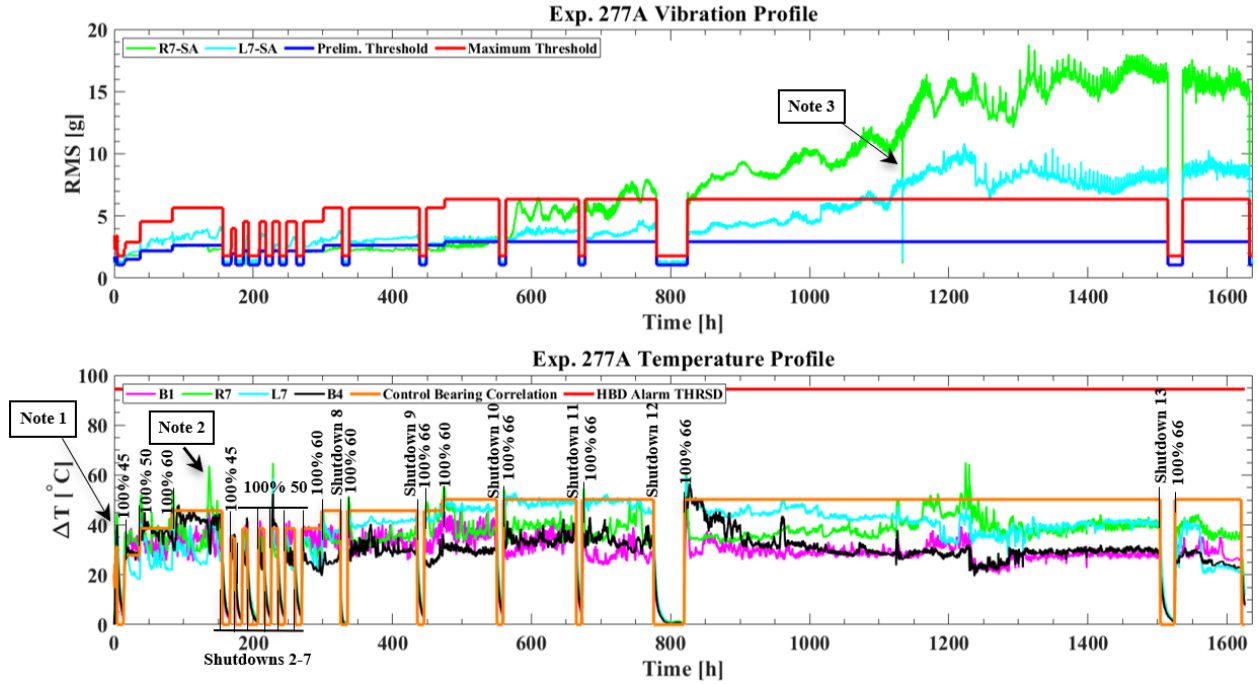
Figure 5: Vibration and temperature above ambient profiles

Examining the vibration profiles of Figure 5, it is apparent that the R7 bearing developed a defect around 724 hours into the test, as exhibited by the vibration levels exceeding the maximum threshold represented by the solid red line (i.e., level 1 vibration analysis described in reference [1]). In fact, the vibration profile of the R7 bearing suggests that the defect developed earlier, a little after 570 hours into the test, but the vibration levels did not exceed the maximum threshold until 724 hours into the test. As explained earlier, vibration levels that lie between the solid blue and red lines suggest that the bearing is possibly defective [1]. Interestingly, while the vibration levels clearly suggest that the R7 bearing developed a significant defect, the temperature profile was below the average operating temperature for healthy bearings running at the same speed and load conditions, and well below the HBD alarm threshold. Considering the significant damage observed on the R7 bearing components depicted in Figure 11-21 and summarized in Table 6, it is concerning that the bearing operating temperature did not exhibit any signs of distress.

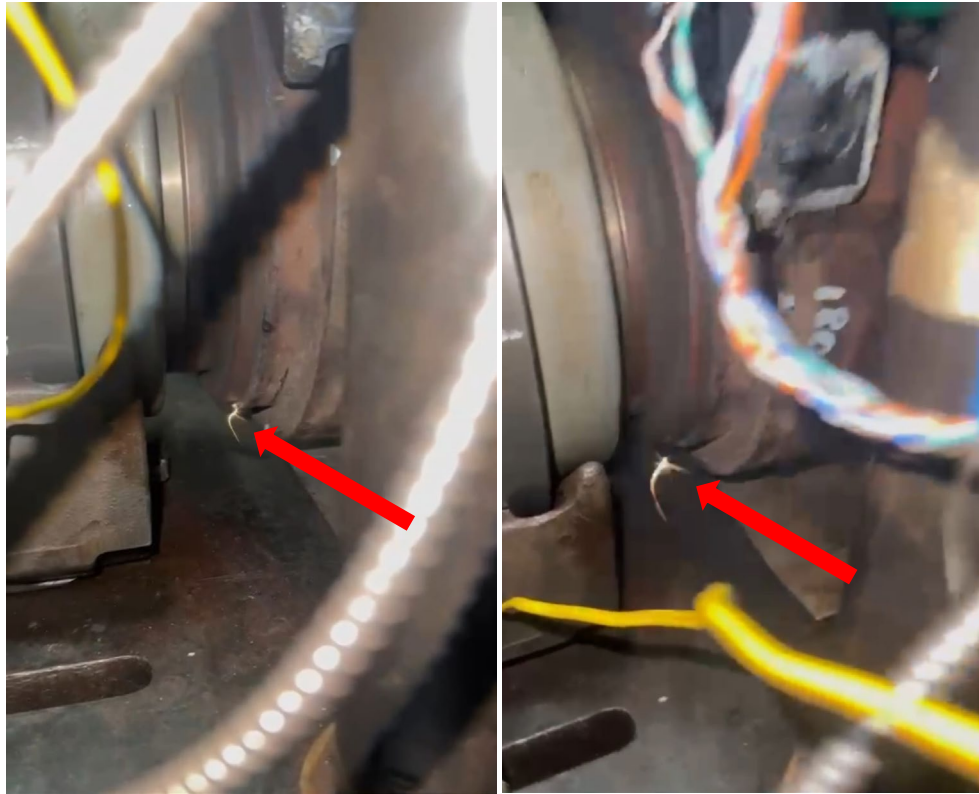
Figure 8: Pictures showing sparks emitting from the inboard seal location of R7 bearing

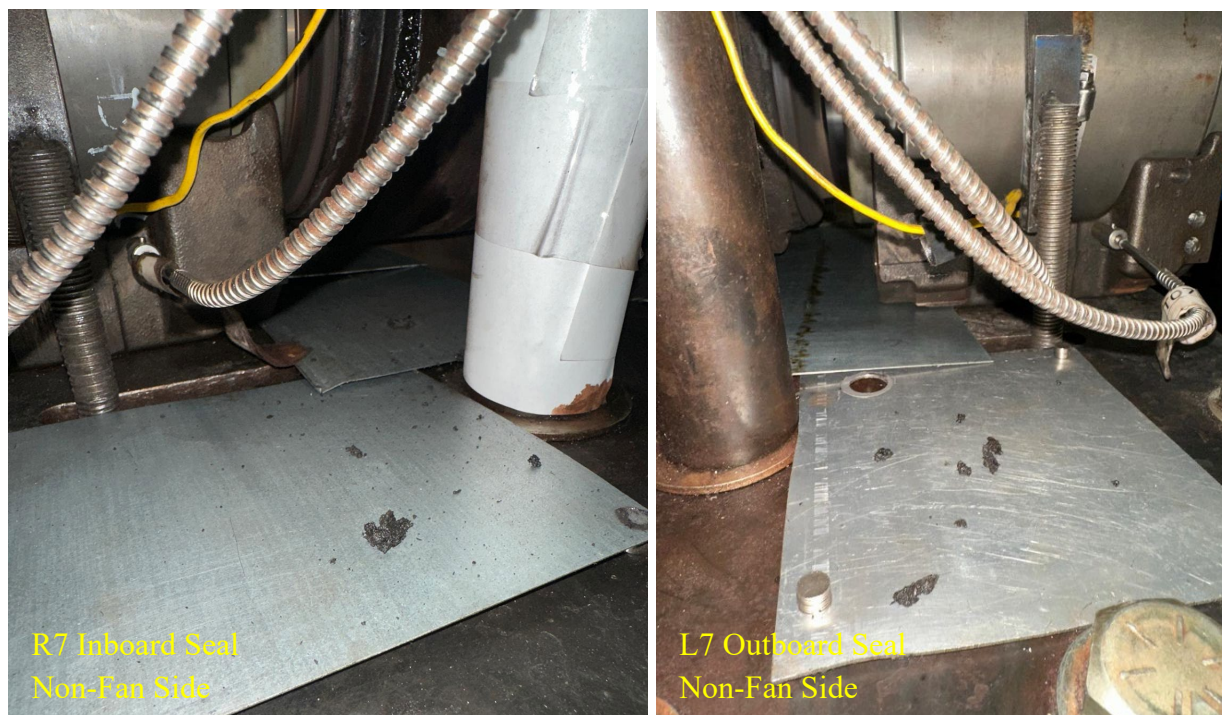
Bearings released grease for a second time (see Figure 10). Samples R7-12 (grease from the tester surface on the inboard side of R7 bearing), R7-13 (grease from the plate in between R7 and L7), and L7-12 (grease from the plate on outboard side of L7) were collected for later analysis.	R7 and L7	18,997 / 30,573	100	60 / 97	436.2
Sudden spike in the vibration levels read by the accelerometer	R7	27,620 / 44,450	100	66 / 97	570.0
Bearing started emitting a loud, persistent, growling noise.	R7	32,913 / 52,968	100	66 / 97	664.4
Vibration levels exceeded the maximum RMS threshold for	R7	36,213 / 58,279	100	66 / 97	724.0

Figure 10: Pictures of the grease that was released from the R7 and L7 bearings around 19,000 miles from the start of the test

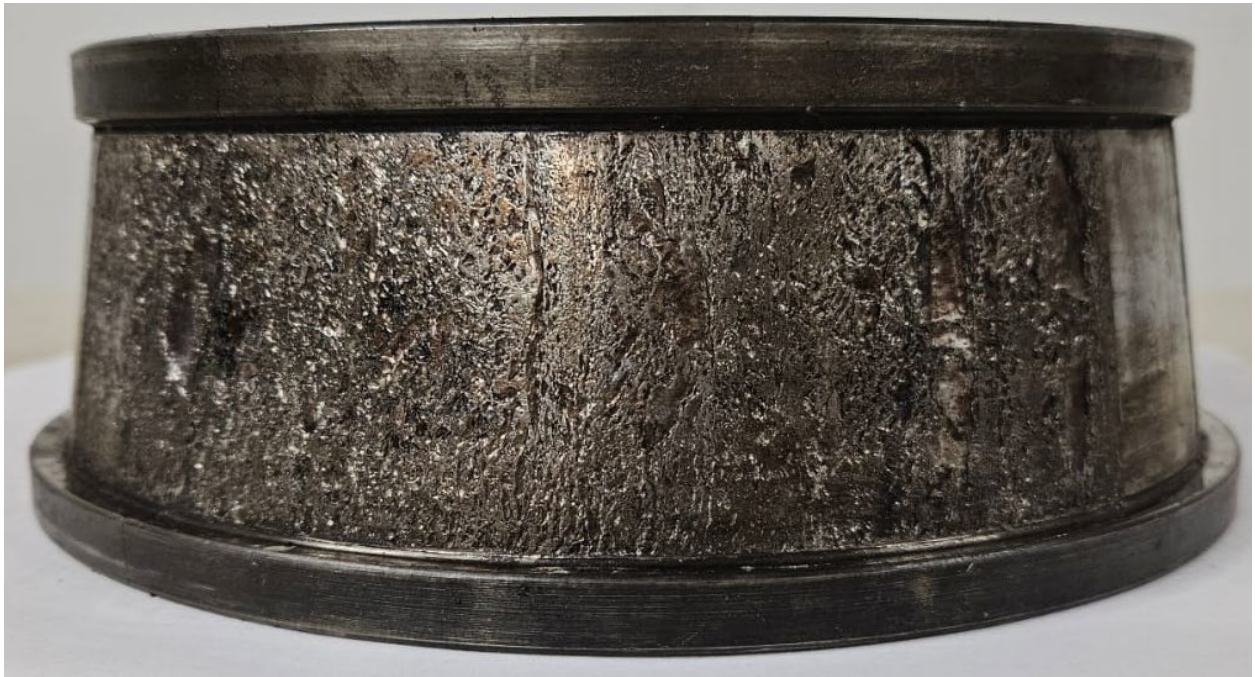
Figure 11: R7 inboard cone (inner ring) raceway – Picture 1

Figure 30: One of three parts of the R7 inboard cone spall which had a total area of 13.6 in² (refer to Figure 11)

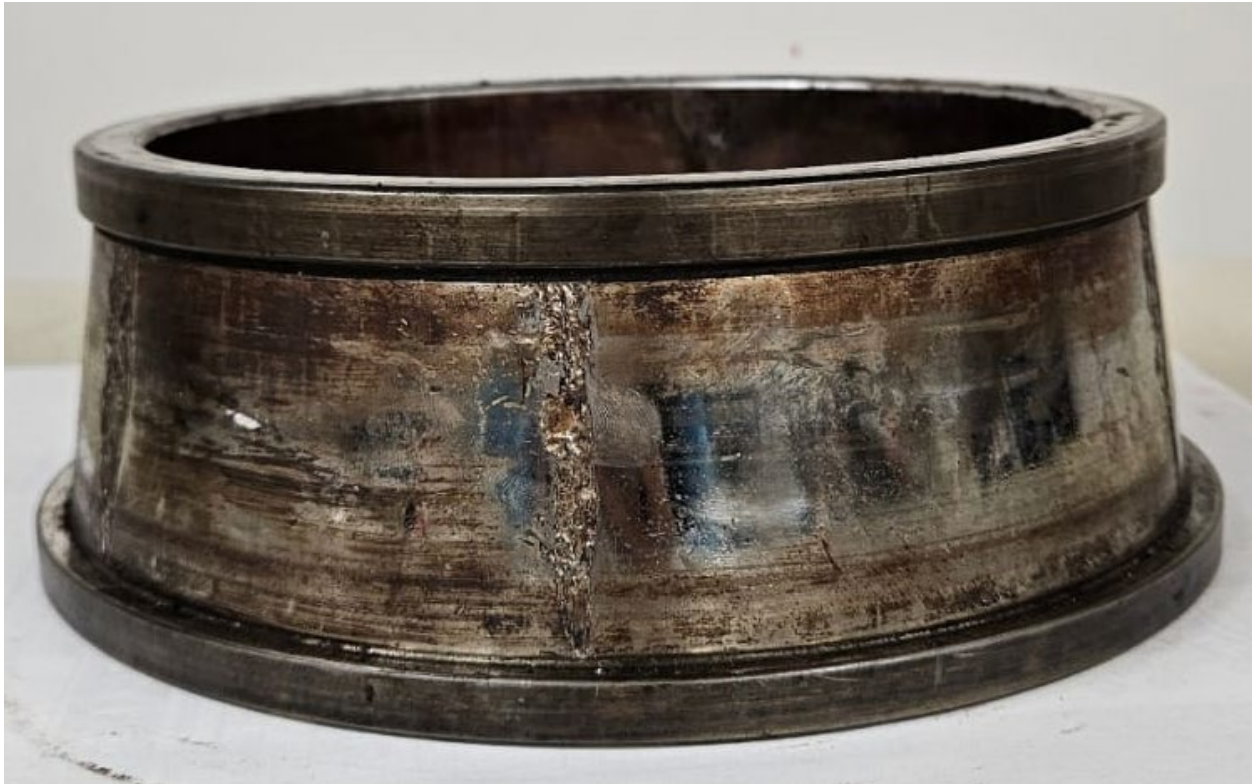
Figure 12: R7 inboard cone (inner ring) raceway – Picture 2

Figure 32: R7 inboard cone spall of Figure 12 with an area of 0.45 in² (left) and R7 inboard cone spall of Figure 14 with an area of 0.61 in² (right)

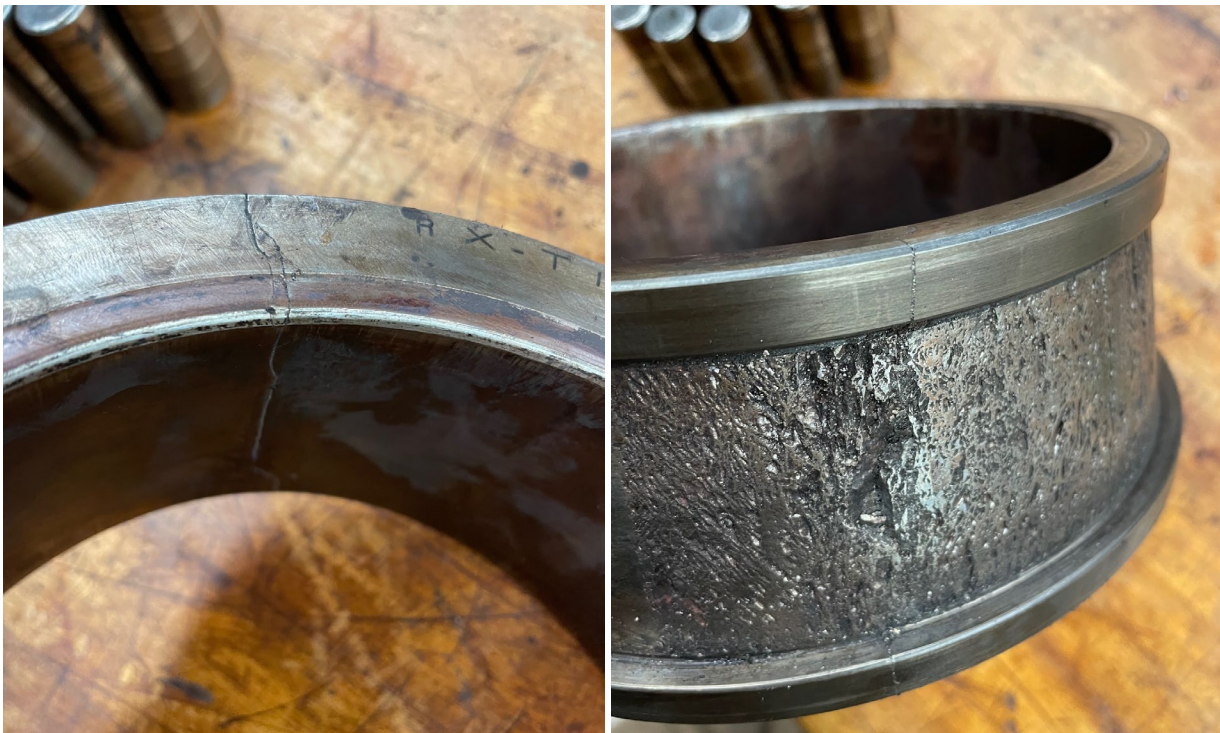
Figure 16: R7 inboard cone (inner ring) raceway showing crack along the width

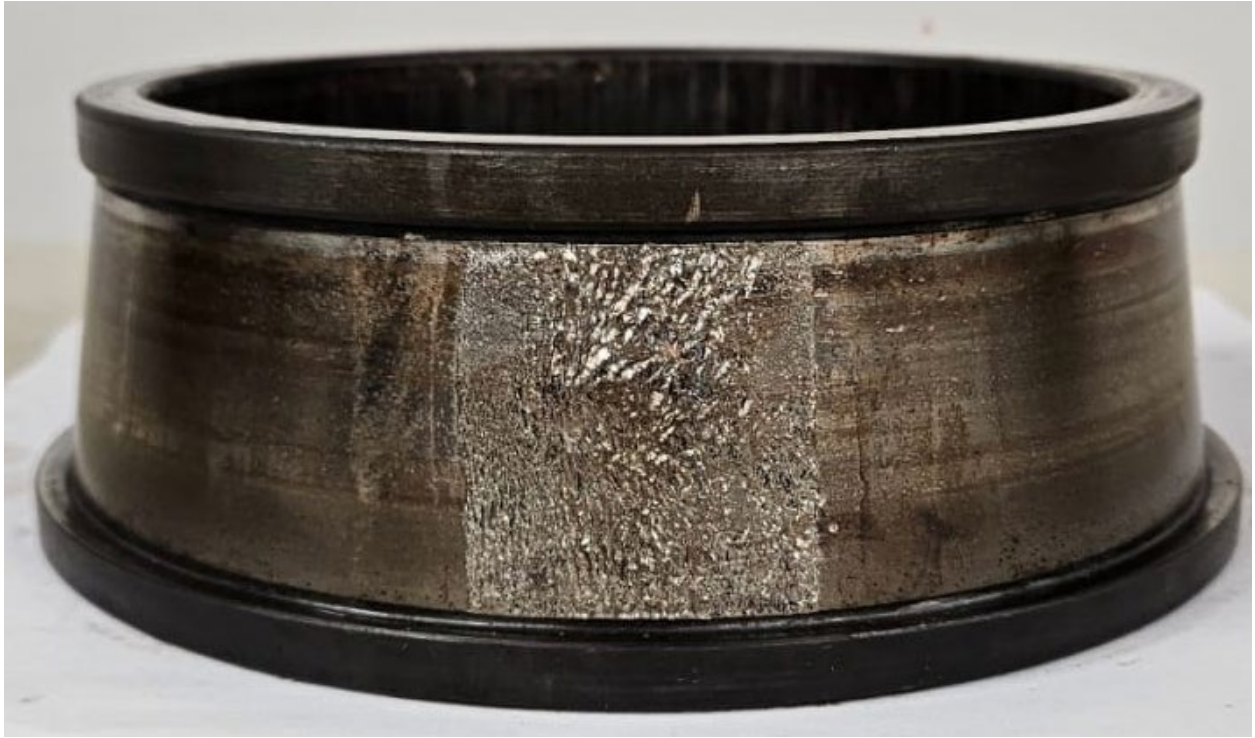
Figure 17: R7 outboard cone (inner ring) raceway – Picture 1

Figure 33: R7 outboard cone spall of Figure 17 with a measured area of 2.47 in² (left) and R7 outboard cone spall of Figure 18 with a measured area of 1.43 in² (right)

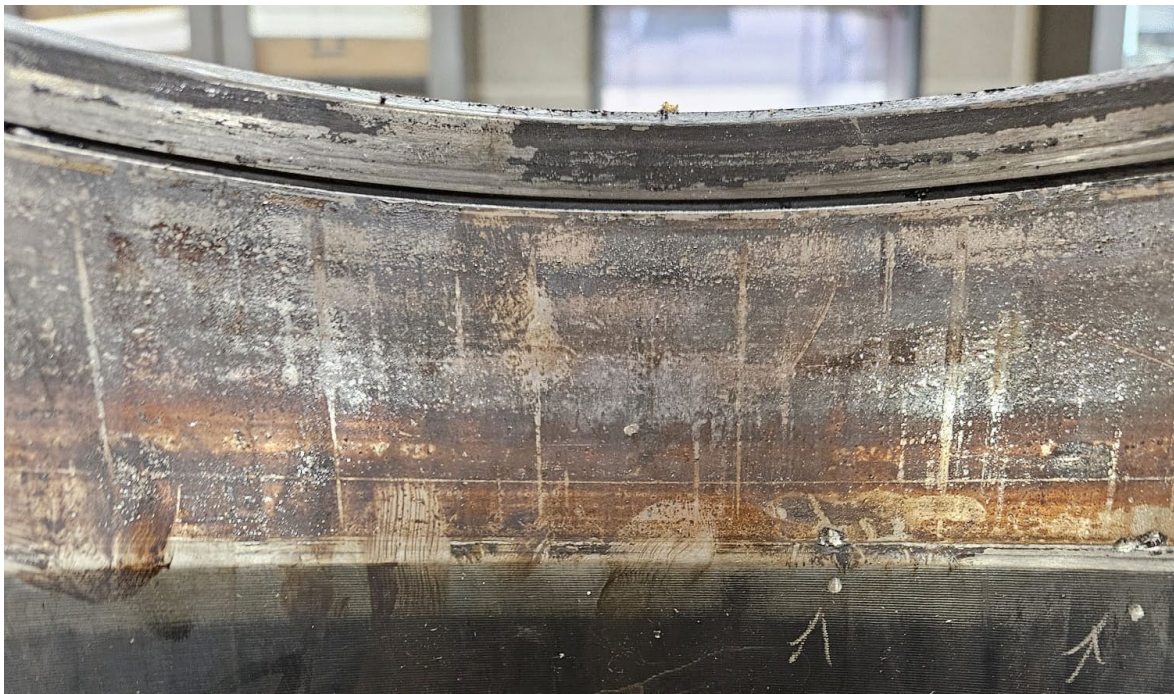
Figure 20: R7 cup (outer ring) inboard raceway on loaded side showing repaired spalls

Not surprisingly, the inboard side of R7 bearing, which is the side with the dislodged seal, exhibited the most damage, with 38.1% of the total cone raceway area being damaged. Interestingly, the cup inboard raceway showed no signs of notable damage other than some small pits and accelerated surface wear. However, the outboard raceway of the cup sustained damage on the loaded portion covering 13.8% of the total cup outboard raceway. In total, the damaged area within the R7 bearing was 28.26 in², which represents 14.1% of the 200.38 in² of total surface area for all four raceways in an AAR Class F bearing (two cone raceways and two cup raceways).

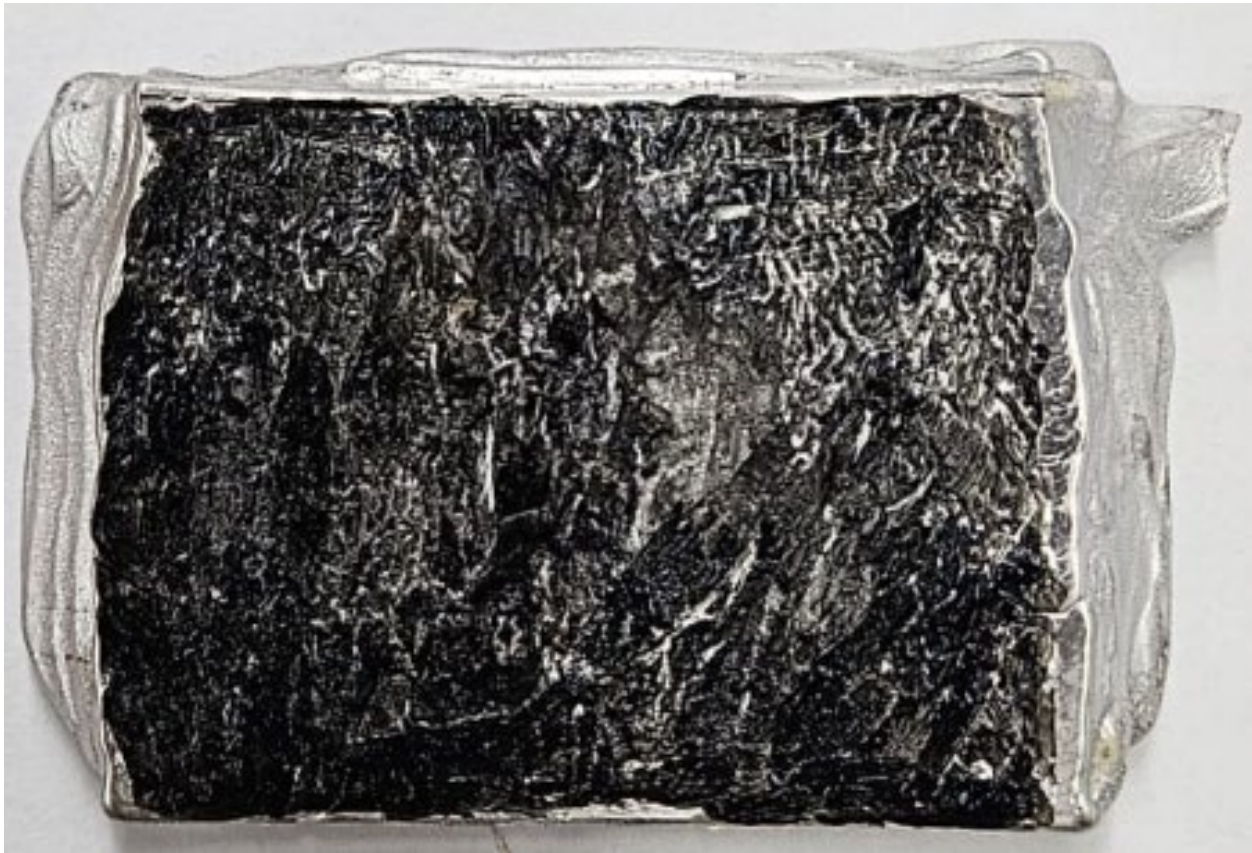
Damaged Area	Spall Size [in ²]	Total Raceway Area [in ²]	Percentage of Area Spalled [%]
R7 inboard cone – Figure 30	13.60	43.26	31.4
R7 inboard cone – Figure 31	1.82	43.26	4.2
R7 inboard cone – Figure 32 (left)	0.45	43.26	1.1
R7 inboard cone – Figure 32 (right)	0.61	43.26	1.4
R7 inboard cone – Total	16.48	43.26	38.1
R7 outboard cone – Figure 33 (left)	2.47	43.26	5.7
R7 outboard cone – Figure 33 (right)	1.43	43.26	3.3
R7 outboard cone – Total	3.90	43.26	9.0
R7 cup outboard raceway – Figure 34	7.88	56.93	13.8
R7 bearing – Total	28.26	200.38	14.1
