PERFORMANCE ASSESSMENT OF RECONDITIONED FREIGHT
RAIL BEARINGS USING EDDY CURRENT ARRAY FOR
ENHANCED NONDESTRUCTIVE INSPECTION

A Thesis

EDUARDO MIRANDA

The University of Texas Rio Grande Valley
December 2025

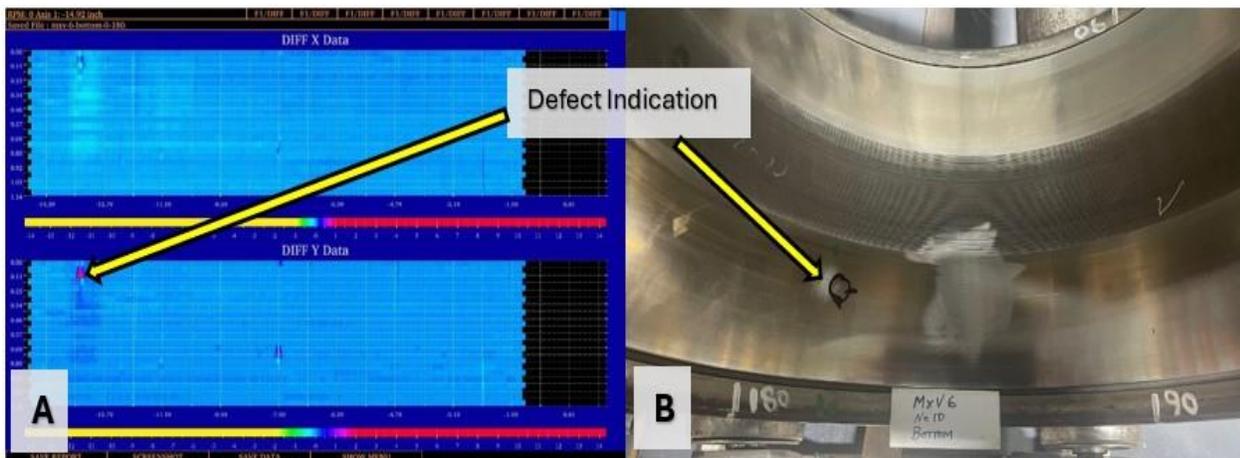
outputs a C-scan image that highlights an indicated anomaly, implying a potential defect within the region of that cup raceway. The red markings in Figure 20(A) indicate localized changes in the probe impedance caused by defects that interfere with the flow of eddy currents through the conductive material. The corresponding region is displayed on the visually inspected surface of the reconditioned bearing cup, displayed in Figure 20(B). It should be noted that the defect was not discernible on the surface of the cup.

Figure 20: (A) ECA indication on the bottom raceway of 2MxV6, (B) Visual inspection of the bottom raceway of 2MxV6

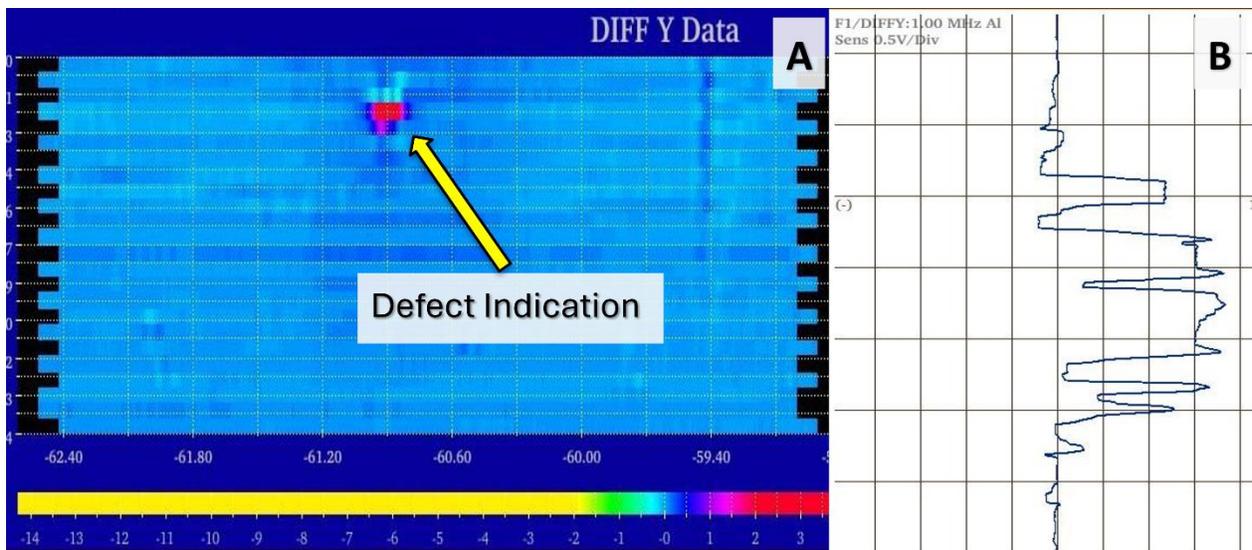
capacitive interaction between the conductive material and the defect, implying the presence of a dielectric and a space between two parallel plates. Peaks that arise on the left-hand side of the graph are defined to be due to the permeability or the presence of man-made dimples in the region. Peaks on the right-hand side correlate to defects in that region. The amplitude of the peaks do not define the severity of the defect as seen in other results, where peak amplitudes were smaller but developed larger defect sizes than others with larger peaks. The graph assists only in defining whether the indication is a potential defect or not.

Figure 21: (A) Magnified C-scan of 2MxV6, (B) A-scan for the defect indication of 2MxV6

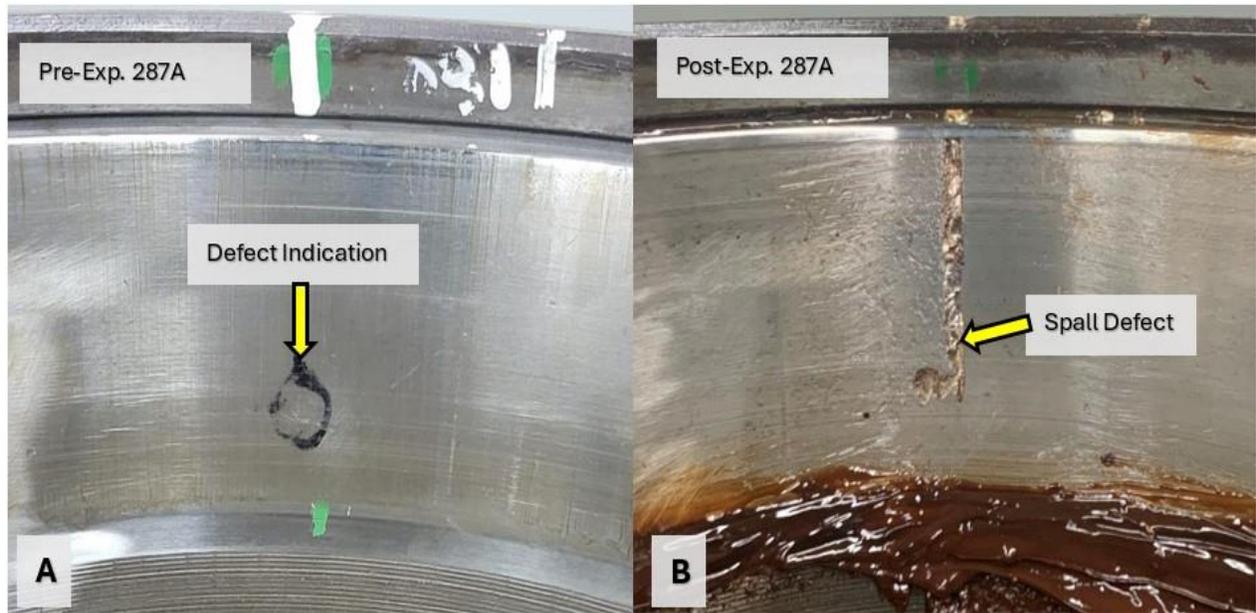
The results of the Level 2 analysis support the ECA scans given that it specifies that the cup was the defective component as expected. To confirm that the defect developed at the location output by the ECA, a full teardown and visual inspection was conducted. Figure 23(B) shows the defect that developed in the region that the ECA indicated. For comparison, the pre-test surface of this region is pictured in Figure 23(A), which shows no surface damage.

Figure 23: 2MxV6 (A) Pre-test inspection, (B) Post-test inspection

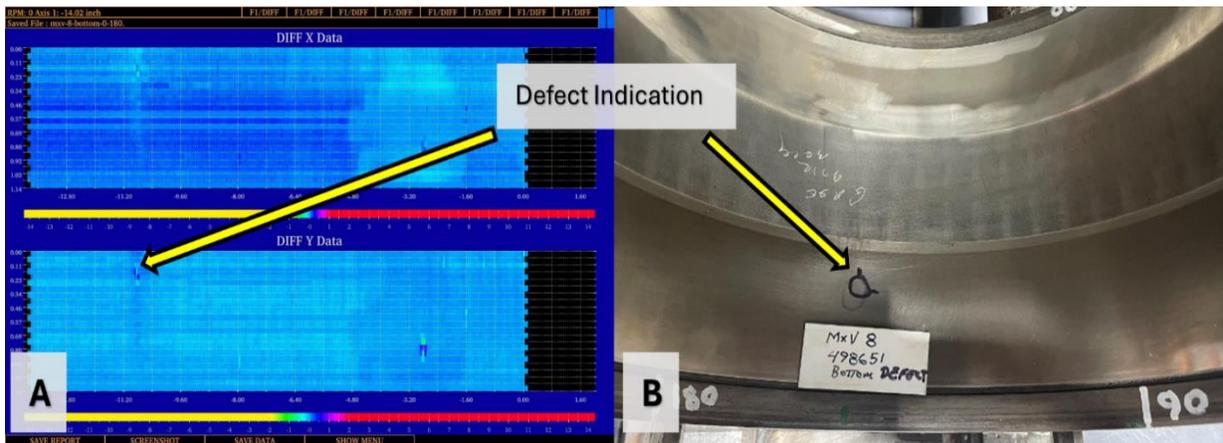
2MxV7 and 2MxV8 were the test bearings utilized in Experiment 290A. Scans of 2MxV8, depicted in Figure 24(A), output a C-scan image with a detected anomaly, indicating a potential defect on the bottom raceway. The corresponding region is displayed on the visually inspected surface of the reconditioned bearing cup, shown in Figure 24(B). The defect was not discernible on the surface of the cup.

Figure 24: (A) ECA indication on the bottom raceway of 2MxV8, (B) Visual inspection of the bottom raceway of 2MxV8

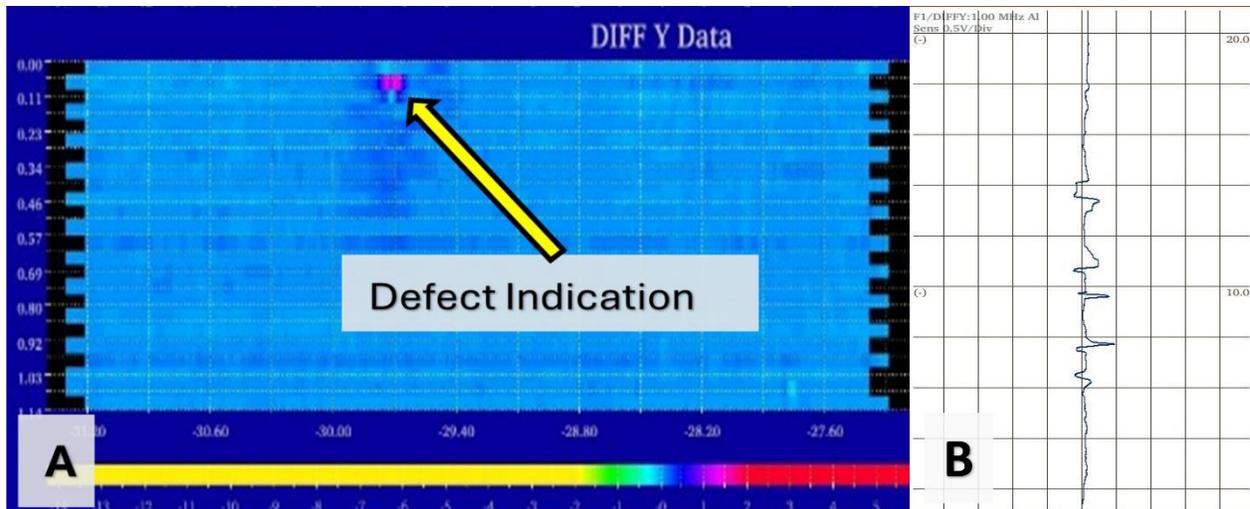
Figure 25(A) provides a magnified image to better represent the indication from the ECA scan. The indication did not output as high of an amplitude as the one for 2MxV6, however the A-scan was still employed to verify that this anomaly was caused by a subsurface defect, as shown in Figure 25(B). The two major peaks observed on the right-hand side of the graph imply that the anomaly indeed correlates to the presence of a subsurface defect. While several smaller peaks appear on the left-hand side, their amplitudes do not surpass the maximum impedance observed on the right. To reiterate, Figure 25(B) distinguishes that there is a near-surface defect that has been indicated rather than the anomaly being caused by signal noise from variations in material permeability or tooling marks.

Figure 25: (A) Magnified C-scan of 2MxV8, (B) A-scan for 2MxV8

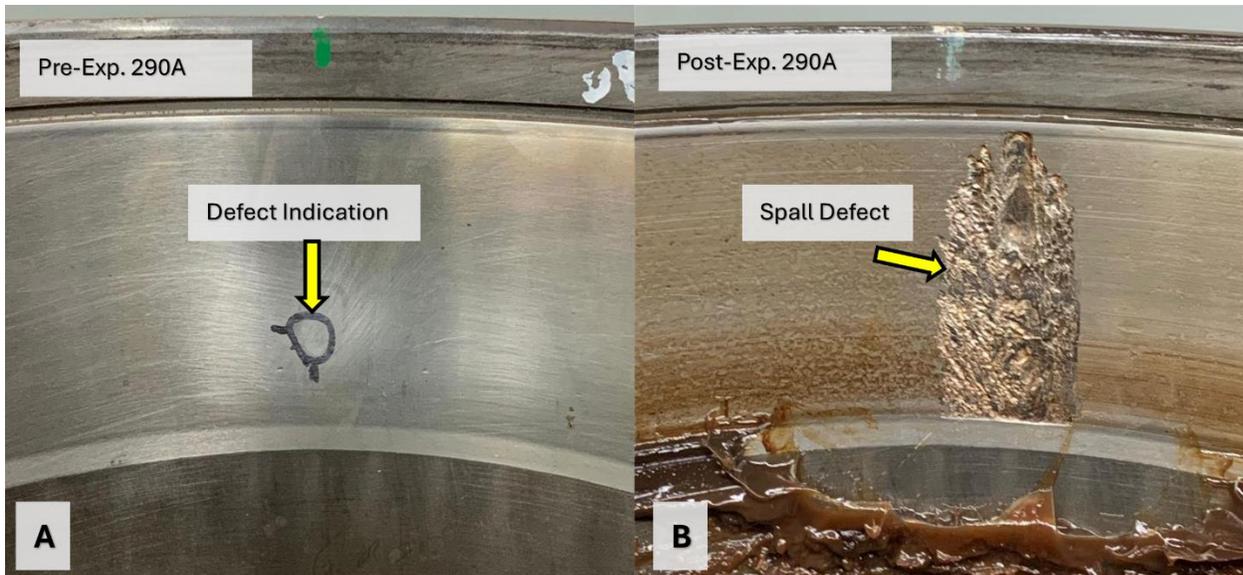
The output of the Level 2 analysis supports the indication from the ECA scan as it confirmed that the defective component was the cup. A full teardown and visual inspection were then conducted. Figure 27(B) displays a post-test image of the loaded zone with the developed defect in the same region that the ECA scan indicated. A pre-test image of this same region displayed no visible defect as shown in Figure 27(A).

Figure 27: 2MxV8 (A) Pre-test inspection, (B) Post-test inspection

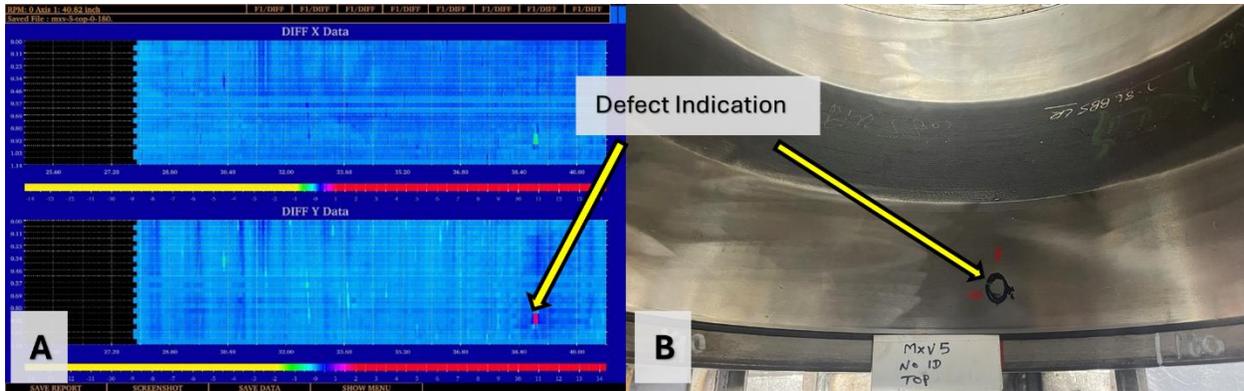
ECA Scans of 2MxV5 and 2MxV7 are depicted in Figure 28(A) and Figure 29(A), respectively. These figures display C-scan images of their corresponding detected anomalies. The visually inspected surfaces of these regions can be seen in Figure 28(B) for 2MxV5 and Figure 29(B) for 2MxV7. There were no discernible defects on either raceway.

Figure 28: (A) ECA indication on the top raceway of 2MxV5, (B) Visual inspection of the top raceway of 2MxV5

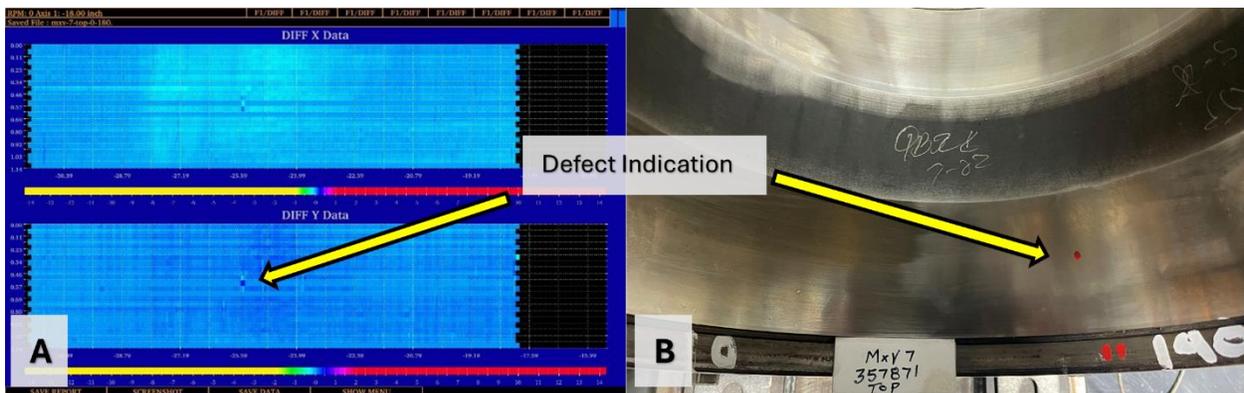
Figure 29: (A) ECA indication on the top raceway of 2MxV7, (B) Visual inspection of the top raceway of 2MxV7

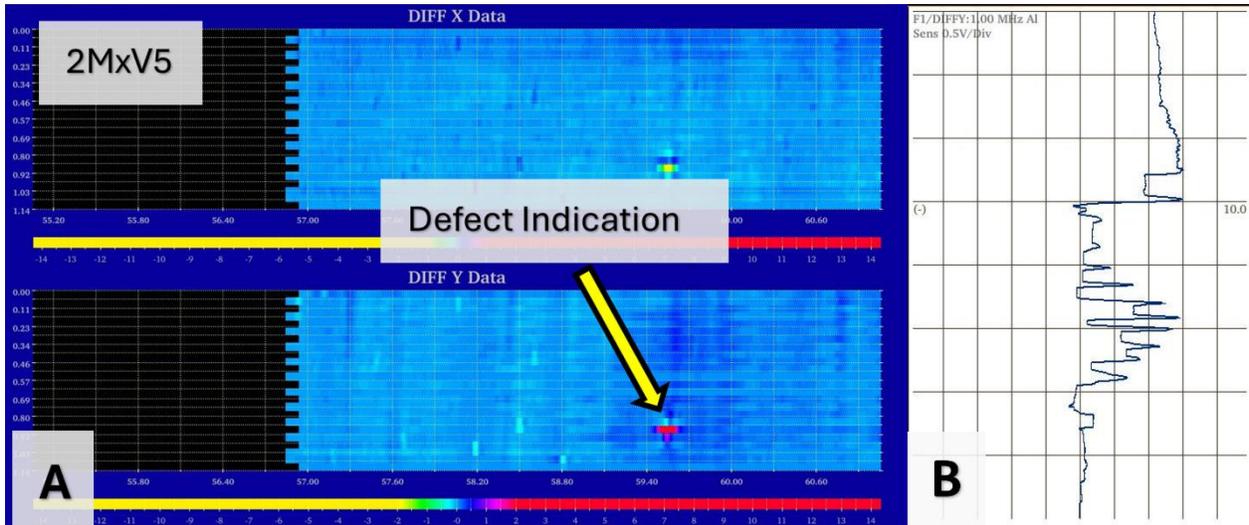
Figure 30: (A) Magnified C-scan of 2MxV5, (B) A-scan for 2MxV5

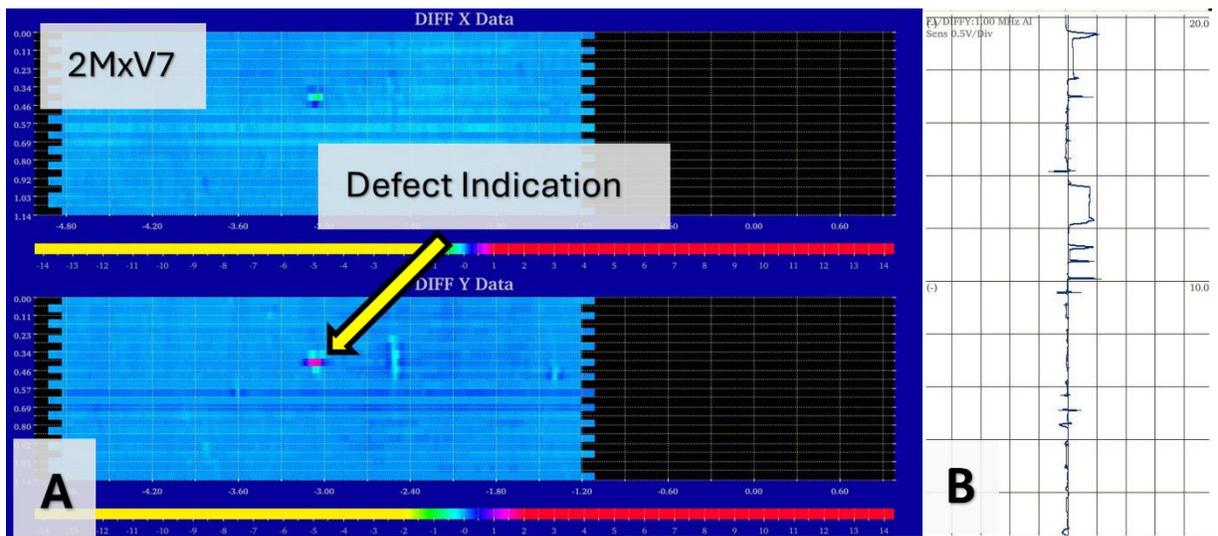
Figure 31: (A) Magnified C-scan of 2MxV7, (B) A-scan for 2MxV7

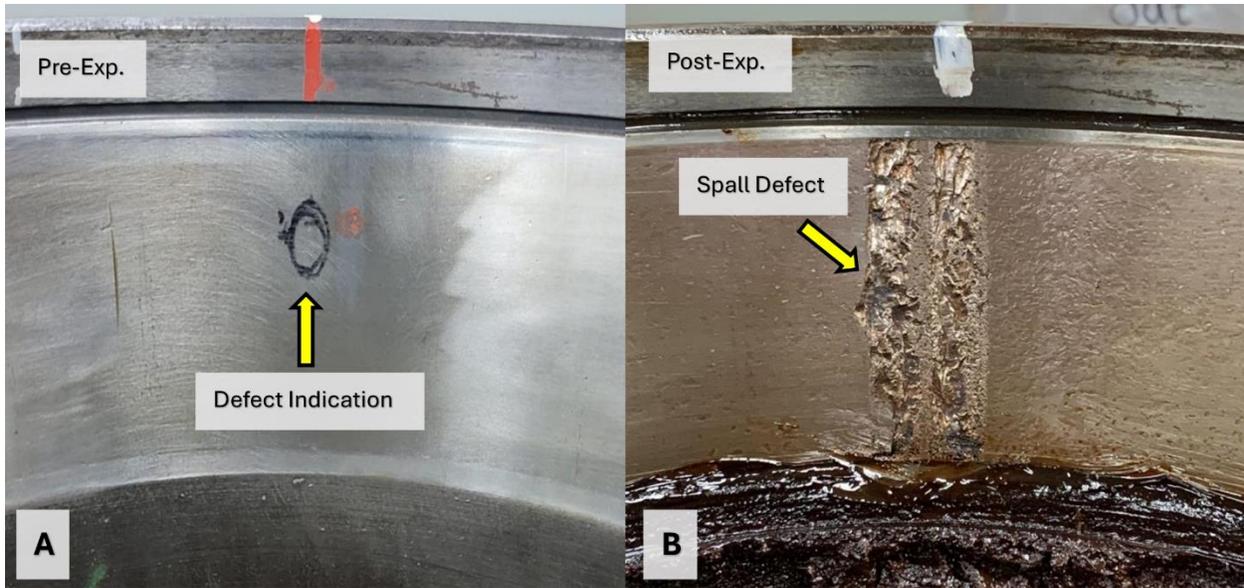
Figure 33: 2MxV5 (A) Pre-test inspection, (B) Post-test inspection

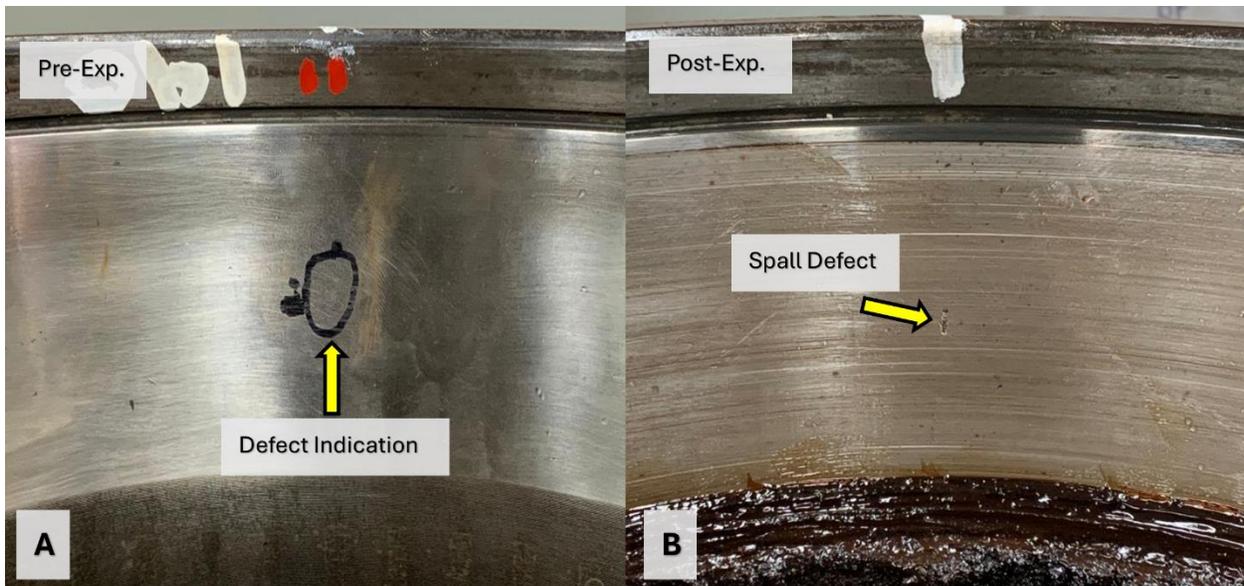
Figure 34: 2MxV7 (A) Pre-test inspection, (B) Post-test inspection

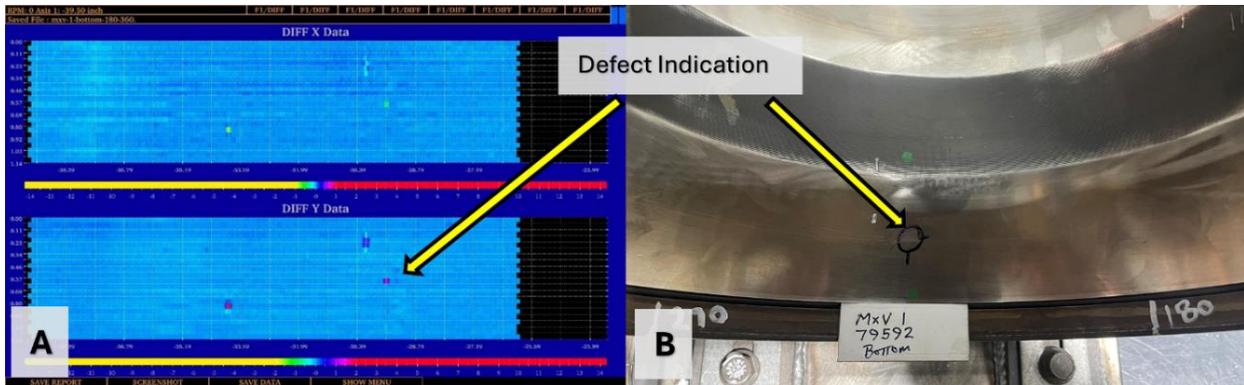
Figure 35: (A) ECA indication on the bottom raceway of 2MxV1, (B) Visual inspection of the bottom raceway of 2MxV1

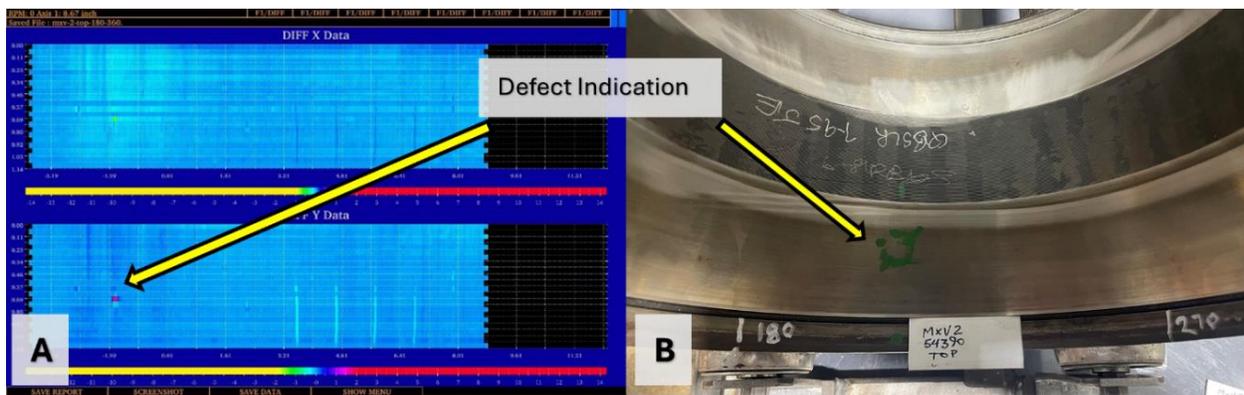
Figure 36: (A) ECA indication on the top raceway of 2MxV2, (B) Visual inspection of the top raceway of 2MxV2

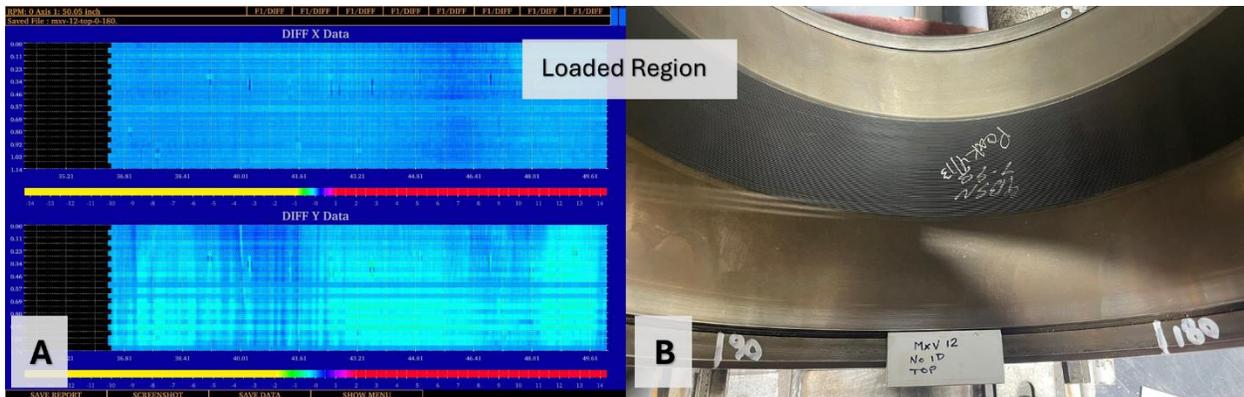
Figure 45: (A) C-scan image of the raceway of 2MxV12, (B) Visual inspection of the raceway of 2MxV12

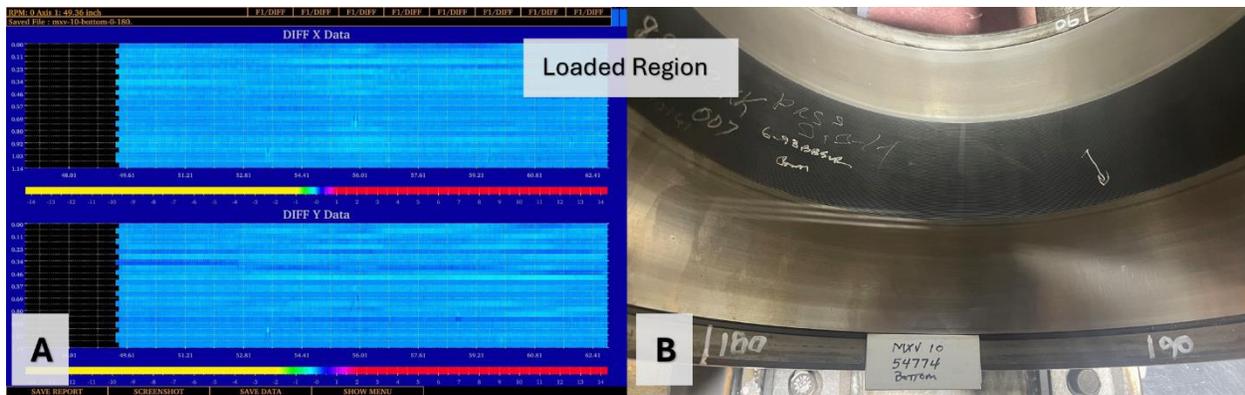
Figure 50: A) C-scan image of the raceway of 2MxV10 B) Visual inspection of the raceway of 2MxV10

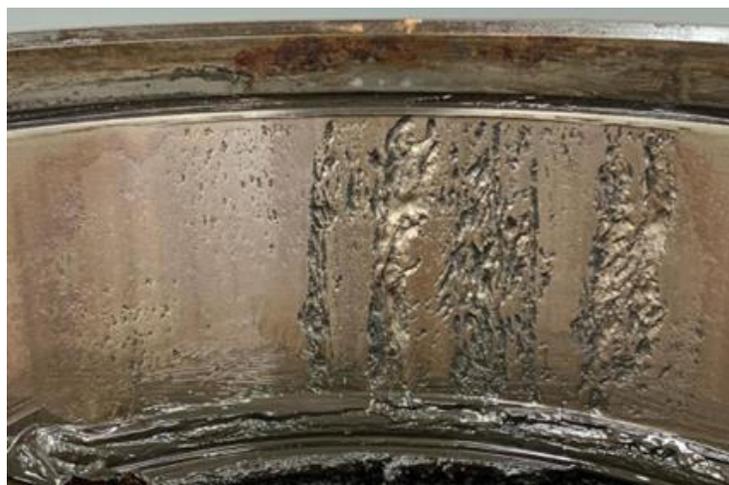
Figure 53: 2MxV10 bottom raceway (loaded zone)

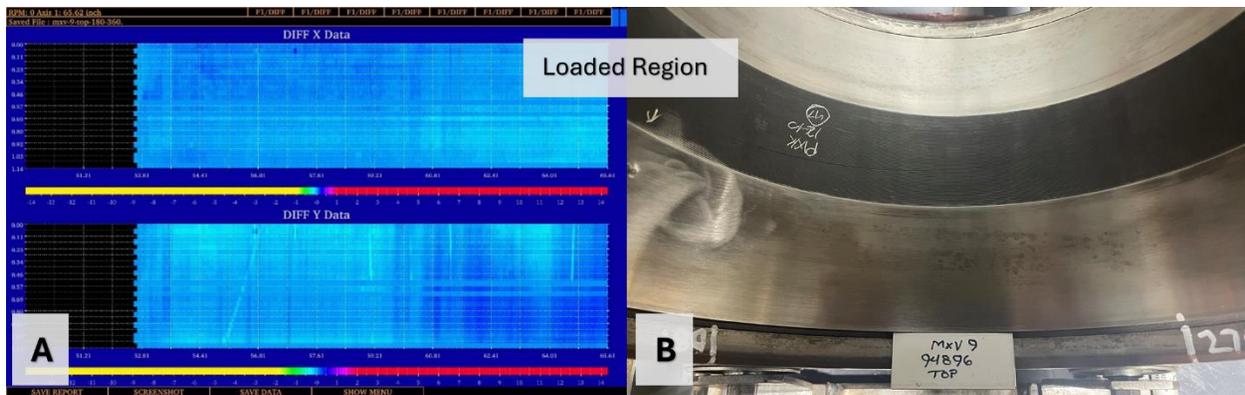
Figure 55: (A) C-scan image of the raceway of 2MxV9, (B) Visual inspection of the raceway of 2MxV9

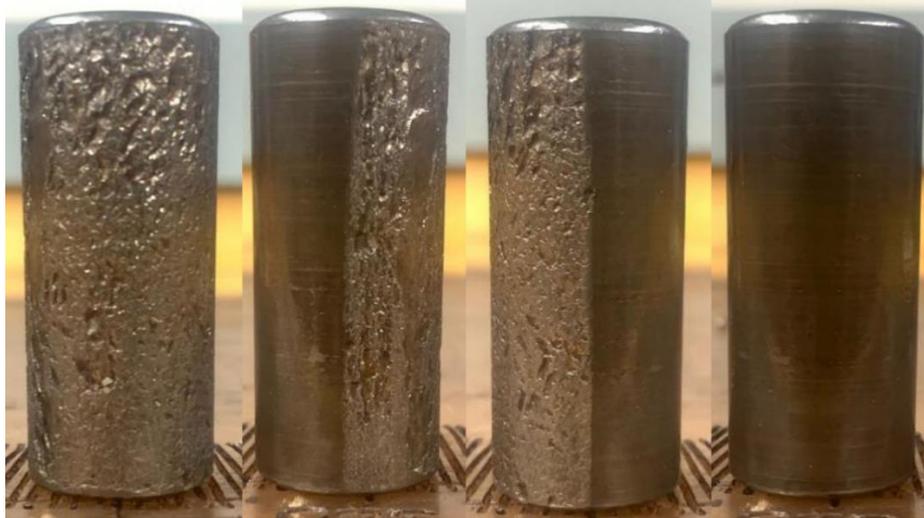
Figure 58: 2MxV9 roller defect

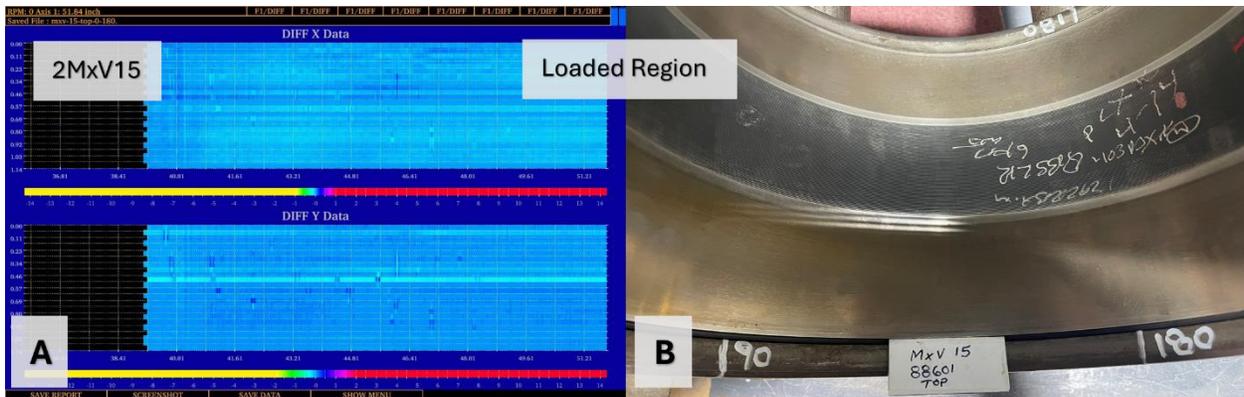
Figure 59: (A) C-scan of the raceway of 2MxV15, (B) Visual inspection of the raceway of 2MxV15

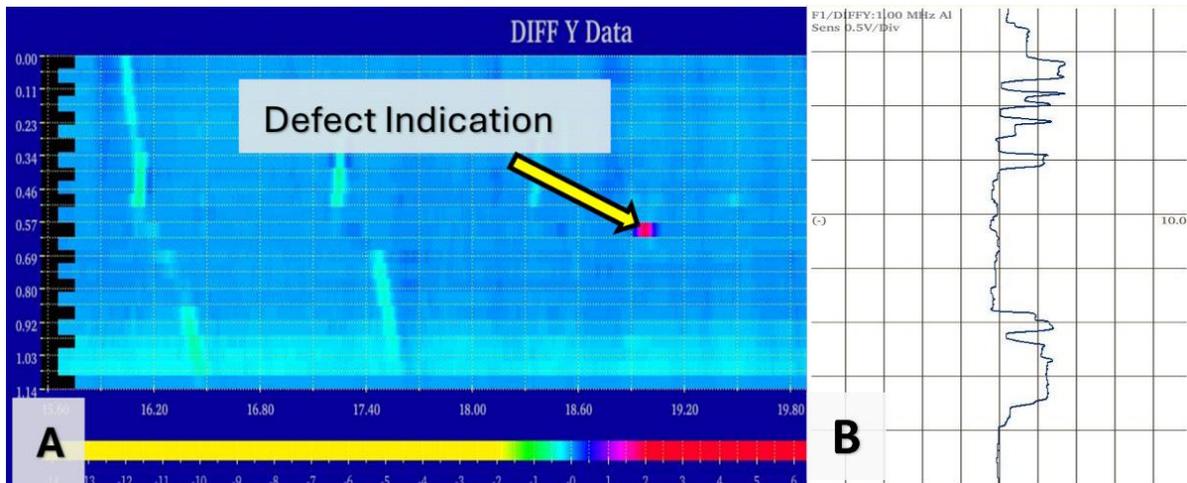
Figure 65: (A) Magnified C-scan of 2MxV4, (B) A-scan for the defect indication of 2MxV4

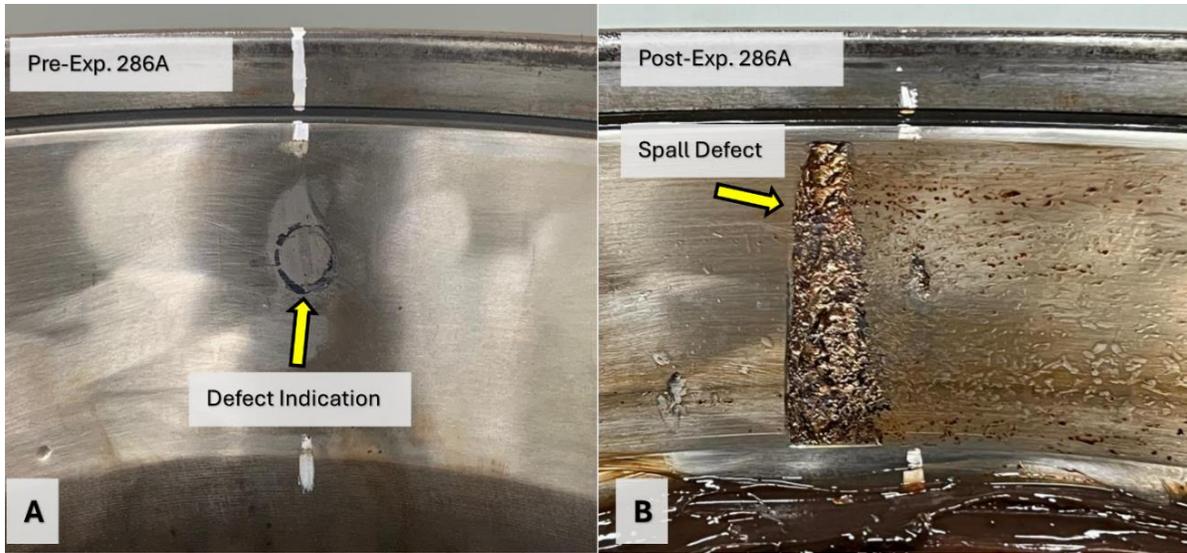
Figure 67: 2MxV4 (A) Pre-test inspection, (B) Post-test inspection: Spall size 0.96 in² (6.19 cm²)

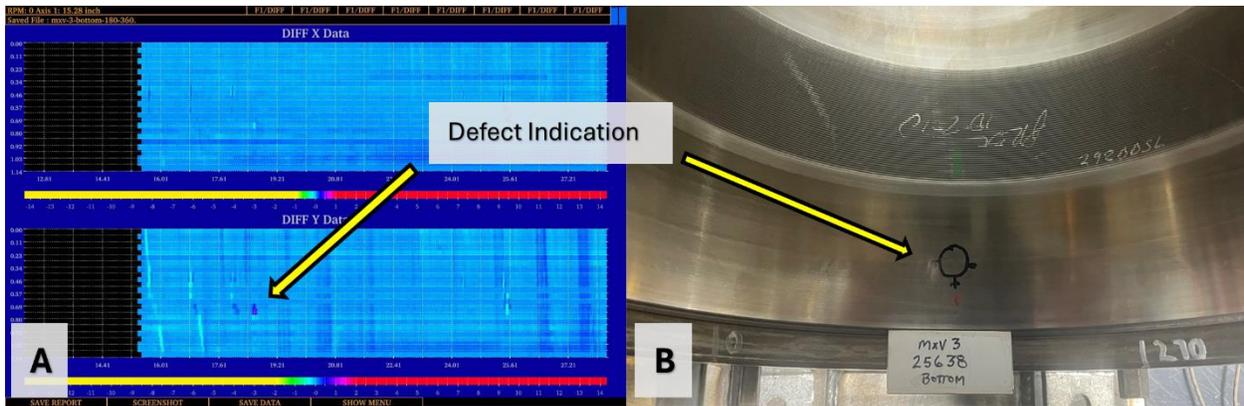
Figure 68: (A) ECA indication on the bottom raceway of 2MxV3, (B) Visual inspection of the bottom raceway of 2MxV3

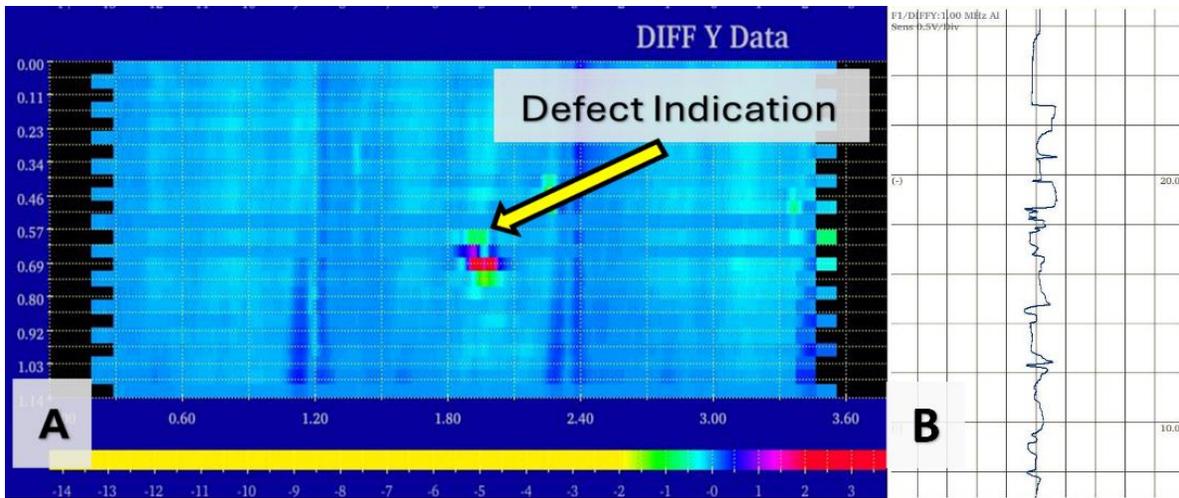
Figure 69: (A) Magnified C-scan of 2MxV3, (B) A-scan for the defect indication of 2MxV3

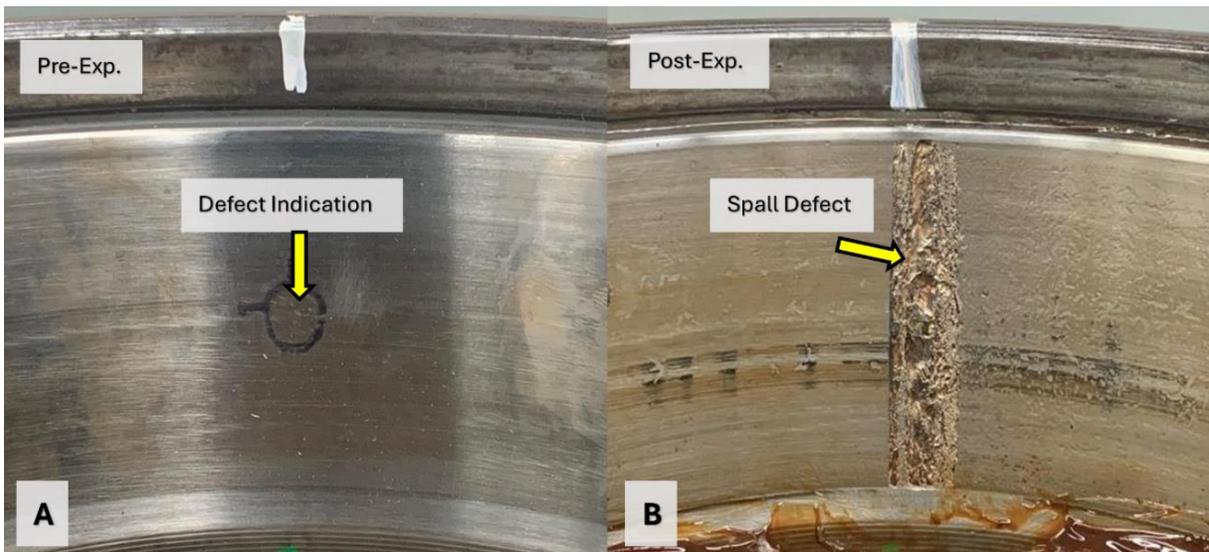
Figure 72: Exp.292A 2MxV5 (A) Pre-test inspection, (B) Post-test inspection: Spall size 1.19 in²
(7.68 cm²)
