**RADIATIVE HEAT TRANSFER ANALYSIS OF RAILROAD BEARINGS
FOR WAYSIDE HOT-BOX DETECTOR OPTIMIZATION**

ABSTRACT

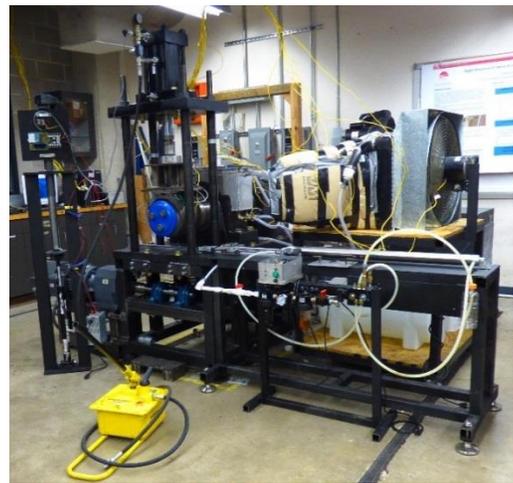
The single bearing tester (SBT) design, pictured in Figure 1, allows for the test bearing to be suspended at the end of an axle with an overhead load pressing down on the bearing through an adapter. This setup also allows for lateral and impact loads to be applied as needed to mimic the conditions a railroad bearing experiences in field service. In order to duplicate the manner in which a hot-box detector (HBD) senses the bearing's temperature in a laboratory setting, a method had to be devised to move the sensor underneath the bearing at a prescribed travel speed. Figure 2 shows how a pneumatic system was employed to accomplish this task. A near frictionless rail-cart system was designed and assembled that could transport the infrared temperature sensor under the bearing. Two IR break sensors, spaced strategically under the bearing area, were utilized to collect time measurements used to calculate the speed of the cart as it passed under the bearing. The cart was attached to a pneumatic cylinder fed by a four-way valve which employed an Arduino Uno as the controller.

Figure 1. Single Bearing Tester (SBT)

which correspond to bearing rotational speeds of 47 to 795 rpm. Speeds utilized in this study were 30, 45, 66, and 85 mph (48, 72, 106, and 137 km/h, respectively), which correspond to rotational speeds of 281, 421, 617, and 795 rpm, respectively. As can be seen in Figure 1, an overhead load is applied to the railroad bearing via a hydraulic cylinder. The two loads generally tested are 17% and 100% of a fully-loaded railcar. The 17% load setting corresponds to an empty (unloaded) railcar and translates to approximately 5848 lbf (26 kN) per class K or F bearing, whereas, the 100% load setting corresponds to a fully-loaded railcar and translates to 34.4 kips (153 kN) per class K or F bearing. The data collected for this study utilized the 100% load setting since fully-loaded railcars are at a higher risk of bearing burn-off than empty railcars. The last parameter, IR sensor travel speed, is the descriptor of the speed at which the pneumatic cylinder pushes the sensor. It was desired to reach speeds of 30 mph (48 km/h), however, with the current setup, only speeds of up to 7 mph (11 km/h) were achieved. Higher IR sensor travel speeds can be achieved through some modifications to the current pneumatic system, but the goals of this study were met with the current system.

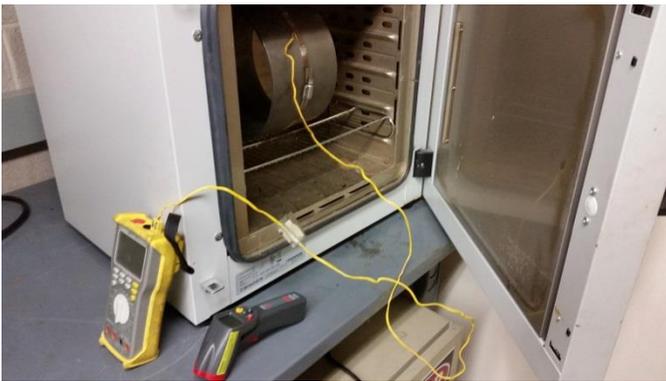
Testing was also conducted to establish the behavior, in a non-dynamic environment, of the MICRO-EPSILON infrared temperature sensor that was employed in the HBD simulation system. A bearing cup was placed in an oven with a K-type thermocouple attached as the control measurement. An infrared gun and the MICRO-EPSILON IR temperature sensor were then used to measure the temperature of the bearing at a number of different heat settings. Figure 9 is a picture of the setup used for this testing. The data of the IR temperature sensor agreed very well with those of the infrared gun and differed by no more than 2°C (~4°F) from the K-type thermocouple data at the highest heat setting tested (~100°C).

Figure 9. Oven test setup. The K-type thermocouple can be seen attached using a hose clamp. The thermocouple multi-meter can be seen attached at the other end of the thermocouple.
