## JRC2016-5816

### TEMPERATURE PROFILES OF RAILROAD TAPERED ROLLER BEARINGS WITH DEFECTIVE INNER AND OUTER RINGS

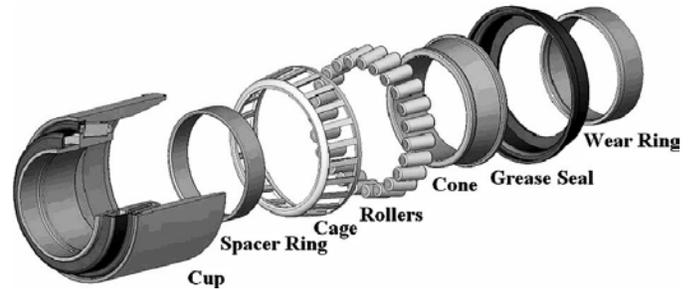
Figure 1. A detailed component view of a typical railroad tapered roller bearing assembly.

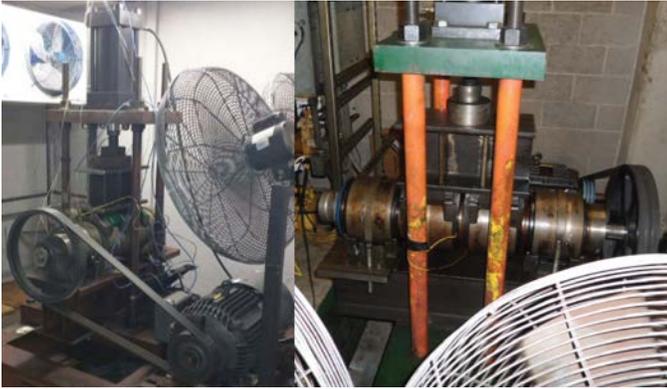
Figure 2. Photographs of the dynamic bearing testers used to conduct the experiments for this study.

All the experiments were performed using the dynamic bearing testers at The University of Texas Rio Grande Valley (UTRGV), pictured in Figure 2. The dynamic test rig can accommodate four Class K (6 ½ × 9") or Class F (6 ½ × 12") tapered-roller bearings. Tests were performed at several different velocities, as listed in Table 1. Convective cooling was achieved with three fans that produced an air stream traveling at an average speed of 5 m/s (11.2 mph) across the bearings. The dynamic bearing testers are equipped with a hydraulic cylinder capable of applying loads ranging from 0 to 175% of full load. The data provided in this paper were acquired utilizing a 17% load setting, which simulates an empty railcar, and a 100% load setting, which simulates a fully-loaded railcar and corresponds to a load of 153,000 N (34,400 lb) per bearing.

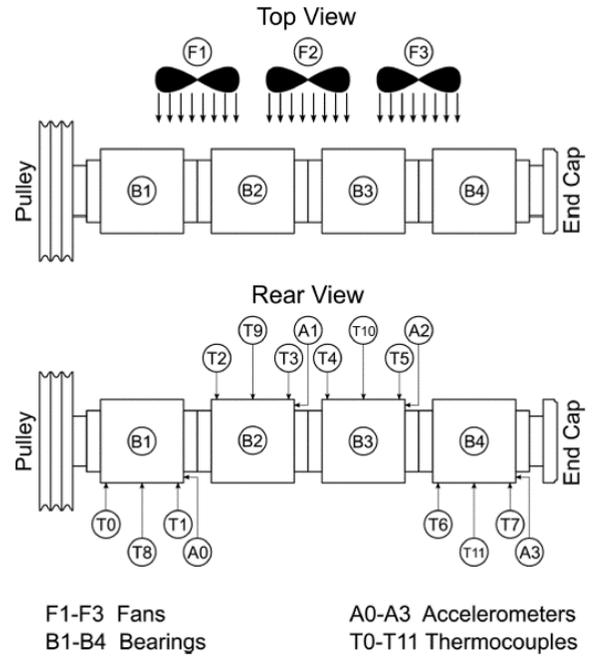
Figure 3. Schematic showing the top and rear view of the dynamic bearing tester, including sensor locations.

The instrumentation setup is illustrated in Figure 3. Four bearing adapters were specially machined to accept a 500g accelerometer and two K-type bayonet thermocouples, one inboard and one outboard. To ensure the accuracy of the bayonet thermocouples, one K-type thermocouple was fixed to the middle of each bearing using a hose clamp and was aligned level with the two bayonet thermocouples. Additionally, two K-type thermocouples were used to monitor and record the ambient temperature surrounding the tester; one was positioned at the front of the tester and the other at the rear of the test rig. Data collected from fourteen thermocouples and four accelerometers were recorded utilizing a National Instruments

(refer to Figure 3). The statistical mean and corresponding uncertainty of the two thermocouples was calculated for every speed and load combination. The uncertainty in the temperature data was within 3°C (5°F). Finally, the data obtained was evaluated according to the defect severity as determined by its area. The approximate area of the spalls was obtained by treating the spall as a rectangle, and measuring the spall's length and width. The area of the spall was measured at the beginning and end of each experiment. The test plan was developed to populate bearing temperature profiles at speeds and loads typical of field service conditions.

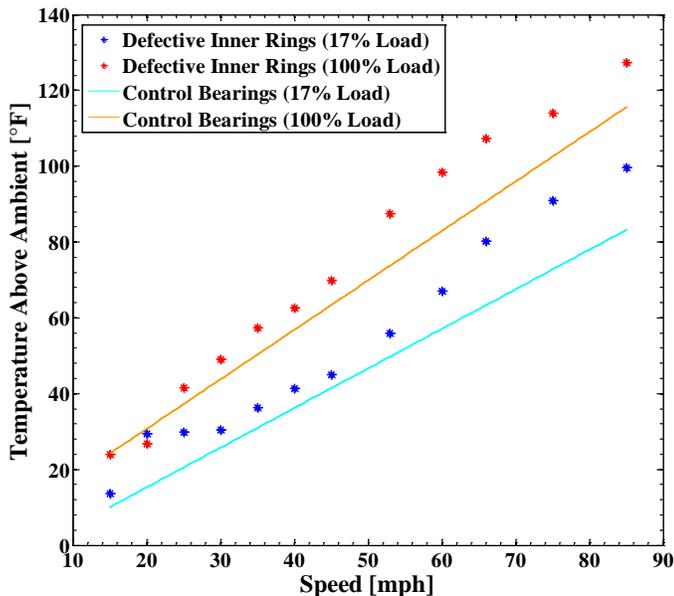
Figure 4. Average operating temperatures above ambient (78°F) of bearings with inner ring defects as compared to healthy (control) bearings at various speeds under 17% (empty railcar) and 100% (full railcar) load conditions.

From Figure 4 and Figure 5, it is evident that there is an almost linear increase in bearing operating temperature with speed. Moreover, speed seems to play a more important role on the bearing operating temperature than load. For example, going from 17% to 100% load will result in an average temperature increase of about 23°F (13°C) in a healthy bearing, whereas, going from 25 to 66 mph results in an average temperature increase of about 48°F (27°C) in a healthy bearing. Note that changes in speed will be more common in field service operation than changes in load.

In Figure 4, the average operating temperatures of the bearings with inner ring defects are mostly above the control bearings average temperature (linear fit). As speed increases, the average temperature of the bearings with inner ring defects appears to diverge from the linear fit of the control bearings; a behavior that is more pronounced in the 17% (empty railcar) load condition. On the other hand, the average operating temperatures of bearings with outer ring defects are consistently at or below the average operating temperatures of the control (healthy) bearings (linear fit) for both loading conditions, as seen in Figure 5. This difference in temperature behavior with respect to the defective bearing component can be explained by referring to the findings in the literature. It was stated earlier that the highest contact pressure during bearing operation occurs between the rollers and the inner ring (cone), and that the higher temperatures within the bearing assembly are seen at the rib – roller contact [8]. It is then expected that if a defect is present on the inner ring (cone) race, it will experience more contact with the rollers, thus, increasing the frictional heating. Moreover, the inner ring is in constant

rotational motion, hence, the likelihood of roller misalignment due to contact with the defect is much higher. If roller misalignment occurs, frictional heating is further exacerbated. The combination of the aforementioned effects tends to raise the overall bearing operating temperature which in turn decreases the viscosity of the lubricant leading to more metal-to-metal contact and added frictional heating. The latter becomes even more evident at higher operating speeds ( $\geq 60$  mph), as demonstrated in Figure 4, where the average operating temperature of bearings with inner ring defects is about  $15^{\circ}\text{F}$  ( $8^{\circ}\text{C}$ ) above that of healthy bearings. One explanation as to why the behavior seen in bearings with inner ring (cone) defects is not observed in bearings with defects present on the outer ring (cup) raceways is that spalls present on the cup raceways may favor the formation of pockets of lubricant which in turn enhances lubrication and maintains the operating temperature at or below the average operating temperature of healthy bearings.

Figure 4 and Figure 5 at 30 and 60 mph for the unloaded (17% load) and loaded (100% load) conditions represent an average of all the data points seen in Figure 6 through Figure 9 for bearings with inner and outer defects of various sizes (as measured by the defect area).

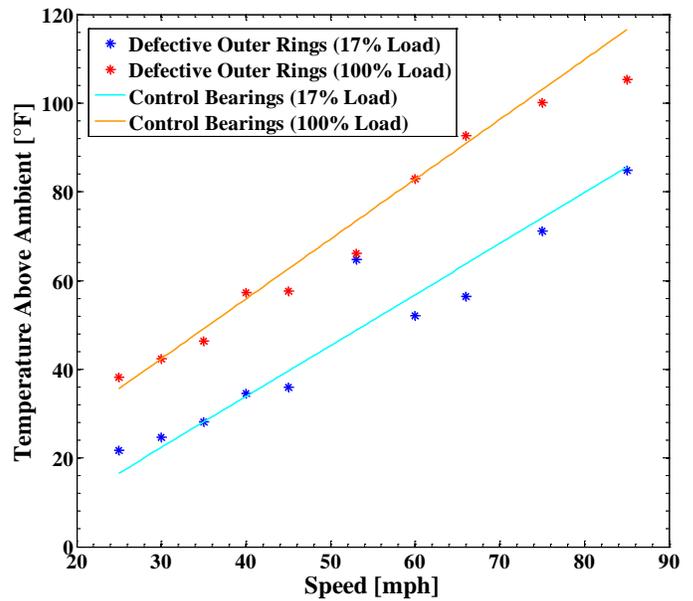
Figure 5. Average operating temperatures above ambient (78°F) of bearings with outer ring defects as compared to healthy (control) bearings at various speeds under 17% (empty railcar) and 100% (full railcar) load conditions.

The main objective of this study is to compare the temperature profiles of bearings with inner and outer ring defects to those of healthy bearings. In doing so, the effectiveness of temperature monitoring as a tool to assess bearing health is evaluated. The mean ambient temperature in all the experiments performed for this study was approximately 78°F (26°C). The average operating temperatures (above ambient) of bearings with inner and outer ring defects at various speeds for 17% (empty railcar) and 100% (fully-loaded railcar) load conditions are plotted in Figure 4 and Figure 5, respectively, as compared to the average operating temperatures (linear fits with  $R^2$  values of 0.95 and 0.99, respectively) of the healthy (control) bearings at the corresponding speed and load conditions. The average inner ring defect size for the data provided in Figure 4 is 0.77 in<sup>2</sup> (497 mm<sup>2</sup>), whereas, the average outer ring defect size for the data given in Figure 5 is 0.92 in<sup>2</sup> (594 mm<sup>2</sup>).

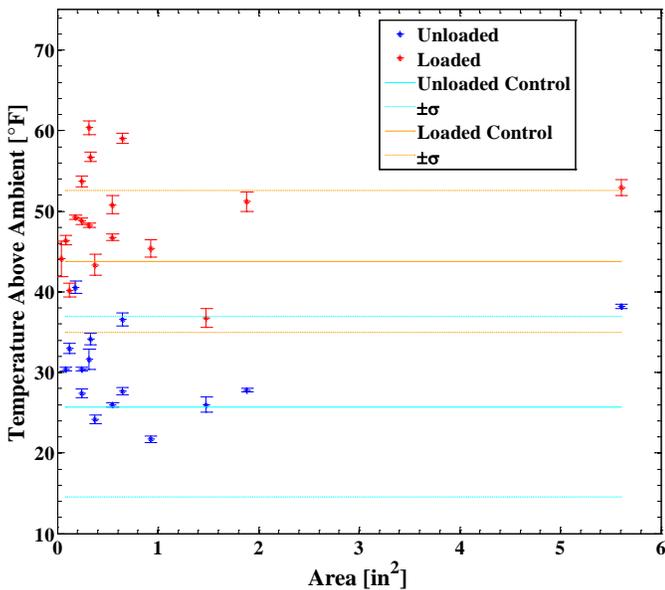
Figure 6. Temperature data of bearings with inner ring defects of various sizes (as measured by defect area) compared against the range of operating temperatures for healthy (control) bearings for unloaded (17% load) and loaded (100% load) conditions at a speed of 30 mph.

For a more detailed analysis, the temperatures obtained for bearings with different size inner and outer ring defects (as measured by the defect area) at two common operating speeds (30 and 60 mph) were plotted and compared against the range of healthy (control) bearing temperatures subjected to the same load and speed conditions. The temperature data for bearings with inner ring defects at operating speeds of 30 and 60 mph are given in Figure 6 and Figure 7, respectively, whereas, the temperature data for bearings with outer ring defects at operating speeds of 30 and 60 mph are provided in Figure 8 and Figure 9, respectively. Note that the data points plotted in

By looking at Figure 6 through Figure 9, it becomes apparent that there is no distinct correlation between defect severity and the corresponding bearing operating temperature. While a few bearings with defective inner and outer rings were found to be operating at temperatures above the control (healthy) bearing temperature range for the given speeds and loads, a significant number of bearings with defective inner and outer rings were running at temperatures within or below the healthy bearing temperature range. Therefore, temperature alone does not seem to be a good indicator of the presence of a defect within a bearing, much less of defect severity. The aforementioned statement can be validated by looking at the two data points circled in green in Figure 7. One data point belongs to a bearing with an inner ring defect size of  $1.48\text{ in}^2$  ( $955\text{ mm}^2$ ), whereas, the other data point belongs to a bearing with an inner ring defect size of  $1.88\text{ in}^2$  ( $1213\text{ mm}^2$ ). These two defects are pictured in Figure 10. While the bearing with larger defect size has an operating temperature that is relatively higher than the healthy bearing operating temperature range, the bearing with the slightly smaller defect has an operating temperature that is markedly lower than the operating temperature range for healthy bearings. In fact, the bearing with the inner ring defect size of  $1.48\text{ in}^2$  has an operating temperature that is significantly lower than that of other

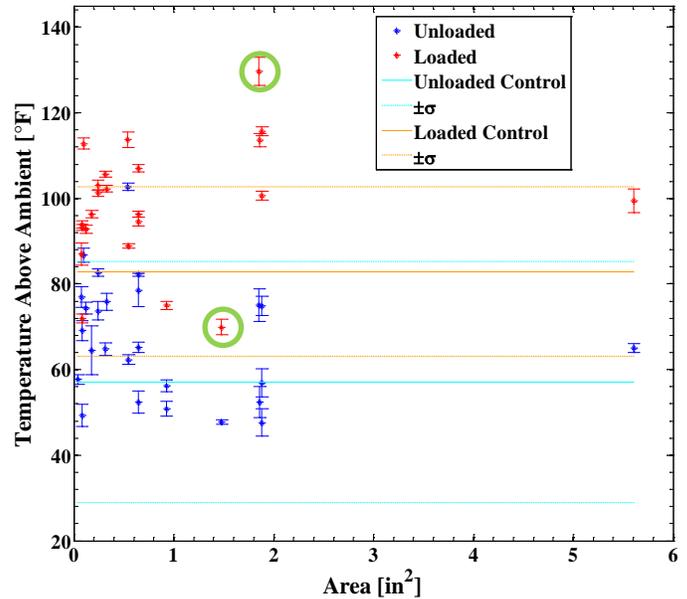
Figure 7. Temperature data of bearings with inner ring defects of various sizes (as measured by defect area) compared against the range of operating temperatures for healthy (control) bearings for unloaded (17% load) and loaded (100% load) conditions at a speed of 60 mph.

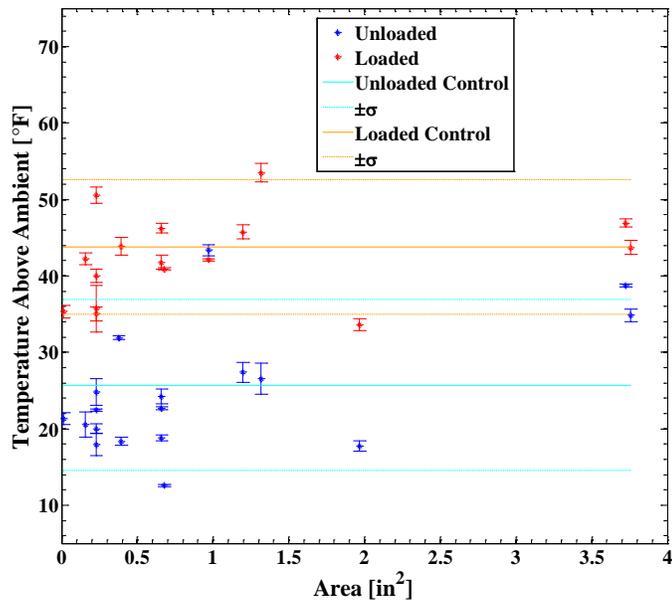
Figure 8. Temperature data of bearings with outer ring defects of various sizes (as measured by defect area) compared against the range of operating temperatures for healthy (control) bearings for unloaded (17% load) and loaded (100% load) conditions at a speed of 30 mph.

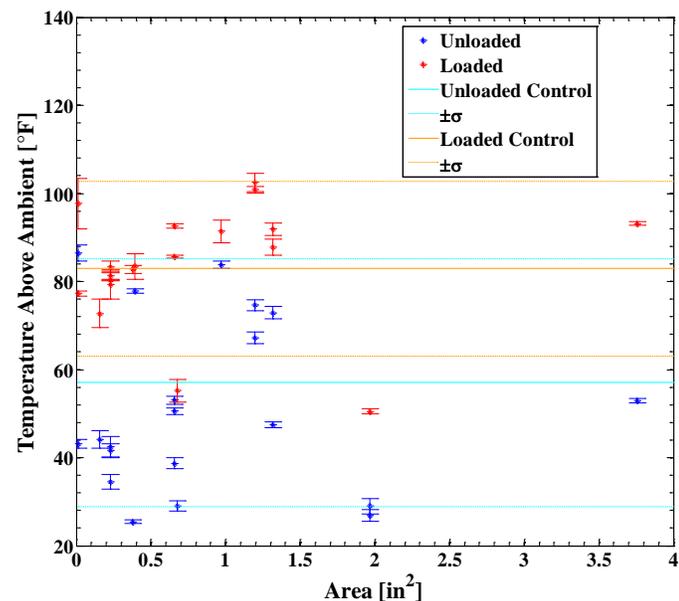
Figure 9. Temperature data of bearings with outer ring defects of various sizes (as measured by defect area) compared against the range of operating temperatures for healthy (control) bearings for unloaded (17% load) and loaded (100% load) conditions at a speed of 60 mph.

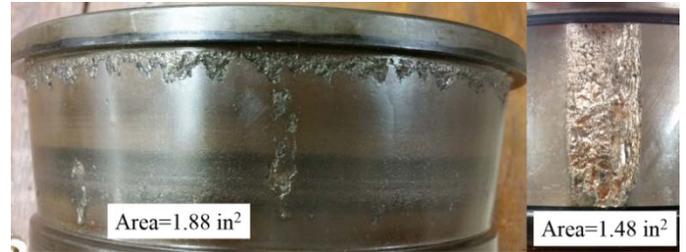
Figure 10. Photographs depicting large defects (spalls) present on bearing inner ring (cone) raceways.

Examining Figure 10, the reason for the large difference in operating temperature of the two defective inner rings becomes apparent. The defect on the left side of Figure 10 is spread across a narrow zone of the raceway closest to the upper cone rib, whereas, the defect on the right side of Figure 10 forms a rectangular spall that stretches across the width of the raceway. As mentioned earlier, the highest temperature within the bearing assembly is expected to occur along the roller – rib contact zone. Thus, the presence of a spall in this zone will exacerbate the frictional heating, degrade the lubricant, and significantly increase the likelihood of roller misalignment, which will result in higher bearing operating temperatures. On the other hand, it seems like when the defect (spall) stretches across the width of the raceway, such as in Figure 10 (right), the spall cavity fills with lubricant which tends to reduce the likelihood of rollers misaligning. Hence, the presence of a defect as severe as the one depicted in Figure 10 (right) will go undetected by conventional wayside HBDs because the bearing operating temperature is below that of the healthy bearing operating range, as can be seen in Figure 7. In this case, the bearing with the inner ring defect size of 1.88 in<sup>2</sup>, depicted in Figure 10 (left), had an operating temperature of about 130°F (72°C) above ambient, whereas, the bearing with the inner ring defect size of 1.48 in<sup>2</sup>, pictured in Figure 10 (right), had an operating temperature of about 70°F (39°C) above ambient. In comparison, the average operating temperature of a healthy

(control) bearing running at 60 mph under full load is about 83°F (46°C) above ambient conditions.

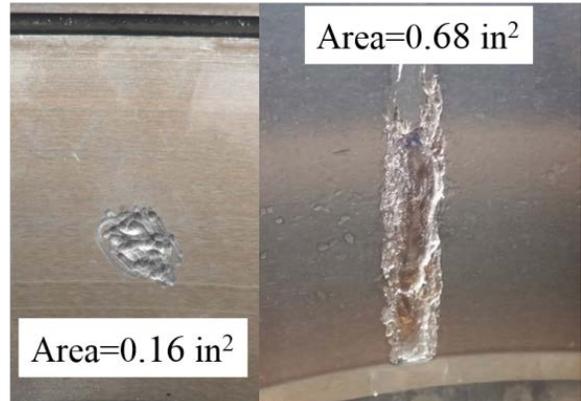
Figure 11. Photographs depicting small (left) and medium (right) size defects (spalls) present on bearing outer ring (cup) raceways.
