TEMPERATURE PROFILES OF RAILROAD TAPERED ROLLER BEARINGS WITH DEFECTIVE INNER AND OUTER RINGS

Constantine Tarawneh, Luz Sotelo, Anthony Villarreal,
Nancy de los Santos, Ryan Lechtenberg, Robert Jones

Mechanical Engineering, The University of Texas Rio Grande Valley,
Edinburg, Texas, 78539-2999, railwaysafety@utrgv.edu

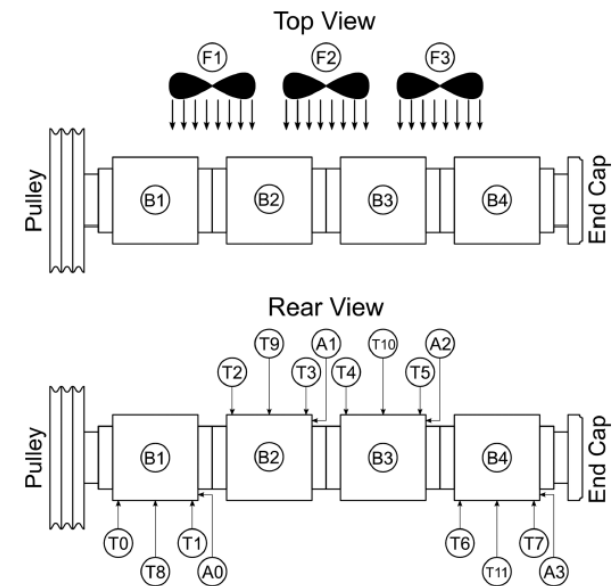
F1-F3 Fans
 B1-B4 Bearings

A0-A3 Accelerometers
 T0-T11 Thermocouples

- Four class K or F bearings
- 14 K-type thermocouples
- Four 500g accelerometers
- LabVIEW™ operated by NI DAQ

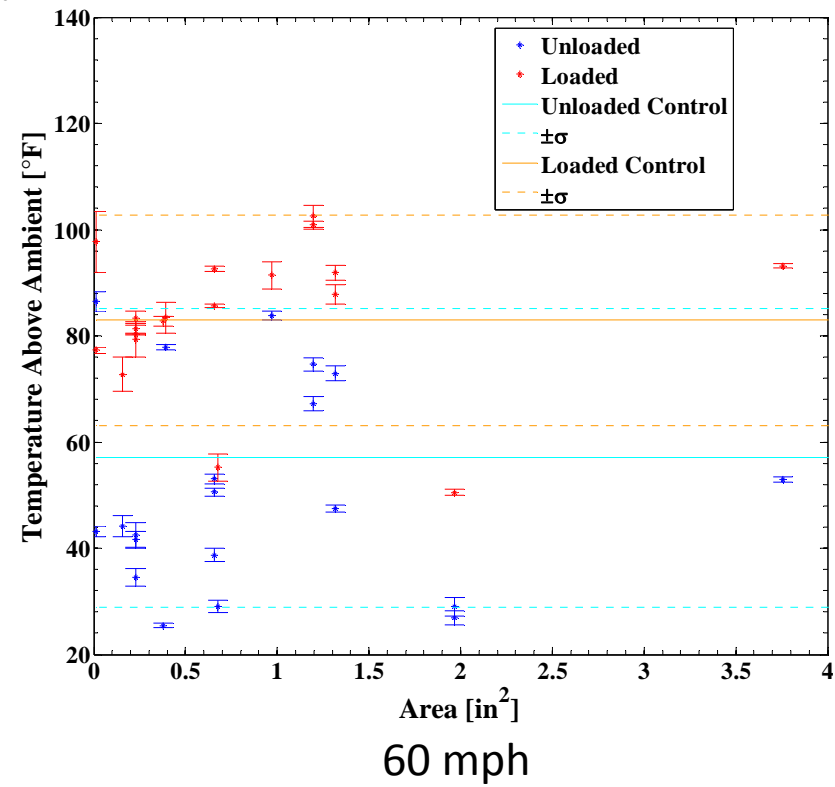
Temperature data of bearings with outer ring (cup) defects of various sizes (defect area) compared against the range of operating temperatures for healthy (control bearings) under fully-loaded (100% load) and unloaded (17% load) conditions.

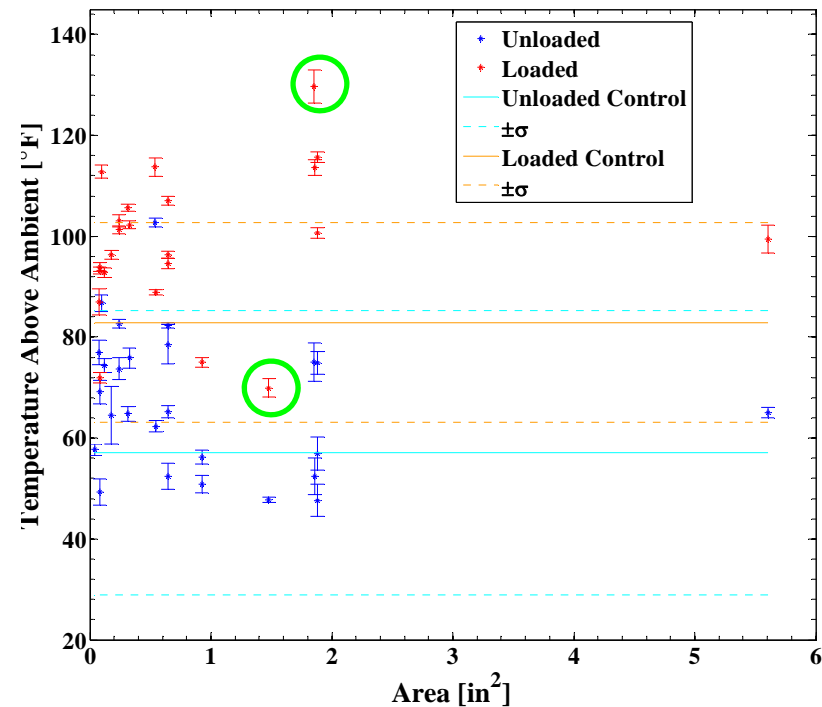
Temperature data of bearings with inner ring (cone) defects of various sizes (defect area) compared against the range of operating temperatures for healthy (control bearings) under fully loaded (100% load) and unloaded (17% load) conditions.

30 mph

60 mph

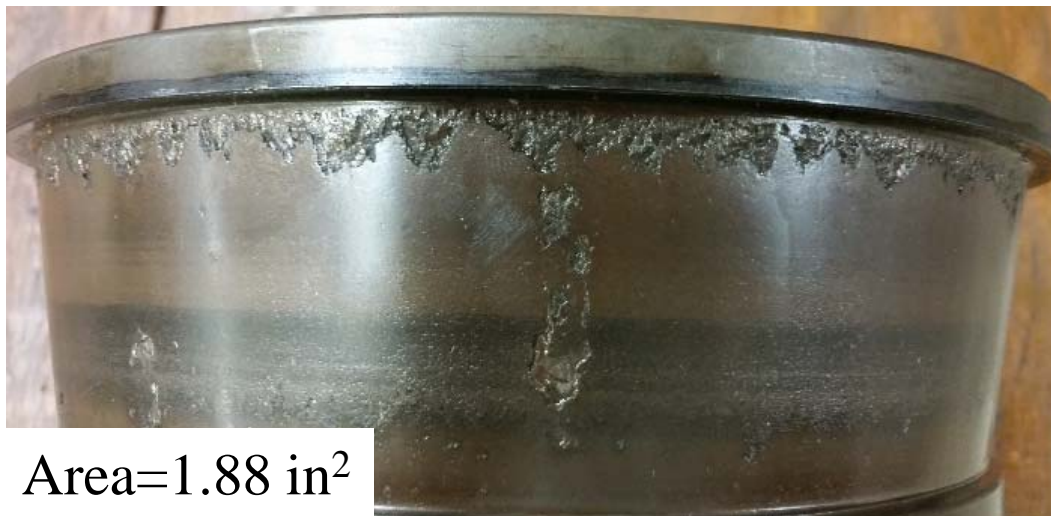
Examples of two large defects of similar size resulting in different operating temperatures.

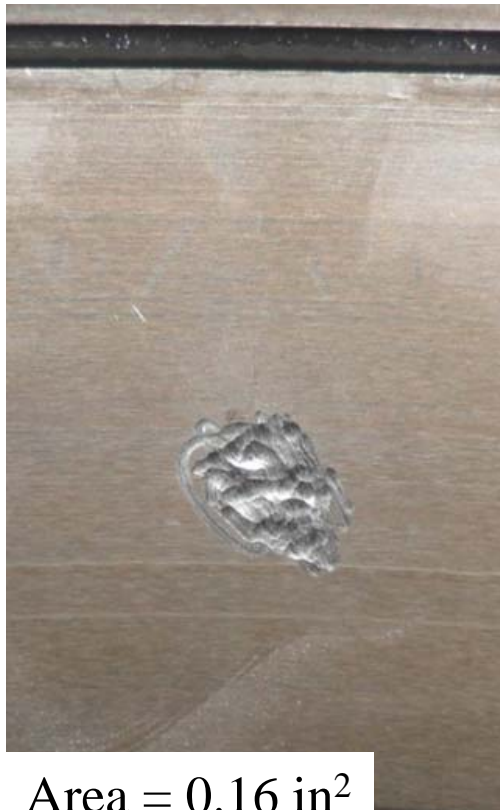
Small Spall

Examples of small and medium sized defects.

Area = 0.16 in²

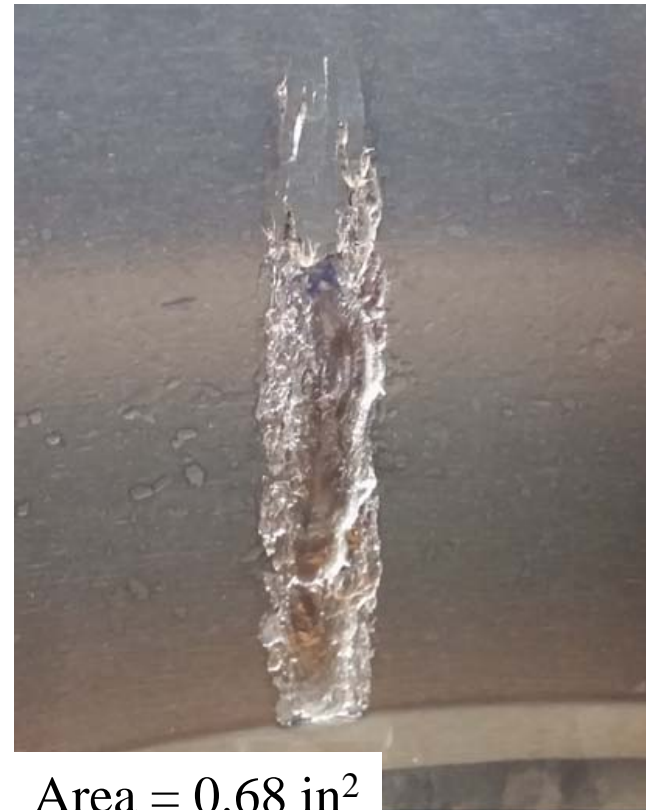
Medium Spall

Area = 0.68 in²
