Pilot Field Test of an Onboard Wireless Condition Monitoring System for Railroad Rolling Stock

JRC2022-78173

**PILOT FIELD TEST OF AN ONBOARD WIRELESS CONDITION MONITORING SYSTEM
FOR RAILROAD ROLLING STOCK**

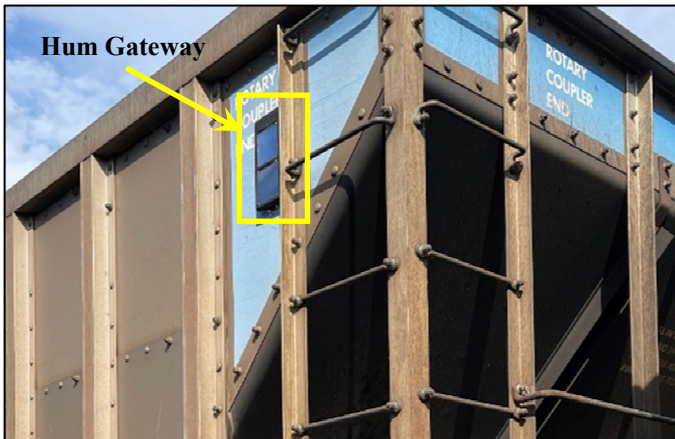
FIGURE 1: HUM GATEWAY INSTALLATION

As shown in FIGURE 1, a single Gateway was installed per railcar while ensuring adequate positioning. Proper placement of the unit is critical to enable optimal solar exposure and communication as the Gateway is a solar-powered device that acts as a data relay bridge between the onboard condition monitoring modules and the railcar owner. Specifically, the Gateway receives the data collected by the Boomerang via cellular data transmission services. Then, the bearing and wheel analytics are transferred and saved in Hum's internet-based server. There, the data is analyzed by the server's software interface, generating automated email notifications when a threshold is surpassed either by vibration or temperature. Stored data can also be downloaded, allowing for thorough inspections of operating bearing and/or wheel states. Any progression into levels of concern by a component can be mapped and identified since its inception.

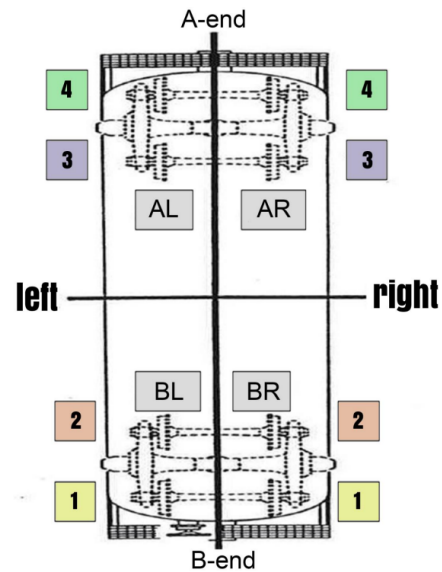
FIGURE 3: RAILCAR SIDE AND END IDENTIFICATION DIAGRAM

Additionally, following the Association of American Railroads (AAR) wheel identification diagram shown in FIGURE 3, the Boomerangs were then registered onto Hum's server using their respective installation positions to facilitate identification of the bearings, wheels, and axles when analyzing the acquired health metrics.

For brevity, only two out of the three wheelsets removed were selected for presentation in this paper. These include a healthy and a defective wheelset as pictured in FIGURE 4 and FIGURE 5, respectively. Since the defective (high-concern wheelset) was in the Axle 2 position (refer to FIGURE 3), a healthy (low-concern wheelset) in the Axle 2 position on a different railcar was removed for direct comparison. Following the AAR wheel identification diagram of FIGURE 3, the paper refers to the wheels as “L2” and “R2” to indicate the left and right locations of the railcar, respectively, while the number “2” indicates the wheelset position on the railcar (i.e., Axle 2).

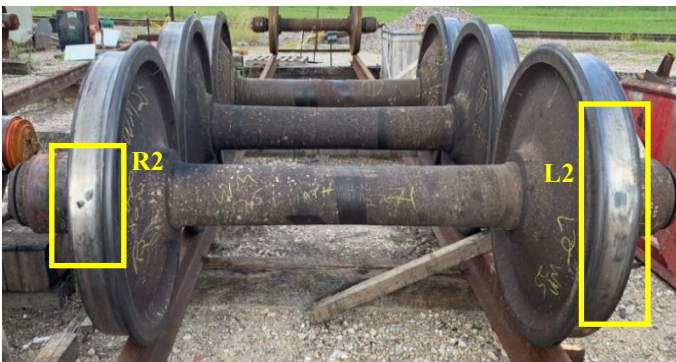
FIGURE 5: AXLE 2 HIGH-CONCERN WHEELSET (DEFECTIVE)

Careful inspection of the three removed wheelsets revealed the identification of defects on the wheel treads and flanges of the axle of interest, confirming the abnormal wheel diagnosis. The other two wheelsets, used for comparison, demonstrated conformity to AAR wheel profile standards. Furthermore, even though BHI signatures from all three axles indicated no bearing abnormalities, the six bearings pertaining to these wheelsets were shipped to the UTCRS laboratory facilities for systematic testing to validate the BHI readings from the field.

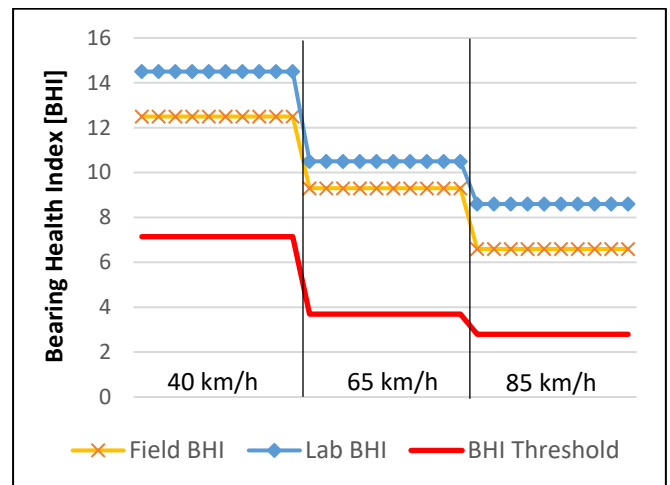
FIGURE 9 and FIGURE 10 present healthy Axle 2 BHI field data in comparison to BHI laboratory data. As the speed increased, the BHI began to decrease, but no bearing fell below the BHI threshold. The BHI responses of the laboratory and field data were mostly analogous with each other. At the higher speeds of 65 and 85 km/h, the BHI values for field and laboratory operations were within 1 BHI unit difference. The slightly larger BHI difference at 40 km/h was due to railcar vehicle dynamics. The systematic laboratory testing verified that the bearings on Axle 2 were healthy and of low concern.

FIGURE 9: HEALTHY AXLE 2 L2 BEARING BHI COMPARISON BETWEEN LABORATORY AND FIELD DATA

FIGURE 10: HEALTHY AXLE 2 R2 BEARING BHI COMPARISON BETWEEN LABORATORY AND FIELD DATA

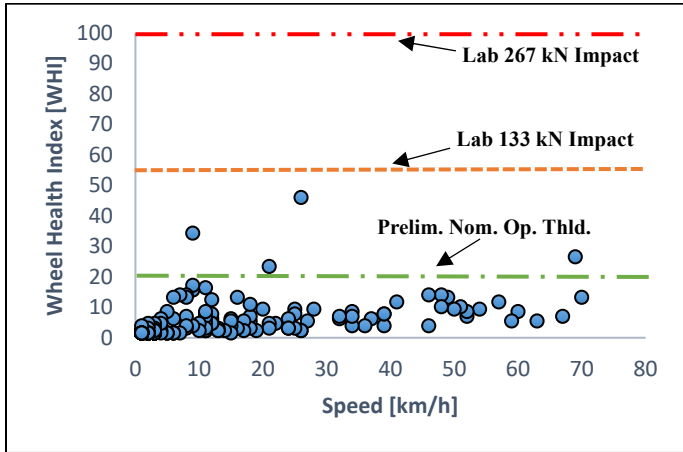
FIGURE 15: HEALTHY AXLE 2 WHI VALUES PRE-CHANGEOUT

FIGURE 16: HEALTHY AXLE 2 WHI VALUES POST-CHANGEOUT

FIGURE 15 and FIGURE 16 delineate the WHI behavior for the healthy Axle 2 before and after its wheelset interchange, respectively. Despite the occasional outlier, which could be the result of bad track segments, there was no significant deviation in WHI caused by the changeout operation establishing that the original wheelset was indeed performing under nominal conditions. The pre- and post-changeout predominant WHI values that fall within a WHI of 20 also exemplify the introduction of the nominal wheel operation threshold.

Nonetheless, by juxtaposing FIGURE 15 and FIGURE 16 onto FIGURE 17, the non-normative wheelset behavior for Axle 2 becomes apparent. Furthermore, superposition of the previously discussed WHI thresholds onto FIGURE 17 clearly map the transition of the wheelset into all the denoted WHI limits until reaching the FRA advised maintenance stage around 50 km/h. The behavior of the data in FIGURE 17 also shows that the effects of wheel irregularities are amplified with increases in speed.

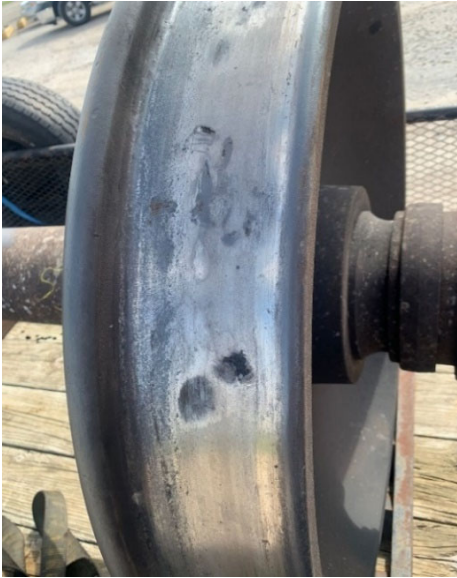
FIGURE 19 and FIGURE 20 provide visual evidence of the wheel flats and spalls found on the defective Axle 2. These

defects further justify the WHI values seen in FIGURE 17. It was also determined that the wheel-rim thickness of one of the wheels of Axle 2 was already at the 1-inch condemning limit [7]. Therefore, reprofiling of the wheel was unfeasible and the wheelset was discontinued from service.

FIGURE 19: WHEEL DEFECTS ON L2 OF AXLE 2

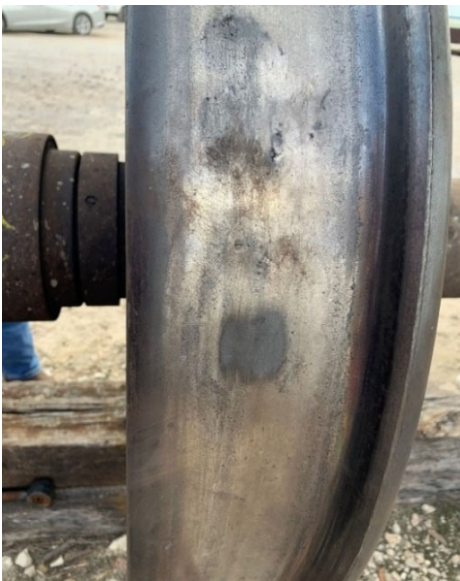
FIGURE 20: WHEEL DEFECTS ON R2 OF AXLE 2
