JRC2018-6210

VIBRATION-BASED DEFECT DETECTION FOR FREIGHT RAILCAR TAPERED-ROLLER BEARINGS

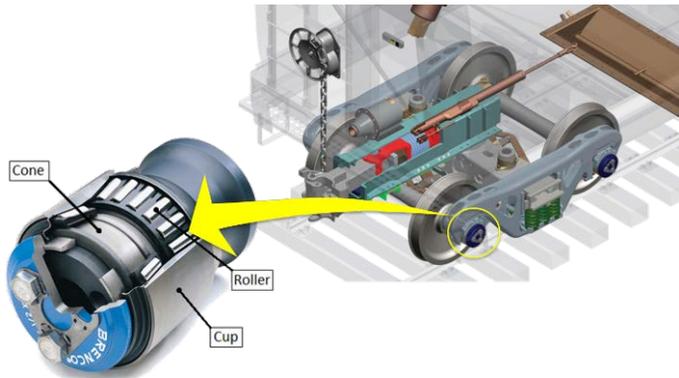
Figure 1. Tapered-Roller Bearing Components [1]

rollers, inner rings (cones), and outer ring (cup). These components, shown in Figure 1, allow for near-frictionless operation under heavy loads and high speeds. However, when one of these components develops a defect, the effectiveness of the near-frictionless rotation is compromised, which may lead to increased frictional heating depending on the size and location of the defect.

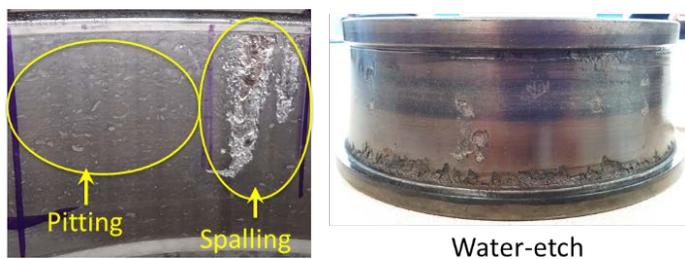
Figure 2. Example of a localized defect (left) and distributed defect (right)

The defects can be categorized into one of three categories: localized defect, distributed defect, or a geometric defect. Two examples of localized defects that include pits, cracks or spalls on a single component of the bearing are illustrated in Figure 2 (left). A distributed defect is when multiple bearing components have localized defects or a single component with multiple defects that are distributed throughout its surface such as a water-etch defect, pictured in Figure 2 (right). Bearings that are out of tolerance due to manufacturing issues or due to geometric inconsistencies are examples of geometric defects.

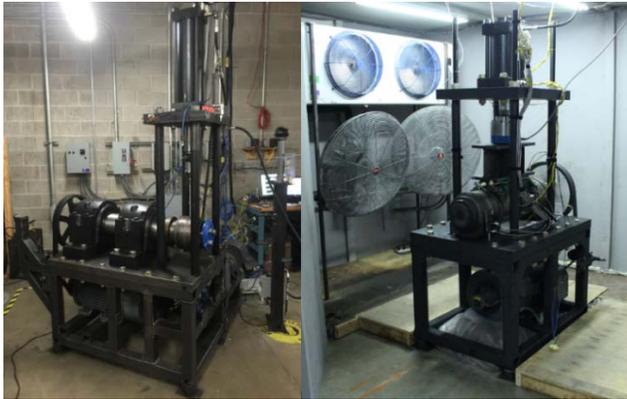
Figure 3. Single Bearing Test Rig (left), Four-Bearing Test Rig (Right)

The University Transportation Center for Railway Safety (UTCRS) dynamic bearing testers shown in Figure 3 were used to perform all relevant experiments for this study. Both test rigs can accommodate Class F (6 1/2" x 12") and Class K (6 1/2" x 9") tapered-roller bearings. A fully loaded railcar applies a load of 153 kN (34.4 kip) per bearing, and each tester is equipped with a hydraulic cylinder that allows each test bearing to be loaded up to 175% of a fully-loaded railcar. The data provided in this paper were collected utilizing three loading conditions; namely, 17% of full load, which represents an empty railcar, 100% of full load, which corresponds to a fully loaded railcar, and 110% of full load, which simulates an overloaded railcar. The test rigs are equipped with a 22 kW (30 hp) variable speed motor which allows the bearings to be tested at the different velocities listed in Table 1. The bearings are air-cooled utilizing two industrial size fans that produce an air stream traveling at an average speed of 5 m/s (11.2 mph).

The Single Bearing Test Rig (SBT) shown in Figure 3 (left) accommodates a single railroad tapered-roller bearing in a cantilever setup, which closely mimics the bearing loading conditions on a freight railcar. A bearing adapter was specially machined to accept four 70g accelerometers (placed in the Smart Adapter (SA) and Mote (M) locations at the inboard and outboard sides of the bearing), one 500g accelerometer (placed in the Radial (R) location on the outboard side), and four K-type bayonet thermocouples (two inboard and two outboard). In addition to the four thermocouples affixed to the bearing adapter, there are seven K-type thermocouples placed equidistantly around the circumference of the bearing outer ring (cup), and held in place tightly via a hose clamp.

The Four-Bearing Test Rig (4BT) shown in Figure 3 (right) accommodates either four Class F or Class K bearings pressed onto a test axle. The instrumentation setup for the 4BT is given in Figure 4. In order to replicate field service conditions, only data collected from the middle two bearings (B2 and B3) were used for this study since they are both top-loaded. Thus, the middle two bearing adapters were machined to accept two 70g accelerometers (placed in the outboard SA and M locations), one 500g accelerometer (placed in the outboard R location), two K-type bayonet thermocouples, and one regular K-type thermocouple aligned with the two bayonet thermocouples and placed midway along the bearing cup width, held tightly by a hose clamp. Figure 5 shows the Smart Adapter (SA), Mote (M), and Radial (R) locations of the accelerometers on the modified bearing adapter.

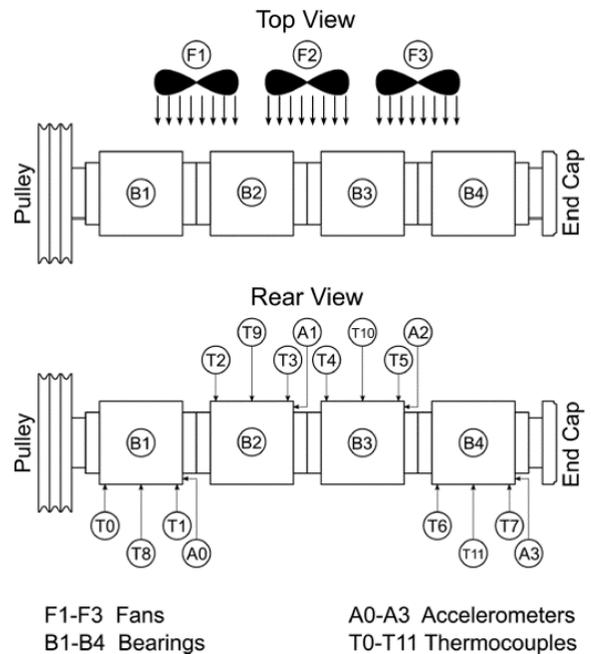
Figure 4. Top and rear views of 4BT including sensor locations

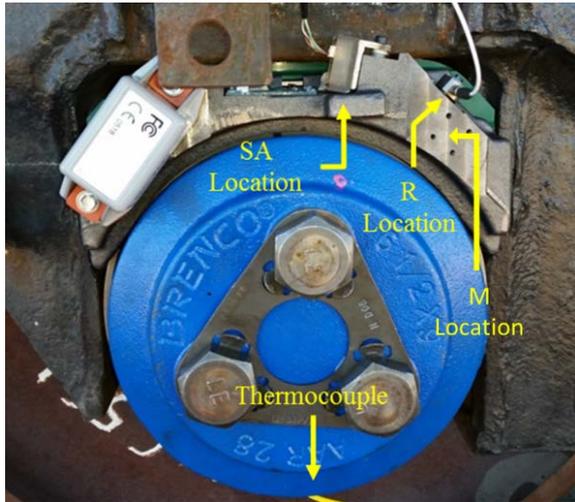
Figure 5. Modified bearing adapter showing sensor locations

It is important to note that this field test was implemented as a blind test; *i.e.*, the UTCRS researcher in charge of analyzing the data did not know the type and location of the four defective bearings within the freight railcar. Out of the eight railroad bearings on the instrumented freight railcar, four were defect-free (healthy), two contained outer ring (cup) defects (spalls), and two had inner ring (cone) defects (spalls). Figure 7 provides the locations of the healthy and defective bearings on the instrumented freight railcar, and Figure 5 shows the sensors used in this field test along with their location on the bearing/adapter assembly.

The field test utilized two different TTCI tracks in order to evaluate the difference in results when the train travels over a smooth versus a rough track. One 70g and one 500g accelerometer were mounted on each bearing adapter at the SA and R locations (see Figure 5), respectively. Note that the 70g accelerometer is mounted on a special circuit board, and the signal produced by this accelerometer passes through specially designed electronic signal conditioning circuitry to filter out any external noise interference prior to being connected to the NI 9215 card. The special circuit board and the signal conditioning circuitry were designed and fabricated by the UTCRS research team as part of the onboard vibration-based bearing health monitoring system development efforts. The 500g accelerometer that is mounted on the adapter at the Radial (R) location is commercially available, has built-in signal conditioning, and plugs directly to the NI 9234 card connected to the DAQ system. In the field test, temperature data was collected at a sampling rate of 128 Hz for half a second, in fifteen second intervals, whereas, the accelerometer data were collected continuously at a rate of 5,556 Hz. All instrumentation was powered by the locomotive. The final version of the prototype onboard sensor will be wireless and battery-powered.

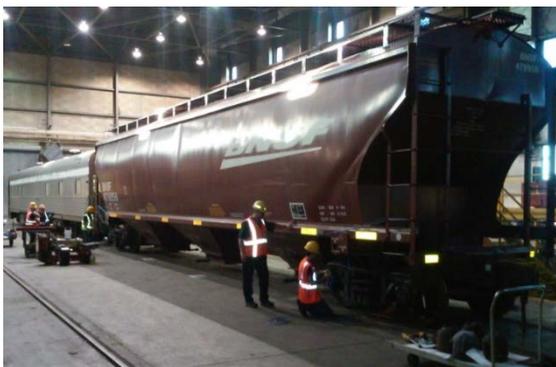
Figure 6. A picture of the business car and the freight railcar being instrumented for the field test at TTCI

In 2015, the UTCRS research team, in collaboration with Amsted Rail Engineers, conducted a proof of concept field test at the Transportation Technology Center, Inc. (TTCI) in Pueblo, Colorado. The primary objective of the field test is to validate the accuracy and reliability of the onboard accelerometer-based condition monitoring system in detecting defective bearings. A locomotive towing a business car and an instrumented freight railcar (empty one day and fully loaded the second day) along different TTCI tracks at speeds ranging from 48 to 105 km/h (30 to 65 mph) provided the field-test data for this study. The data acquisition system was set up in the business car. Figure 6 is a picture of the business car and the freight railcar as the UTCRS research team was completing the instrumentation in preparation for the field test at TTCI.

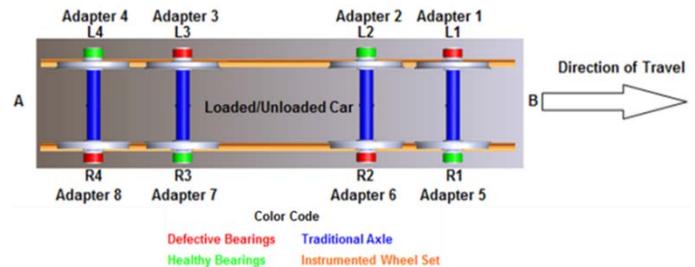
Figure 7. Test Railcar Setup at TTCI

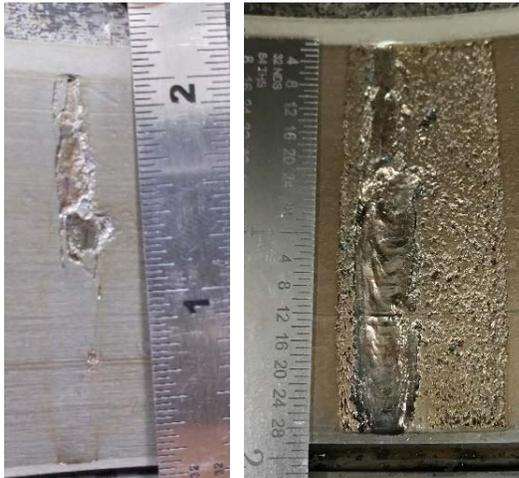
Figure 8. Starting cup spall for Bearing 3 (left); ending cup spall for Bearing 3

In Experiment 203, a defective bearing with an outer ring (cup) spall on the outboard raceway, approximately 0.865 cm² (0.134 in²) in initial size, was run on the four-bearing tester (4BT). The bearing with the initial defect shown in Figure 8 (left) was placed in the B3 position on the 4BT (see Figure 4). The spall propagated throughout the course of the experiment and grew in size to 9.50 cm² (1.47 in²), as depicted in Figure 8 (right). For direct comparison, the bearing placed in the B2 position right next to the defective bearing (B3) is a control (defect-free) bearing that is run at the same exact load and speed operating conditions.

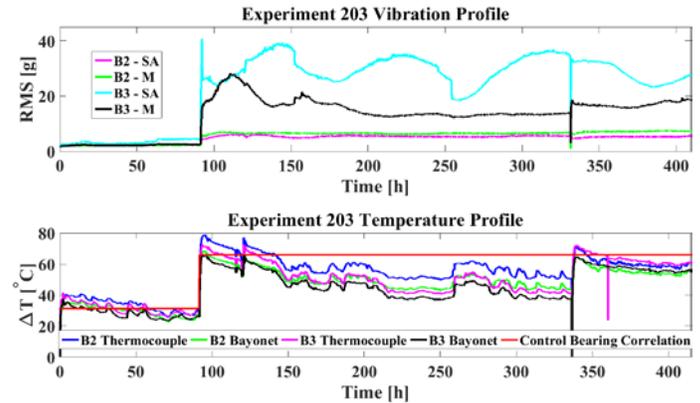
Figure 9. Vibration and temperature profiles for Experiment 203

The bearings were initially run at a speed of 64 km/h (40 mph) and a full load (153 kN or 34.4 kip per bearing) in order to allow the grease to break in, after which, the test conditions were changed to 137 km/h (85 mph) and 110% of full load. The vibration and temperature profiles for the defective versus the control bearing are displayed in Figure 9. Looking at the temperature histories for both bearings, two observations can be made; first, both bearings seem to be running at or below the average operating temperature correlation for control bearings depicted by the solid red line, with the exceptions being at the initial break in period and the settling periods following abrupt changes in operating conditions; second, the healthy bearing is running hotter than the defective bearing throughout the experiment, which is counterintuitive. Table 2 provides a summary of the results depicted in Figure 9.

Examining the vibration signatures of the healthy versus the defective bearing shown in Figure 9, and looking at the

average root-mean-square (RMS) values of the accelerations summarized in Table 2, it is evident that the defective bearing (Bearing 3) has a higher vibration signature than the healthy bearing (Bearing 2). As stated earlier, the spall within the defective bearing propagated during the experiment, which resulted in a significant increase in the vibration levels of that bearing as exhibited by the RMS values listed in Table 2. Previous testing performed has revealed that as the defect size increases, the vibration levels of the bearing increase as well. This increase is attributed to small metal pieces surrounding the spall region that break off and affect the rotational behavior of the bearing rolling elements. As the bearing continues to operate, the metal debris circulates throughout the bearing and gets crushed by the rollers. When that happens, the vibration levels of the bearing decrease as the metal shards shrink in size. This cycle will repeat itself every time the spall deteriorates introducing more metal debris into the bearing rolling raceways. This behavior is captured through the vibration oscillations of Bearing 3 (defective) seen in Figure 9. Both accelerometers on Bearing 3 (SA and M locations) exhibit this behavior after the change in the load and speed operating conditions. However, Bearing 2 (healthy) does not exhibit any oscillations, and maintains near constant vibration levels at each operating condition.

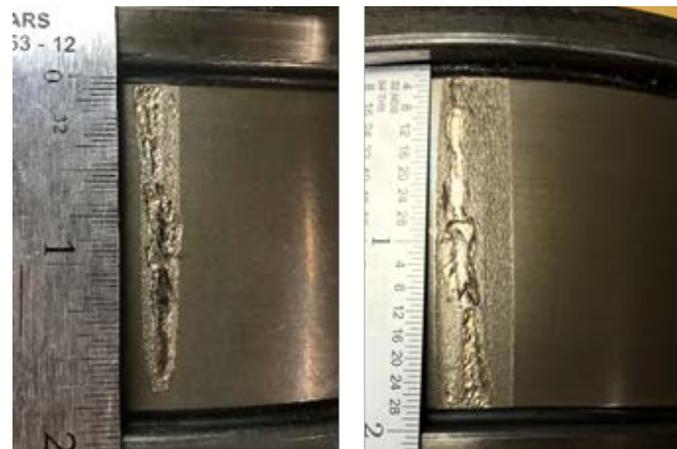
Figure 10. Starting cone spall for Bearing 2 (left); ending cone spall for Bearing 2 (right)

Two defective bearings were used in Experiment 204: Bearing 2 has a spalled cone (inner ring), whereas, Bearing 3 has a pitted cone raceway. Bearing 2 had a starting spall size of approximately 2.85 cm² (0.441 in²), and an ending spall size of 5.04 cm² (0.781 in²). The pits on Bearing 3 did not grow. Figure 10 and Figure 11 depict the starting and ending defect size for Bearing 2 and Bearing 3, respectively.

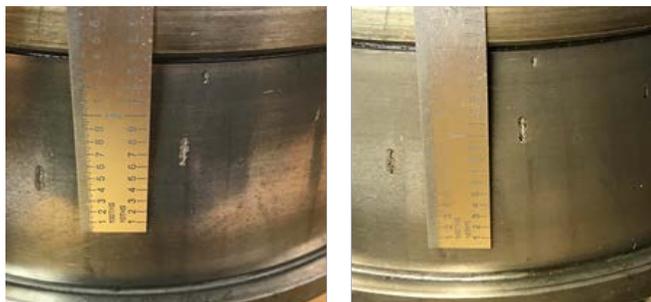
Figure 11. Starting pitted cone raceway for Bearing 3 (left); ending pitted cone raceway for Bearing 3 (right)

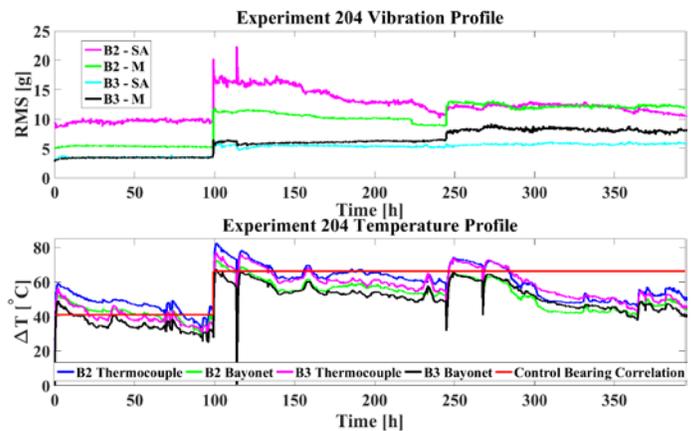
Figure 12. Vibration and temperature profiles for Experiment 204

Again, the results of Experiment 204 demonstrate that the bearing operating temperature alone is not adequate to identify defects in bearings. Looking at Figure 12 and the results summarized on Table 3, it can be observed that both defective bearings operated at or below the average operating temperature of the control (defect-free) bearing, with Bearing 2 running slightly hotter than Bearing 3. However, when examining the average RMS values for both bearings, it is clear that the vibration levels of Bearing 2 (the one with the spall) are higher than those for the control bearing at all loading and speed conditions. As for Bearing 3 (the one with the cone raceway pits), the vibration levels begin to exceed those of the control bearing at the highest load and speed conditions, which is not surprising given that these pits are very minimal in size. As stated earlier, the spall of Bearing 2 propagated during the experiment. By observing the vibration history of Bearing 2, it appears that the spall is still approximately 2.85 cm² (0.441 in²) in size during the lower speed and load conditions. The latter implies that the devised vibration-based condition monitoring system is capable of reliably detecting defects less than 3.22 cm² (0.500 in²) in size.

Note that the increase in the vibration levels as the spall propagated was masked by the change in speed and load conditions. The ensuing decrease in the vibration levels of Bearing 2 is the result of the small metal shards that broke off from the spall shrinking in size and being pushed out of the way by the rollers. Finally, it is important to point out that the increase in the vibration levels of Bearing 3 at around 245 hours into the test, as indicated by the accelerometer in the mote (M) location, mimics the increase exhibited by the mote location accelerometer of Bearing 2, and is the result of the cross-talk between the two bearings that are next to each other.

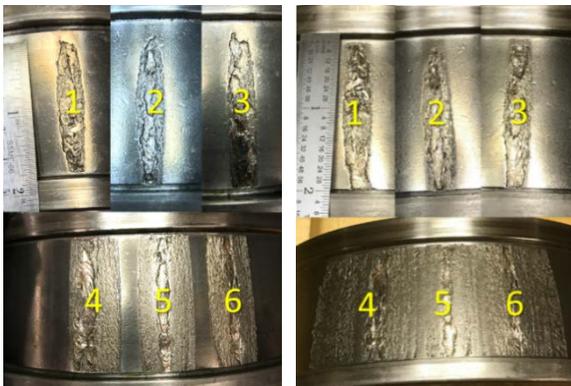
Figure 13. Starting cone spalls for Experiment 206 (left); ending cone spalls for Experiment 206 (right)

Experiment 206 was carried out on the single bearing tester (SBT) and was intended to examine a severely defective inner ring (cone) with large size spalls, as pictured in Figure 13. The test bearing originally contained a defective cone with six spalls, as shown in Figure 13 (left). After the experiment ended, it was noticed, upon teardown and disassembly, that three of the spalls had combined forming a large rough patch that covered a significant area of the cone, as can be seen in Figure 13 (right). Table 4 lists all the spall sizes pre- and post-testing. The test bearing was run at three different speeds and two loading conditions, 17% load (empty railcar), and 100% load (full railcar). By the end of the experiment, the cone raceway had degraded to the point where the motor was not able to rotate the axle due to roller misalignments in the defective bearing.

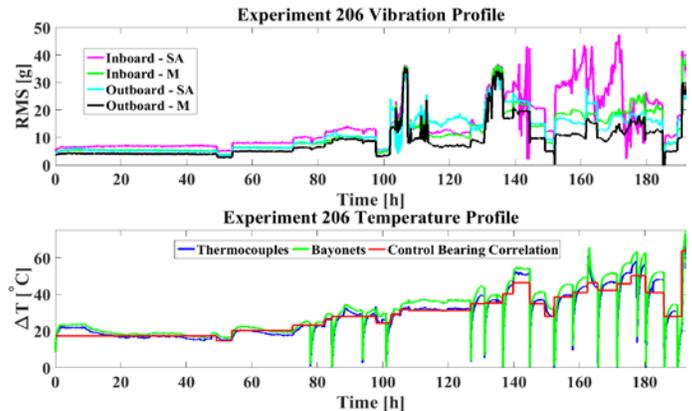
Figure 14. Vibration and temperature profiles for bearing 1 for Experiment 206

Looking at Figure 14 and Table 5, it is evident that the test bearing vibration levels far exceed those of a control (healthy) bearing for similar loading conditions. At 64 km/h (40 mph) and 100% load, the test bearing RMS value is about five times that of a control bearing while still operating at a temperature that is only 3°C (5°F) higher than the operating temperature of the control bearing correlation. In fact, the highest average operating temperature of this test bearing is only 5.3°C (9.5°F) greater than the control bearing correlation. None of the operating temperatures for this defective bearing are high enough to trigger the HBD alarm threshold of 94.4°C (170°F) above ambient conditions set by the Association of American Railroads (AAR). The latter is a cause for concern given the severity of the defects within this bearing and the fact that the test rig was having difficulties rotating the axle due to the high roller misalignments causing the bearing to lock up. A bearing with a similar defective cone in field service would have probably seized under similar operating conditions. The train’s momentum would cause the rollers to heat up excessively and melt the bearing onto the axle, which may lead to a catastrophic derailment depending on the traveling speed of the train and the load it is carrying.

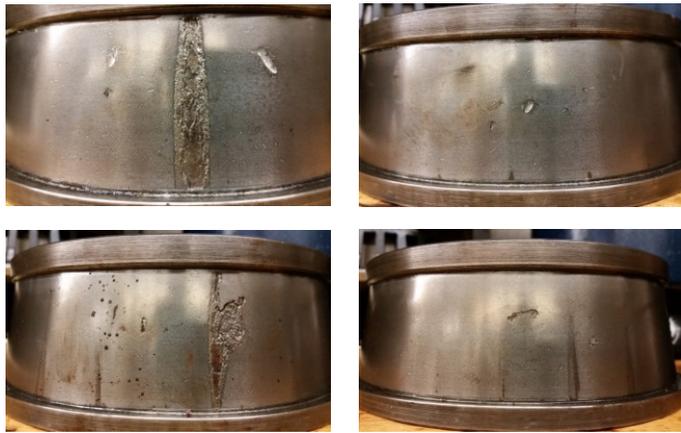
Figure 15. Photographs of Bearing L1 inner ring (cone) defect

UTCRS researchers along with Amsted Rail engineers instrumented a railcar at TTCI in Pueblo, CO, with accelerometers and thermocouples, as depicted in Figure 5. As described earlier, this test was intended to be a blind test in order to validate the developed vibration-based bearing condition monitoring technology. Hence, four defective and four healthy bearings were strategically positioned throughout the railcar. For brevity, this section will focus on the four bearings located at the front half of the railcar during the first day of field testing. Bearing L1 had a defective cone with a total spall area of 14.2 cm² (2.2 in²), as shown in Figure 15. Bearing R2 had a defective outer ring (cup) with a total spall area of 34.2 cm² (5.3 in²), as pictured in Figure 16. The railcar operated at speeds of 48 km/h (30 mph), 80 km/h (50 mph), and 89 km/h (55 mph) with a full load (153 kN or 34.4 kip per bearing). The average ambient temperature during this test was 17.5°C (63.5°F). Figure 17 along with Table 6 and Table 7 summarize the most relevant results of this test.

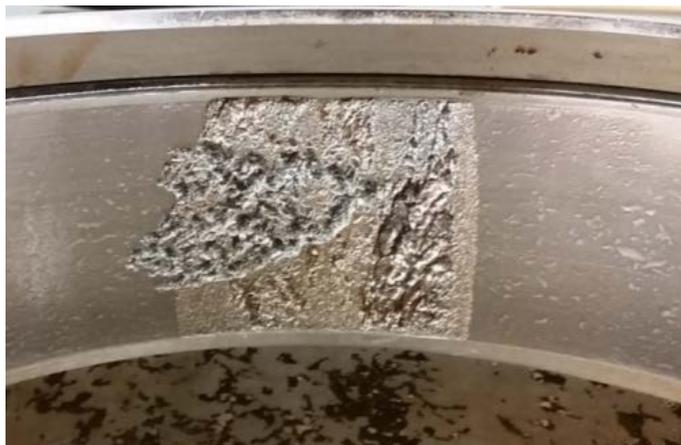
Figure 16. Photograph of Bearing R2 outer ring (cup) defect

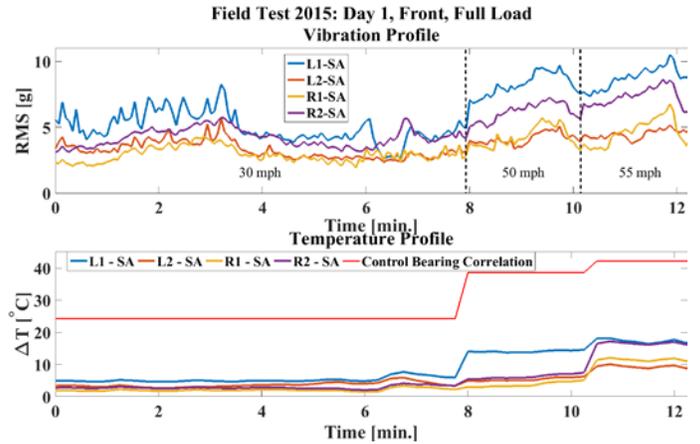
Figure 17. Vibration and temperature profiles for defective and healthy bearings located at the front of a fully loaded railcar (refer to Figure 7)

According to Figure 17, Table 6, and Table 7, the defective Bearings L1 and R2 have vibration levels that are, on average, 50% higher than those for the healthy Bearings L2 and R1. When comparing these four bearings to the control bearing values established in Table 2, it is evident that Bearings L1 and R2 operating at 100% load with speeds of 89 km/h (55 mph) and lower exhibit vibration levels that are 33% higher than those of the control bearing operating at a speed of 137 km/h (85 mph) with an overload of 110%. In contrast, Bearings L2 and R1 have vibration levels that fall in-line with the control bearing. Examining the temperature histories of the four bearings, it can be observed that the defective Bearings L1 and R2 are running at higher operating temperatures than those of the healthy Bearings L2 and R1, but the operating temperatures of all four bearings are well below the average operating temperatures given by the control bearing correlation. Moreover, the operating temperatures of the two defective bearings are well below the HBD alarm threshold. Similar trends are shown by the back four bearings for this test day, and for the second day field tests performed under different loading conditions. These results demonstrate the effectiveness of the devised vibration-based bearing condition monitoring system.
