## Lateral Load Effect on Railway Tapered Roller Bearing Performance

A Report on Research Sponsored by  
University Transportation Center for Railway Safety (UTCRS)  
University of Texas Rio Grande Valley (UTRGV)

EXAMINING THE EFFECTS OF LATERAL LOADING  
ON RAILROAD TAPERED ROLLER BEARINGS

A Thesis

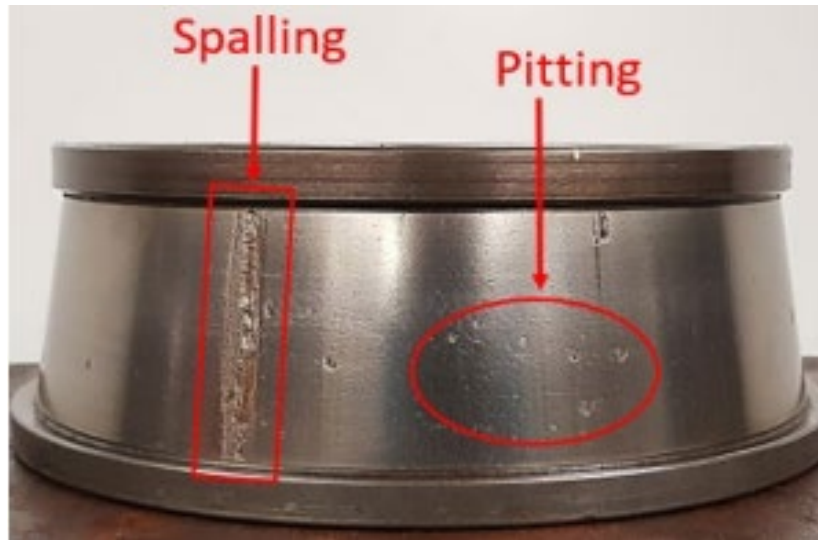
Bearing defects are generally caused by one or more of the following three factors: rolling contact fatigue (RCF), lubricant contamination, and geometric out-of-tolerance conditions. RCF can cause microcracks to develop, which can propagate during operation, leading to surface spalling [3][4]. Spalls release metallic debris, increasing wear and further degrading the performance of components with rolling raceways [5] leading to increased temperatures and accelerated lubricant breakdown. A localized RCF defect characterized by spalling and pitting on a bearing cone (inner ring) is depicted in Figure 3.

Figure 3. Fatigue spalling and pitting on a cone raceway of a tapered roller bearing [3]

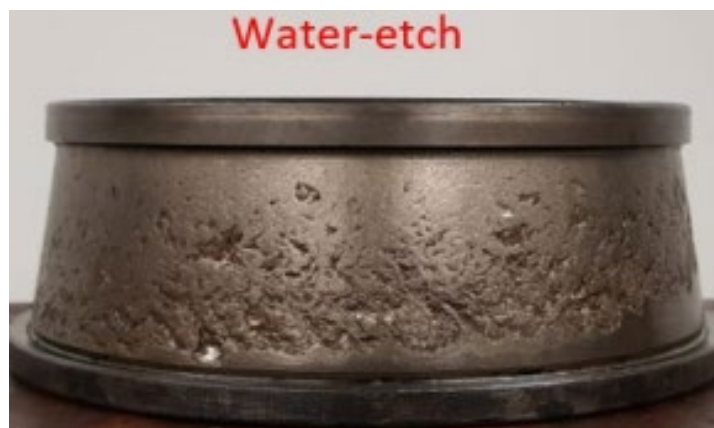
Lubricant contamination most commonly occurs when moisture mixes with the bearing grease. This form of contamination, often referred to as water-etching, is frequently observed in field applications. Moisture interaction with the grease causes lubricant degradation and leads to raceway corrosion. As a result, etch marks appear along the raceways. Under continuous operation, this type of defect can propagate, accelerating bearing degradation. Figure 4 shows water-etch damage on a cone raceway.

Figure 4. Water-etch damage on a cone raceway of a tapered roller bearing [3]

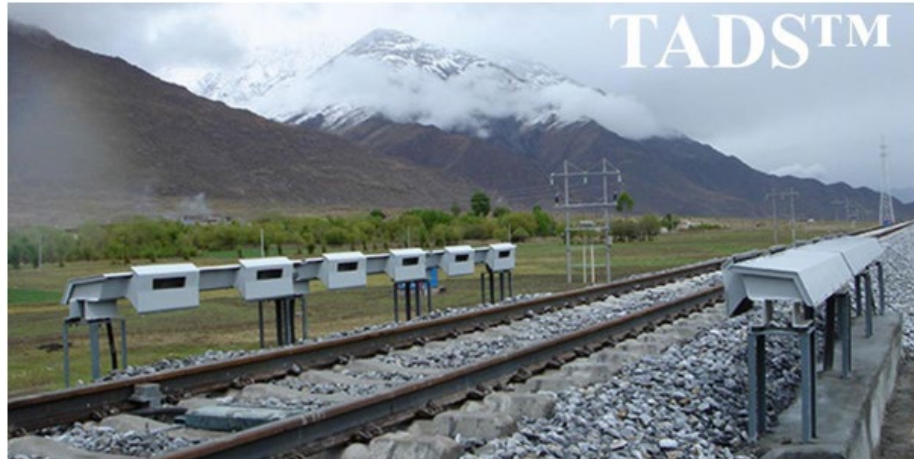
Trackside Acoustic Detection Systems (TADS™) are an example of an ABD that uses microphones to detect acoustic signatures during bearing operation, as pictured in Figure 6. The system uses sound to determine the condition of the bearings and wheels as they pass through the detectors. TADS™ detect bearings known as “growlers,” which contain defects spanning the

Figure 6. Trackside Acoustic Detection System (TADS™) site [15]

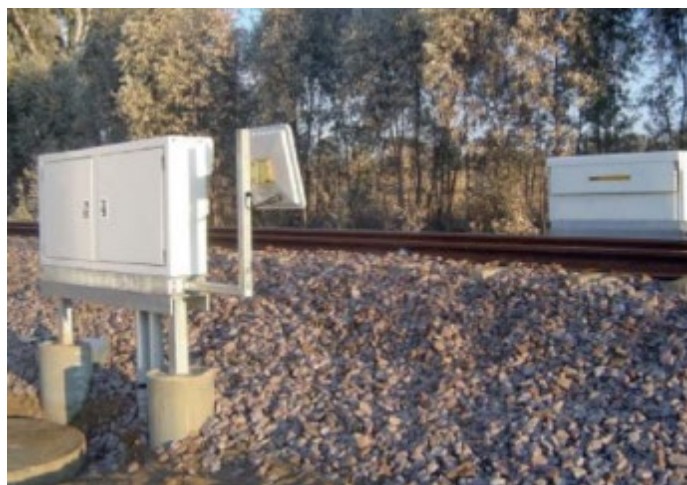
RailBAM (Rail Bearing Acoustic Monitor), pictured in Figure 7, uses tie-mounted auxiliary sensors and a signal-processing electronics rack located in a wayside enclosure. Similar to TADS™, RailBAM uses microphones to assess the condition and severity of bearing defects; it can detect early signs of defects with 95% reliability. There are 20 RailBAMs installed throughout North America as of 2017 [16].

Figure 7. RailBAM (Rail Bearing Acoustic Monitor) site [16]

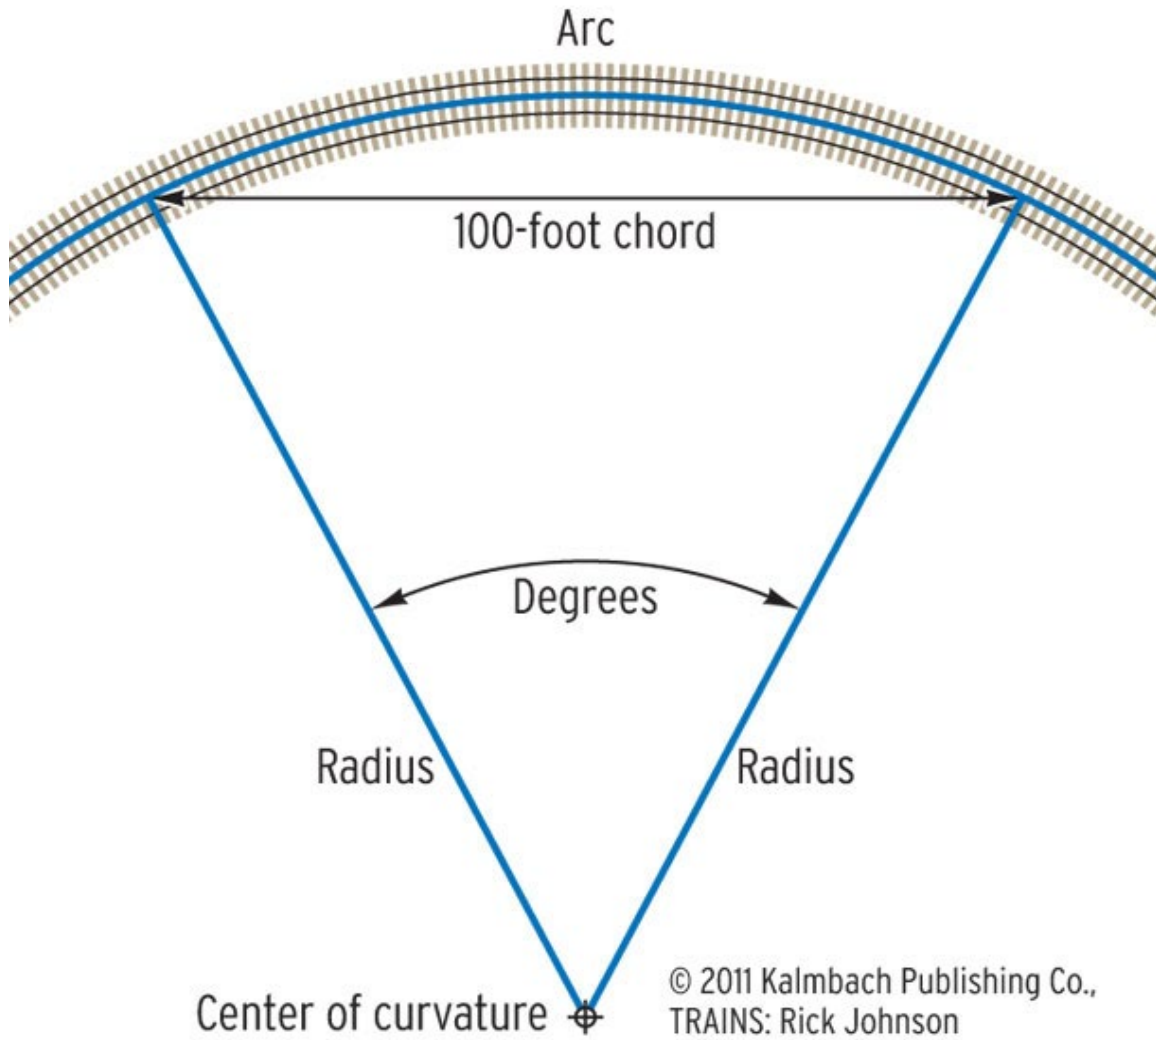
Figure 9. 1° curve based on a 100-ft chord [22]

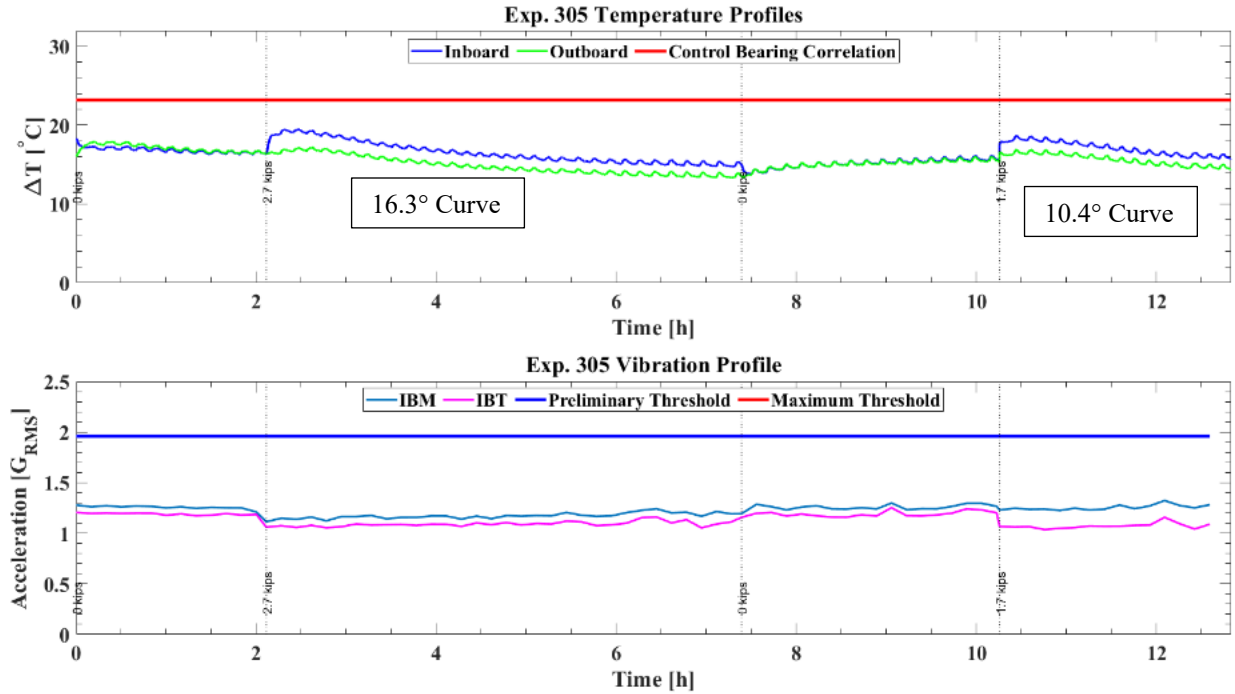
After the lateral load was removed (~7.5 hours), the bearing temperatures gradually returned to their original baseline values. The second lateral load application of 7.6 kN (1.7 kips) ( $L/V = 0.24$ ) at the 10-hour mark, corresponding to a 10.4° curve, produced a similar response. The inboard temperature showed a moderate increase, while the outboard temperature remained relatively stable, with both temperatures returning to baseline levels after the lateral load was removed. Overall, the temperature remained consistent with expected temperature profiles for a healthy bearing operating under stable conditions.

Figure 19. Control bearing temperature and acceleration at 72 kph (45 mph) for 17% load (empty railcar load) with varying lateral loads

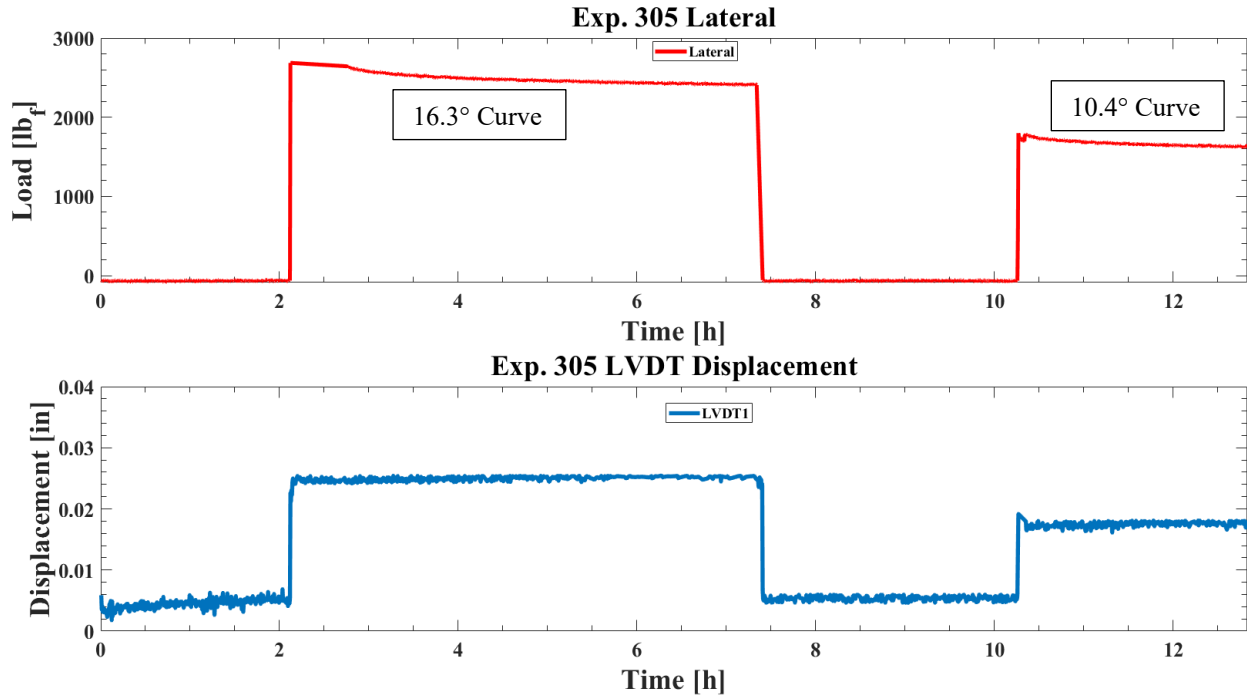
The displacement response follows the applied lateral load, increasing with L/V and returning to near-baseline values upon load removal. The maximum measured displacement approached the unmounted lateral clearance of the bearing (0.584-0.660 mm or 0.023-0.026 in), indicating that lateral loading progressively reduces internal clearance and shifts the internal load distribution.

Figure 20. Control bearing lateral load and displacement at 72 kph (45 mph) for 17% load (empty railcar load) with varying lateral load

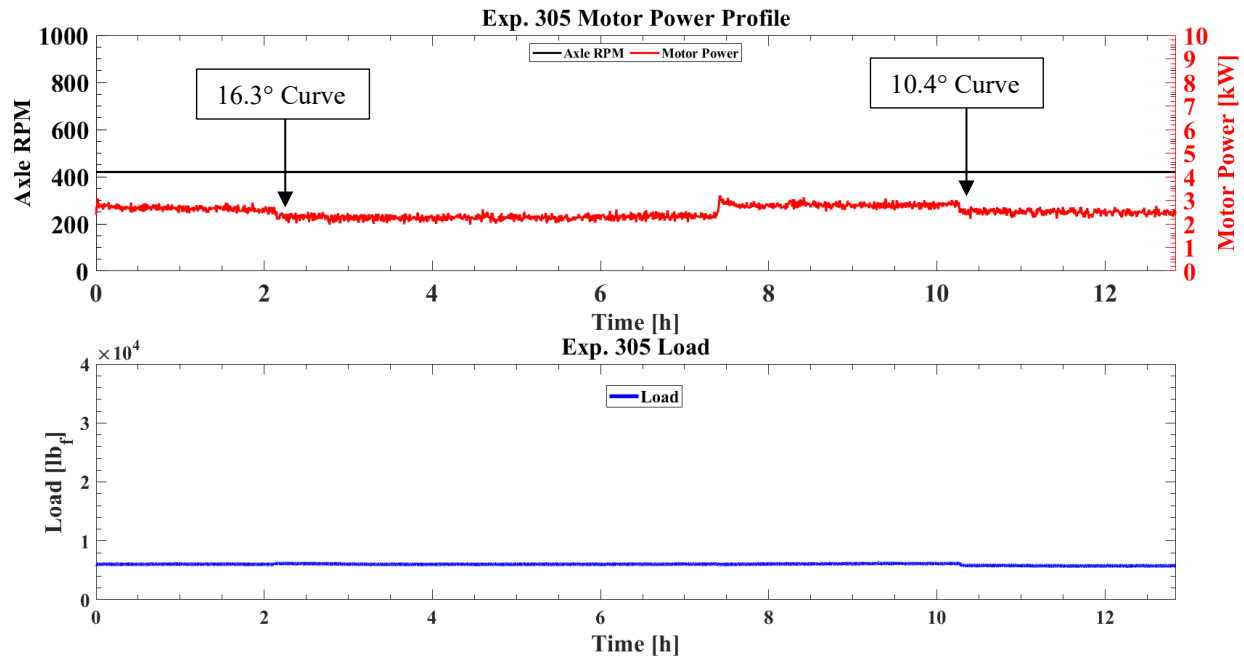
Figure 21. Control bearing power and vertical load at 72 kph (45 mph) for 17% load (empty railcar load) with varying lateral loads

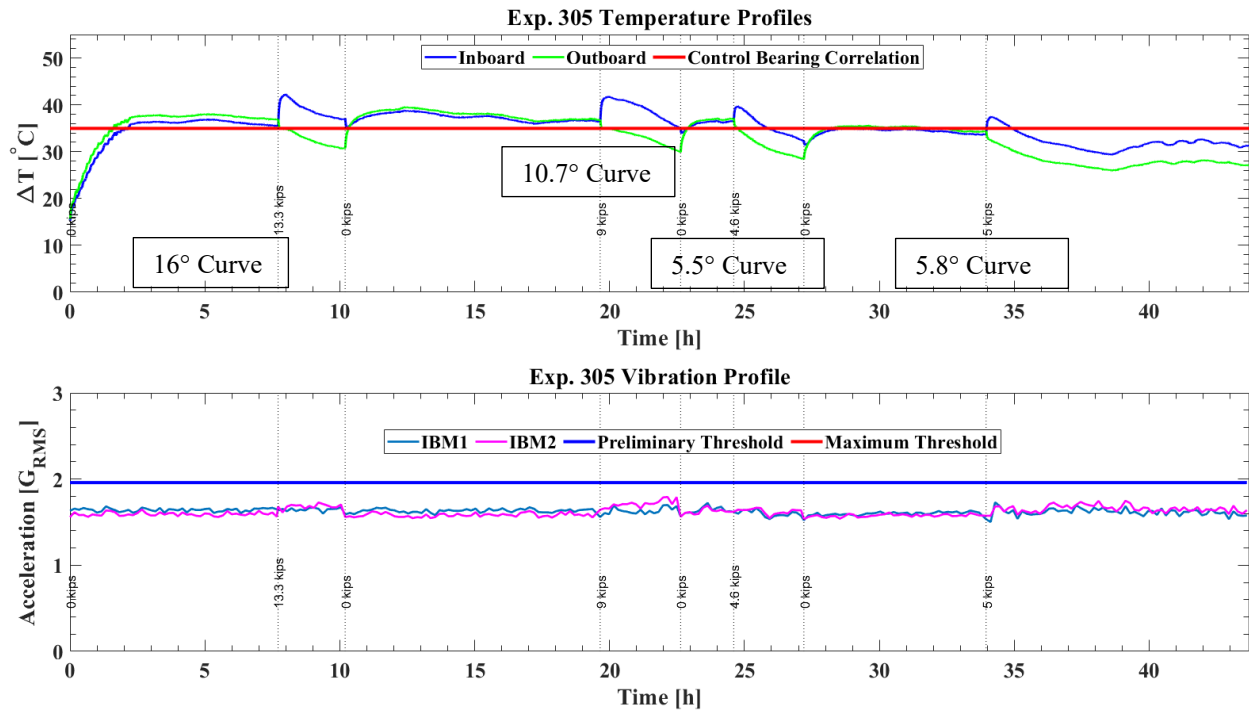
Figure 22. Control bearing temperature and acceleration at 72 kph (45 mph) for 100% load (fully loaded railcar) with varying lateral loads

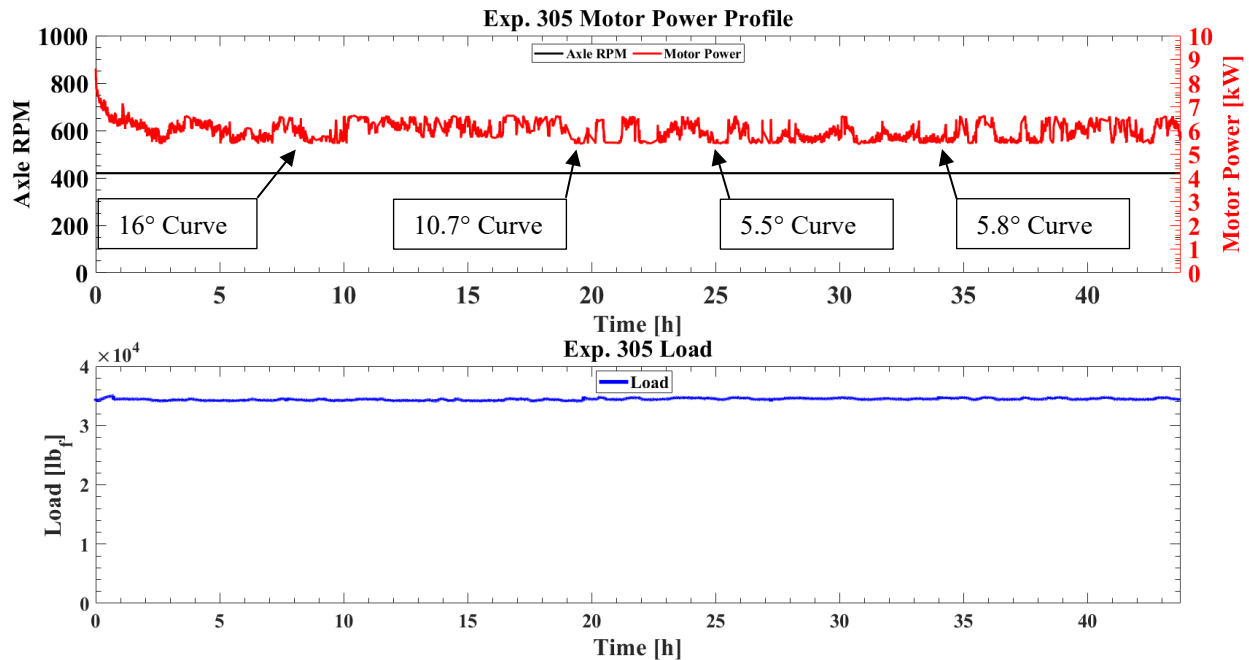
Figure 24. Control bearing power and vertical load at 72 kph (45 mph) for 100% load (fully loaded bearing) with varying lateral loads

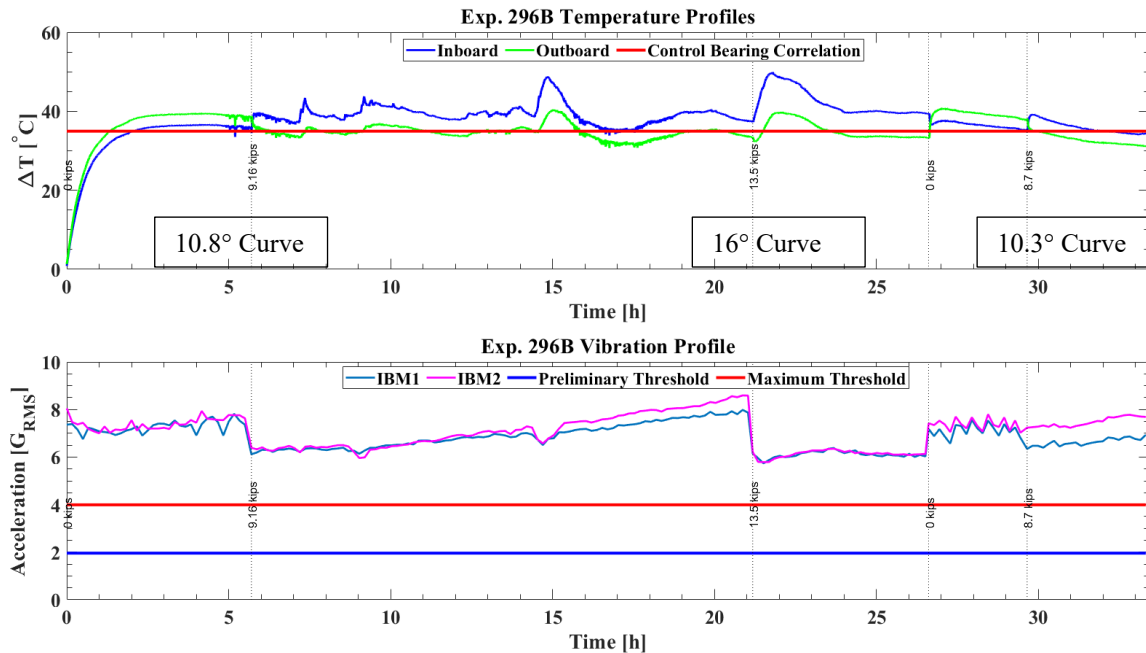
Figure 26. Defective bearing temperature and acceleration at 72 kph (45 mph) for 100% load (fully loaded railcar) with varying lateral loads

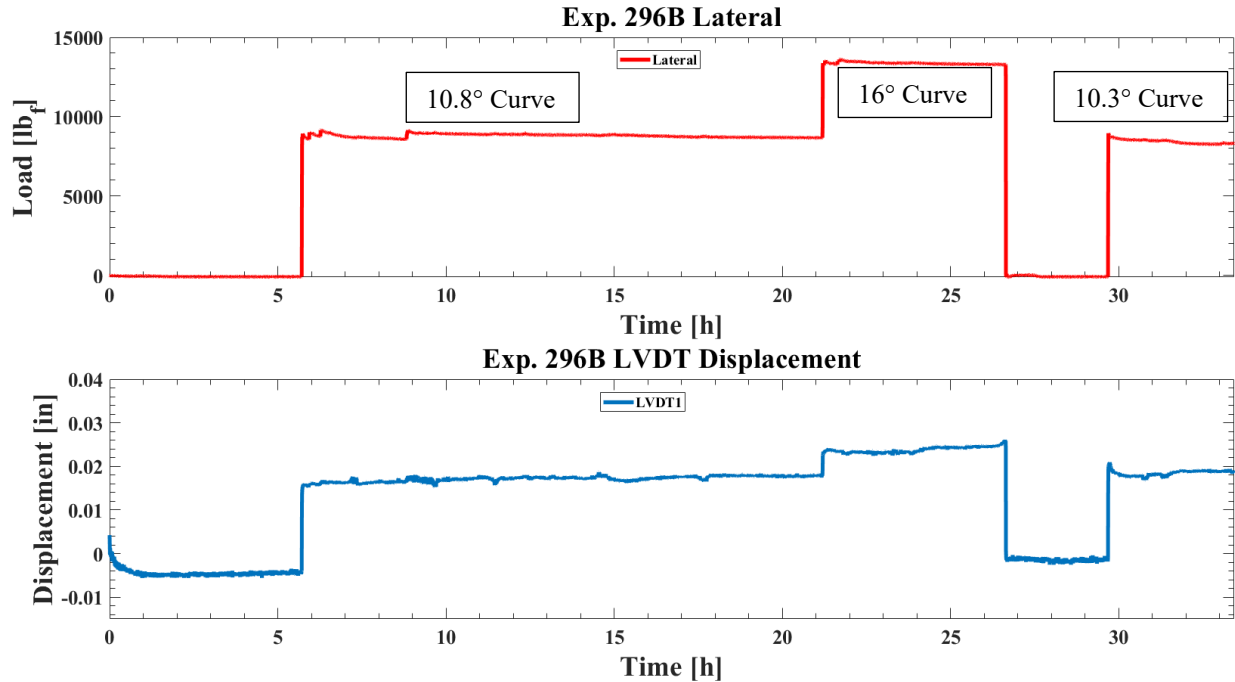
Figure 27. Defective bearing lateral load and displacement at 72 kph (45 mph) for 100% load (fully loaded railcar) with varying lateral load

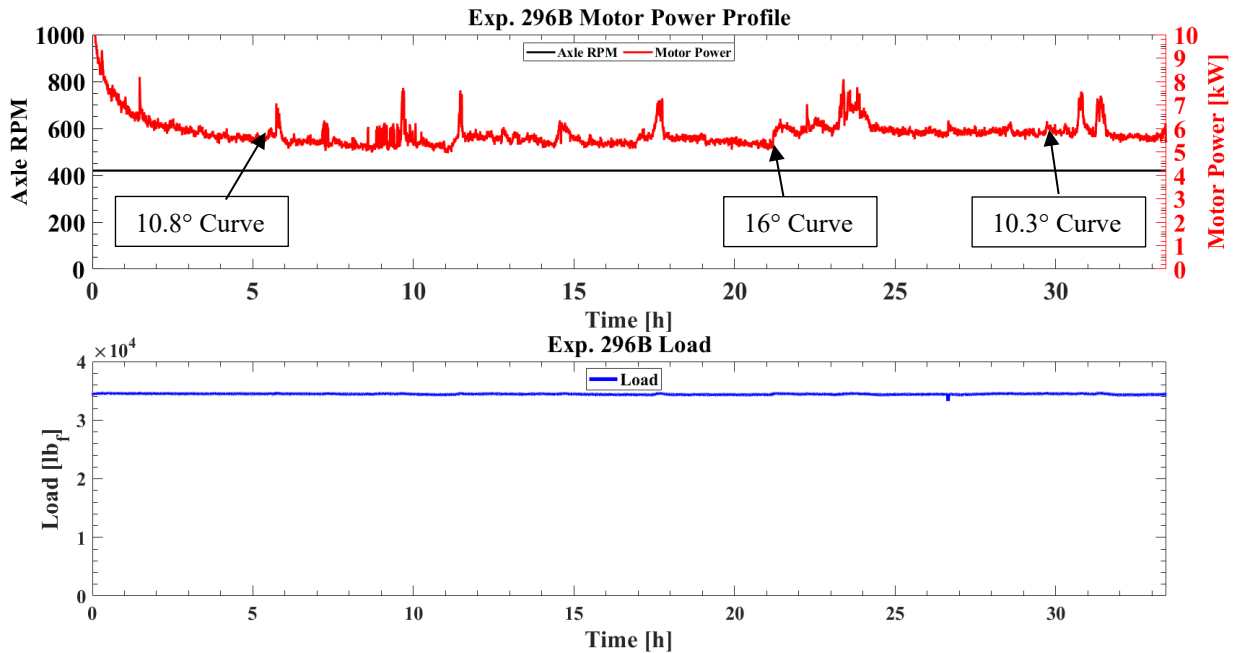
Figure 28. Defective bearing power and vertical load at 72 kph (45 mph) for 100% load (fully loaded railcar) with varying lateral loads

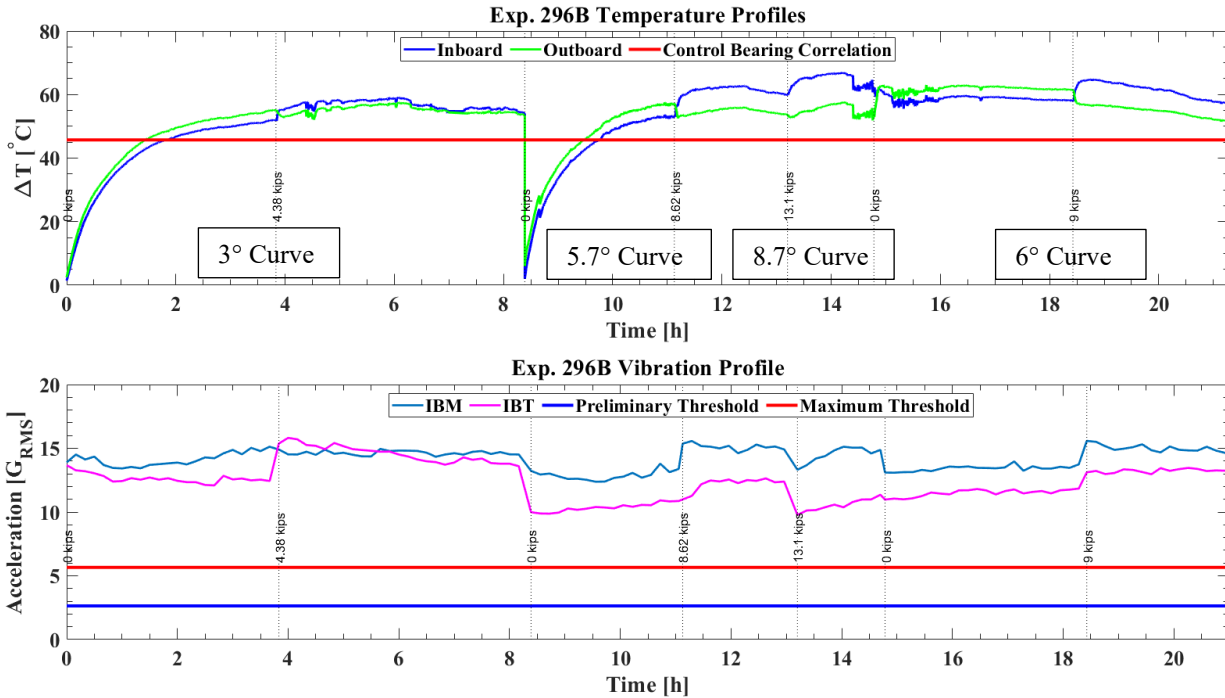
Figure 29. Defective bearing temperature and acceleration at 97 kph (60 mph) for 100% load (fully loaded railcar) with varying lateral loads

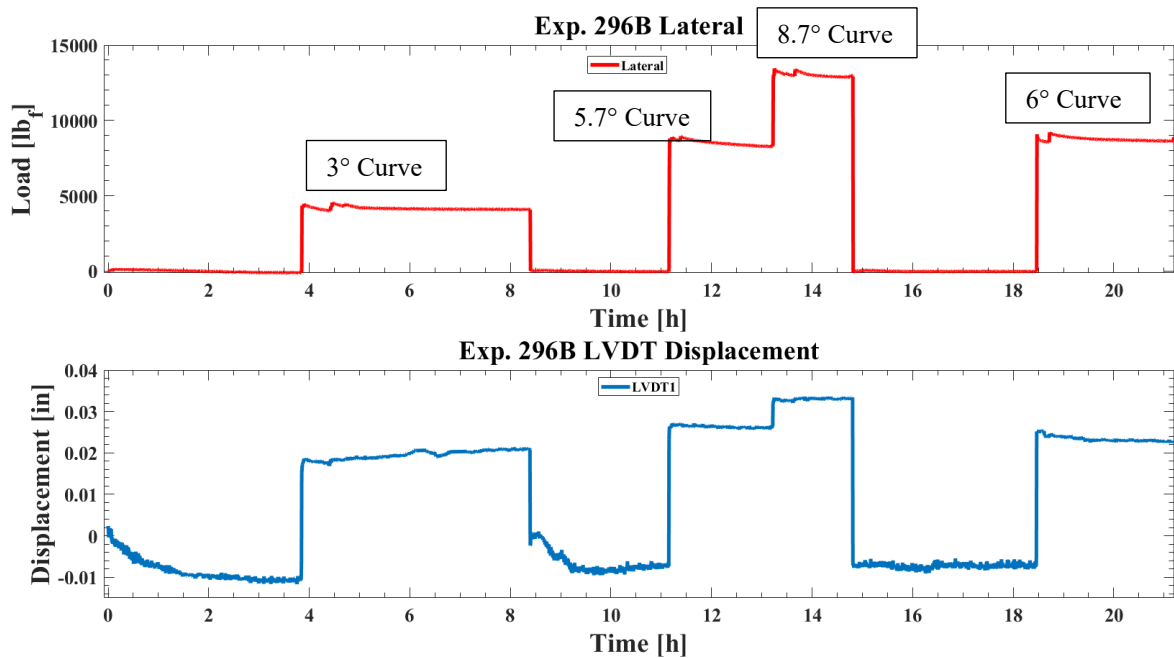
results demonstrate that the applied lateral loads significantly reduced the available lateral clearance within the bearing.

Figure 30. Defective bearing lateral load and displacement at 97 kph (60 mph) for 100% load (fully loaded railcar) with varying lateral load

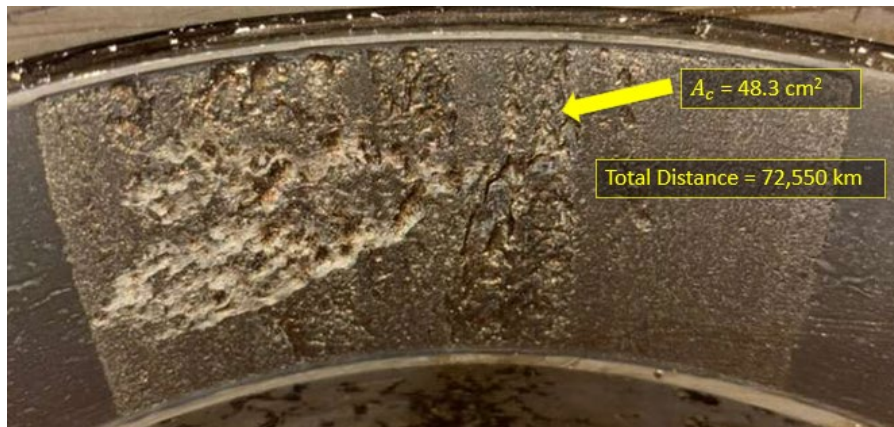
Figure 35. Post-test of the defective cup used with an OB spall

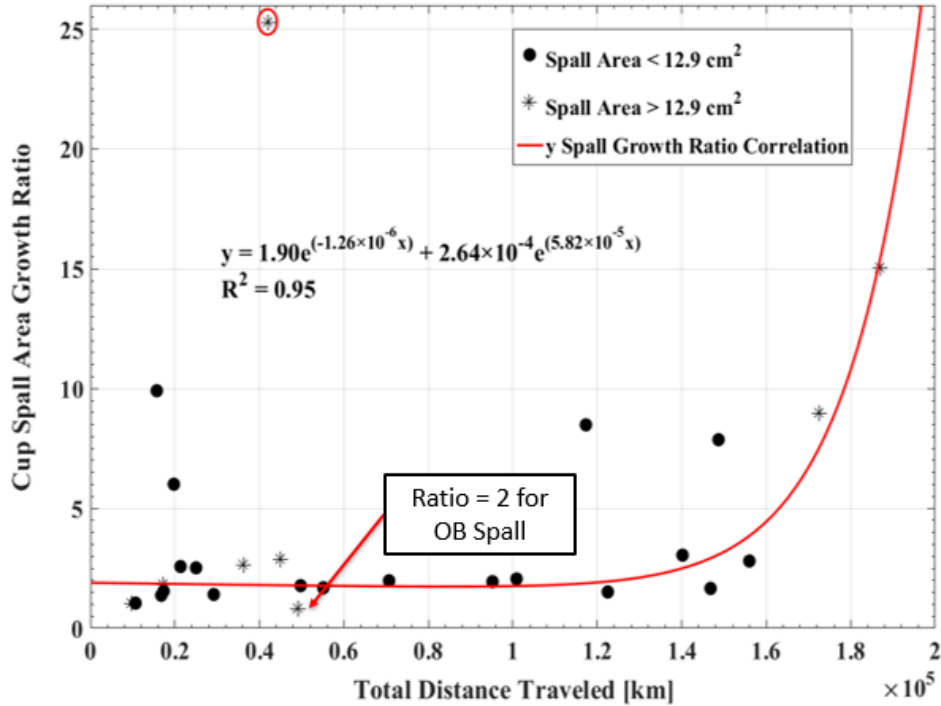
Figure 36. Spall Area Growth Ratio versus total distance traveled [31]

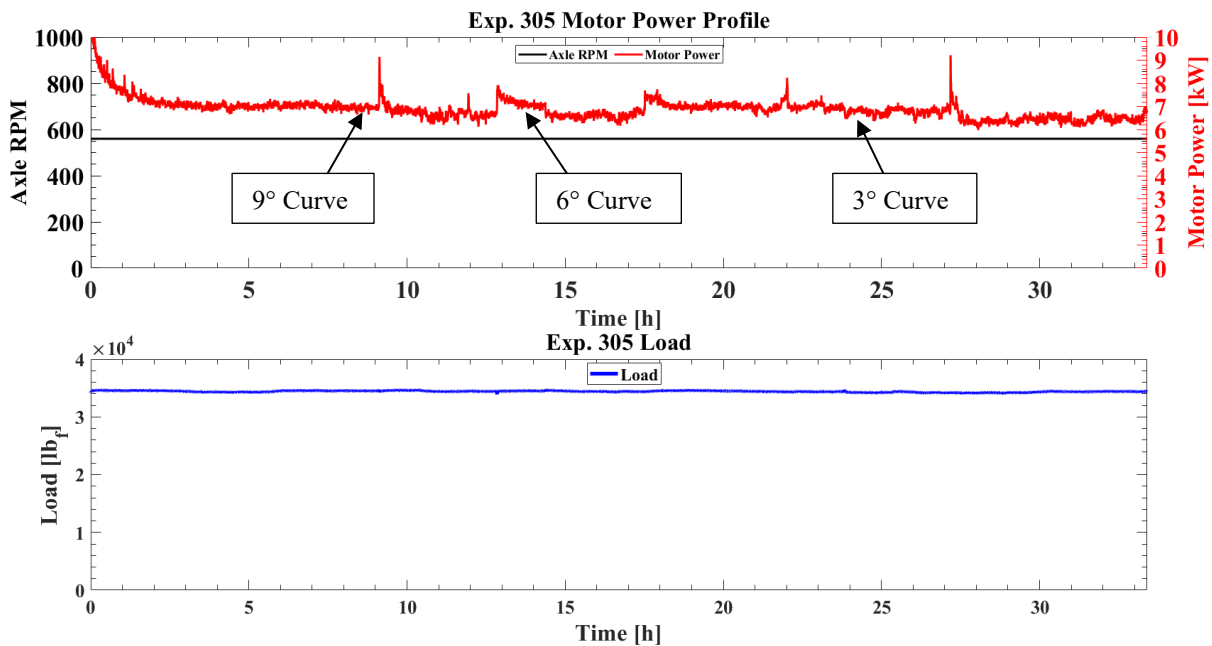
Figure 59. Control bearing motor power and vertical load at 97 kph (60 mph) for 100% load (fully loaded railcar) with varying lateral loads
