## Effect of Long-Term Inactivity on Railcar Bearing Lubricant Performance

A Report on Research Sponsored by

University Transportation Center for Railway Safety (UTCRS)

1. Report No. UTCRS-UTRGV-M2CY24	2. Government Accession No.	3. Recipient's Catalog No.	
4. Title and Subtitle  Effect of Long-Term Inactivity on Railcar Bearing Lubricant Performance		5. Report Date June 21, 2026

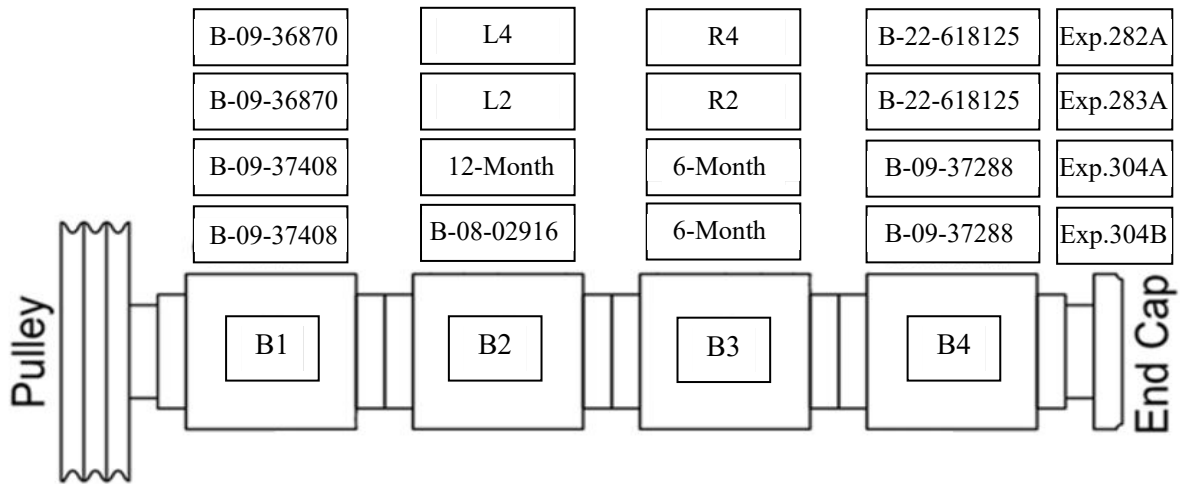
Figure 1. Schematic of the bearing setup showing the position of each bearing on the test axle

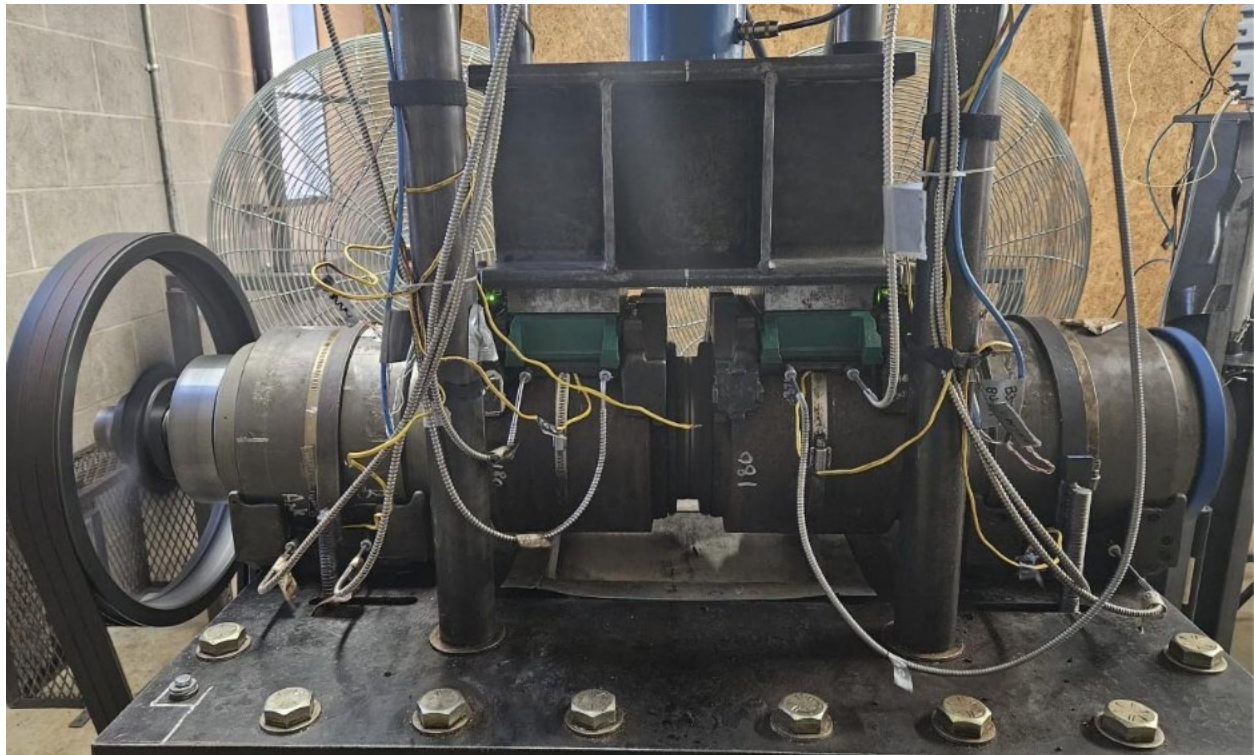
Figure 2: Picture of the UTRGV-UTCRS four bearing tester (4BT) used for this testing

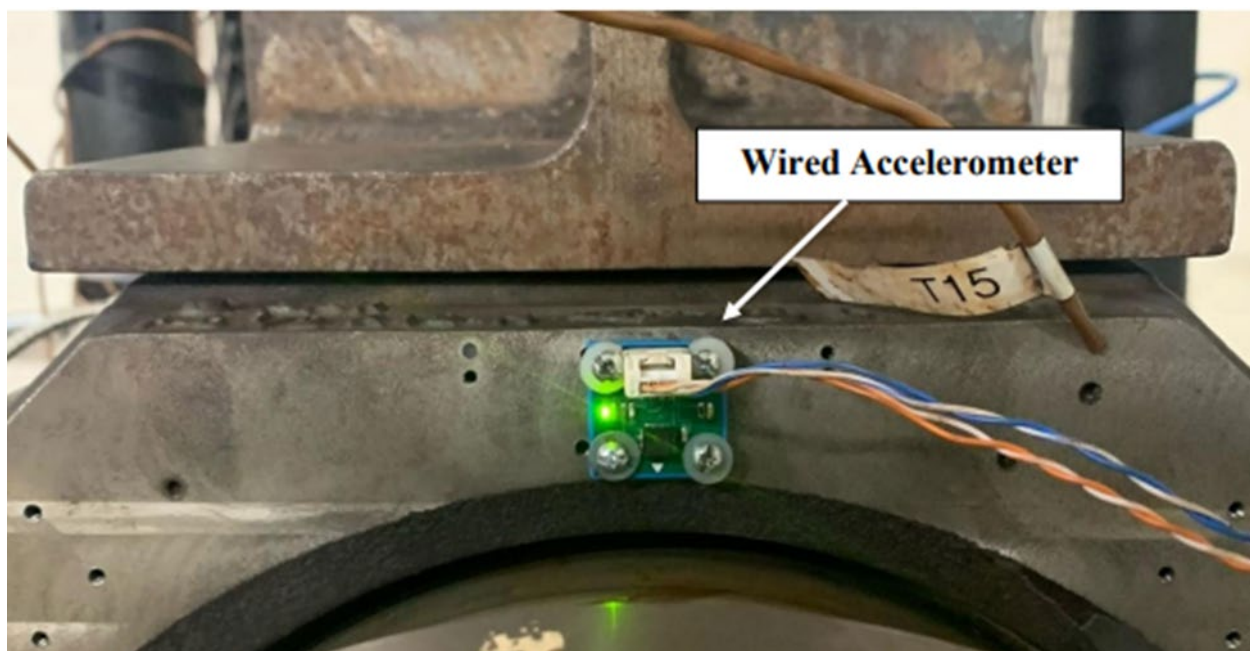
Figure 4: Wired accelerometer location in the top-dead-center (TDC) position

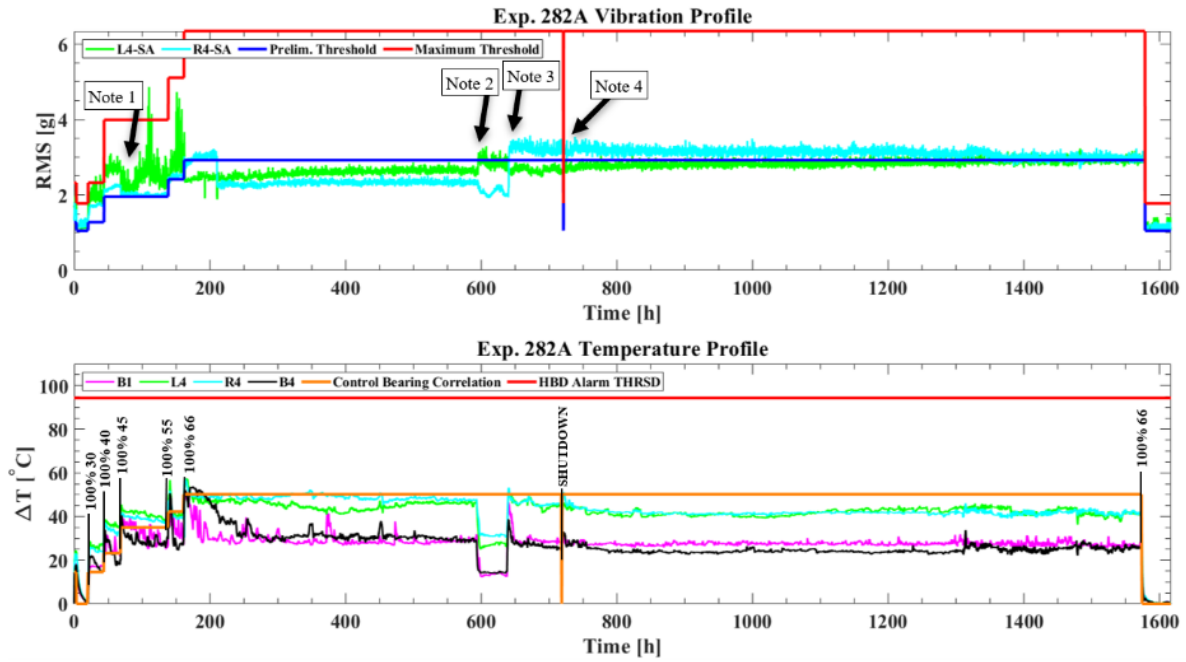
The solid blue and red lines shown in the vibration profile plot in Figure 6 represent the “Prelim. Threshold” and “Maximum Threshold”, respectively. These thresholds are based on statistical analysis of the extensive library of bearing vibration data at the UTCRS. The preliminary threshold is used to differentiate between healthy bearings and possibly defective bearings. In other words, bearings with vibration levels that are lower than the preliminary threshold (solid blue line) are healthy (defect-free) bearings, whereas bearings with vibration levels above the preliminary threshold are possibly defective. If a bearing’s vibration levels are above the maximum threshold (solid red line), then that bearing is defective with a 97% confidence level [3]. The solid orange line in the temperature profile plot represents the maximum average bearing operating temperature-above-ambient for healthy bearings at the respective speed and load condition. The solid red line represents the recommended AAR Hot Bearing Detector alarm threshold, which is 170°F (94.4°C) above ambient conditions. The data plots presented in the subsequent experiment sections use the same thresholds and reference lines as described in this section.

Figure 6: Vibration and temperature above ambient profiles for Exp. 282A

The speed was incrementally increased from 25 mph (40 km/h) to 66 mph (106 km/h) over the course of about 10 days during which the bearings ran for about 21,000 miles (33,800 km), as shown in Figure 6. As a safeguard, initial operating conditions were set to 25 mph at an unloaded railcar condition (i.e., 17% of full load or 5.85 kips per bearing) due to uncertainty regarding the performance of bearings that had remained idle for approximately three years under varying environmental conditions.

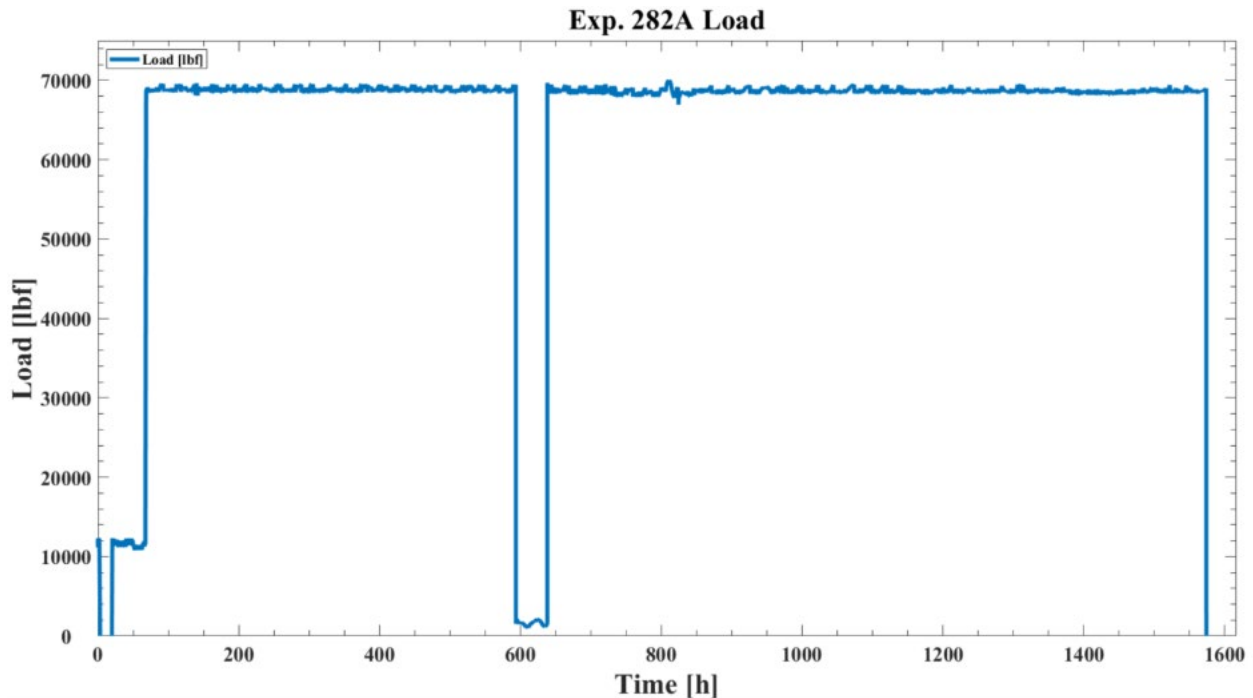
Figure 8: Applied load profile for Exp.282A

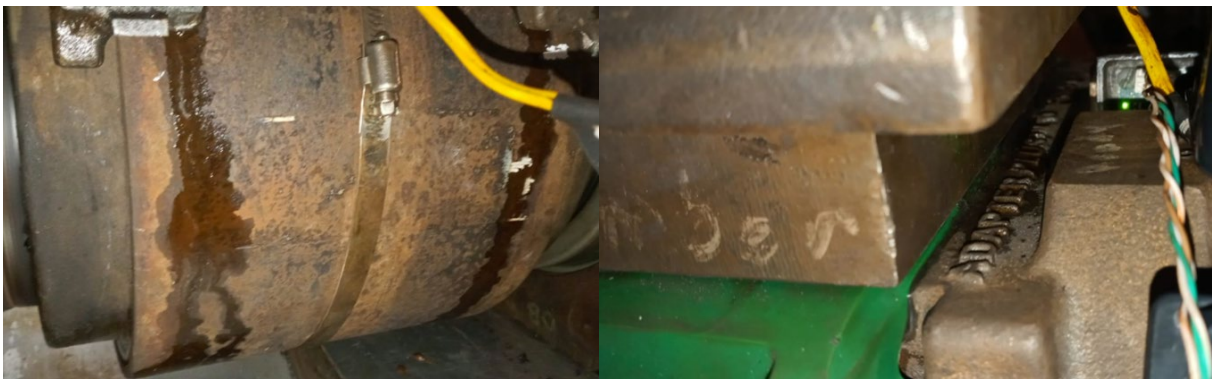
Figure 9: Pictures showing grease leak from bearing R4

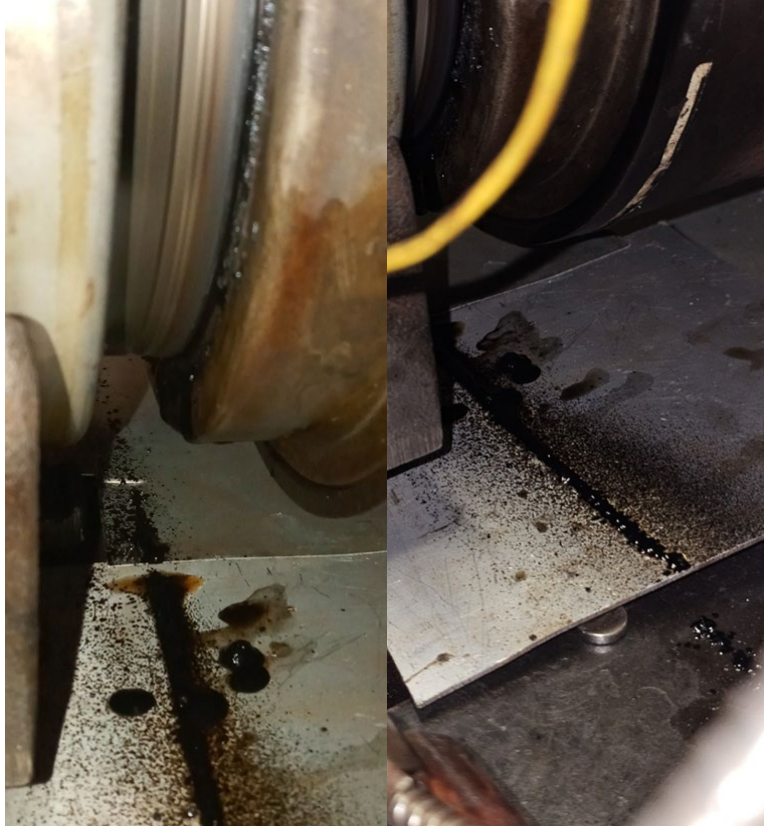
Figure 10: Pictures of grease accumulation below the inboard (IB) seal of bearing L4

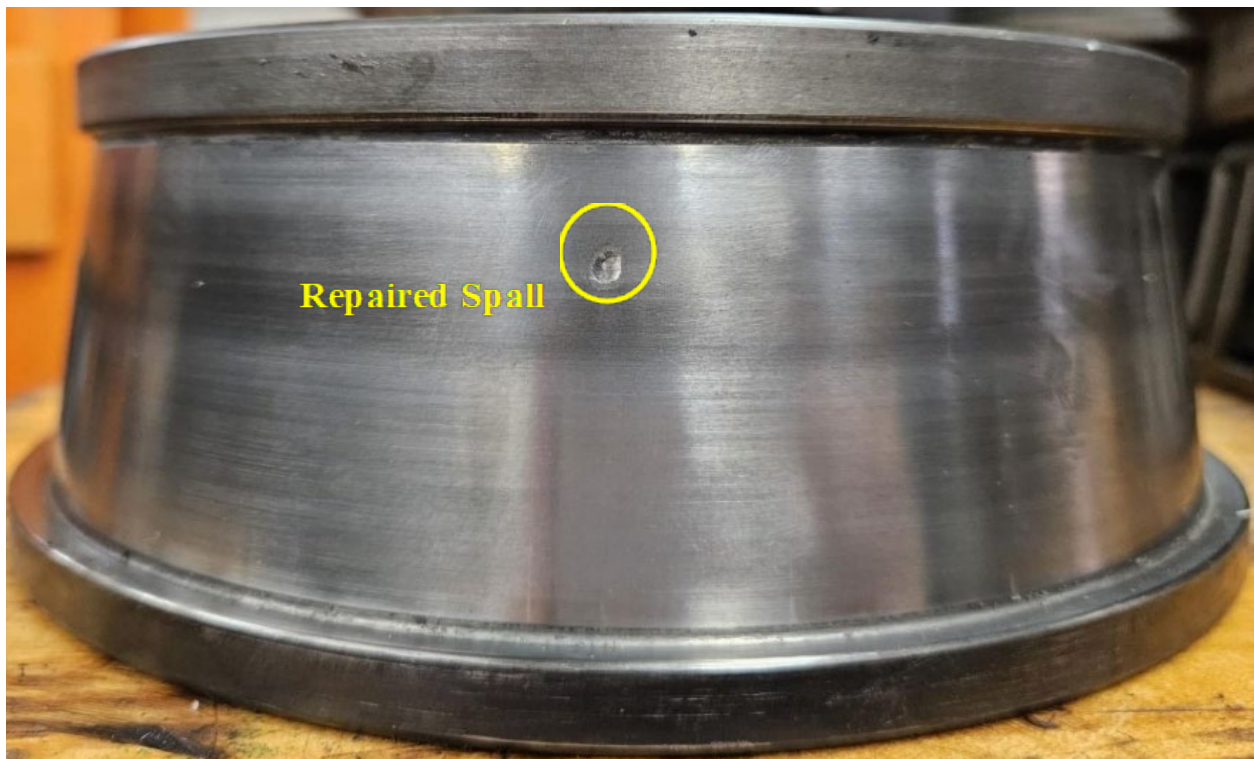
Figure 19: L4 IB cone raceway showing repaired spall region

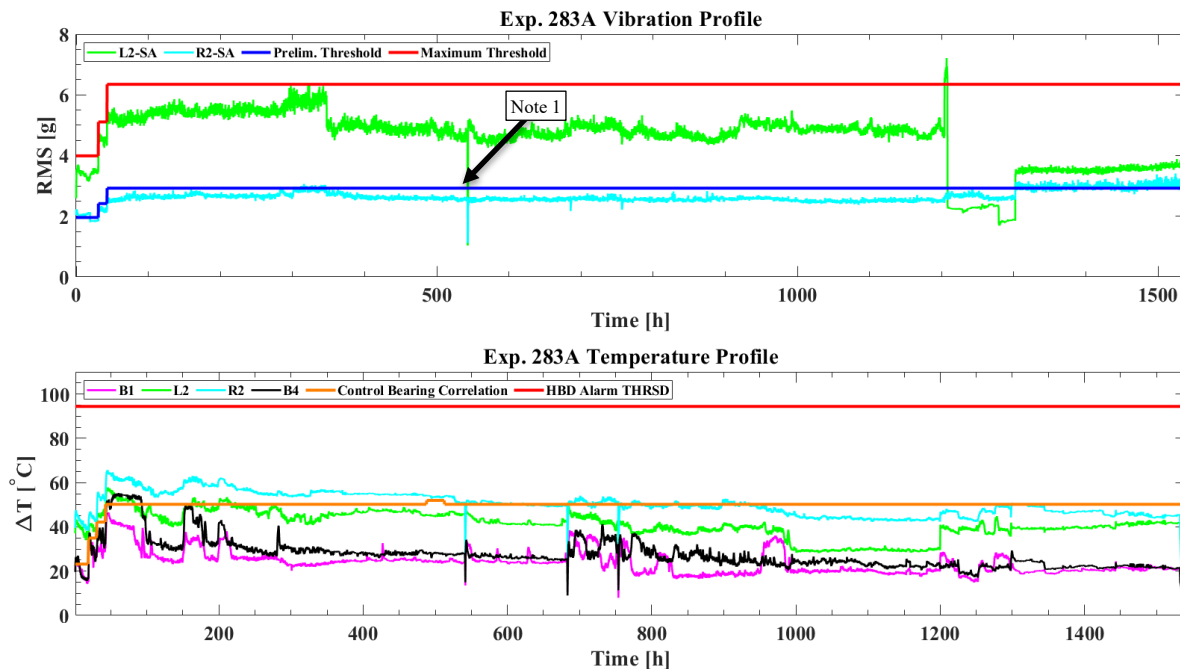
Figure 28: Vibration and temperature above ambient profiles for Exp. 283A

**Note 1:** [November 21, 2024, ~ 3 PM] A momentary power loss activated the tester’s safety features and halted the motor. Event was caught within 20 minutes of the power loss, and the tester was quickly restarted back to previous operating conditions with no immediate impact. Event can be seen across all plots.

Figure 28 shows the speed incrementally increased from 45 mph (72 km/h) to 66 mph (106 km/h) over the course of several days, during which the bearings accumulated approximately 2,400 miles (3,862 km) of operation. As a precaution, the operating conditions were initially set to 45 mph (72 km/h) at an unloaded railcar condition. Higher than normal torque was required to initiate rotation at the start of the test runs, as shown in Figure 29. Once steady state operation was achieved, the speed and load were set to 66 mph (106 km/h) and 100% load (full railcar load), respectively. Detailed test notes are summarized in Table 14.

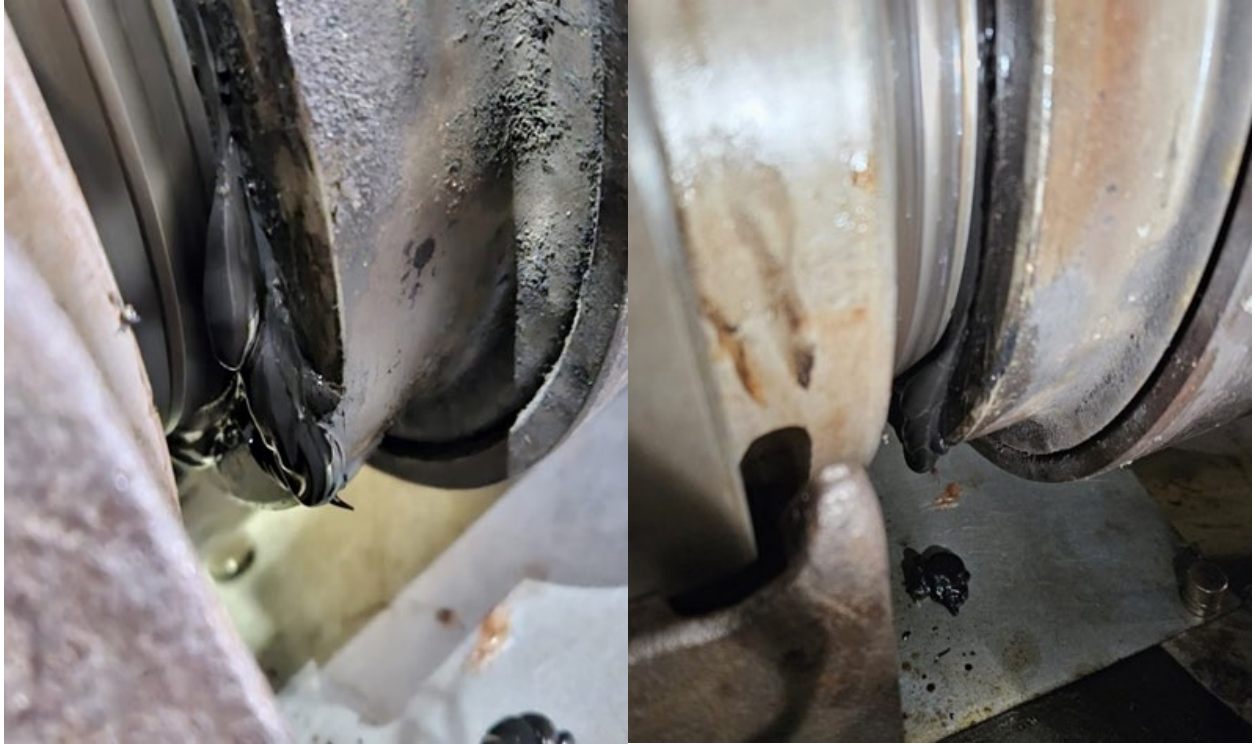
Figure 31: Grease leaking from the IB seal of Bearing L2 (11/05/2024)

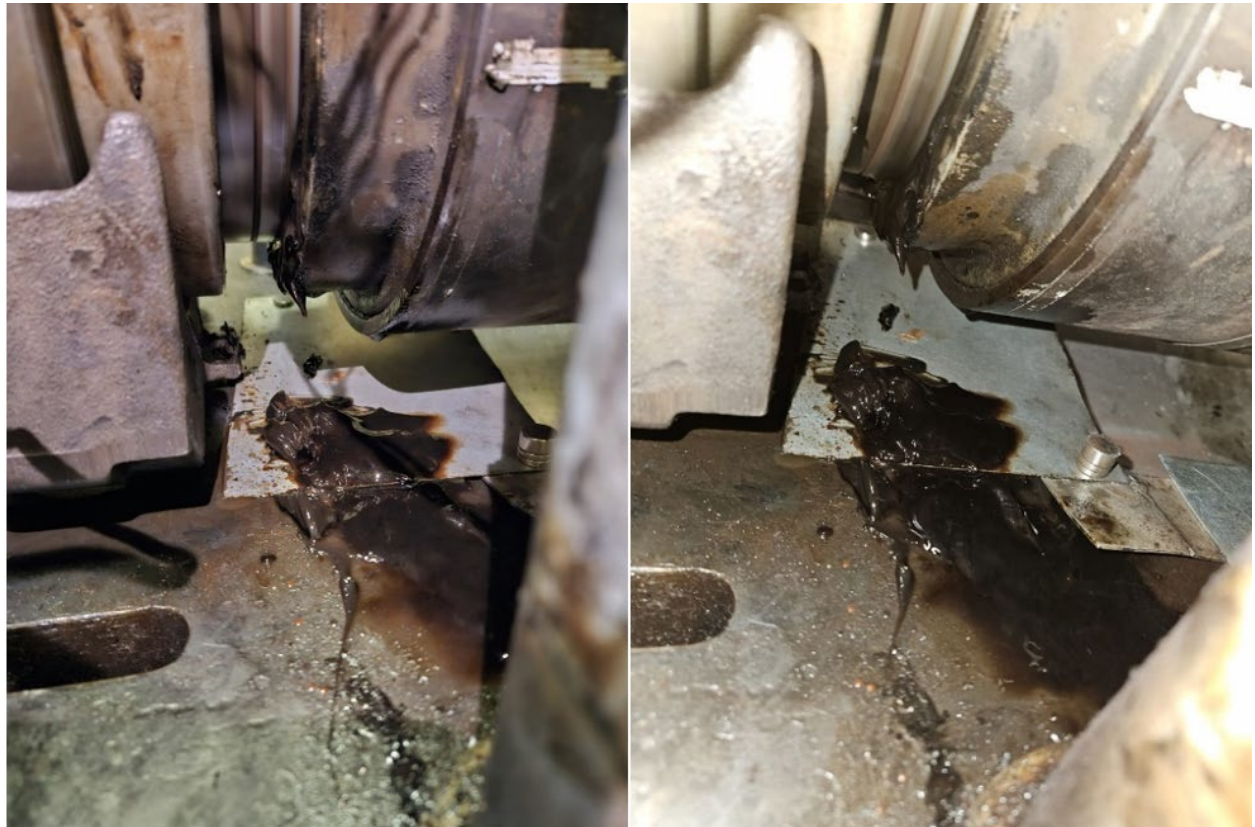
Figure 32: Leaked grease accumulation on IB side of Bearing L2 (11/08/2024)

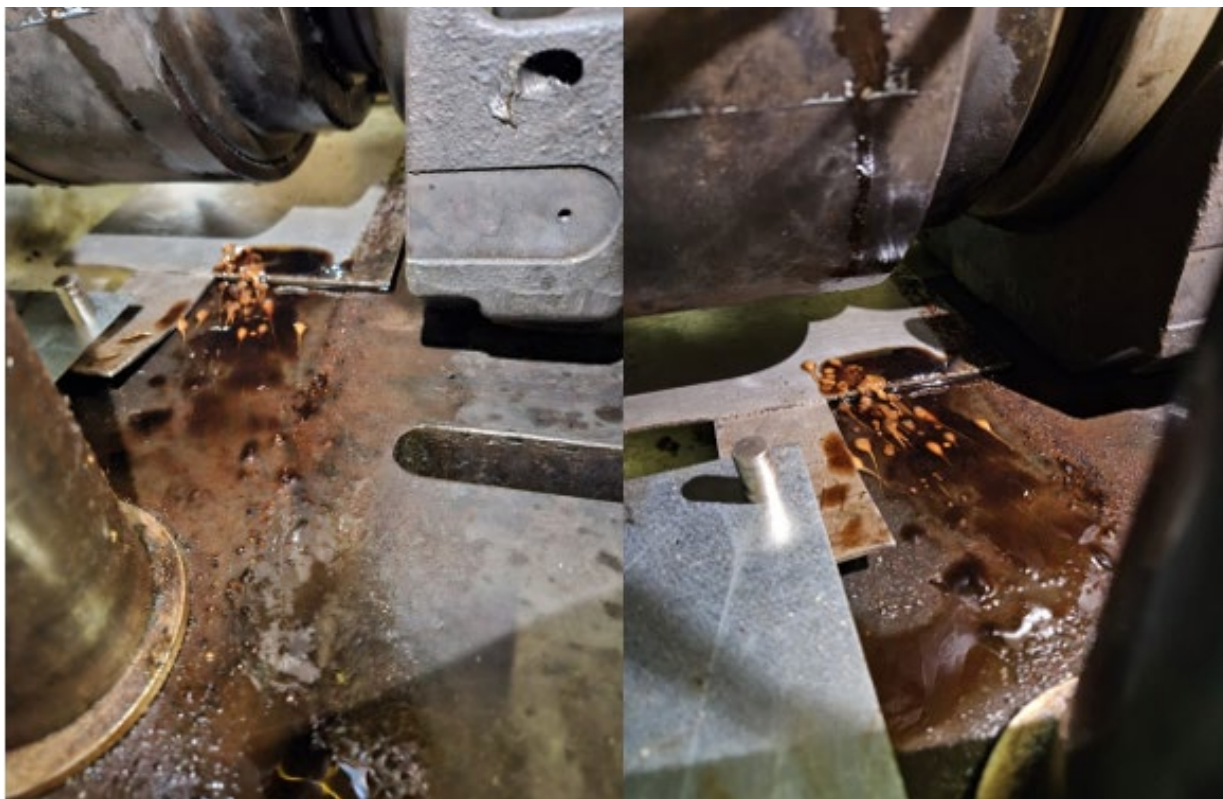
Figure 33: Grease leaking from OB seal of Bearing R2 (11/11/2024)

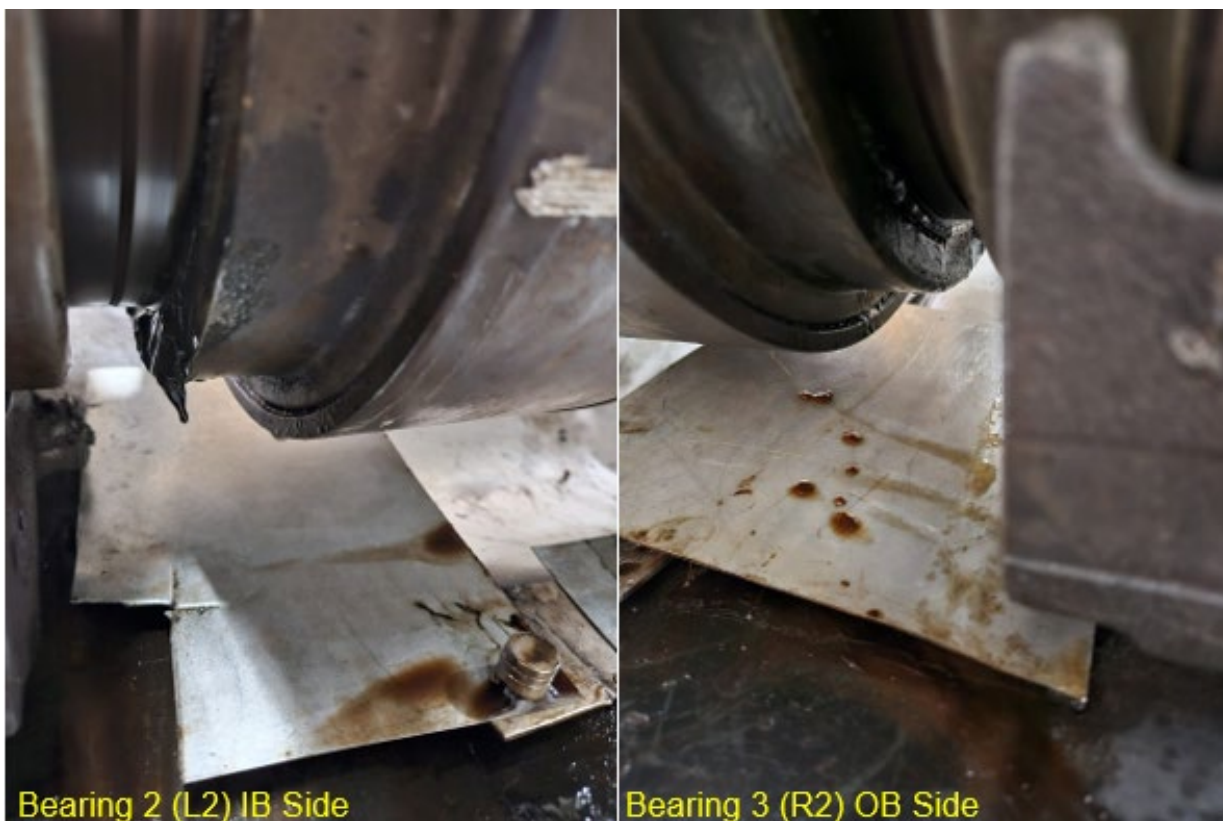
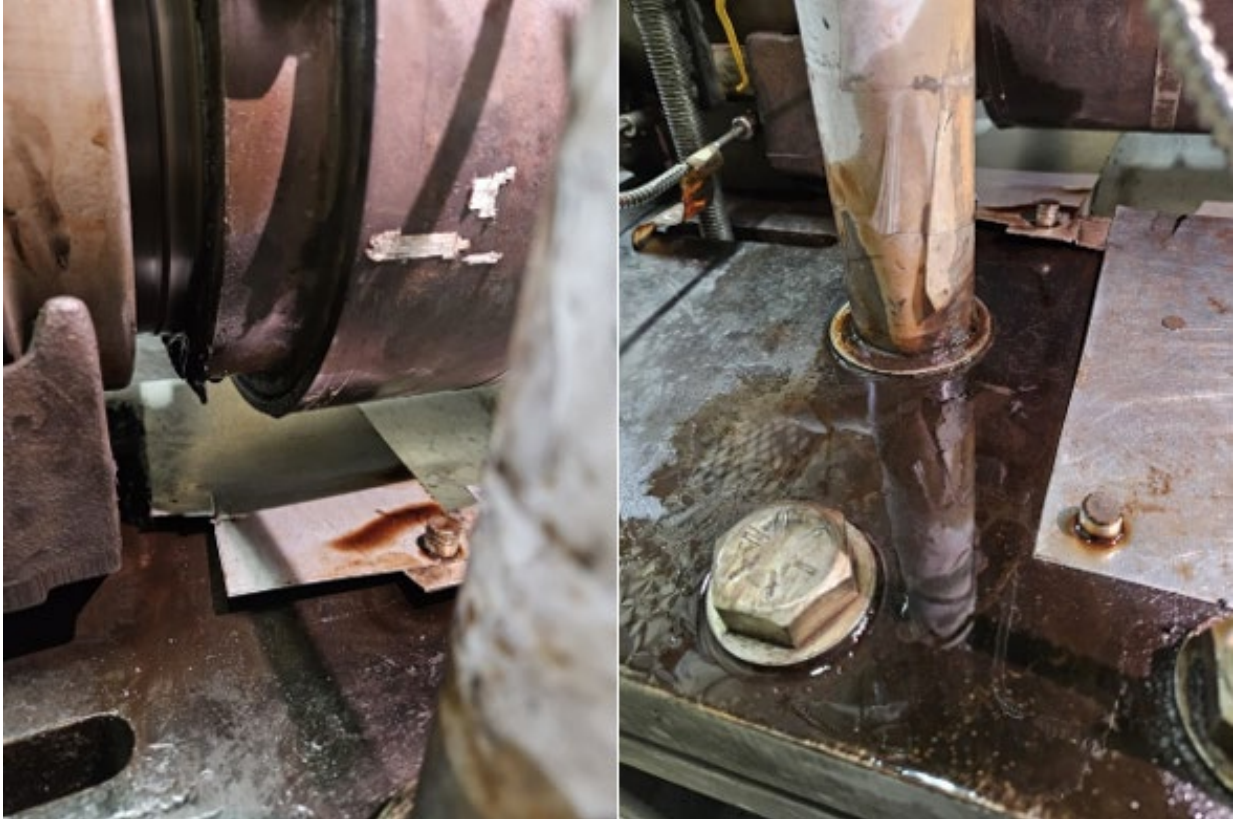
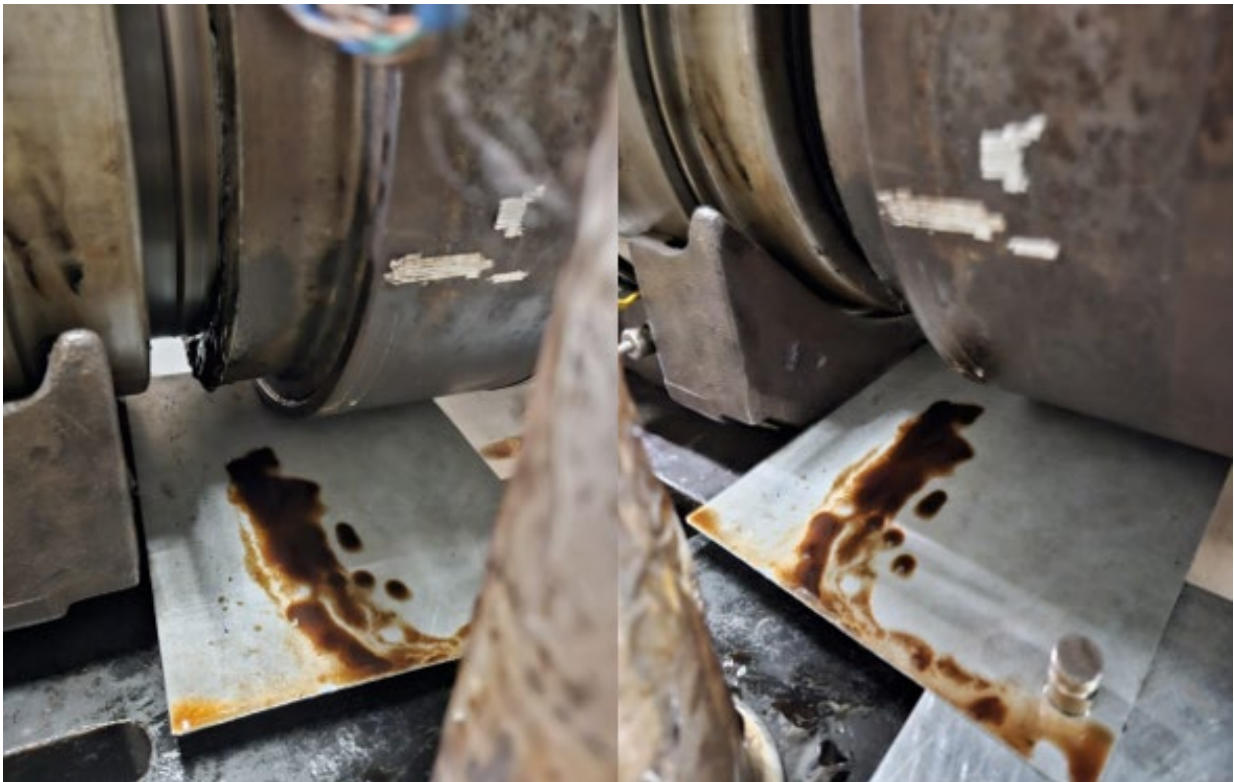
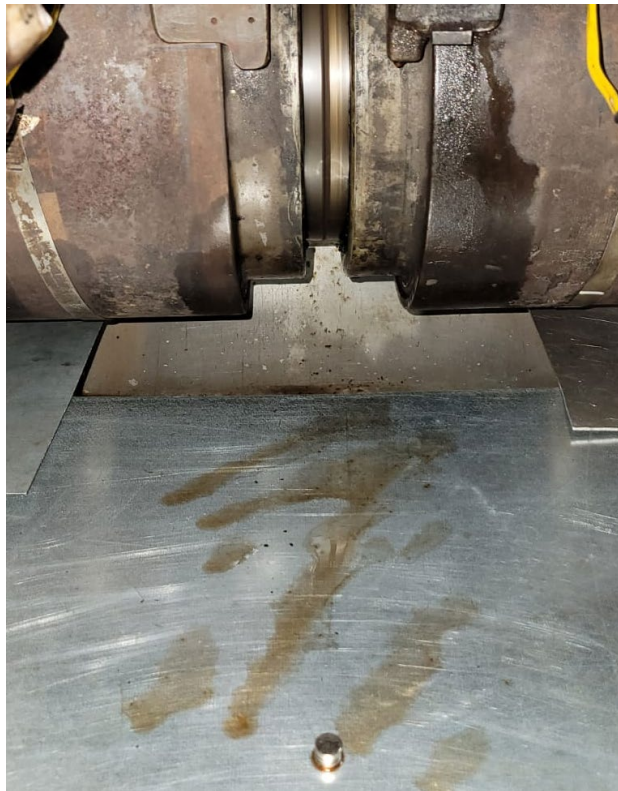
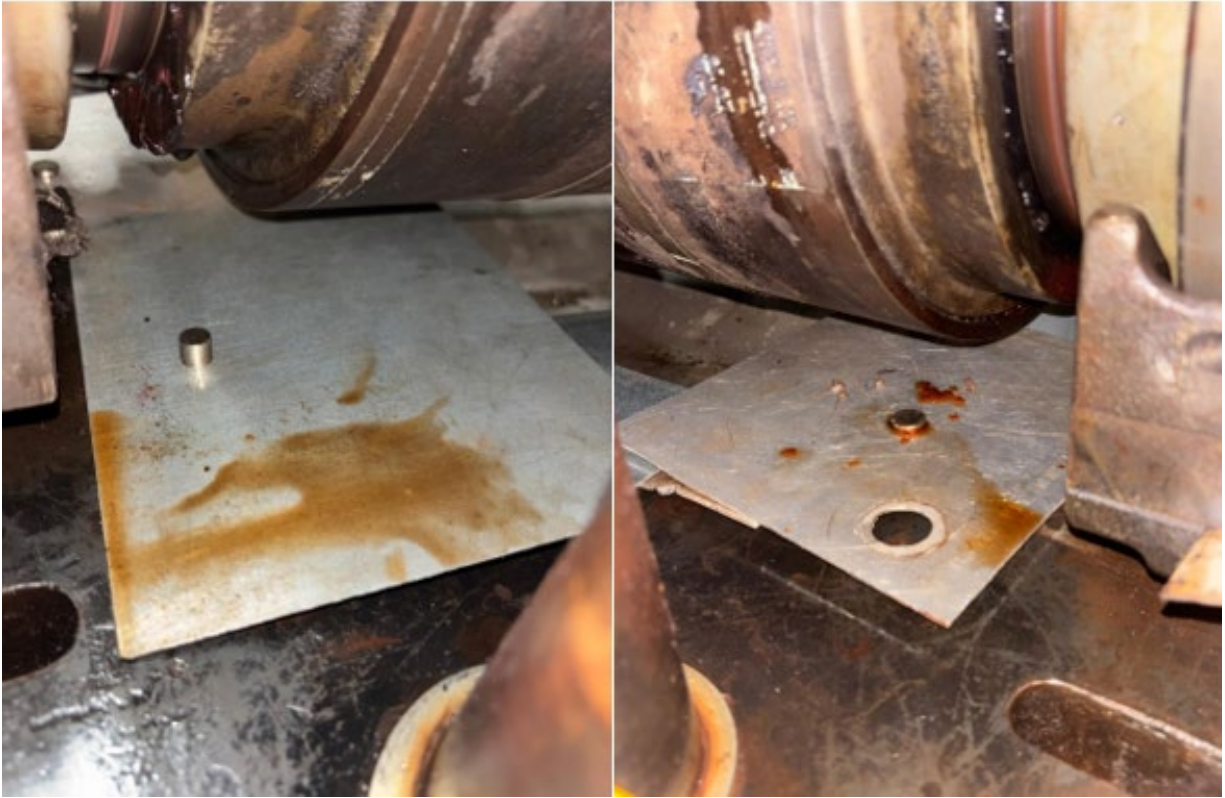
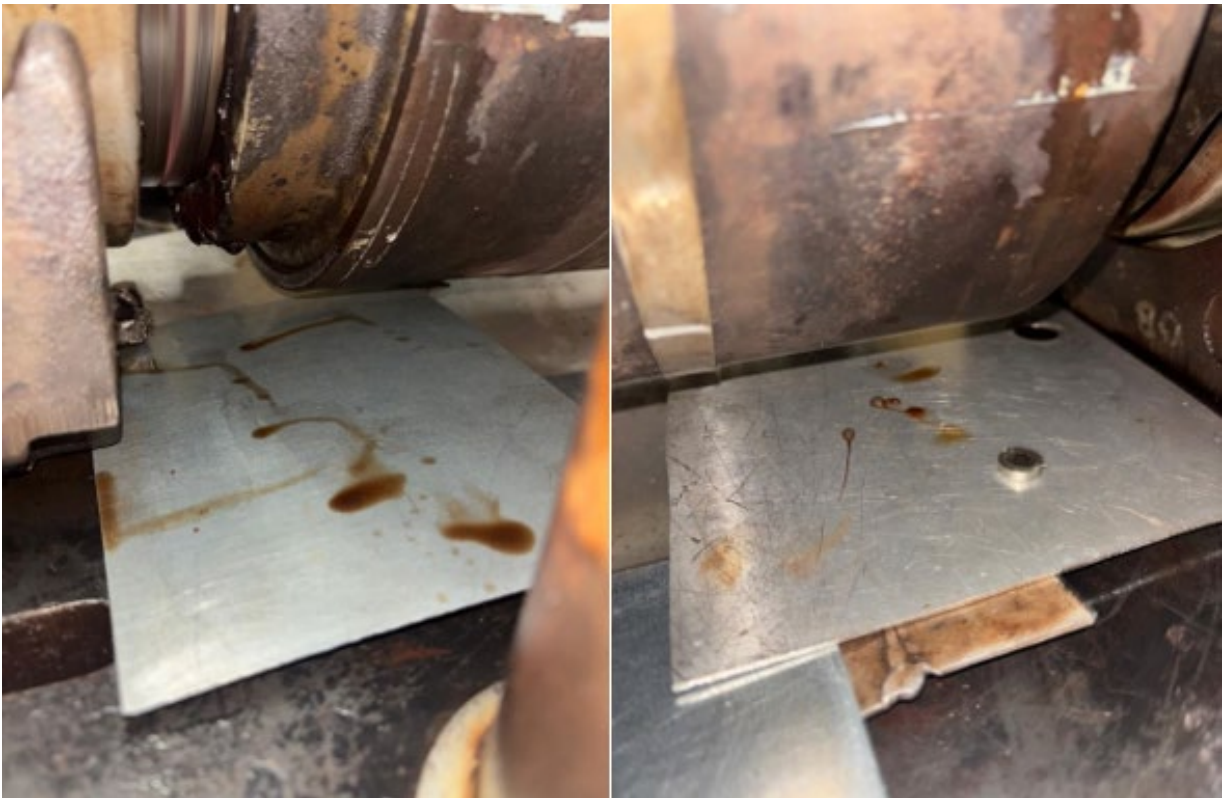
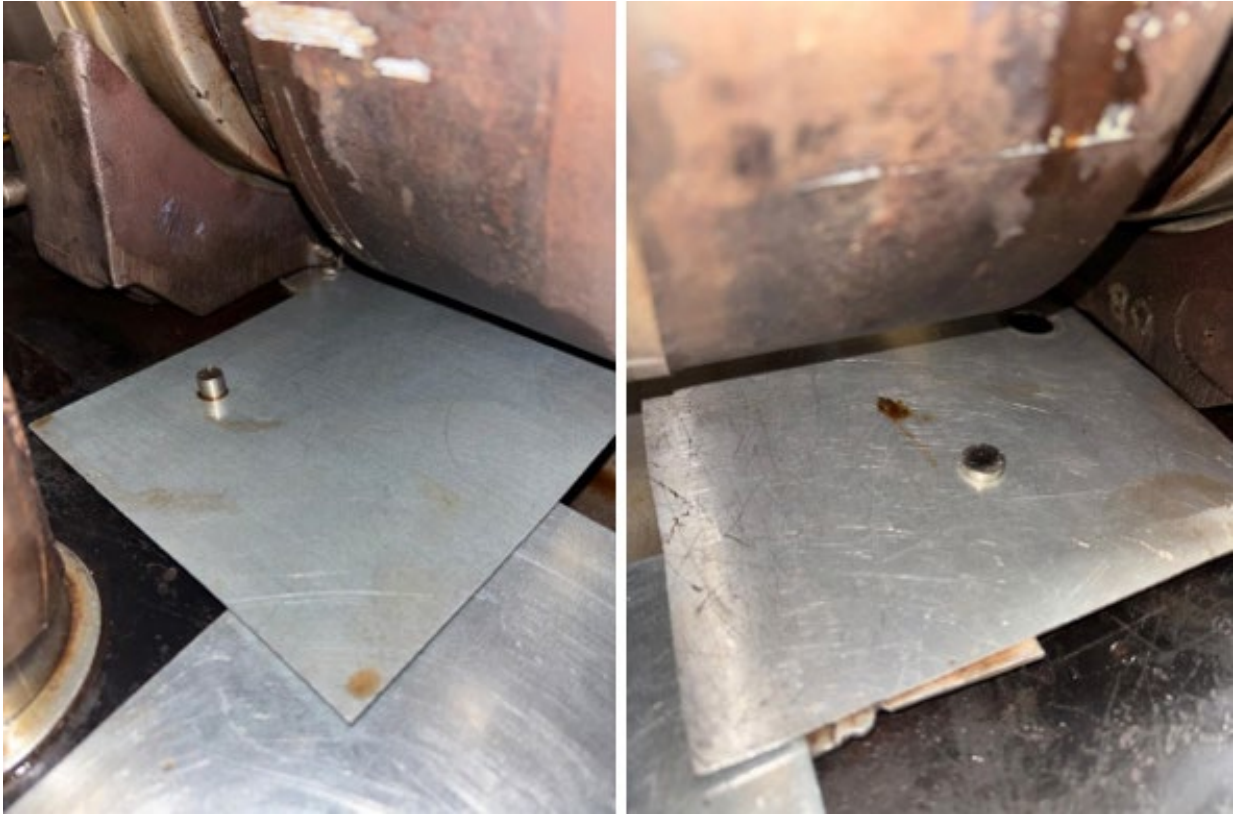
Figure 34: Leaked grease accumulation on IB (L2) and OB (R2) sides (11/14/2024)

Figure 35: Leaked grease accumulation on IB side of Bearing L2 (11/18/2024)

Figure 36: Leaked grease accumulation on IB side of Bearing L2 (12/09/2024)

Figure 37: Leaked grease accumulation on IB (L2) and OB (R2) sides (12/17/2024)

Figure 38: Leaked grease accumulation on OB (L2) and IB (R2) sides (12/27/2024)

Figure 39: Leaked grease accumulation on IB (L2) and OB (R2) sides (12/30/2024)

Figure 40: Leaked grease accumulation on IB (L2) and OB (R2) sides (12/31/2024)

Figure 41: Leaked grease accumulation on IB (L2) and OB (R2) sides (01/02/2025)

Figure 42: Leaked grease accumulation on IB (L2) and OB (R2) sides (01/08/2025)

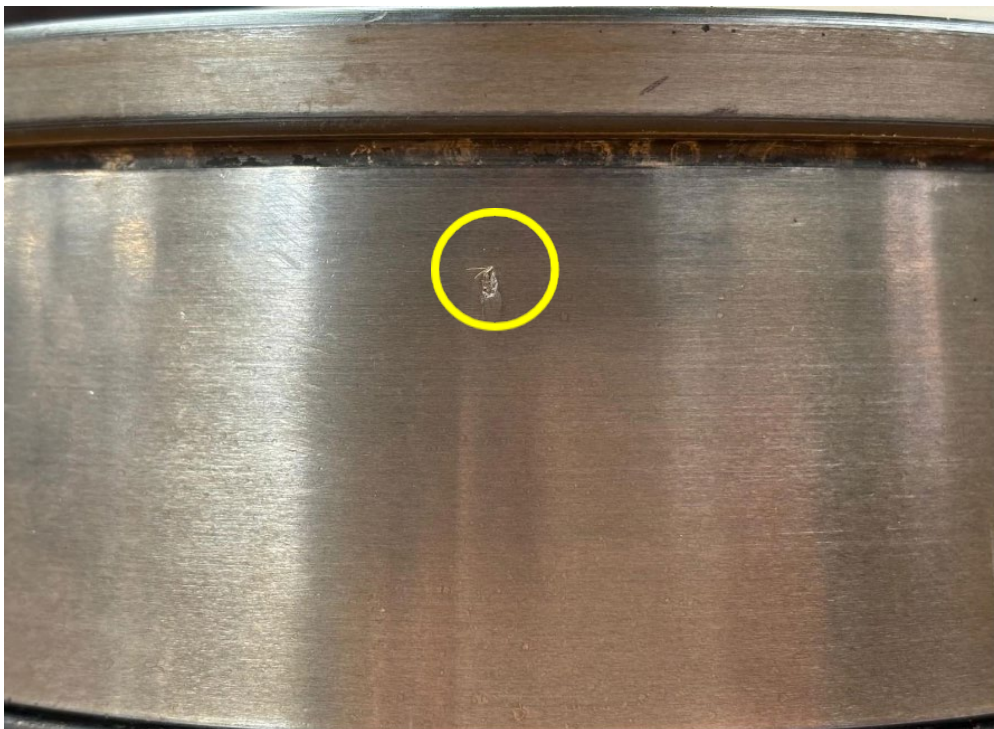
Figure 44: Small spall (0.015 mm<sup>2</sup> / 0.006 in<sup>2</sup>) on R2 IB cone raceway

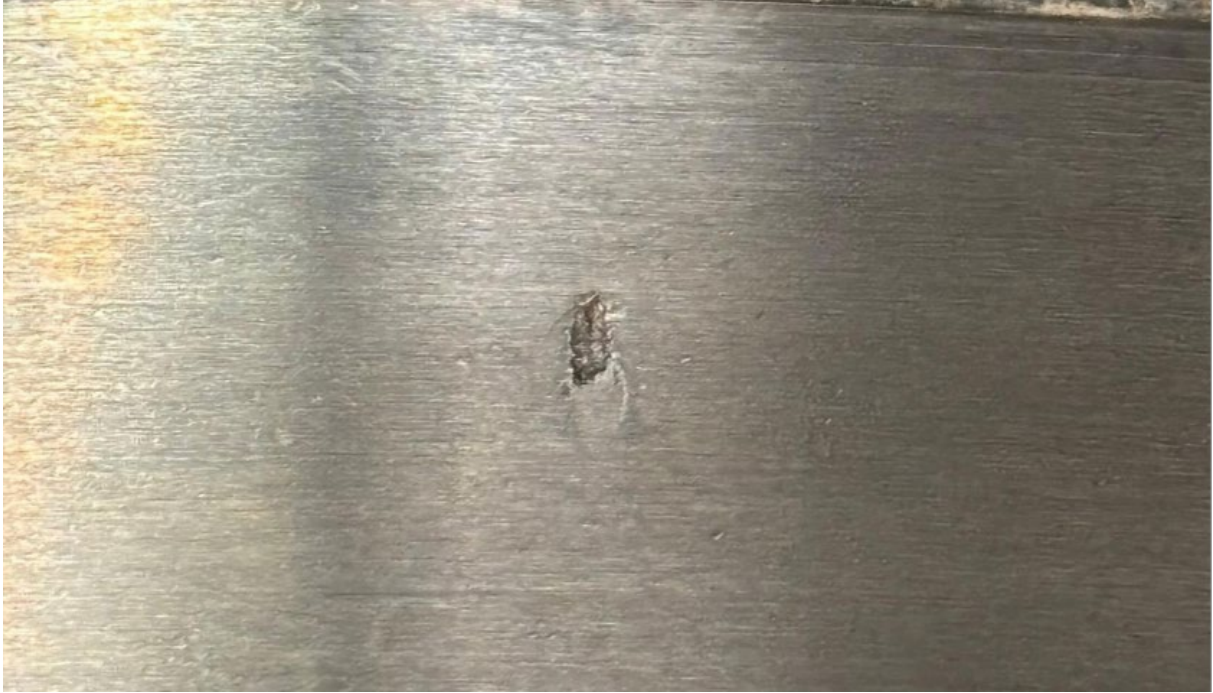
Figure 45: Close-up of small spall on R2 IB cone raceway

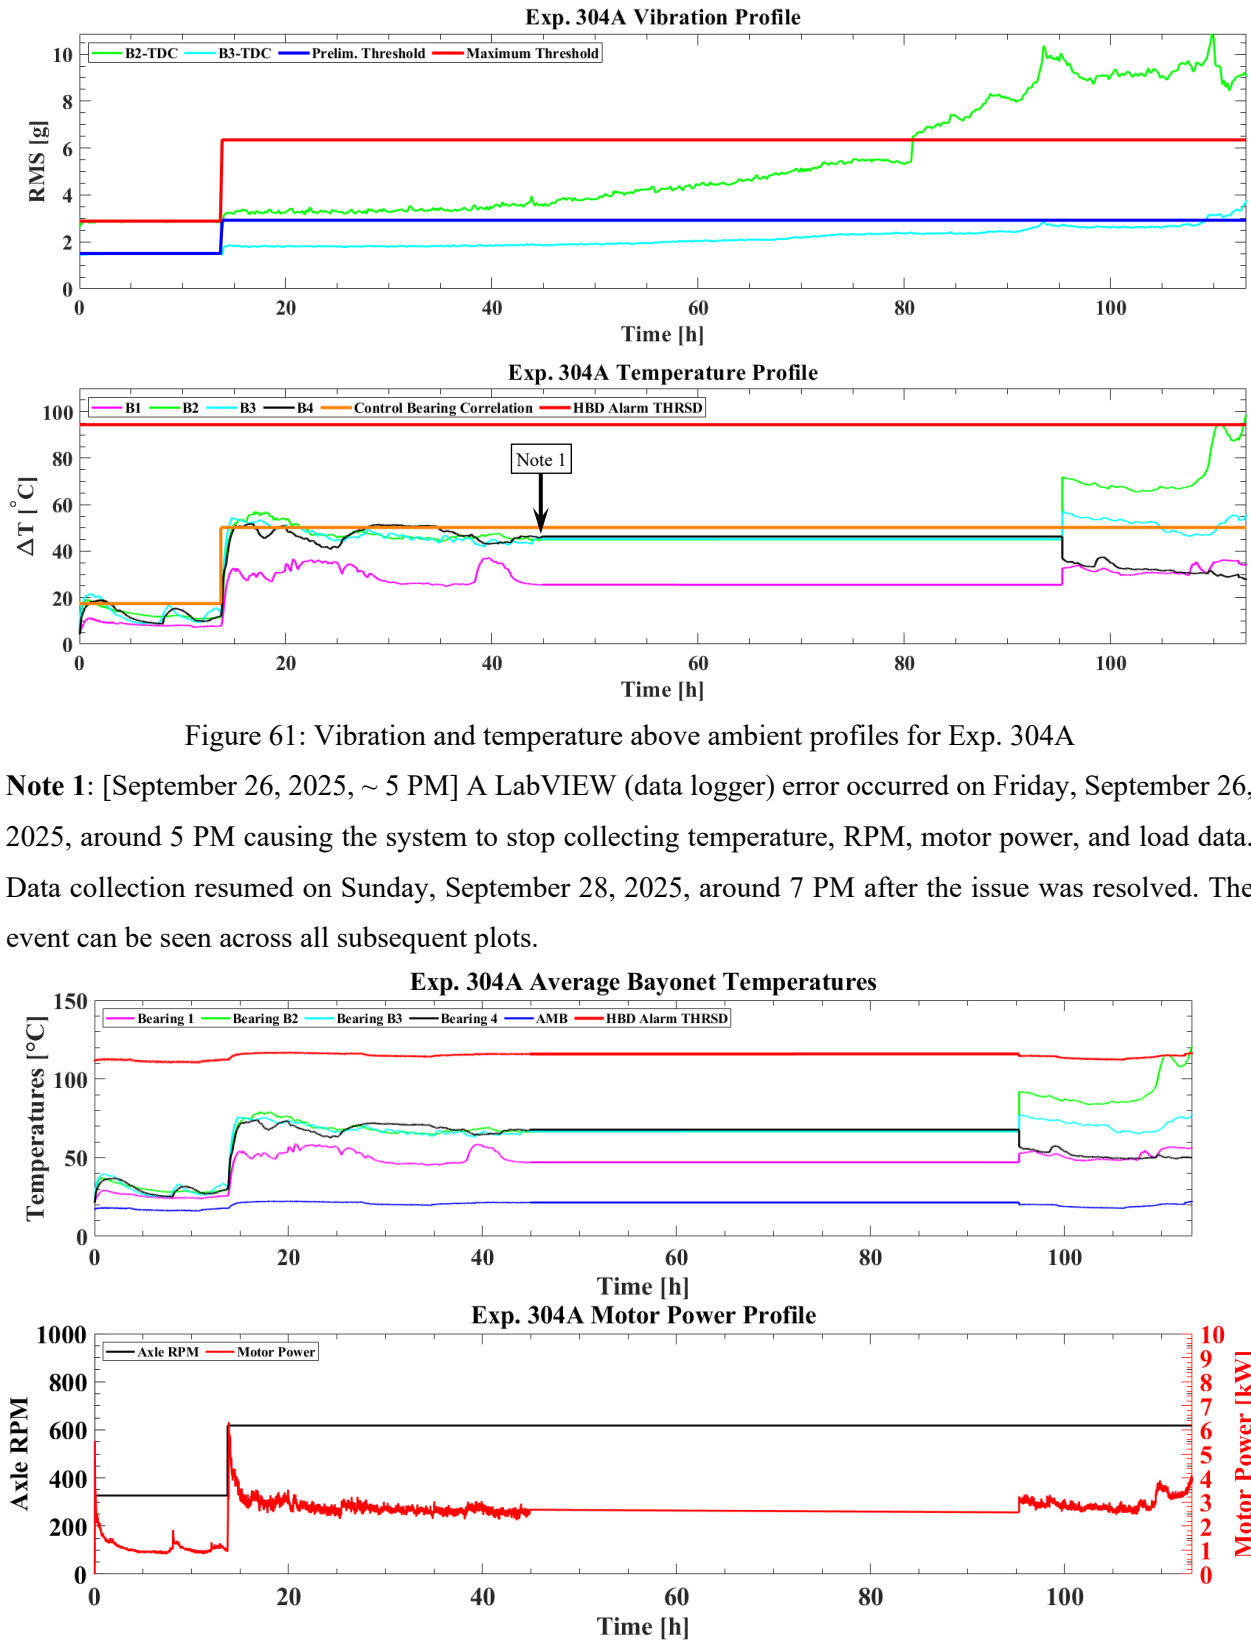
Figure 61: Vibration and temperature above ambient profiles for Exp. 304A

The vibration and temperature-above-ambient profiles are provided in Figure 61. The absolute temperature, motor power, and axle rotational speed profiles are provided in Figure 62, while the applied load profile is plotted in Figure 63.

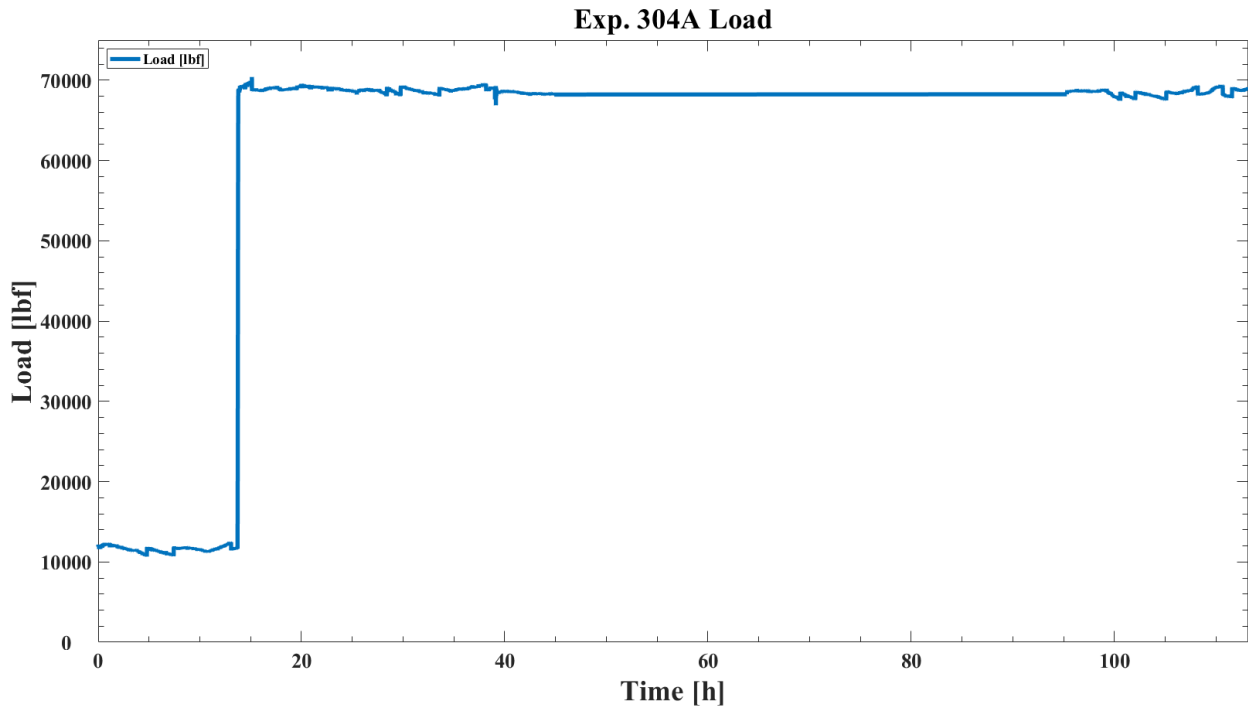
Figure 63: Applied load profile for Exp. 304A

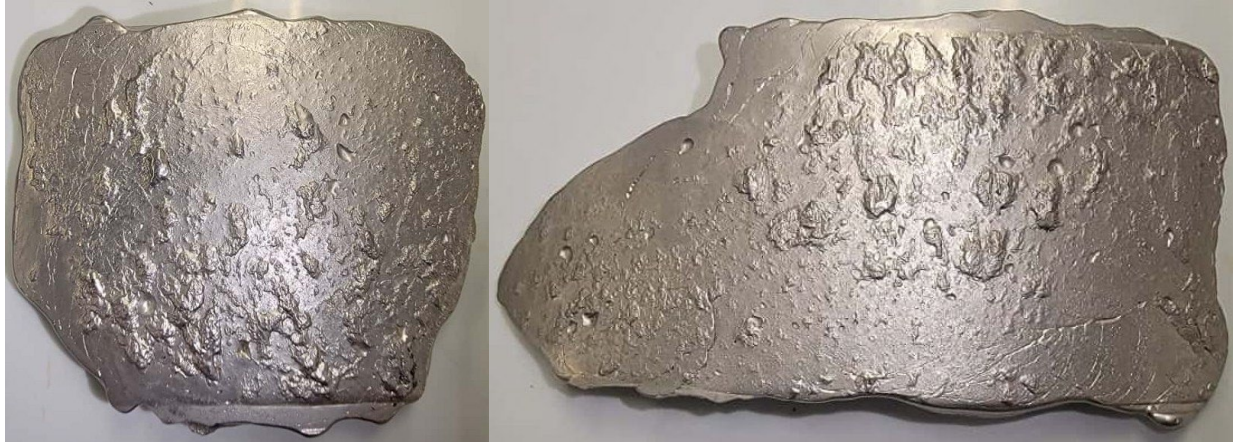
Spall area measurements were obtained by creating multiple imprints of the major damaged regions using molten bismuth. Each imprint was subsequently scanned and processed using image-analysis software to determine the spall area and the corresponding percentage of the total surface area. Multiple spalls were also identified on the roller surfaces and were documented and analyzed using the same image-processing software. The spall mapping process is presented in detail in reference [2].

Figure 81: B2 (12-Month) bearing OB cup spall with an area of 4.57 in<sup>2</sup> (29.48 cm<sup>2</sup>) (left) and 7.31 in<sup>2</sup> (47.16 cm<sup>2</sup>) (right)
