## Effect of Long-Term Inactivity on Railcar Bearing Lubricant Performance

A Report on Research Sponsored by

University Transportation Center for Railway Safety (UTCRS)

1. Report No. UTCRS-UTRGV-M2CY24	2. Government Accession No.	3. Recipient's Catalog No.	
4. Title and Subtitle  Effect of Long-Term Inactivity on Railcar Bearing Lubricant Performance		5. Report Date June 21, 2026

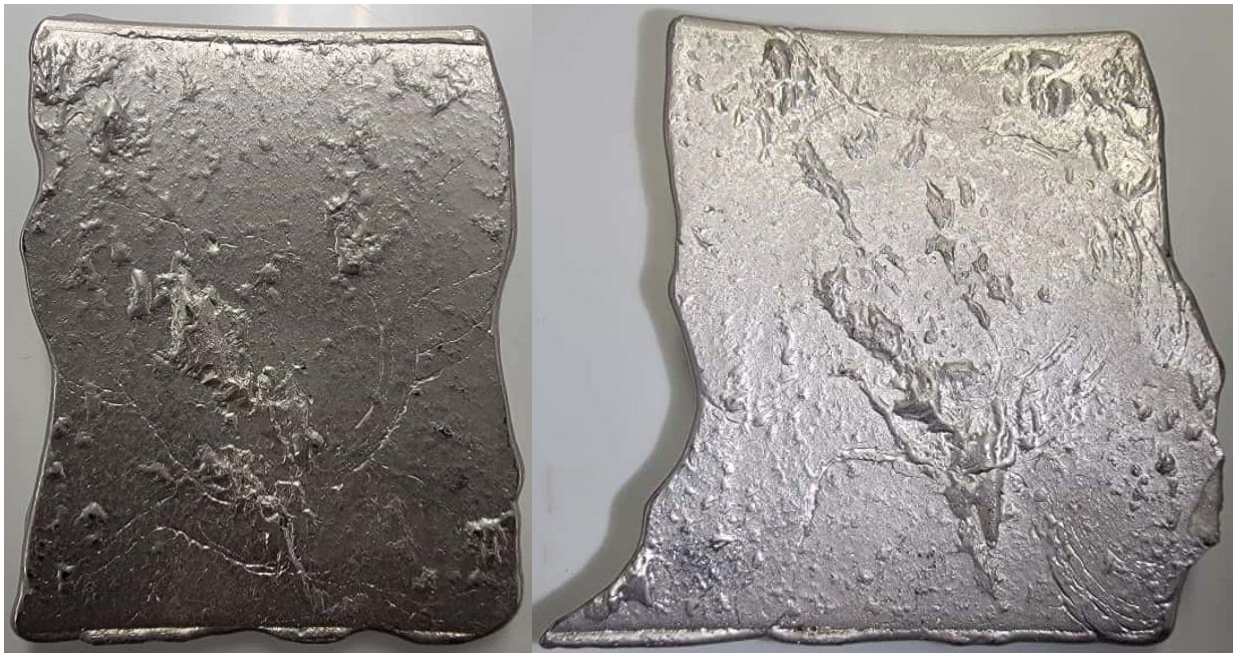
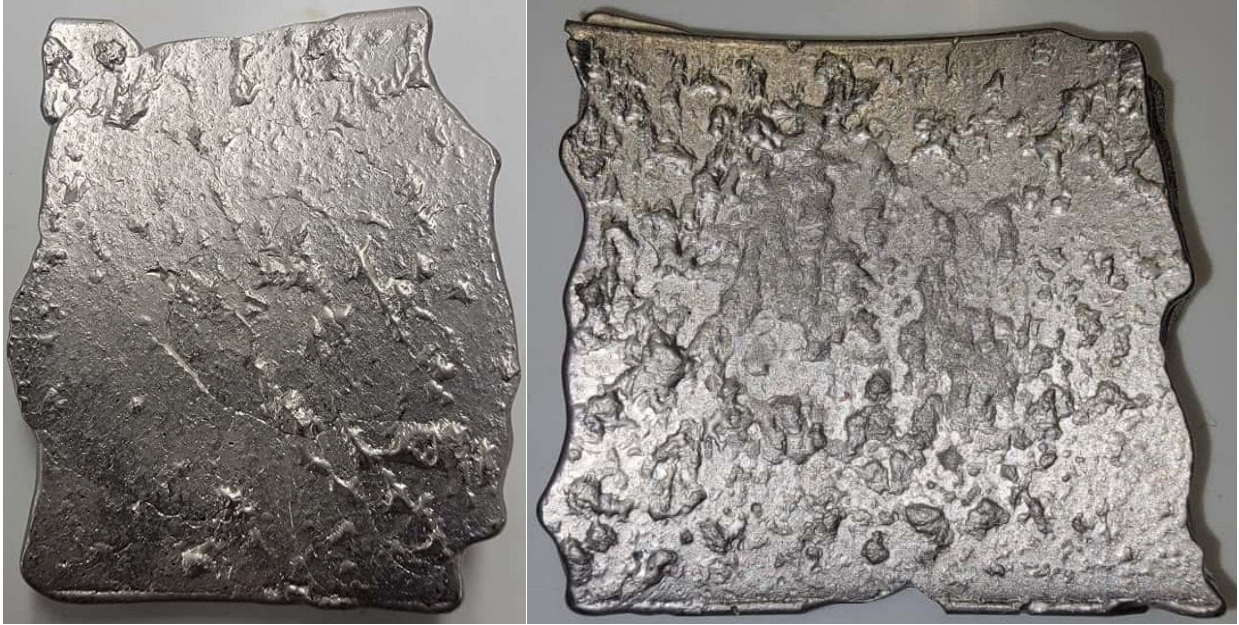
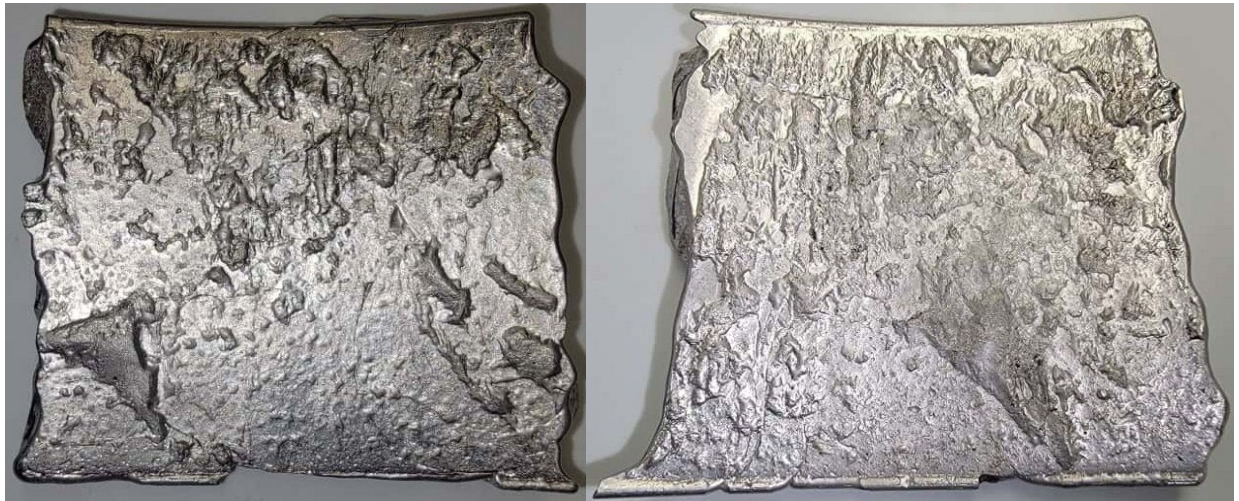
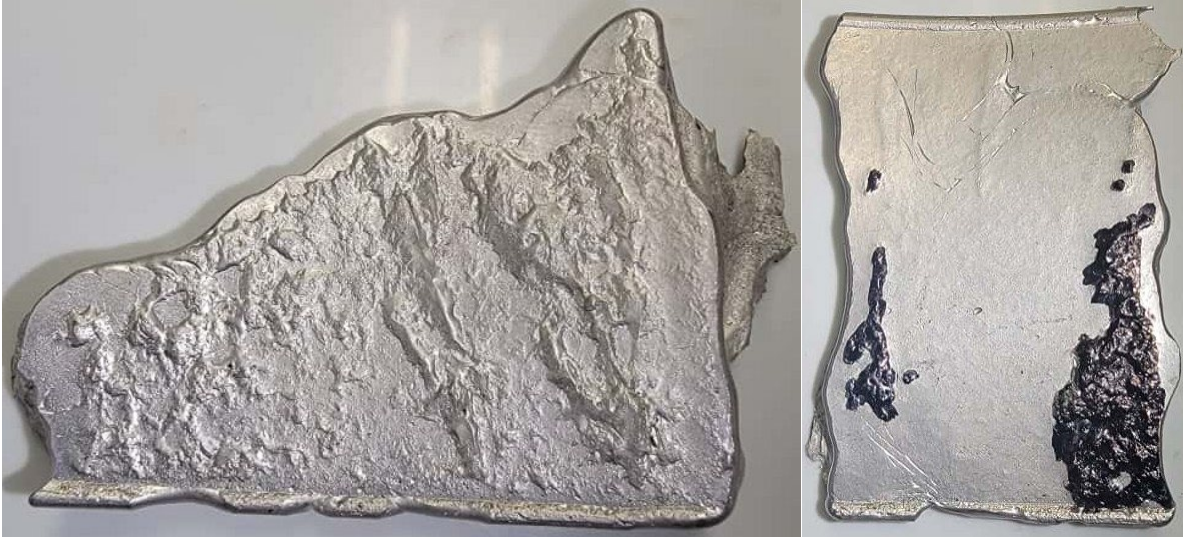
Figure 82: B2 (12-Month) bearing OB cone spall with an area of 3.18 in<sup>2</sup> (20.52 cm<sup>2</sup>) (left) and 3.32 in<sup>2</sup> (21.42 cm<sup>2</sup>) (right)

Figure 83: B2 (12-Month) bearing OB cone spall with an area of 3.12 in<sup>2</sup> (20.13 cm<sup>2</sup>) (left) and 3.96 in<sup>2</sup> (25.55 cm<sup>2</sup>) (right)

Figure 84: B2 (12-Month) bearing OB cone spall with an area of 4.41 in<sup>2</sup> (28.45 cm<sup>2</sup>) (left) and 4.27 in<sup>2</sup> (27.55 cm<sup>2</sup>) (right)

Figure 85: B2 (12-Month) bearing OB cone spall with an area of 2.03 in<sup>2</sup> (13.10 cm<sup>2</sup>) (left) and 0.42 in<sup>2</sup> (2.71 cm<sup>2</sup>) (right)

A summary of the spall area measurements is provided in Table 17. The outboard cone exhibited the most significant damage, with approximately 58% of the total cone raceway area affected by spalling. The outboard cup also showed significant degradation, with roughly 22% of its raceway area damaged. In contrast, the inboard cup exhibited only minor surface damage, representing about 1% of its total raceway area. Spalling was present on all rollers of the outboard cone assembly to varying degrees of severity and collectively accounted for approximately 11% of the total roller surface area for that cone assembly. Figure 86 shows five of the most severe roller spalls.

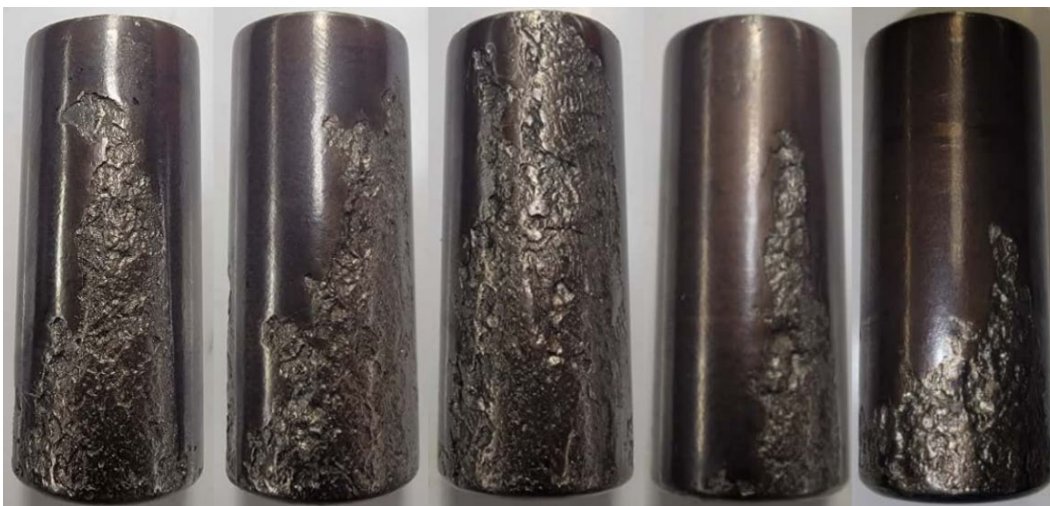
Figure 86: B2 (12-Month) bearing OB cone assembly roller spalls with areas of 1.30 in<sup>2</sup> (8.39 cm<sup>2</sup>), 1.45 in<sup>2</sup> (9.35 cm<sup>2</sup>), 2.41 in<sup>2</sup> (15.55 cm<sup>2</sup>), 0.84 in<sup>2</sup> (5.42 cm<sup>2</sup>), and 1.07 in<sup>2</sup> (6.90 cm<sup>2</sup>) [left to right]

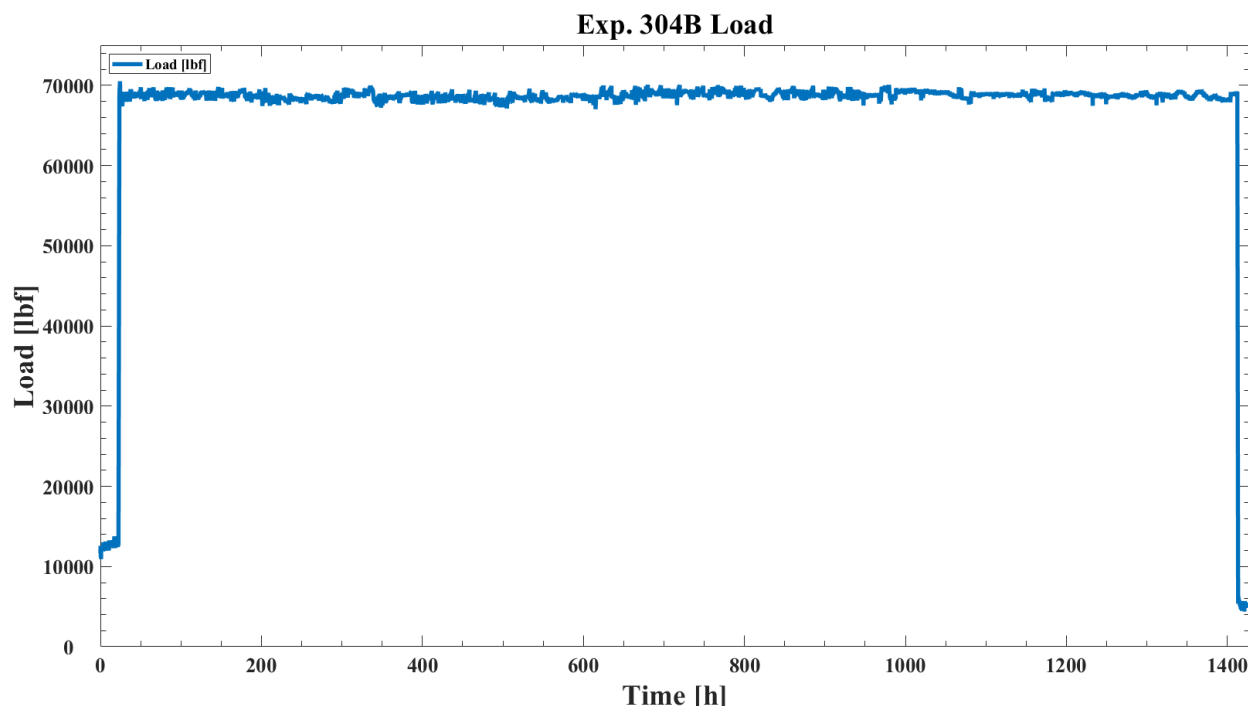
Figure 89: Applied load profile for Exp. 304B

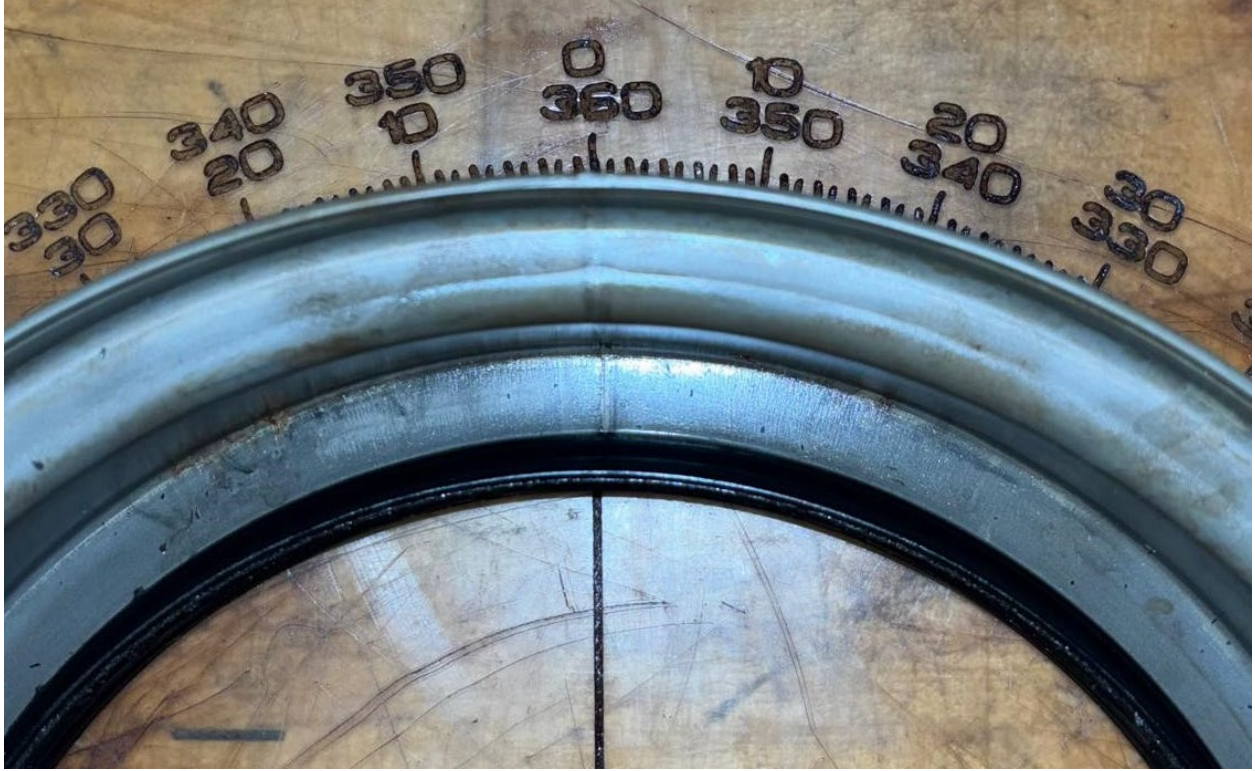
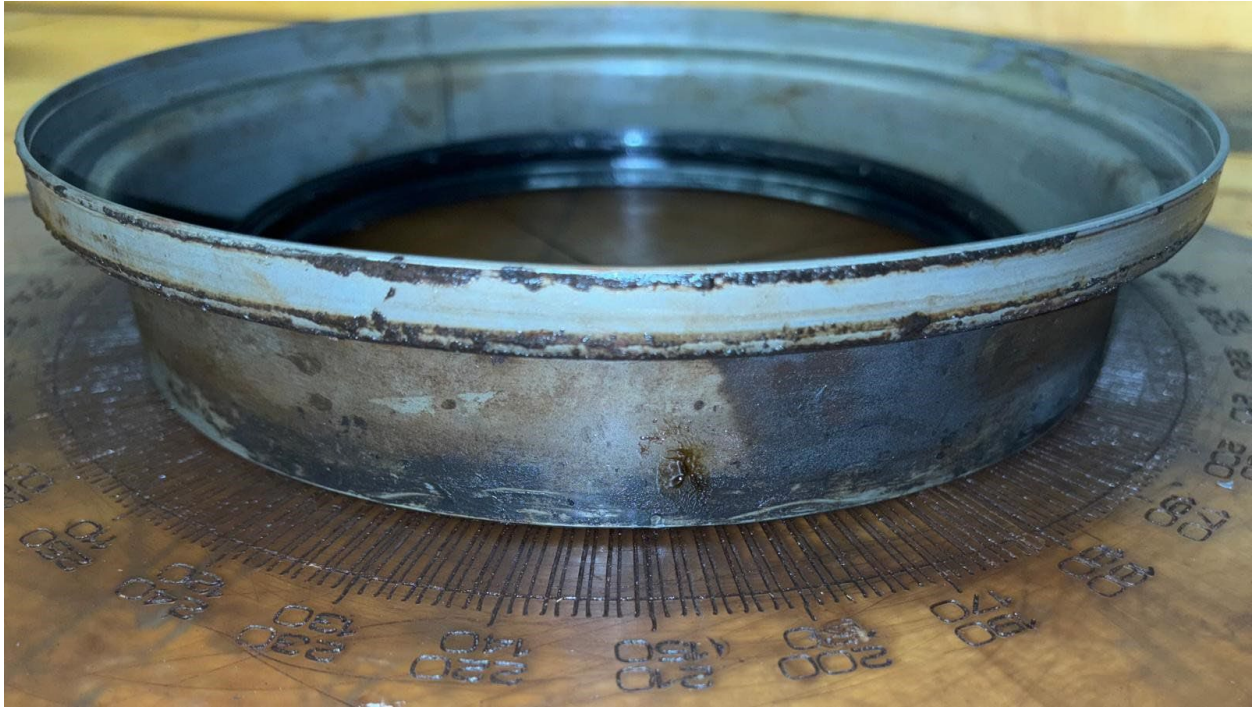
Figure 98: Overview of Bearing L2 OB seal

Figure 99: Seal weld line of Bearing L2 OB seal

Figure 100: Grease leak area of Bearing L2 OB seal

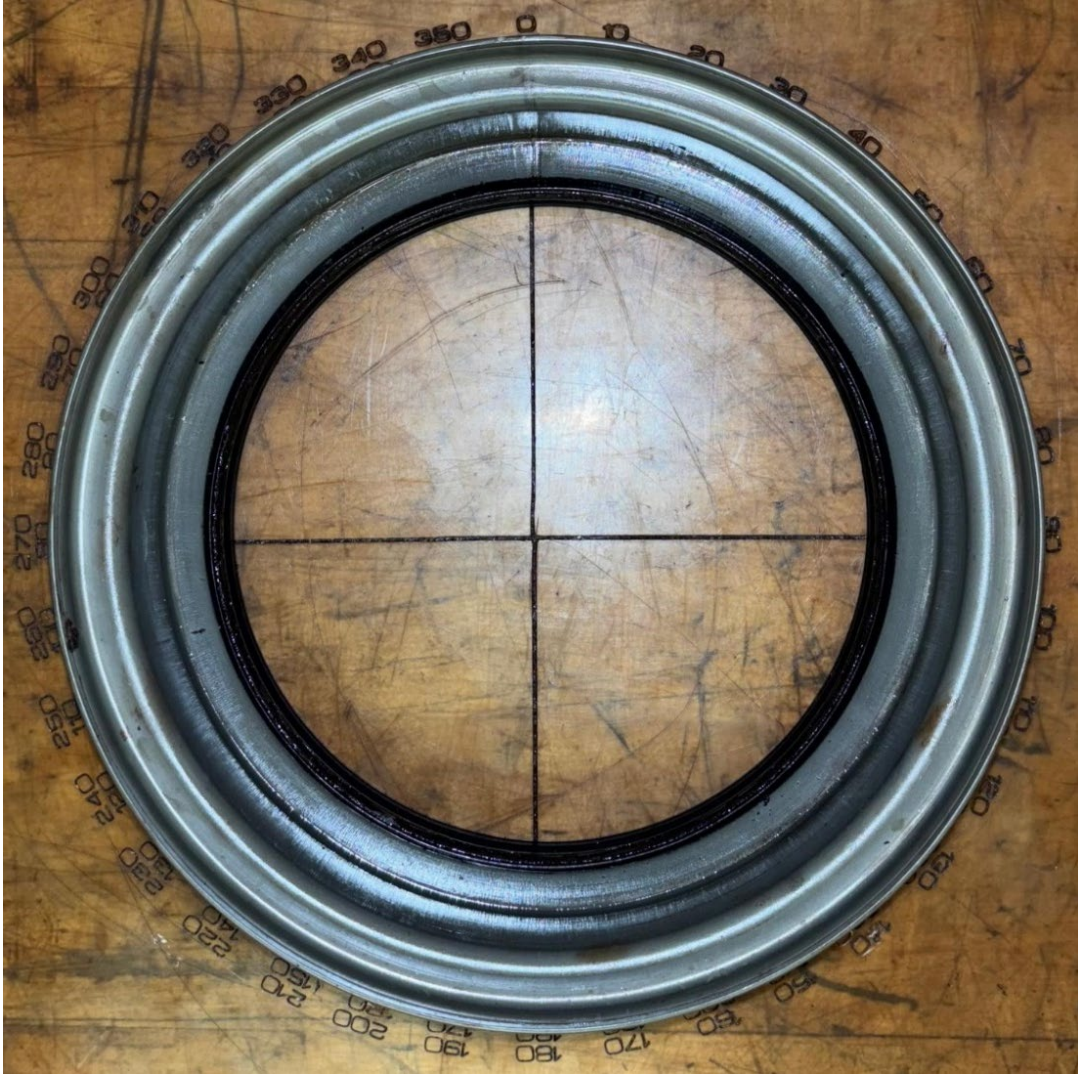
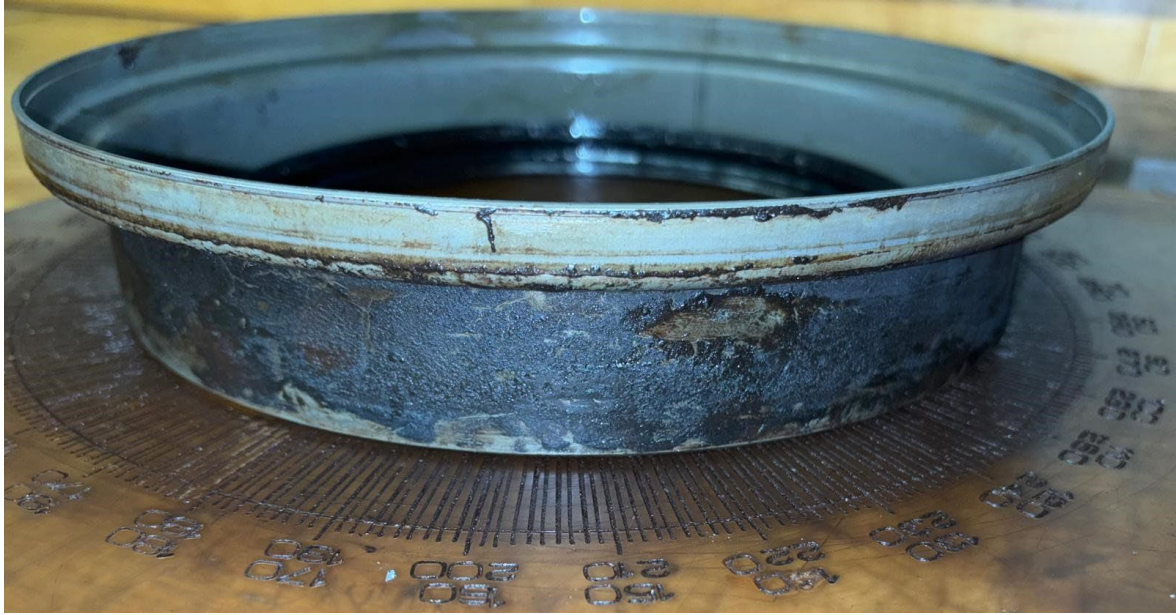
Figure 101: Overview of Bearing R2 IB seal

Figure 103: Grease leak area of Bearing R2 IB seal

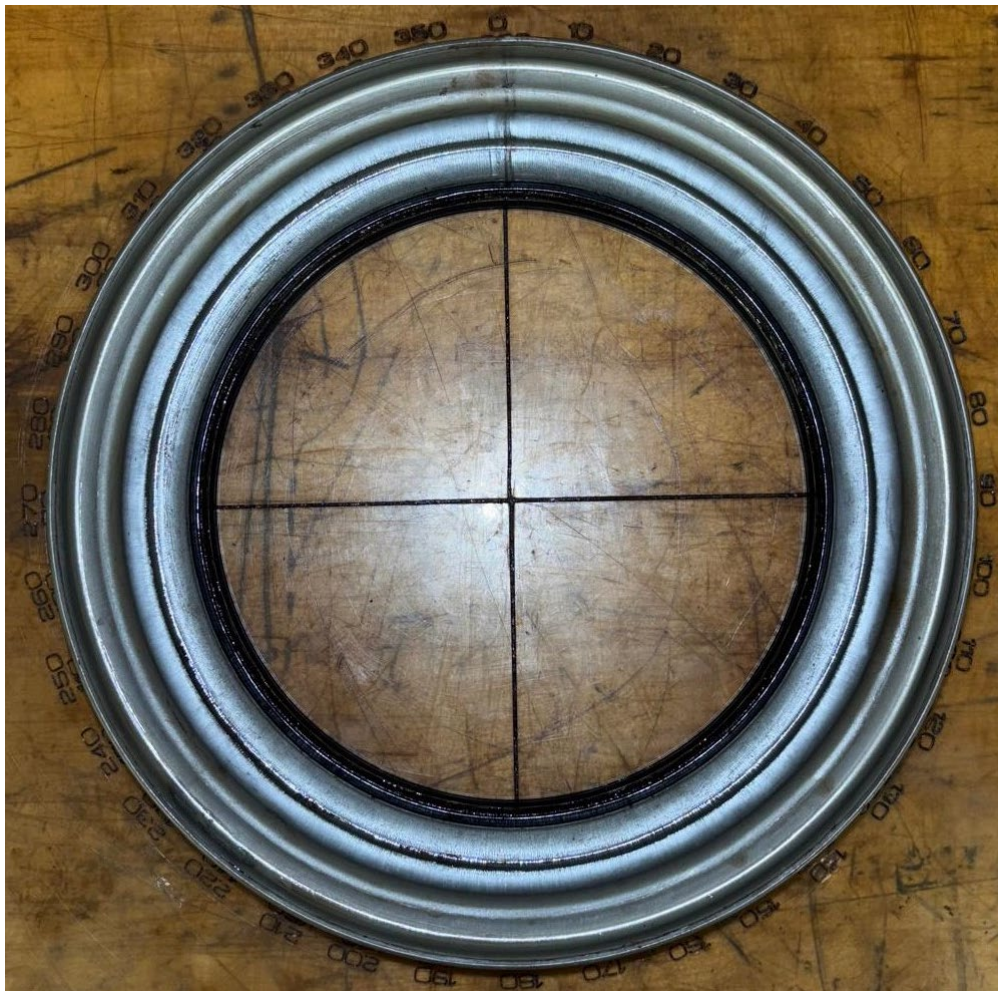
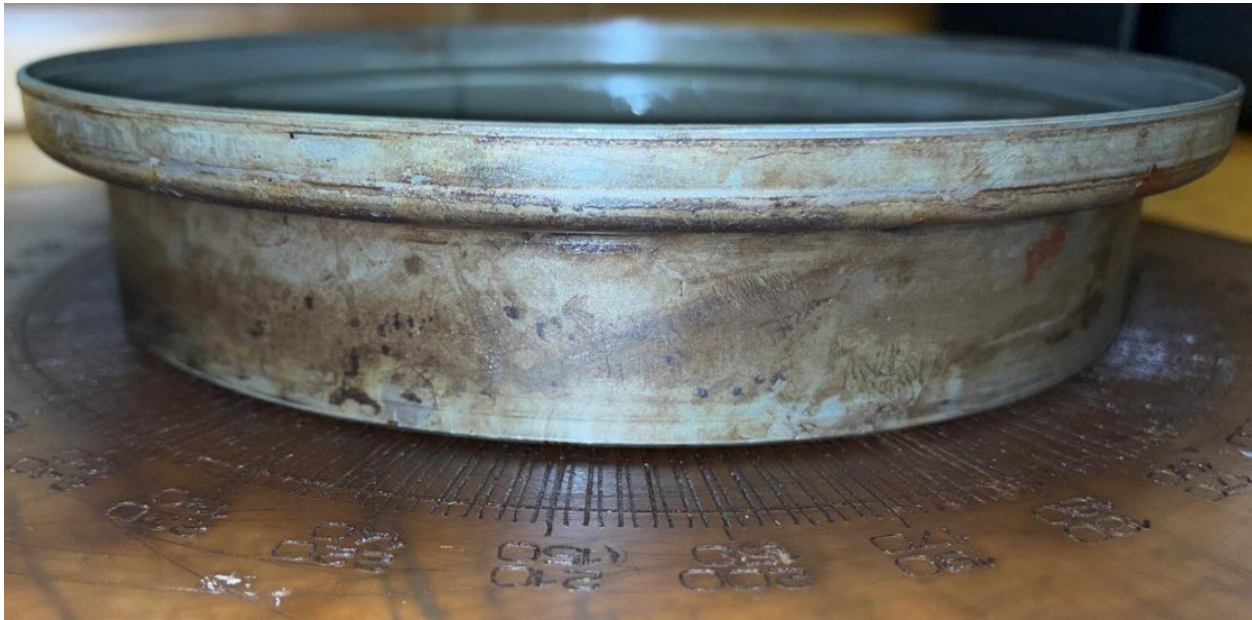
Figure 104: Overview of Bearing R2 OB seal

Figure 105: Seal weld line of Bearing R2 OB seal

Figure 106: Grease leak area of Bearing R2 OB seal

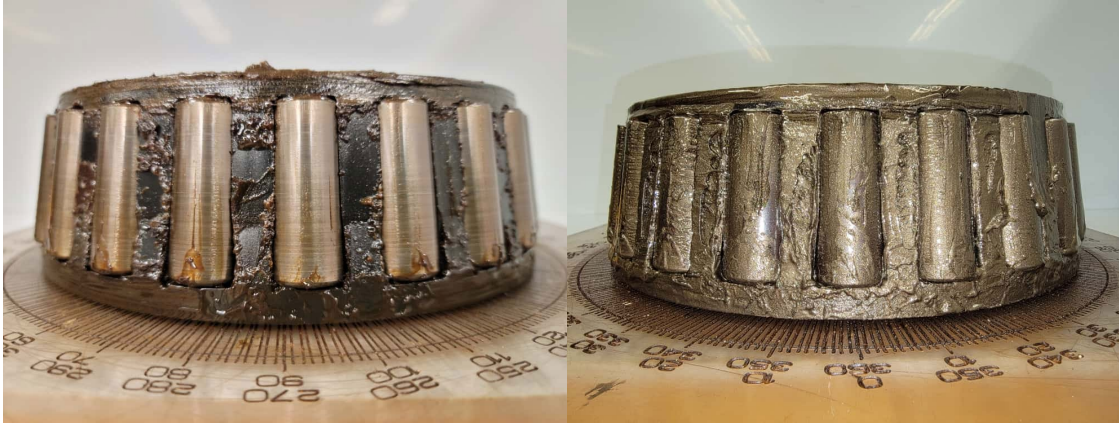
In summary, the 12-Month bearing experienced a progressive increase in both vibration and temperature, followed by an abrupt rise near the end of the test, consistent with spall initiation and subsequent growth. Conversely, the 6-Month bearing exhibited normal operating behavior, with only minor increases in vibration and temperature remaining within acceptable healthy limits.

Figure 107: Comparison of the IB cone assembly (left) and OB cone assembly (right) for the B2 (12-Month) bearing

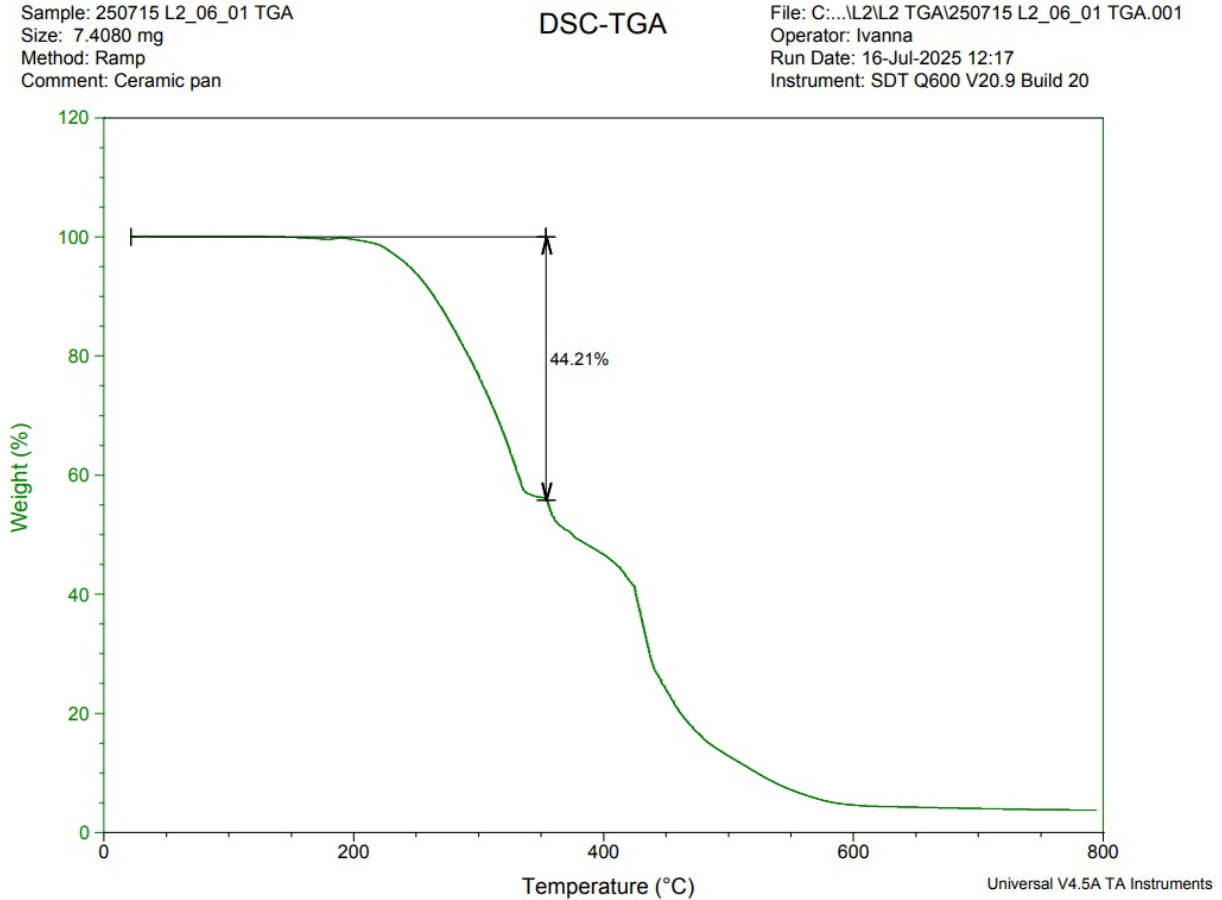
Sample masses of 7 mg per specimen were tested using ceramic pans that permitted heating rates of 10°C per minute until a final temperature of 800°C (1472°F) was reached. An example TGA scan is presented in Figure 110.

Figure 110: Sample TGA output depicting first decomposition step
