## **Ultrasonic Inspection of Reconditioned Railroad Bearing Components – Year 2**

A Report on Research Sponsored by

University Transportation Center for Railway Safety (UTCRS)

January 2026

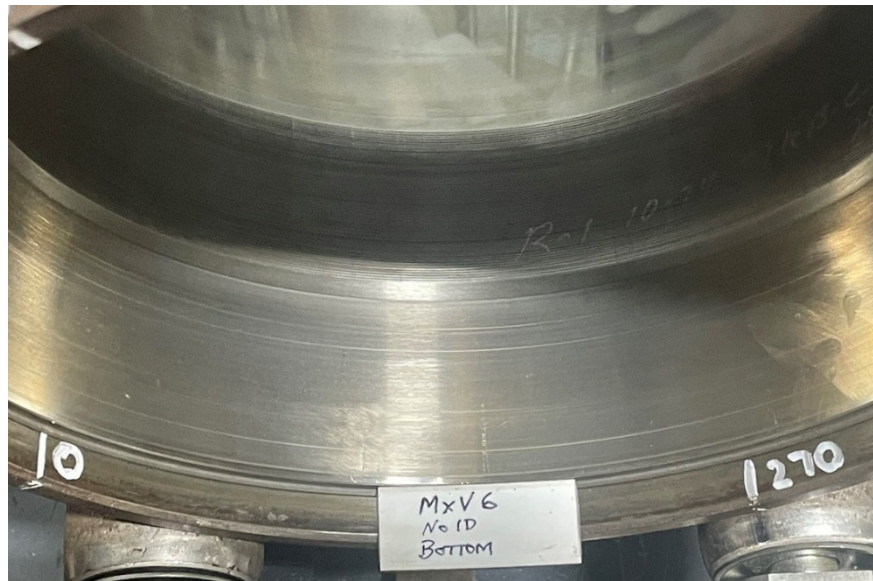
Figure 7. Pre-test condition of the bottom raceway of MxV6.

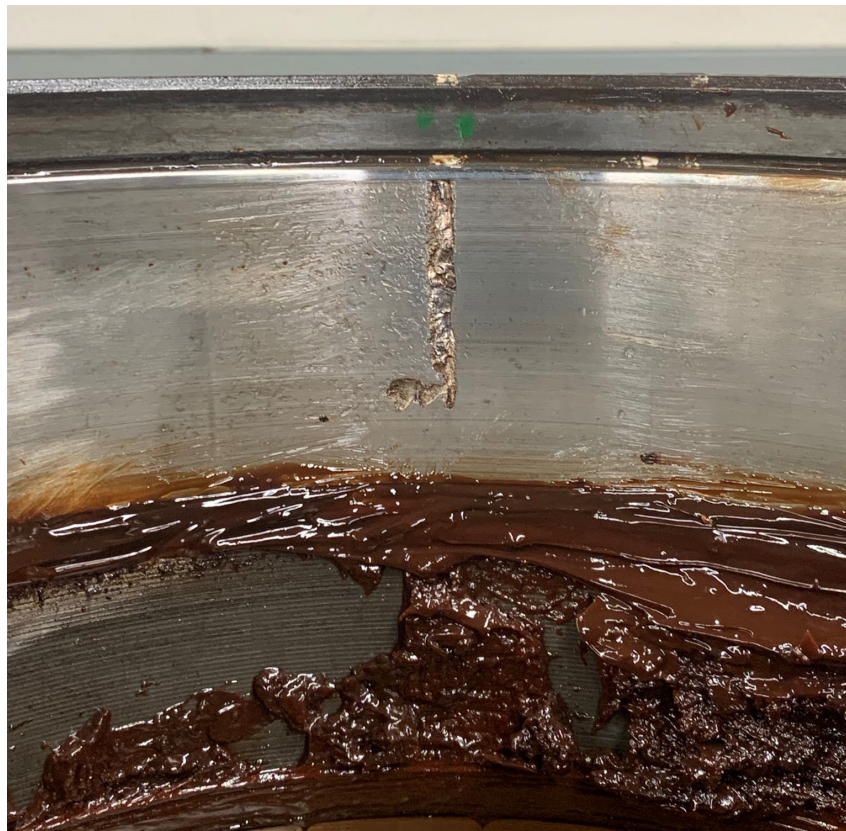
Figure 8. Post-test condition of the bottom raceway of MxV6 after spall formation.
