## Exhibit F - UTCRS

| <b>UTC Project Information</b> | |
|---|--|
| Project Title | Improving Safety at Rural Highway-Rail Grade Crossings by Utilizing Light Detection and Ranging (LiDAR) Technology |
| University | University of Nebraska-Lincoln (UNL) |

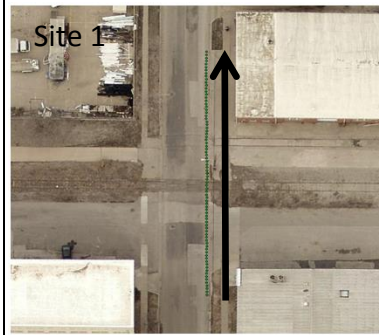
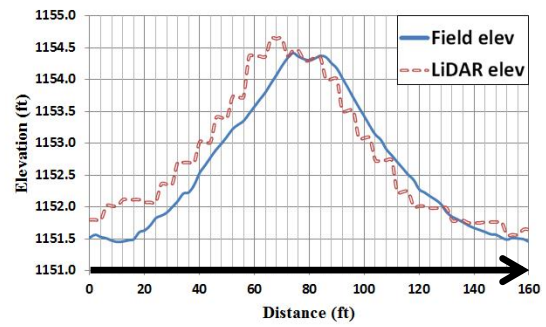
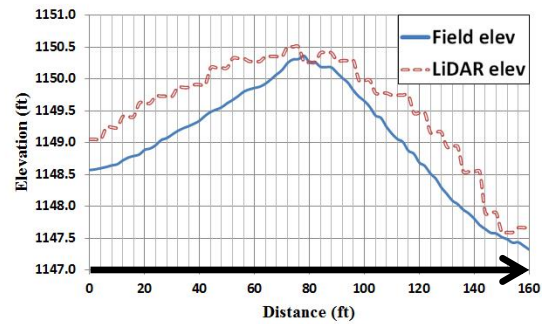
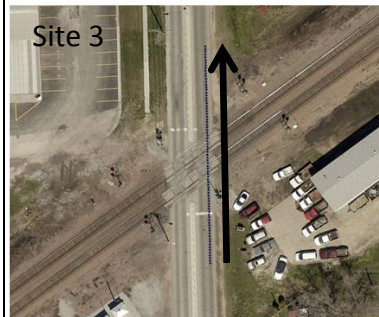
**Figure 4.1** Comparison of vertical elevation profiles for LiDAR and field-measured data

| <p>Describe Implementation of Research Outcomes (or why not implemented)</p> <p>Place Any Photos Here</p> | <p style="text-align: center;"><b><u>Data Analysis</u></b></p> <p>Geo-referenced points of 160-ft ranges for crossing roads and a 2 meter resolution LiDAR elevation raster were integrated in the study area orthophoto using ArcGIS. An autonomous relative accuracy test of the data was conducted to see how accurately the data represented elevation of the study area. To conduct the assessment, LiDAR elevation data pertaining to the geo-referenced points in the three rail grade crossings were obtained from the GIS database and verified against field observations obtained using a geo-positioning system and a theodolite. The two corresponding groups of data were compared for relative accuracy. <b>Figure 4.1</b> shows the aerial photos of the rail grade crossing geometry and vertical elevation profiles between LiDAR data and field-measured data. The geo-referenced points were obtained along the arrows shown in the figure. In a range of 160-ft, point spacing for each was 2-ft resulting in 81 elevation points at each site. For the three sites, there were 243 elevation sample points for both LiDAR and field measured elevation data. A list of the total LiDAR and field elevation geo-referenced points appears in Appendix B. RMSE for each pair of all 243 points were only 0.30-ft, so the authors decided to proceed with further analysis.</p> |

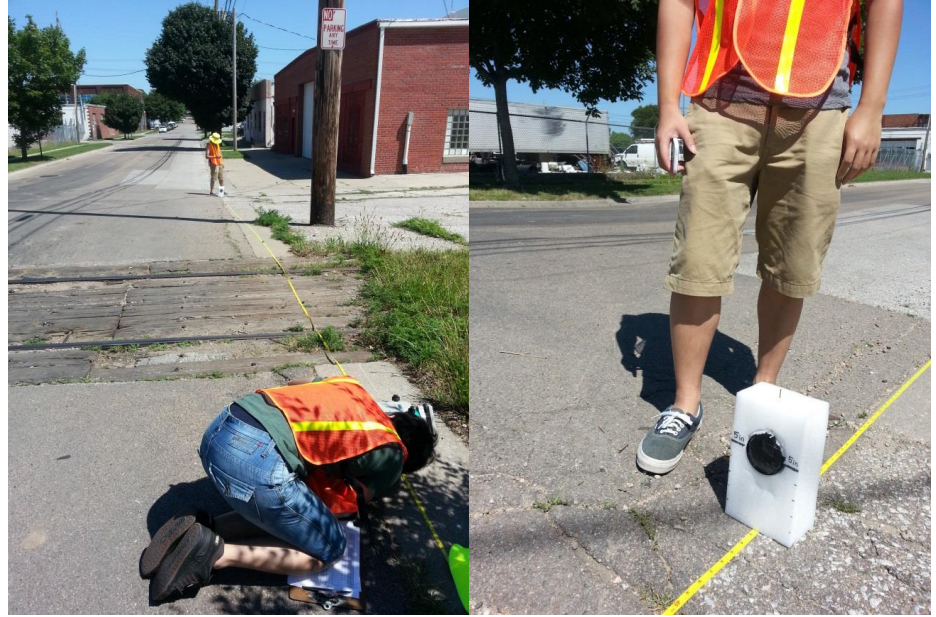
**Figure 4.5** Field validation of crossing suitability using a line laser and a retro-reflective lens

The GIS-derived crossing suitability assessment results were validated in the field using a level line laser instrument, a geo-positioning surveying tool, and level rods. When a line laser was set at a certain distance from the railway centerline, the wheelbase distance of design vehicles were used to set a level rod from the line laser instrument. The height of the line laser instrument was set to be the ground clearance of the vehicle. Then it was observed if the laser beam reached the level rod at the same height of ground clearance without any obstruction from the crossing surface. If the straight line between the level line laser and level rod was uninterrupted, it implied a safe passage situation for the design vehicle (i.e., no hang-up issue). If the straight line between the level line laser and level rod was interrupted then the obstruction location was noted for later comparison with the crossing suitability results from the GIS. **Figures 4.4** and **4.5** illustrate field validation with the line laser instrument. A retro reflective lens was also used in a replacement of the level rod under the bright sunlight since laser beams were more clearly viewed by using it. Field validation results showed that all hang-up spots identified from the field validation process corresponded with the line-of-sight analysis results from the GIS, indicating that the adopted methodology successfully identified vulnerable rail grade crossings for the vehicle hang-up issue.
