Heavy Truck and Bus Traversability at Highway-Rail Grade Crossings

HEAVY TRUCK AND BUS TRAVERSABILITY AT HIGHWAY-RAIL GRADE CROSSINGS

MwRSF Research Report No. TRP-03-392-18

June 29, 2018

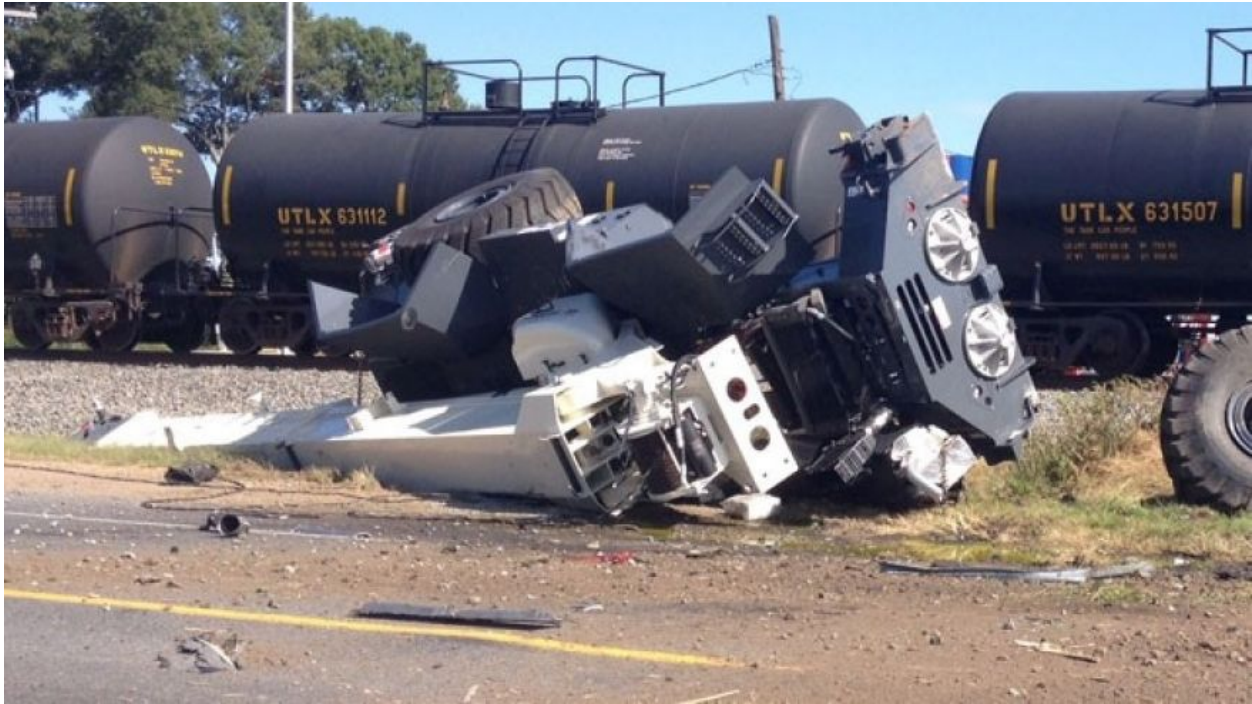
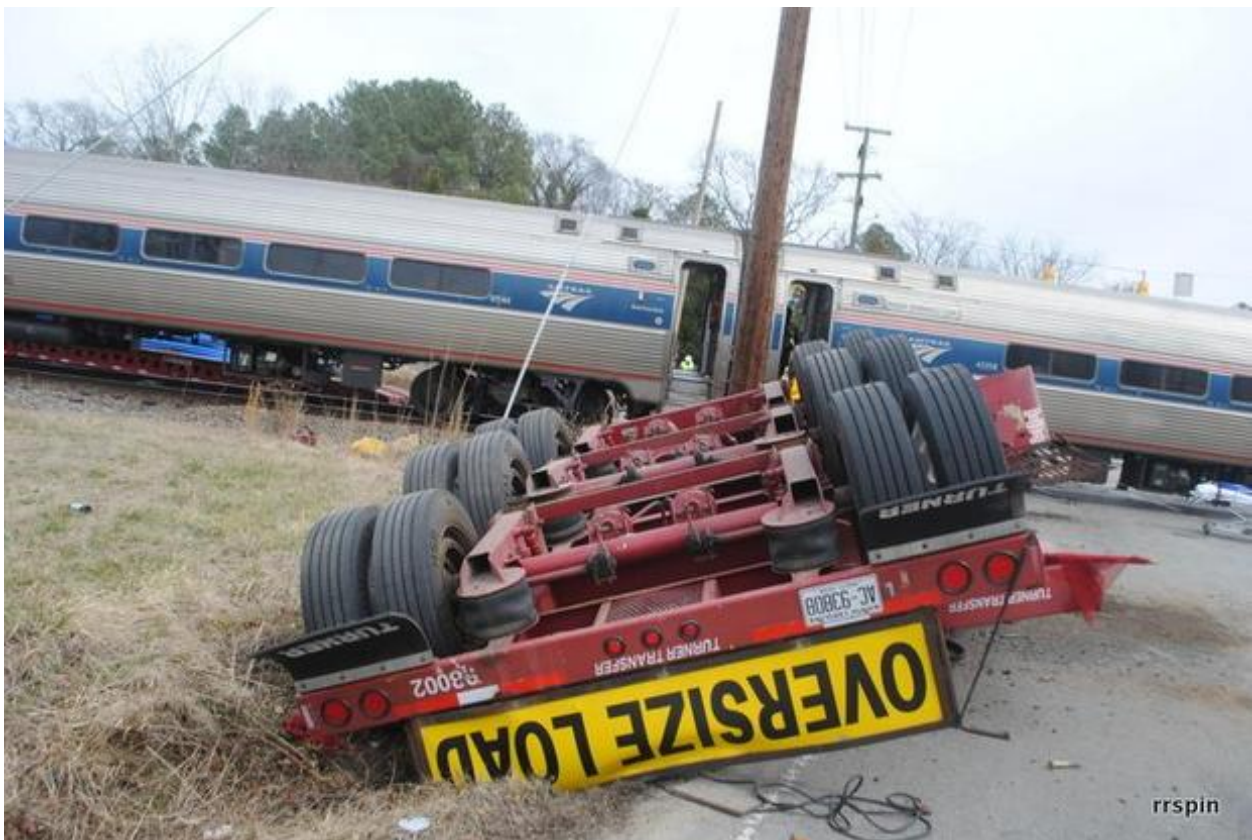
Figure 3. Train Crashes with Trucks High-Centered on Train Tracks in (a) Louisiana [6] and (b) North Carolina [7]

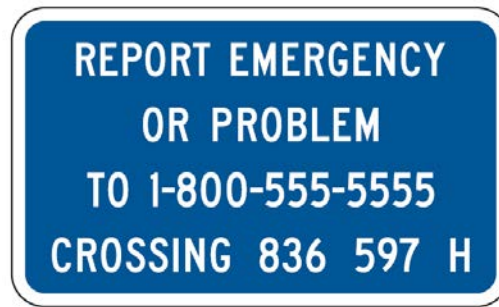
crossing signs, barricades, and crossing arms [9]. According to Section 8B.18, emergency notification signs (I-13) should be installed at all highway-rail grade crossings. These signs must show an emergency contact telephone number and the United States Department of Transportation (USDOT) crossing inventory number, as shown in Figure 5.

Figure 5. Example of an Emergency Notification Sign [9]

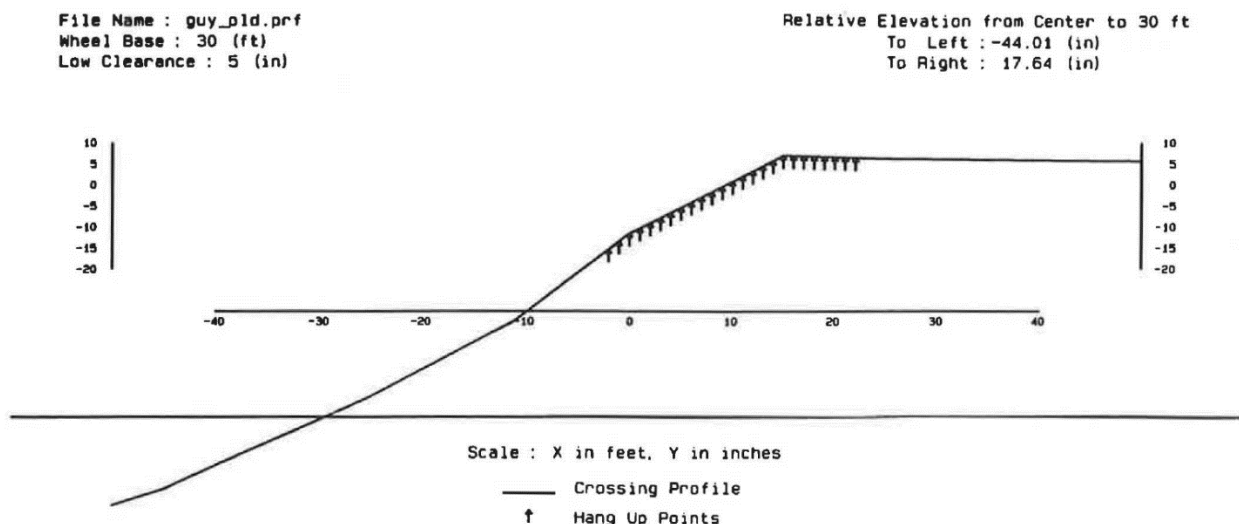
Figure 18. HANGUP Manual Mode Output [4]

A computer program, HANGUP, was developed to simulate low-clearance vehicles traversing grade crossings. The program can run in either manual or automatic mode. Manual mode can be utilized when specific wheelbase and ground clearance values need to be evaluated at a crossing. The output of a manual-mode simulation is shown in Figure 18. The arrows indicate points where a vehicle would become high-centered. To determine which combination of wheelbase and ground clearance values will cause high-centering over a crossing, automatic mode can be used. It will test wheelbases from 10 to 40 ft (3.0 to 12.2 m) in 1 ft (0.3 m) increments and ground clearances from 1 to 10 in. (25 to 254 mm) in 1 in. (25 mm) increments. The output of an automatic-mode simulation is shown in Figure 19. Results are given in binary code, where a high-centering incident is signified by a 1 and a safe crossing is signified by a 0.

The HANGUP program has many limitations. It is a 2D modeling program that does not take vehicles' dynamic factors into consideration. In addition, the program only accepts integer values. For ground clearance, rounding to the nearest whole inch could give an incorrect result.

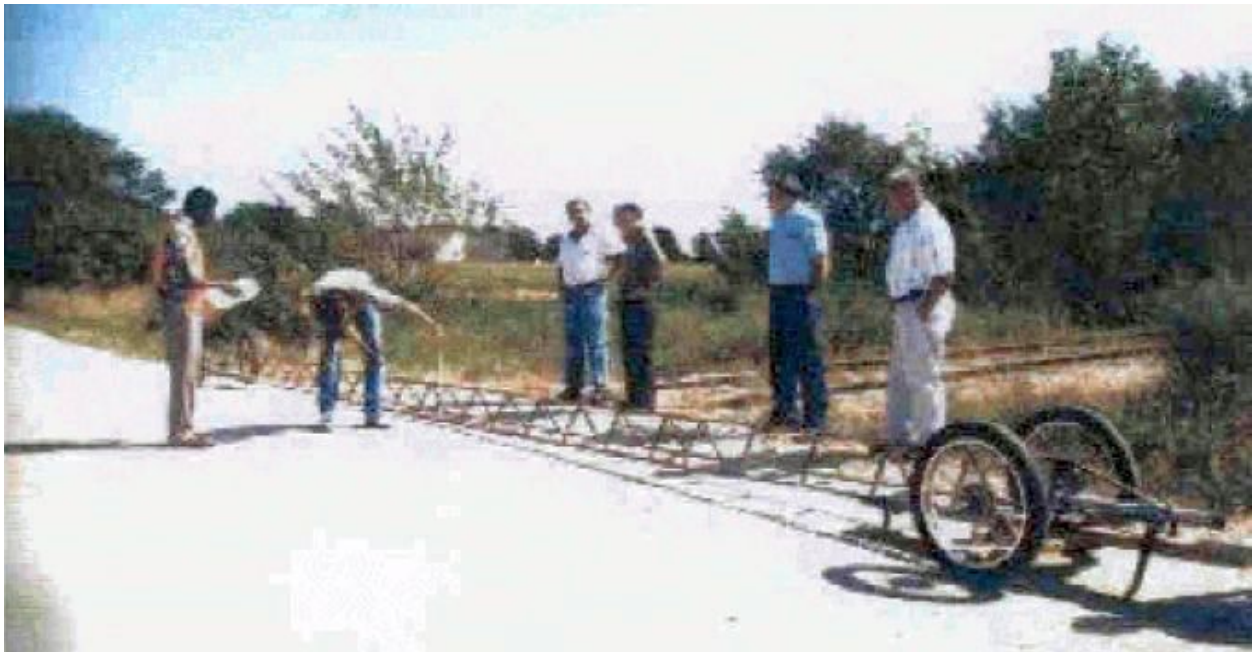
KDOT created a physical model to evaluate hump crossings, shown in Figure 20. The model can be adjusted to represent a vehicle with a wheelbase up to 30 ft (9.1 m) and a ground clearance from zero to several inches. Bike tires were utilized for the model, in addition to a leaf spring suspension system and a truss frame structure.

Figure 20. Physical Model Built for Evaluation of Crossings in Kansas Study [18]

To evaluate the accuracy of the physical model, it was compared against a lowboy trailer with the same wheelbase and ground clearance. Both the model and the tractor-trailer were driven over the same crossing, but on different days. The crossing was located on an unpaved road, which was graveled and graded after the lowboy trailer measurements were taken and before the model measurements were taken. It was concluded that the model measurements were comparable to those for the trailer, and if the crossing had not been changed, the model and trailer would have yielded the same results. Furthermore, the model measurements were much easier and quicker to obtain.

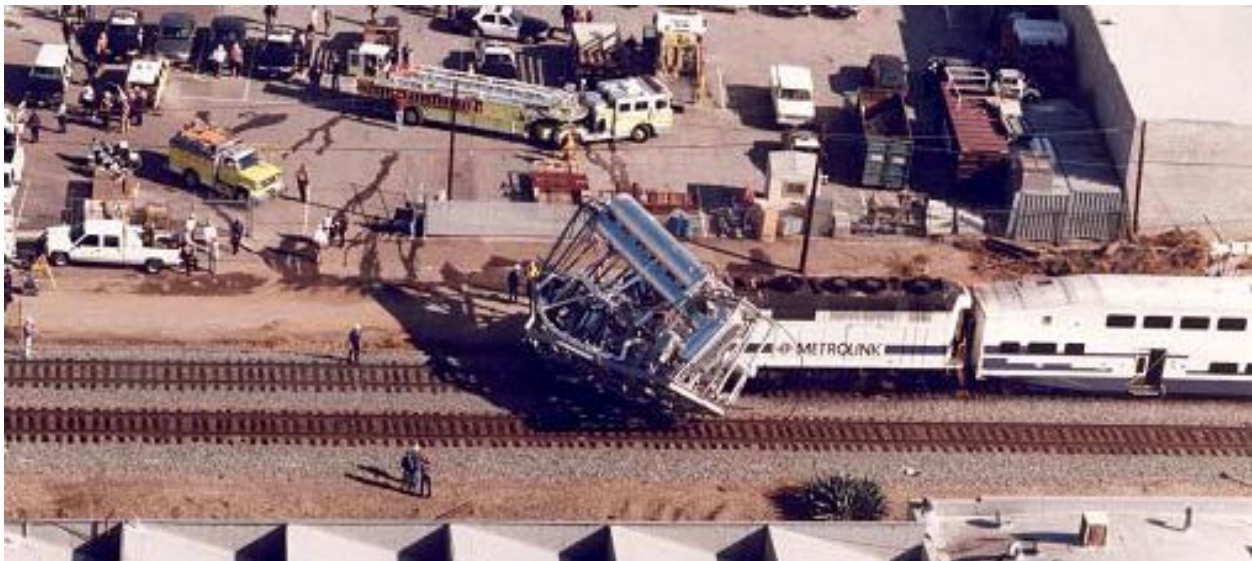
Figure 23. Oil Refinery Condenser Unit and Train [19]

Total damages were around \$2,274,000 and minor injuries occurred to the train engineer, train conductor, and four train passengers. The train experienced significant damage to the engine, as well as minor damage to the coaches. In addition, the warning devices on the north side of the road were destroyed, the impacted trailer separated into three parts, and the oil refinery condenser was destroyed, as shown in Figure 23. The railroad tracks and tractor received no damage.

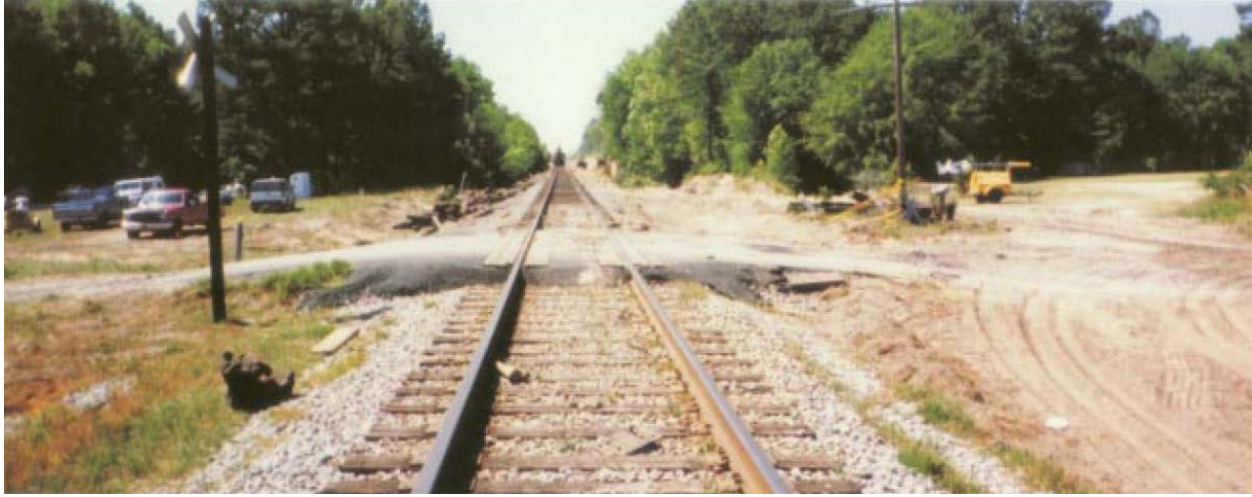
Figure 24. Boogaloo Crossing [5]

To return home after a delivery, the driver had to traverse a hump railroad crossing located on an unpaved road known to locals as Boogaloo Road. The crossing had 5.28 percent and 9.97 percent grades on either side, has USDOT grade crossing number 634810U, and is shown in Figure 24. No hump crossing warning signs were posted. The truck driver had traversed this crossing before, but never with a trailer as low as the one involved in the crash.

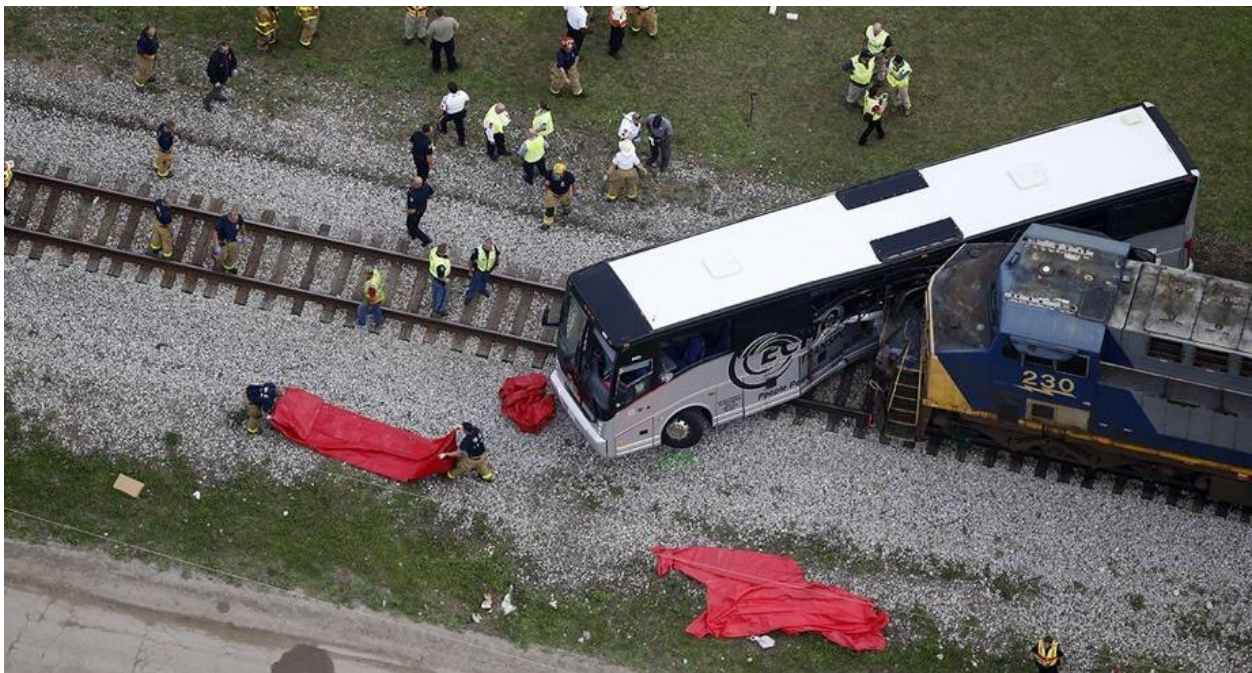
on the crossing and was hit by a train. The crash resulted in four deaths and thirty-nine injuries. The bus was high-centered on the tracks for about five minutes before the train struck [38]. While attempting to traverse the crossing, the bus frame became lodged on the tracks. The bus driver opened the entry door to let passengers escape before the train struck [37]. Robert Sumwalt, an NTSB member, said the bus driver used directions from a GPS set for commercial vehicles instead of the directions given by the tour company [39]. The train was traveling at 26 mph (41.8 km/h) when the emergency brake was applied and slowed to 19 mph (30.6 km/h) when it collided with the bus, which was pushed 203 ft (61.9 m) down the track before the train came to a stop, as shown in Figure 26 [37].

Figure 26. Train and Bus in Biloxi, Mississippi Crash After the Train Came to a Stop on March 7, 2017 [40]

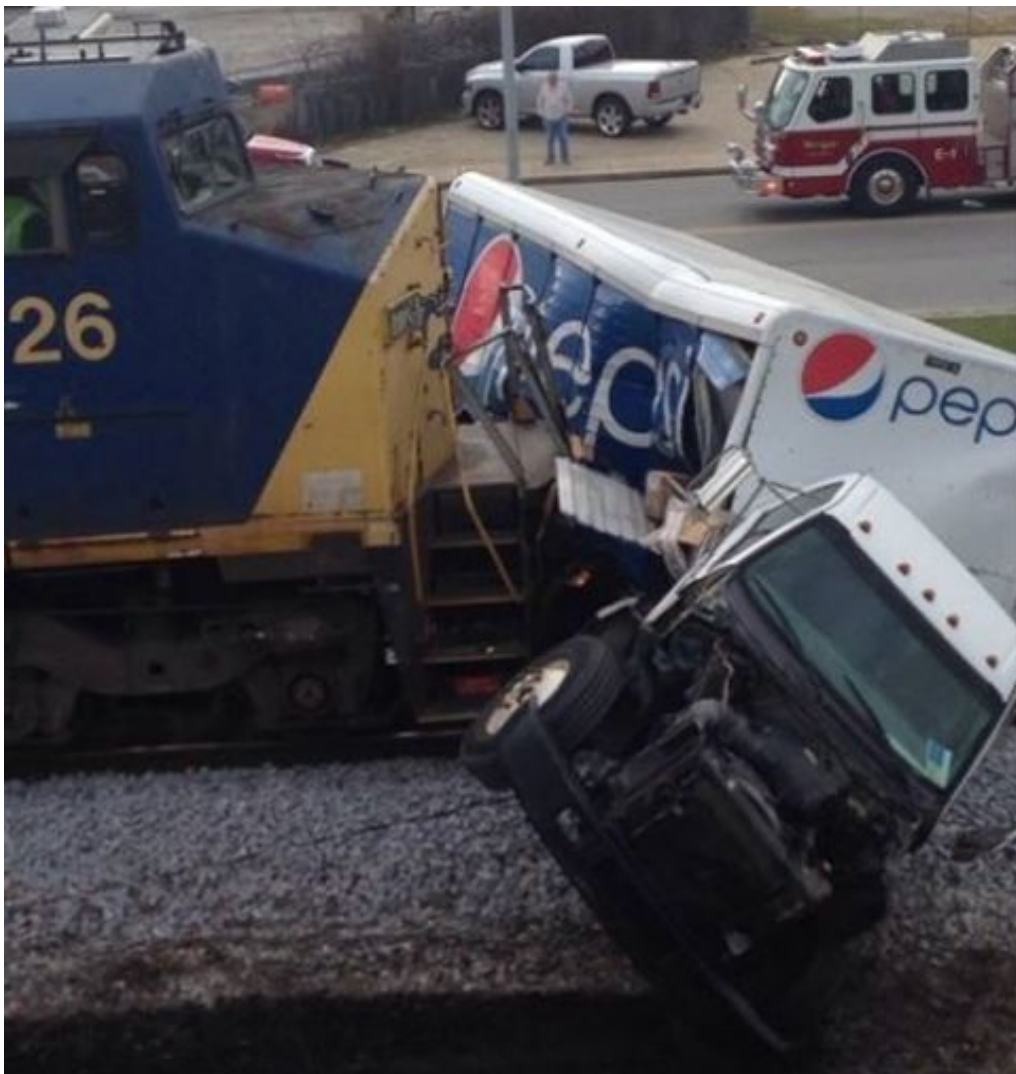
Figure 27. Pepsi Truck after the Train Crash at the Main Street Crossing in Biloxi, Mississippi on January 5, 2017 [41]

On January 5, 2017 a Pepsi delivery truck became high-centered on the crossing and was hit by a CSX train, as shown in Figure 27 [41]. The driver left the cab before the train hit and no one else was injured. On March 12, 2016 a charter bus carrying twenty-eight passengers became high-centered on the crossing, as shown in Figure 28. The oncoming train was stopped a few blocks before the crossing to prevent a crash. On August 28, 2014 a tractor-trailer became high-centered on the crossing and was struck by a train. One railroad employee was injured in this crash.

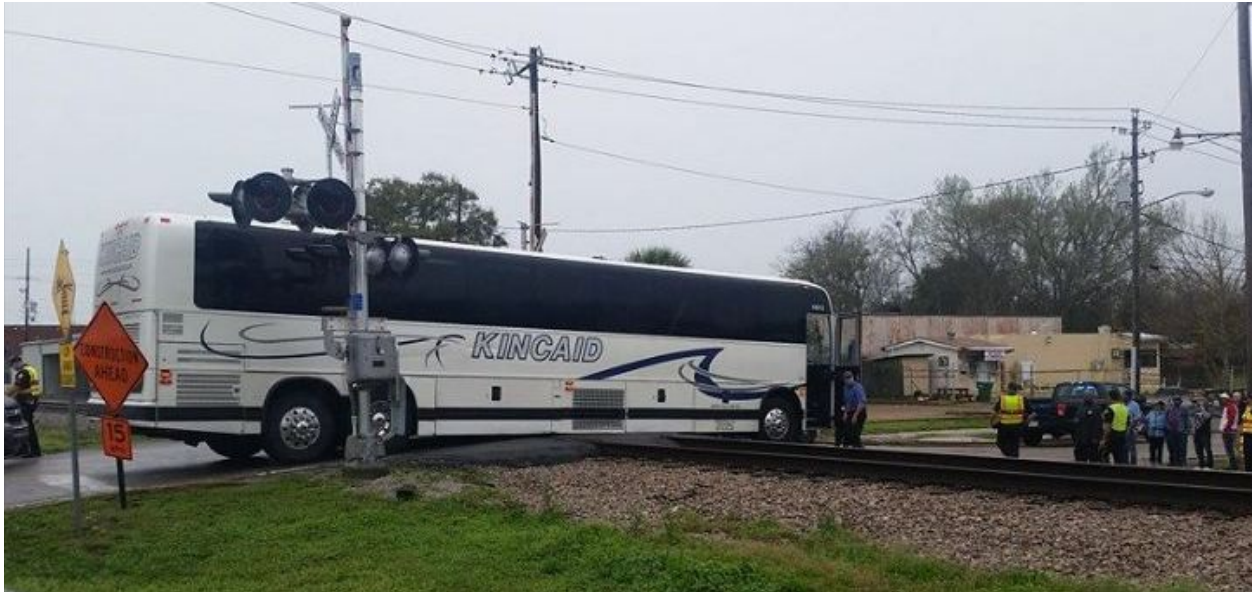
Figure 28. Charter Bus High-Centered at Main Street Crossing in Biloxi, Mississippi on March 12, 2016 [41]

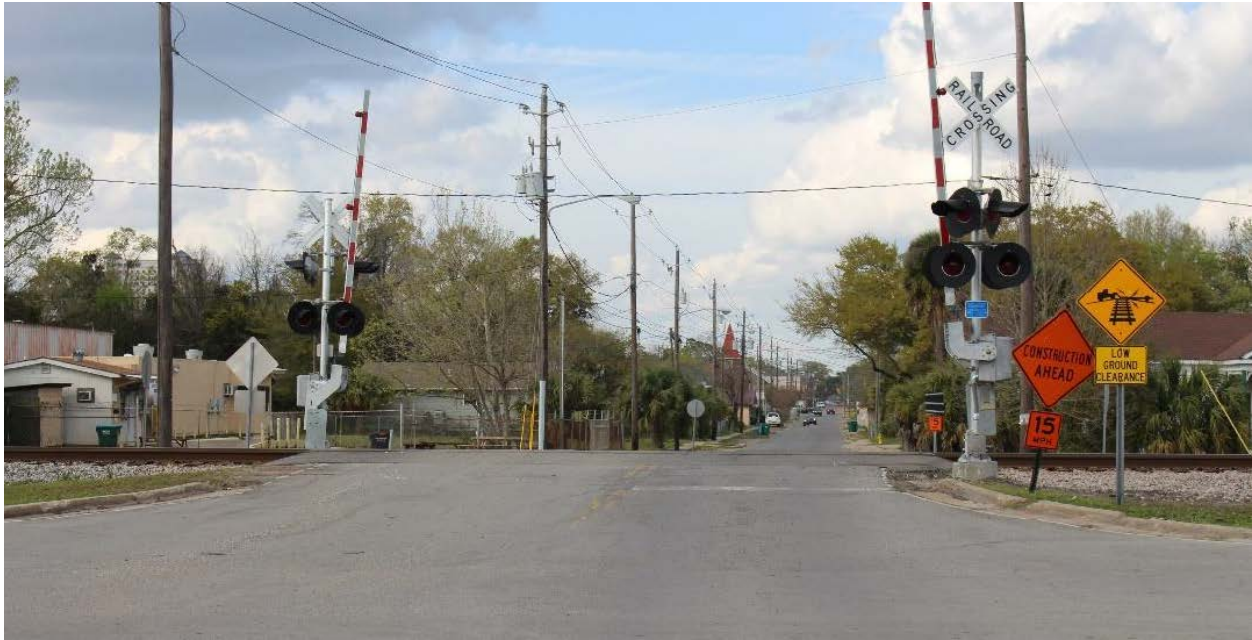
Low ground clearance signs are posted on both sides of the Main Street crossing as shown in Figure 29, as well as bells, lights, and crossing arms [37]. The signs do not prohibit any vehicles from crossing, they only warn of the hump crossing.

Figure 29. Main Street Crossing and Low Ground Clearance Sign in Biloxi, Mississippi [37]

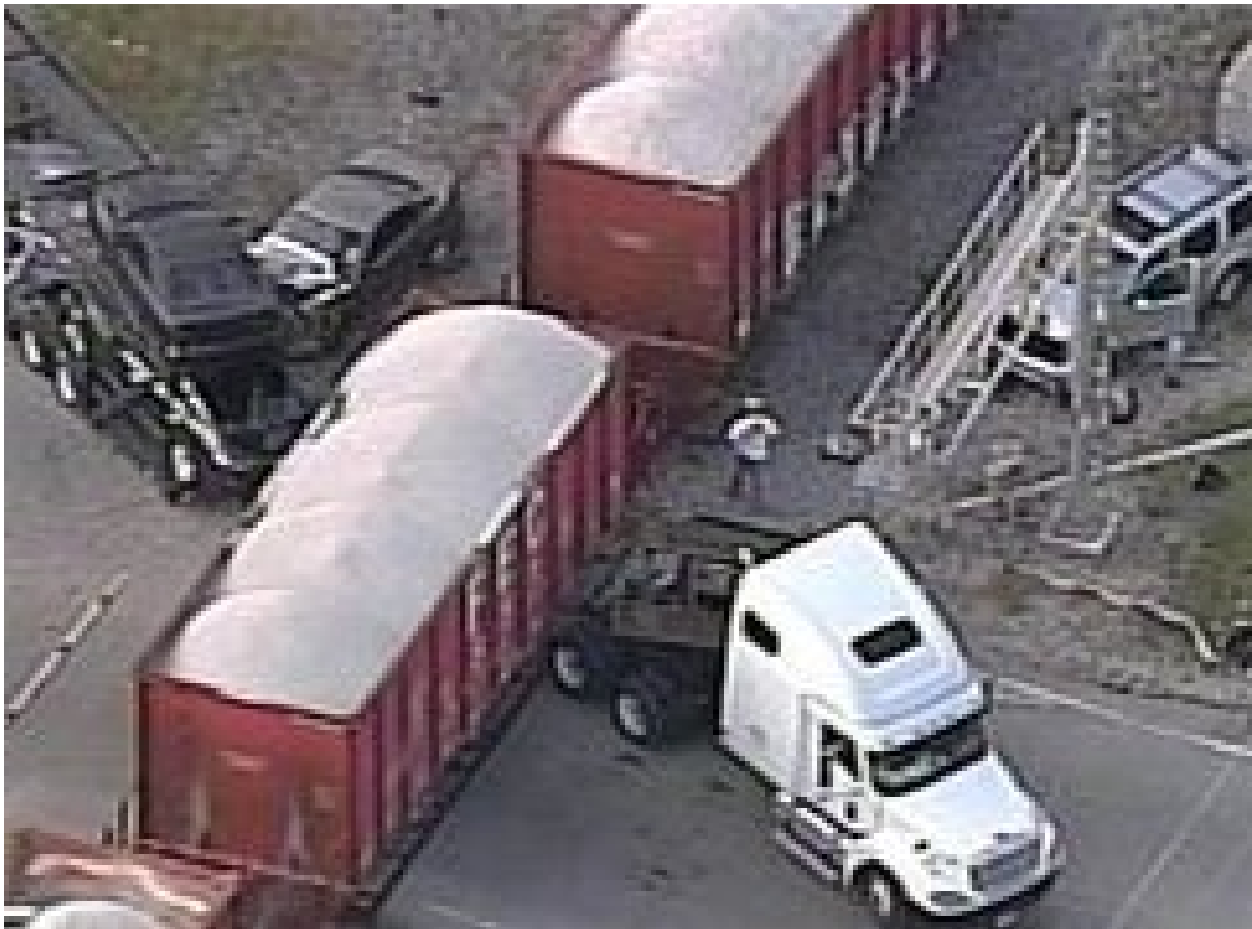
Figure 30. Tractor Separated from Auto Transport Trailer [24]

On March 22, 2010, an auto-transport trailer carrying Lexus vehicles became high-centered on a railroad crossing in North Miami, Florida, as shown in Figure 30 [24]. The crash caused two of the vehicles to fall off the trailer and tore the trailer into two pieces.

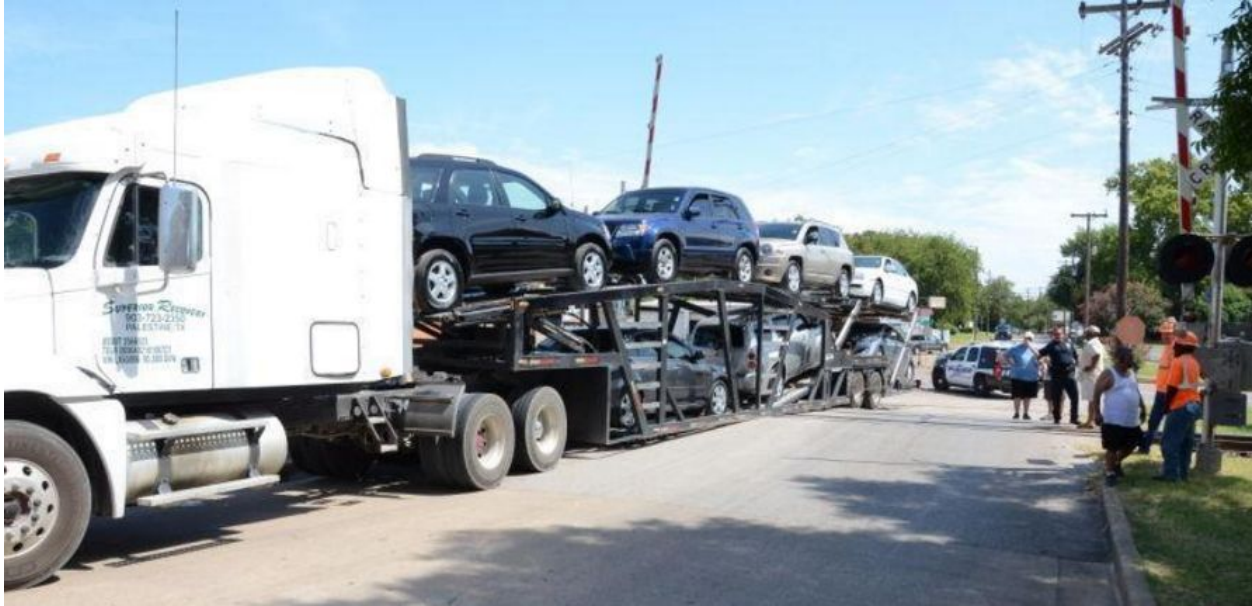
An auto-transport vehicle became lodged on a crossing in Waxahachie, Texas on July 22, 2015, as shown in Figure 31 [28]. Police arrived on scene and contacted Union Pacific (UP), which alerted the train to the obstruction. In addition, the police set out flares along the track in case the railroad could not get in contact with a train. Subsequently, another truck arrived to pull the high-centered auto-transport truck off the tracks, and no train-truck crash occurred.

Figure 31. Auto-Transport Trailer High-Centered on Tracks in Waxahachie, Texas [28]

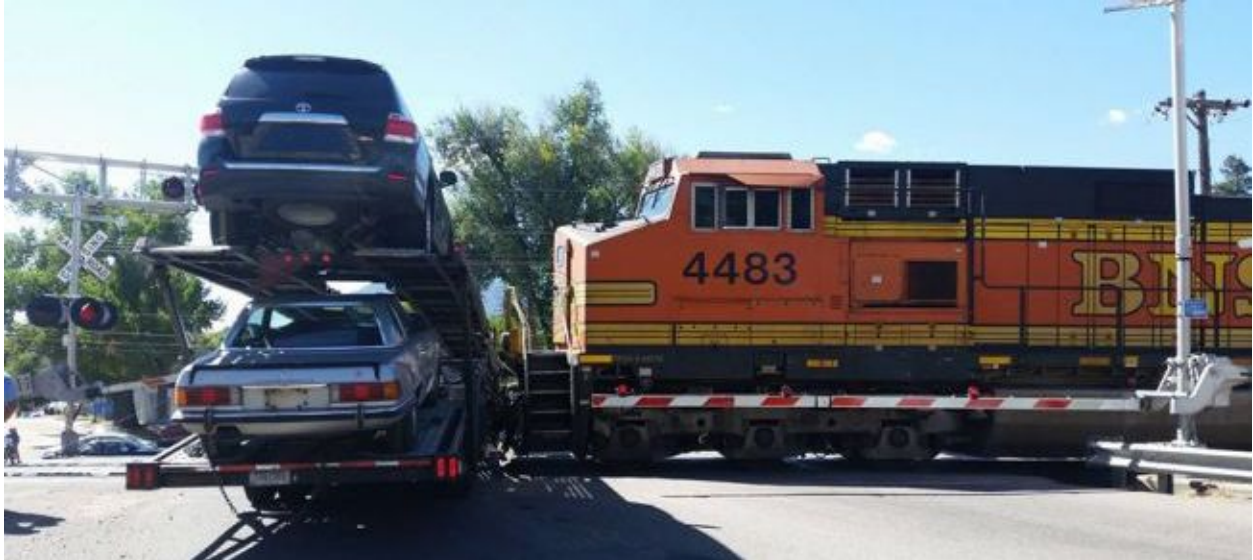
Figure 32. Slow Moving Train Collided with Auto-Transport Trailer [29]

An auto-transport truck became high-centered on a railroad crossing south of Colorado Springs, Colorado on October 4, 2016, as shown in Figure 32 [29]. The train was traveling at 3 mph (4.8 km/h) when it struck the auto-transport trailer, which resulted in minor damage to the truck and trailer, and no injuries were reported. A sign prohibiting trucks, buses, limousines, and recreational vehicles (RVs) was posted at the crossing, as shown in Figure 33, but the truck driver did not heed the warning.

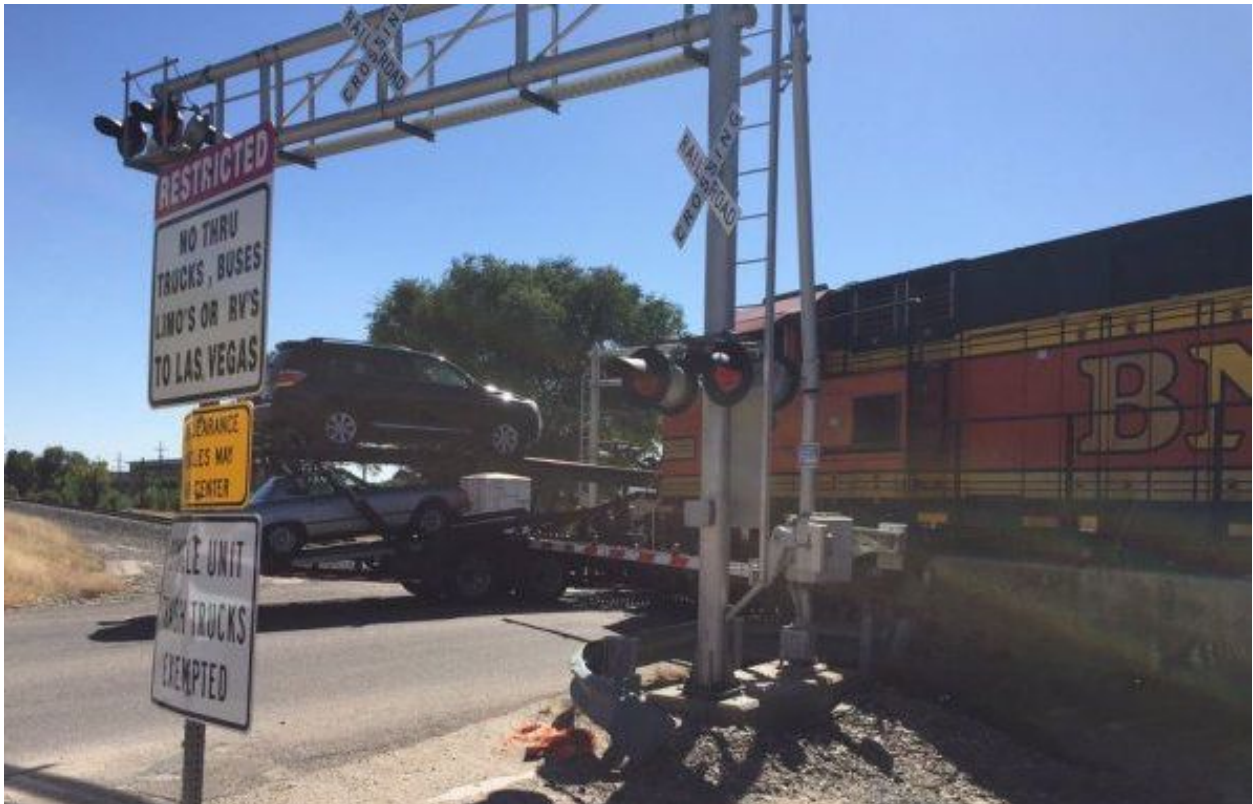
Figure 33. Sign Posted at Crossing Prohibiting Trucks, Buses, Limousines, and RVs [29]

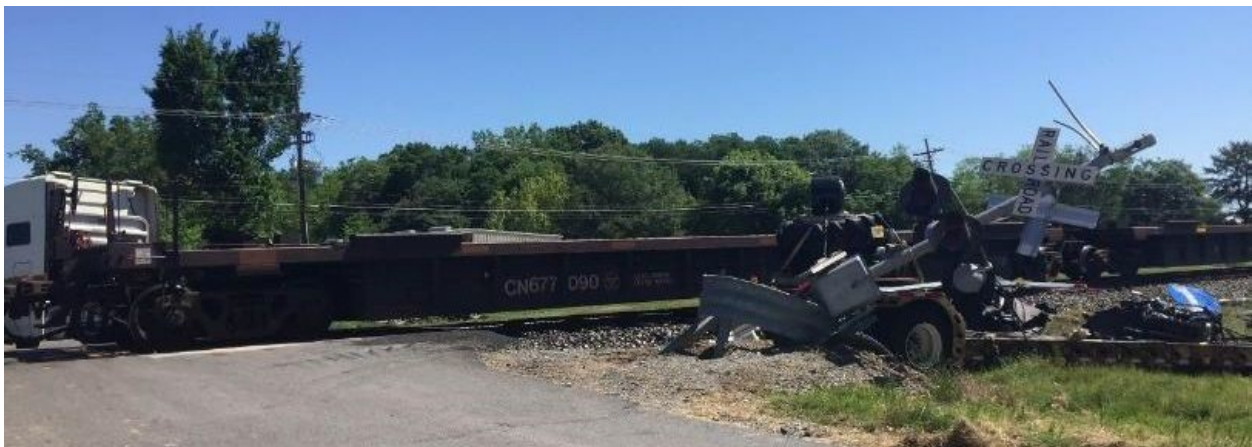
Figure 34. Tractor-Lowboy Combination after the Crash [31]

On May 5, 2016 near Rayville, Louisiana a truck equipped with a lowboy trailer was transporting a large farm tractor when it became high-centered on a railroad crossing [31]. The truck driver was not traveling his permitted route when he became lodged on the tracks, and a few minutes later the train collided with the trailer, causing damage to the trailer and farm tractor, as shown in Figure 34.

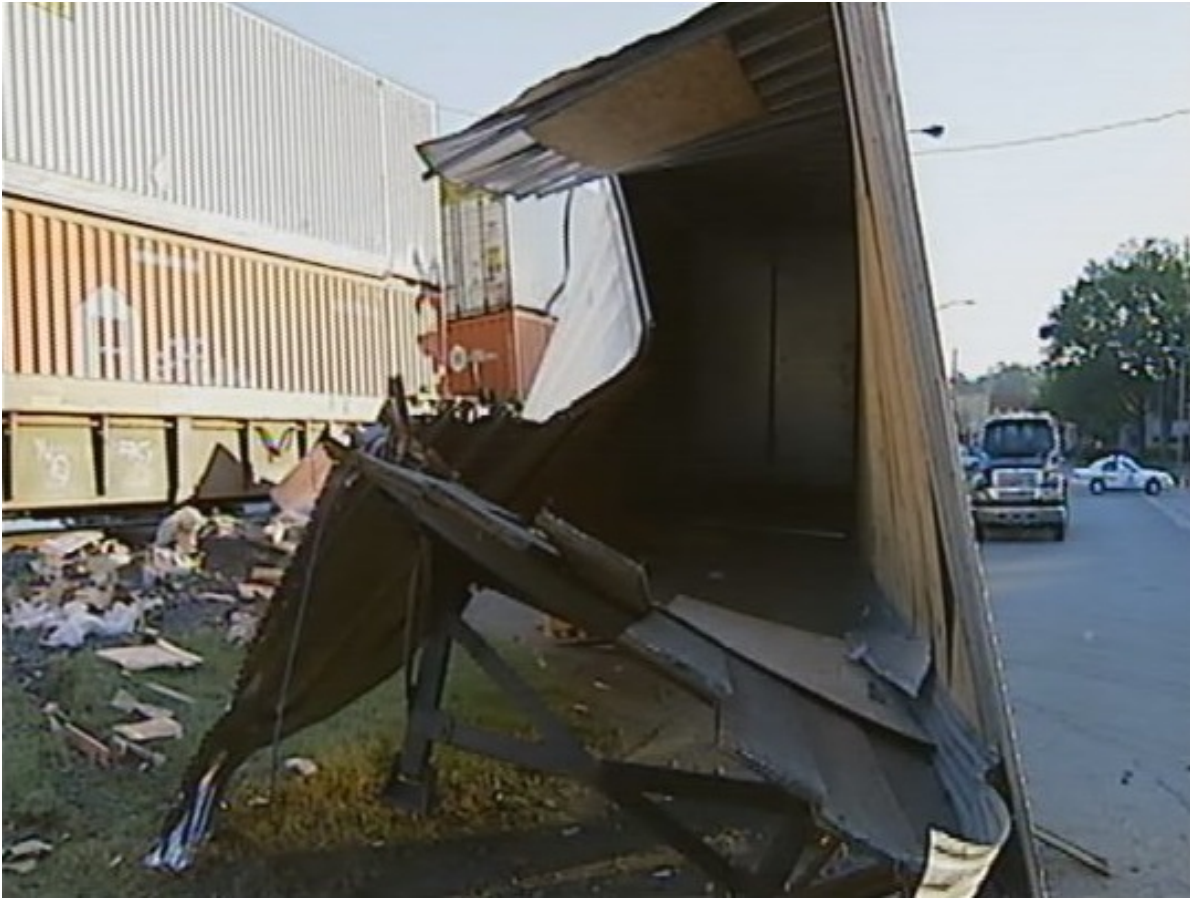
In Kings Mountain, North Carolina in November 2011, a train collided with a tractor-interstate trailer lodged on a railroad crossing, as shown in Figure 35 [32-33]. The crossing has “Low Ground Clearance” and “No Truck Crossing” signs posted, as shown in Figure 36, but the truck driver did not avert his course. The crash occurred at approximately 1:30 a.m. According to local police, seven large tractor-trailer combination vehicles had become lodged on this crossing during 2011 despite posted warning signs.

Figure 35. Interstate Semi-trailer after the Crash with the Train [32]

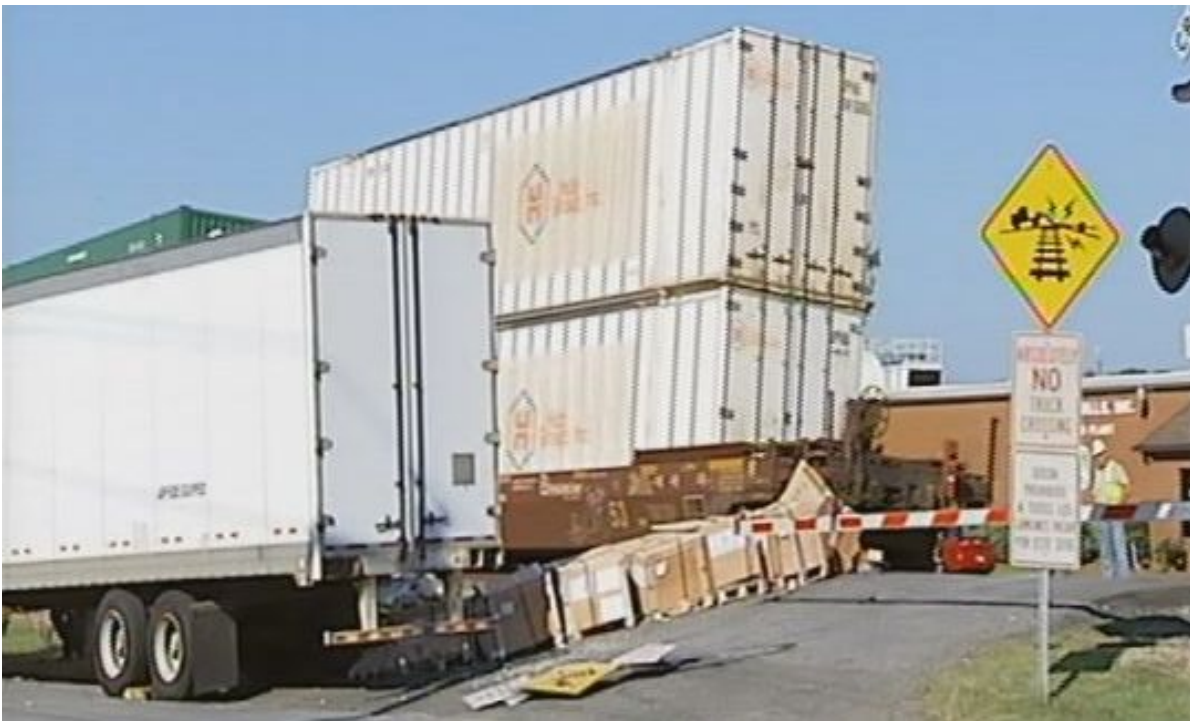
Figure 36. Low Ground Clearance Warning Sign Posted at Crossing [32]

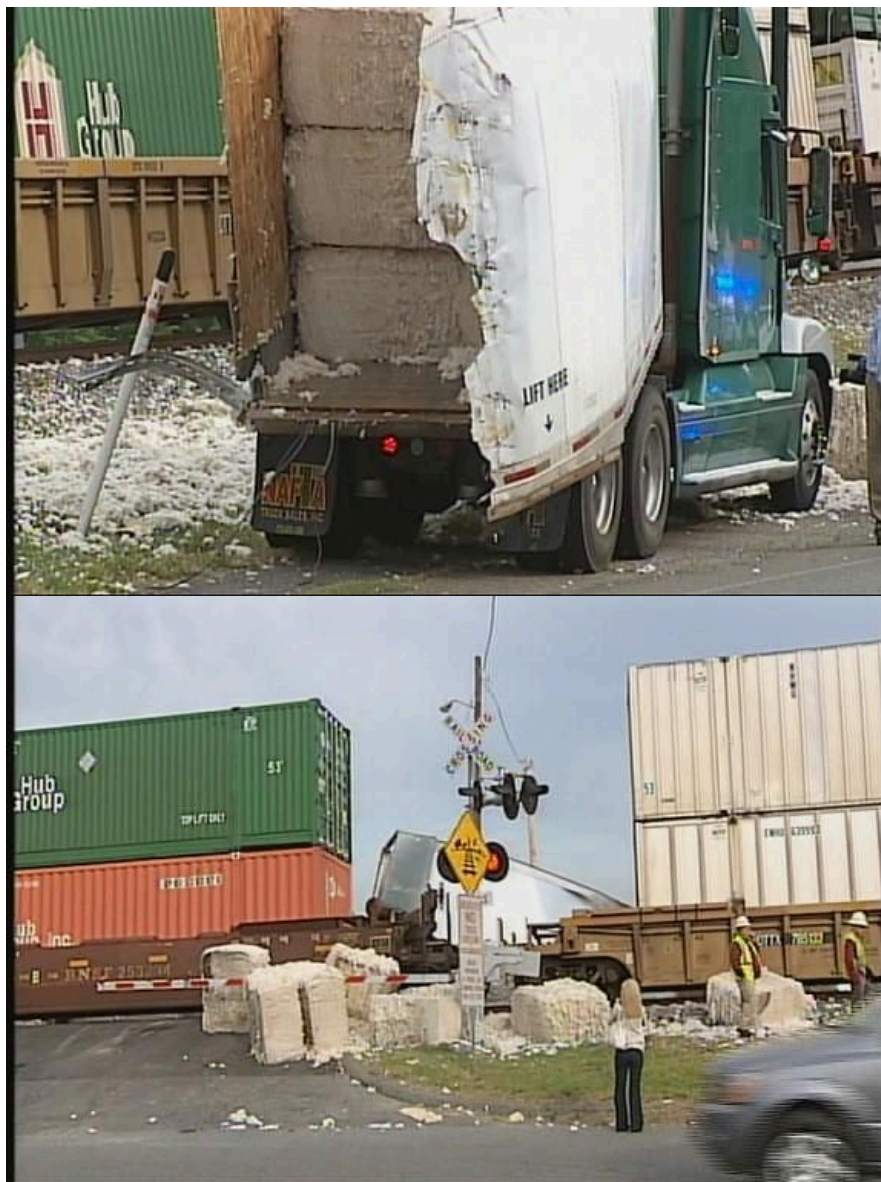
On May 4, 2012, a few months after the first crash, another tractor-trailer became high-centered at an adjacent grade crossing blocks away from the first [34-35]. The tractor-trailer was carrying bundles of cotton which were scattered after the collision with a train. The collision was documented on video using a phone, and the video was posted to YouTube [36]. It was the fifth stuck tractor-trailer to be impacted by a train at that location. Shortly after this crash, the grade crossing was closed while the city council and mayor's officials determined what to do with high-slope grade crossings.

Figure 37. Second Train Crash at Kings Mountain, North Carolina [35]

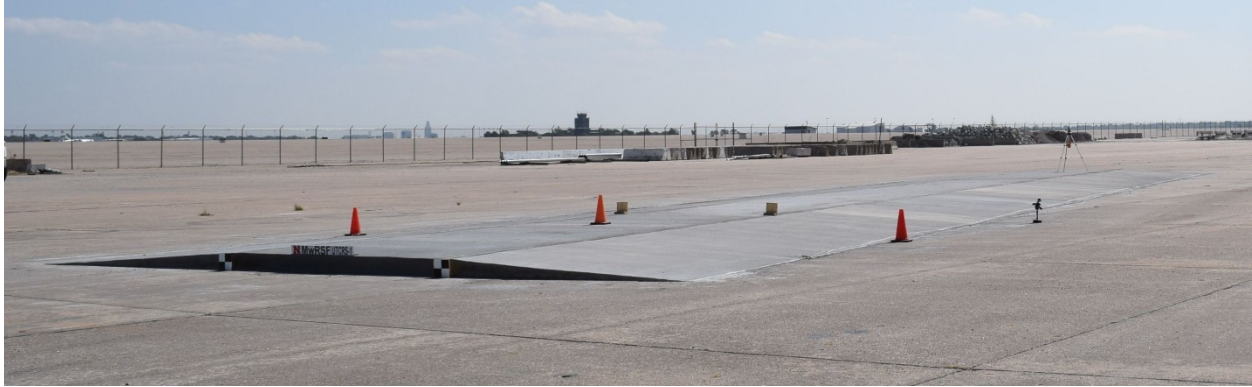
Ideally, instrumenting and evaluating trucks crossing real grade crossings is desirable. However, due to the difficulty and risk associated with traversing real grade crossings, researchers utilized a previously-constructed, tall speed table shape as a replica grade crossing geometry. A speed table resembles a railroad crossing, but with steeper and shorter approach slopes. The speed table used in test nos. UTCRS-1 through UTCRS-4 is shown in Figure 39 and the profile drawing is shown in Figure 40. The speed table was 30 ft (9.1 m) long and 8 in. (203 mm) tall at the highest point, with 10-ft (3.0-m) long approach and departure slopes with grades of 6.67 percent on each side.

Figure 39. Speed Table for Test Nos. UTCRS-1 through UTCRS-4

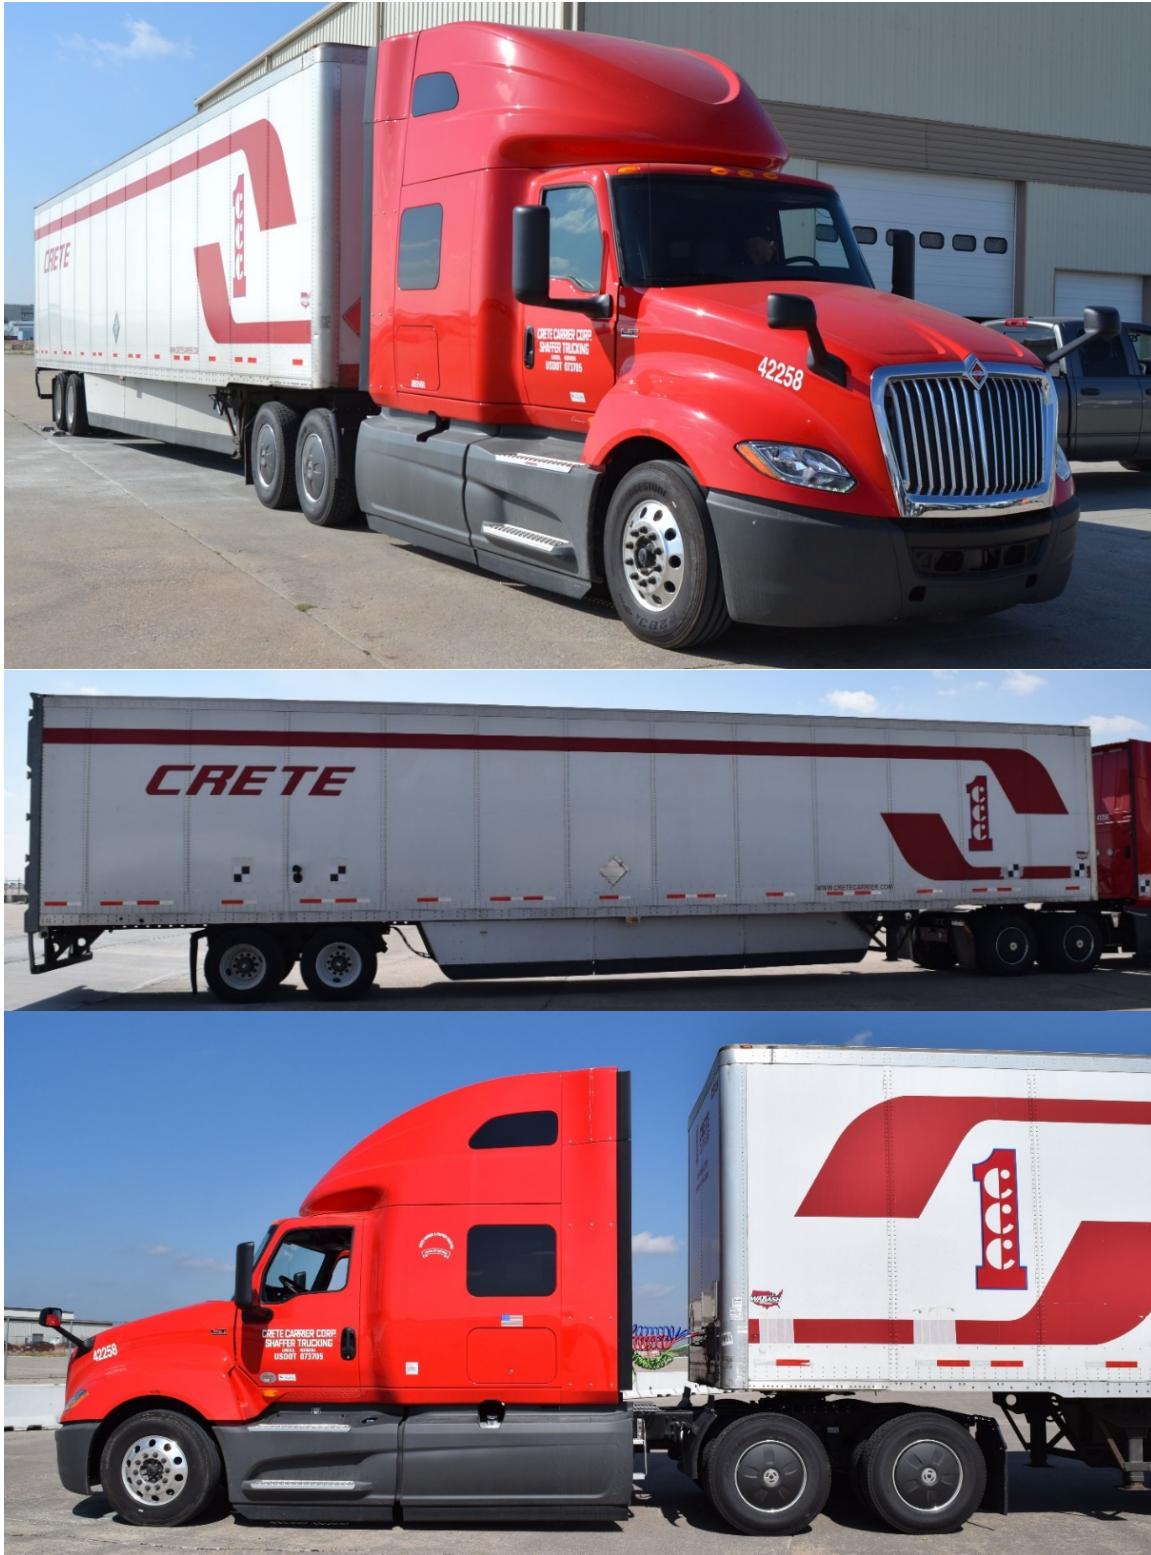
Figure 41. Crete Carrier Tractor-Trailer

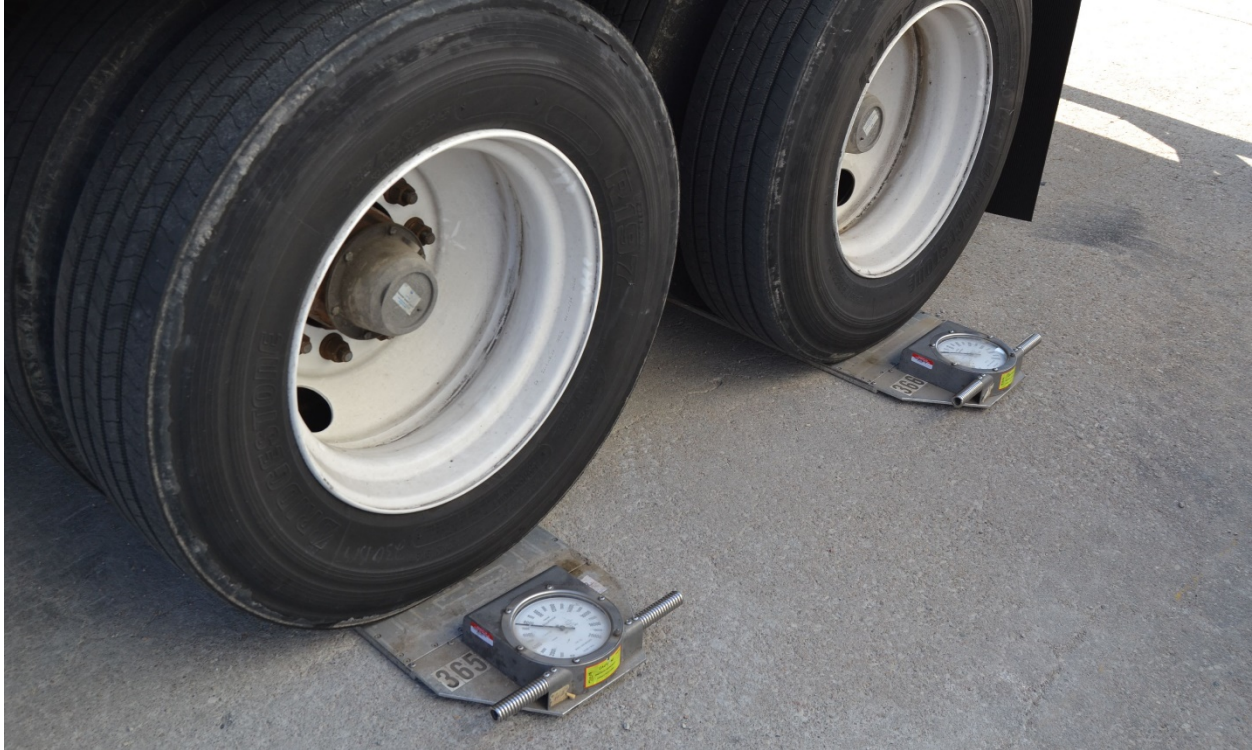
Figure 43. Portable Heavy Duty Truck Scales Weighing the Crete Carrier Tractor-Trailer

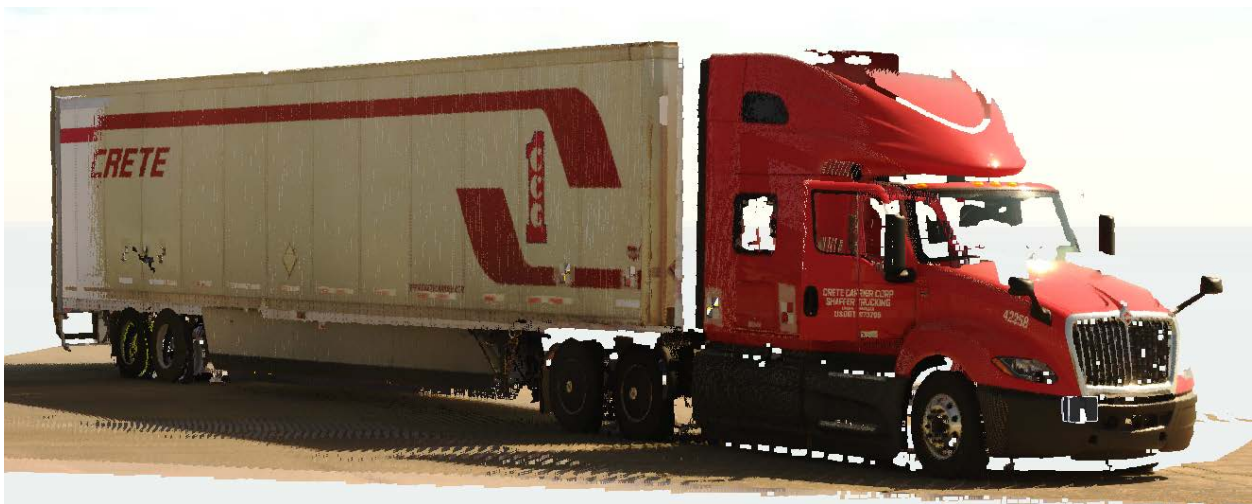
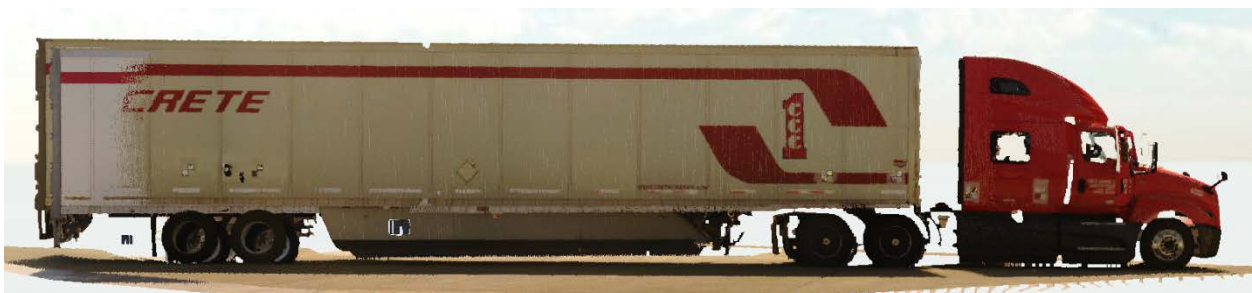
In addition to measuring and weighing the tractor-trailer, 3D scans of the test vehicle were taken using a Faro Focus X130 to produce highly-accurate vehicle geometries for post-test references. The scans were analyzed and registered using the Scene program and the results are shown in Figure 44. Square, black- and white-checkered targets were placed on the vehicle for

Figure 44. 3D Scan of the Crete Carrier Tractor-Trailer
