Heavy Truck and Bus Traversability at Highway-Rail Grade Crossings

HEAVY TRUCK AND BUS TRAVERSABILITY AT HIGHWAY-RAIL GRADE CROSSINGS

MwRSF Research Report No. TRP-03-392-18

June 29, 2018

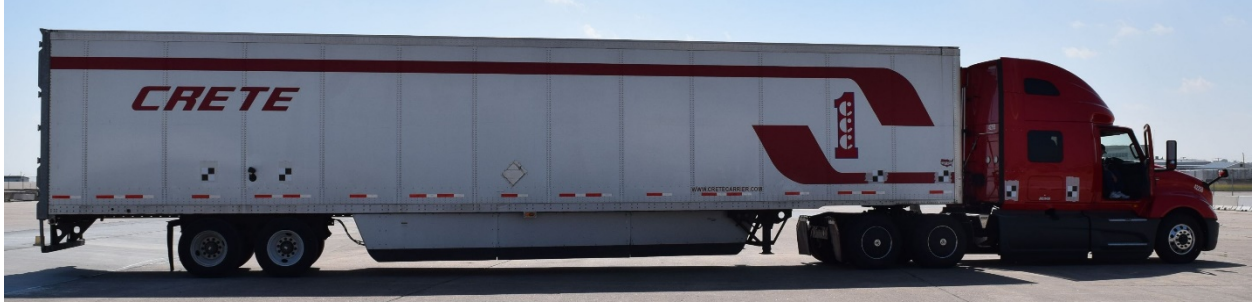
reference to be viewed from the high-speed digital video cameras and aid in the video analysis, as shown in Figure 45.

Figure 45. Crete Carrier Tractor-Trailer with Target Stickers

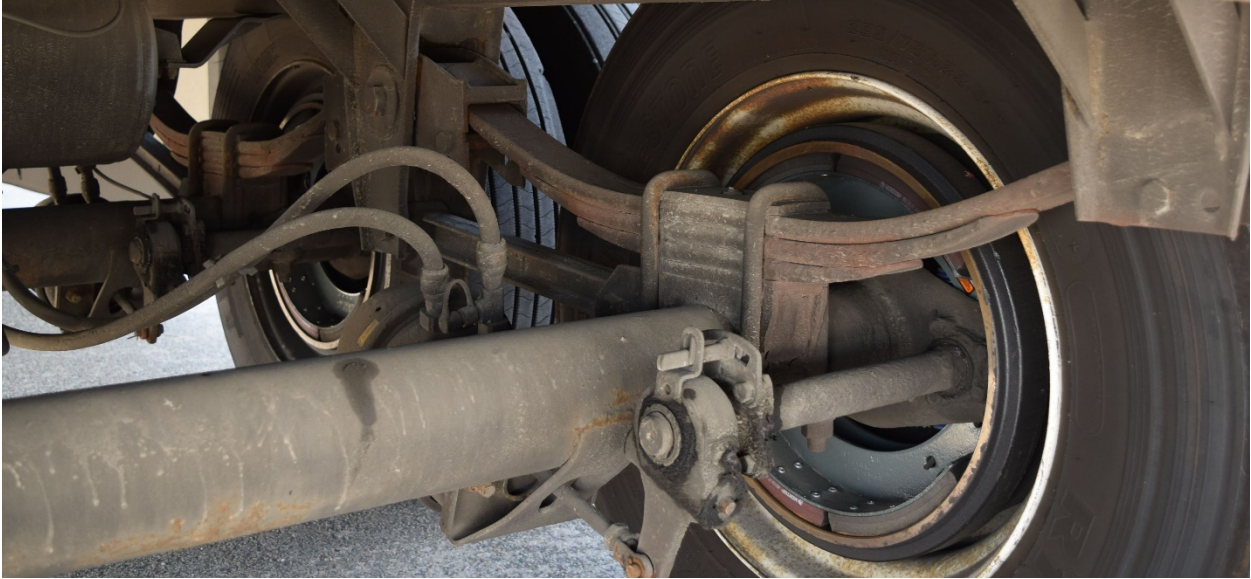
The tractor was equipped with air ride suspension, as shown in Figure 46. The trailer was equipped with leaf spring suspension. Measurements were taken of the right rear leaf spring, shown in Figure 47. The distance from eyelet to eyelet was $43\frac{3}{4}$ in. (1.1 m), distance E in Figure 48. The vertical distance between the eyelet and the bottom of the spring was 6 in. (152 mm). The thickness of each leaf was $\frac{3}{4}$ in. (19 mm), totaling $2\frac{1}{4}$ in. (57 mm), noted as distance D in Figure 48.

Figure 47. Leaf Springs on the Right Rear Wheel of the Crete Carrier Trailer

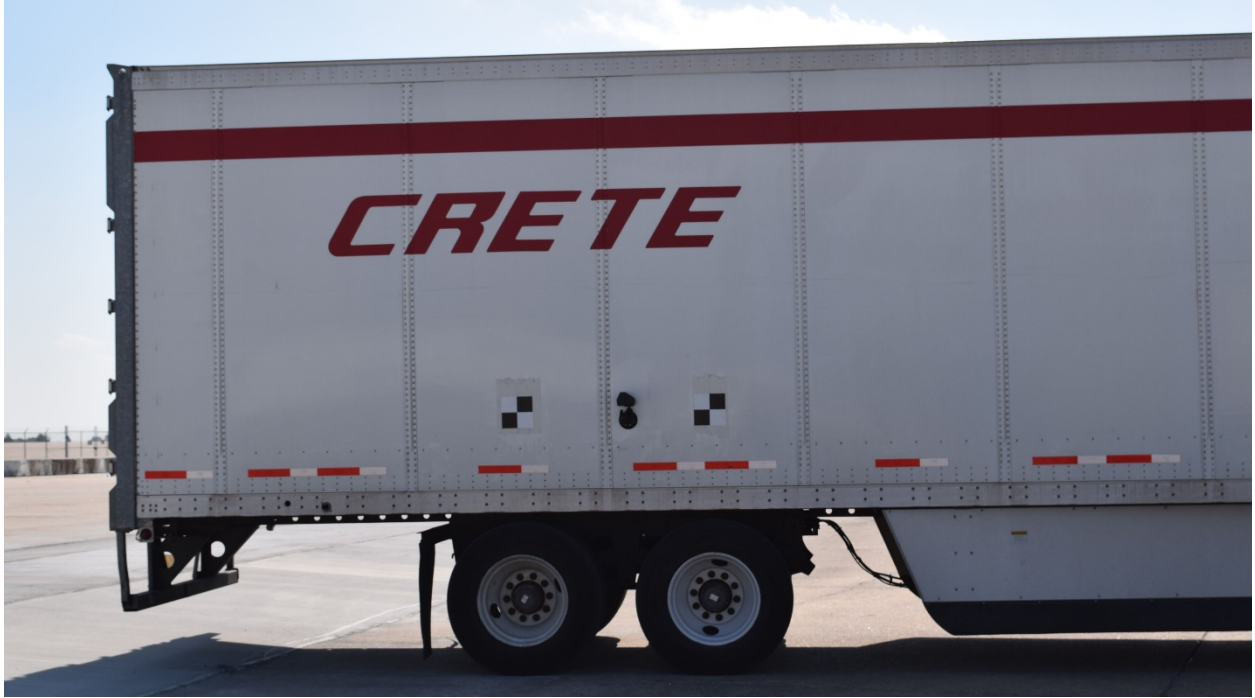
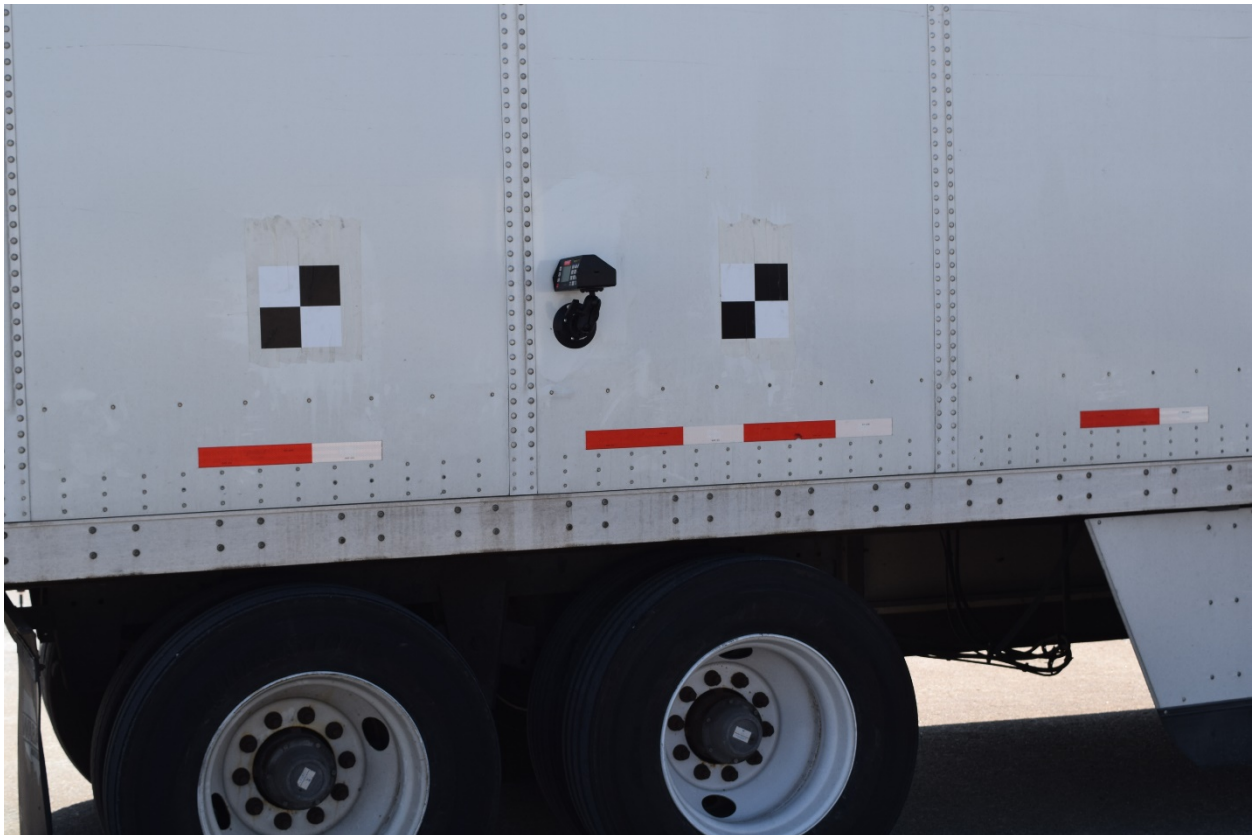
A VC4000 accelerometer was attached to the trailer, as shown in Figure 49. The accelerometer collected various data: acceleration in the x, y, and z directions, compass degrees, GPS speed, GPS distance, GPS latitude and longitude in degrees, pitch rate, and yaw rate. The collected acceleration data was filtered using a CFC-180 filter. A customized Microsoft Excel worksheet was used to analyze and plot the accelerometer data. Plots of longitudinal, lateral, and vertical change in displacement, change in velocity, and acceleration are shown in Appendix C.

Figure 49. VC4000 Accelerometer Mounted on Trailer

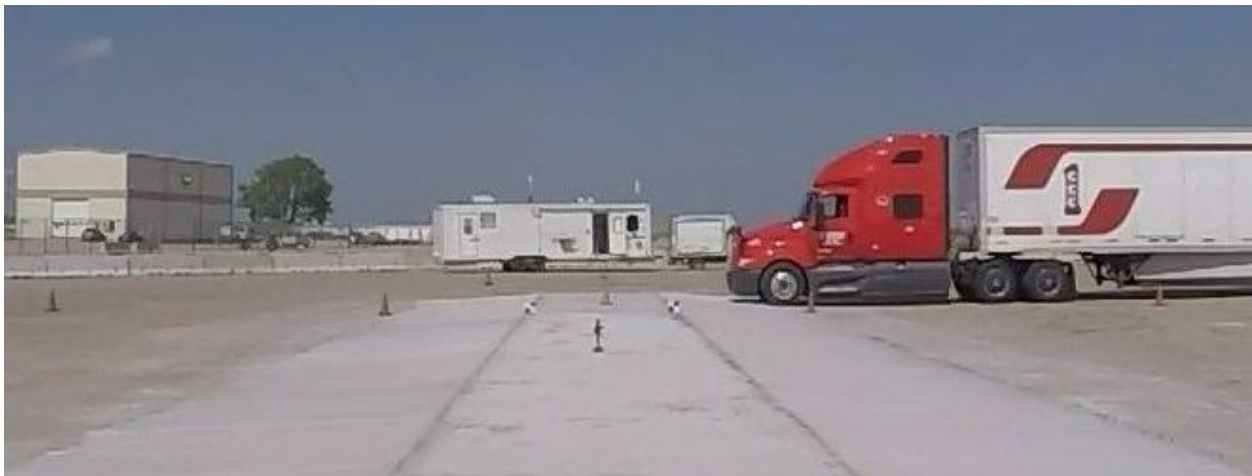
The beginning of each test, or time 0 for each test, was when the tractor front tires contacted the speed table, shown in Figure 51. Each test ended when the trailer rear tires contacted the ground, or when the trailer rear tires lost contact with the speed table, shown in Figure 52.

Figure 51. Beginning of Test for Test Nos. UTCRS-1 through UTCRS-4

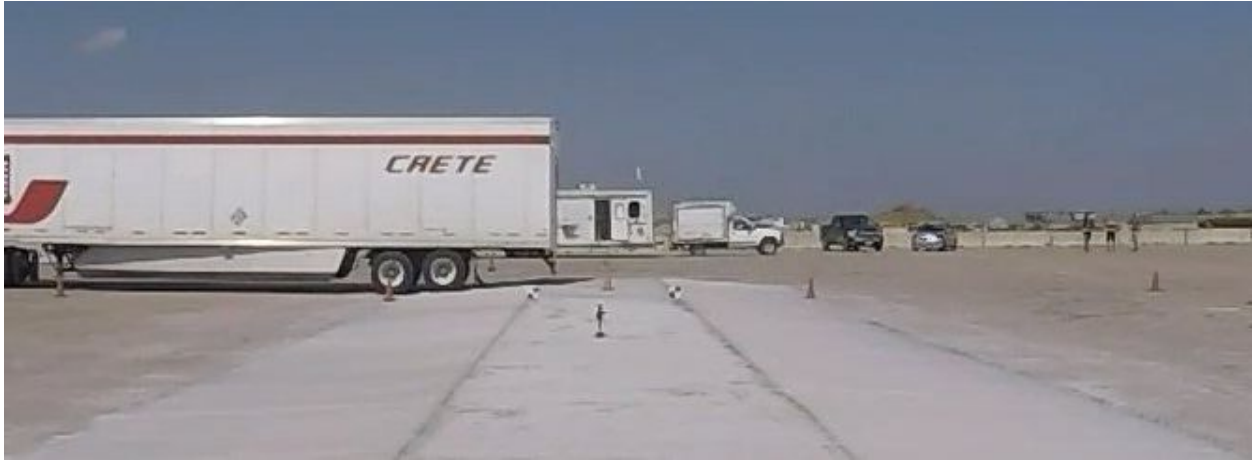
Figure 52. End of Test for Test Nos. UTCRS-1 through UTCRS-4

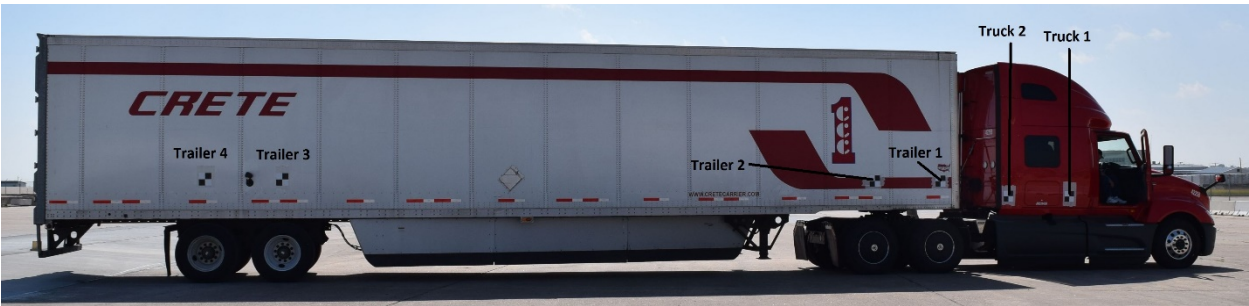
Figure 56. Target Names for Test Nos. UTCRS-1 through UTCRS-4

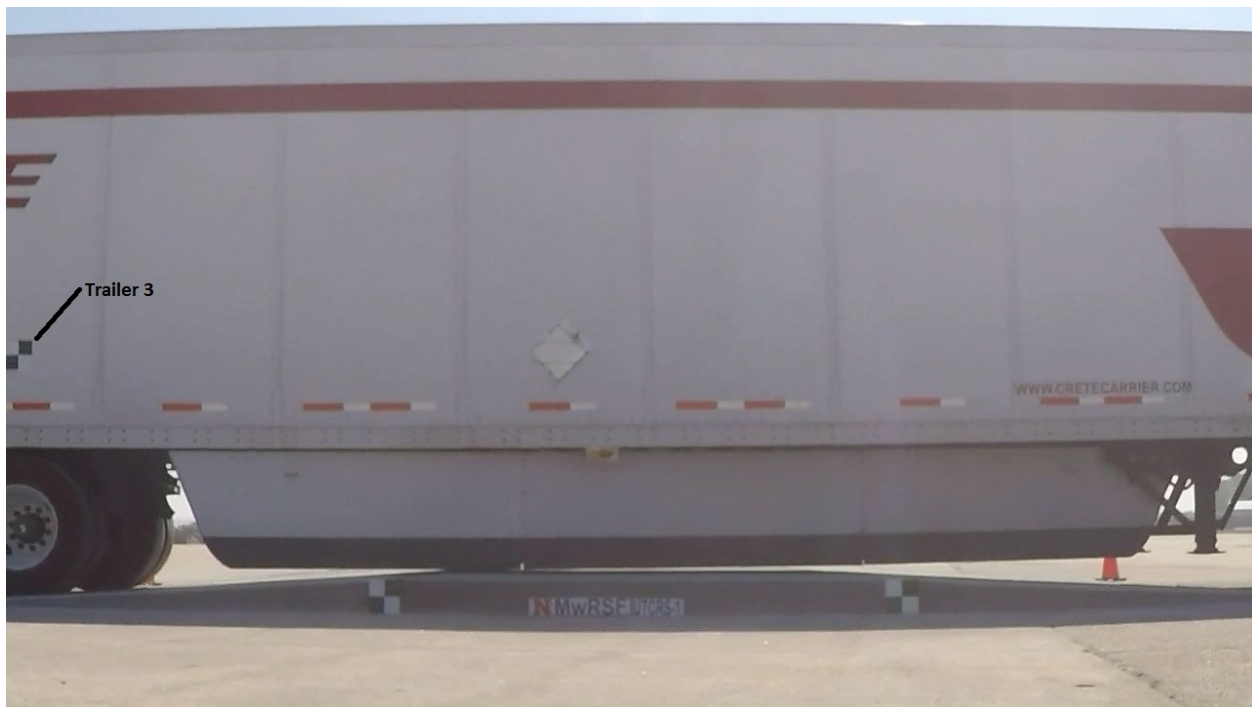
The vertical displacement from video analysis was calculated by subtracting the original target height at the beginning of the video from the height at subsequent times. Because the video view is only as wide as the speed table, the first trailer target height is slightly elevated, as the vehicle has already begun its ascent of the speed table, as shown in Figure 57. Due to the narrow view, the calculated vertical displacement of the trailer targets may be slightly lower than the actual vertical displacement.

Figure 57. Video Analysis with Target First Position Slightly Elevated

A total of six videos were recorded for each test. Only two cameras were placed on the side of the trailer which had the targets, the view shown in Figure 57 and one wider view. The camera capturing the wider view was not perpendicular to the truck and was far enough away from the truck that video analysis was not able to accurately track all the targets throughout the entire test. Therefore, the view shown in Figure 57 was used to determine vertical displacement of the trailer.

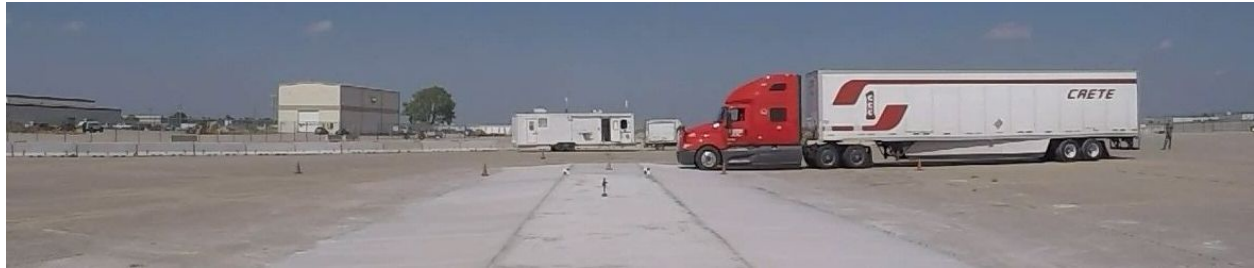
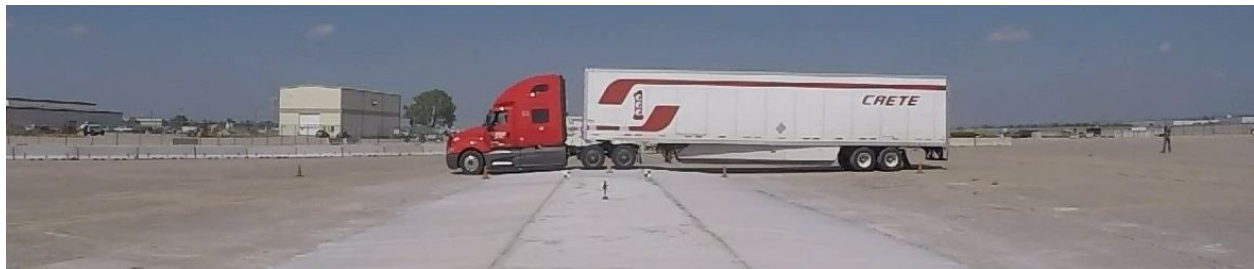
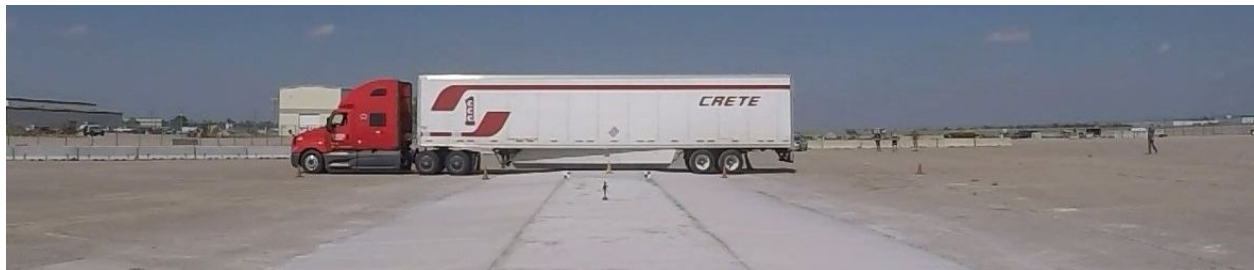
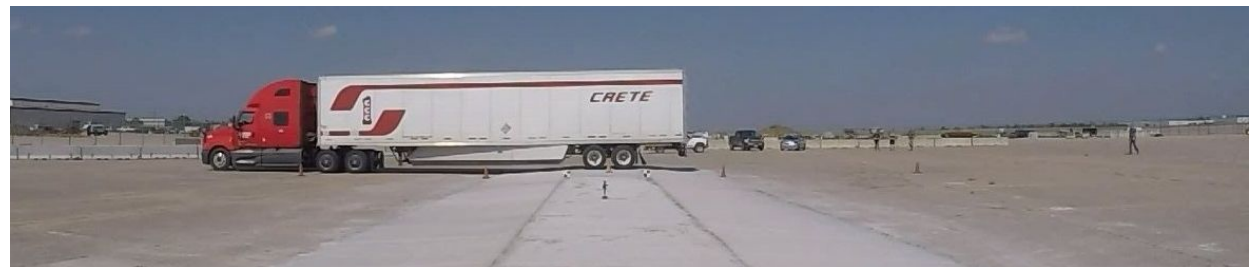
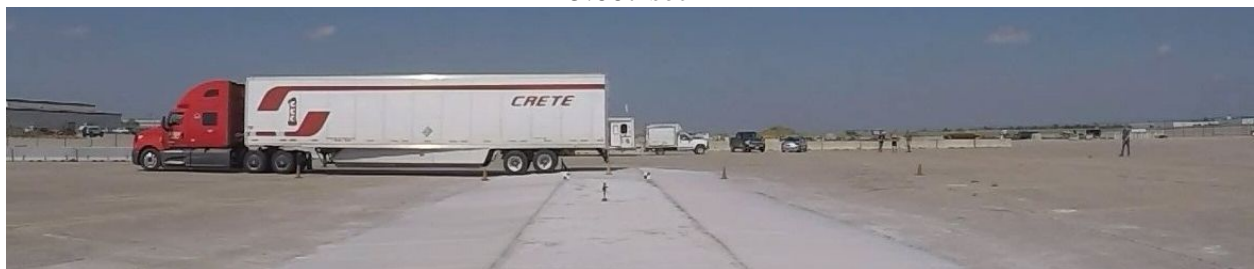
Figure 58. Sequential Photographs, Test No. UTCRS-1

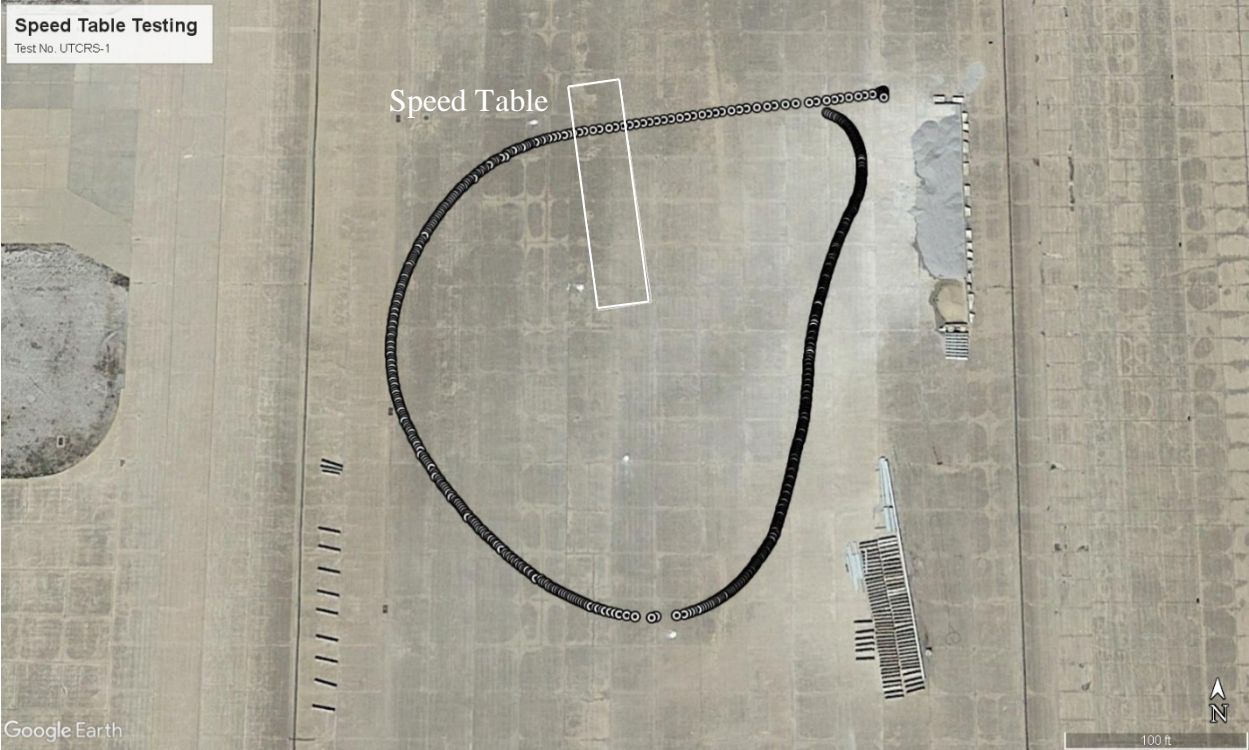
Figure 59. GPS Data Overlaid on Google Earth Image of the Test Site, Test No. UTCRS-1

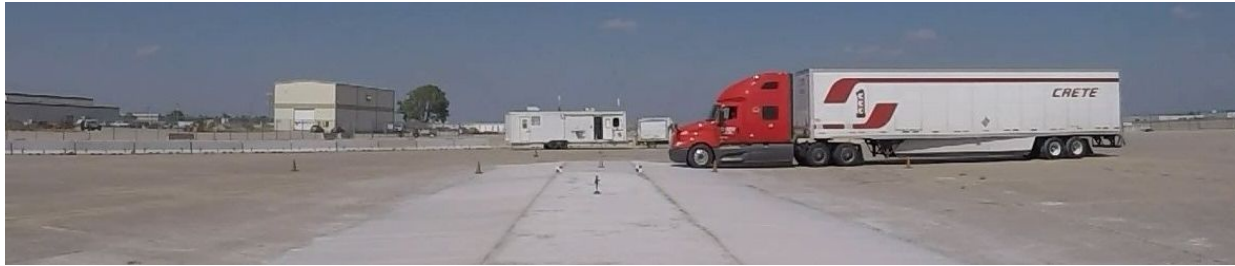
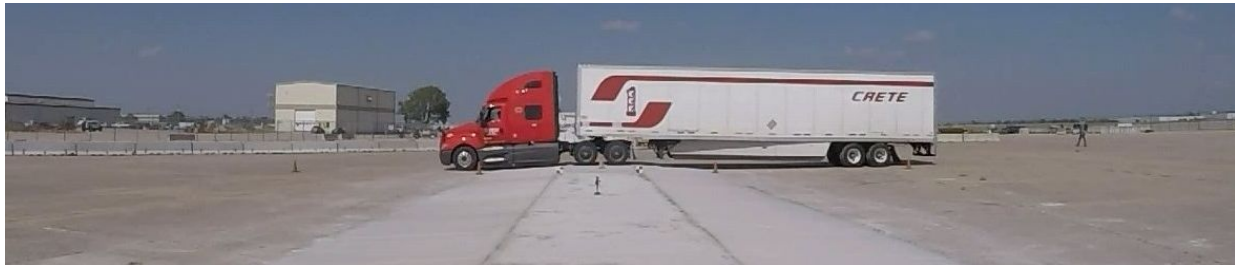
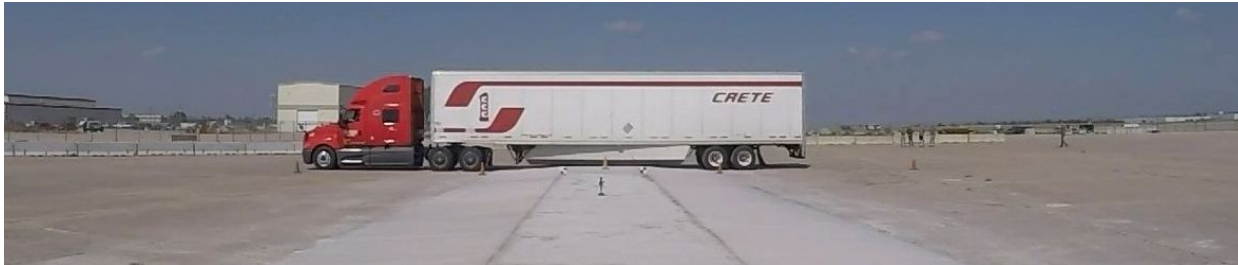
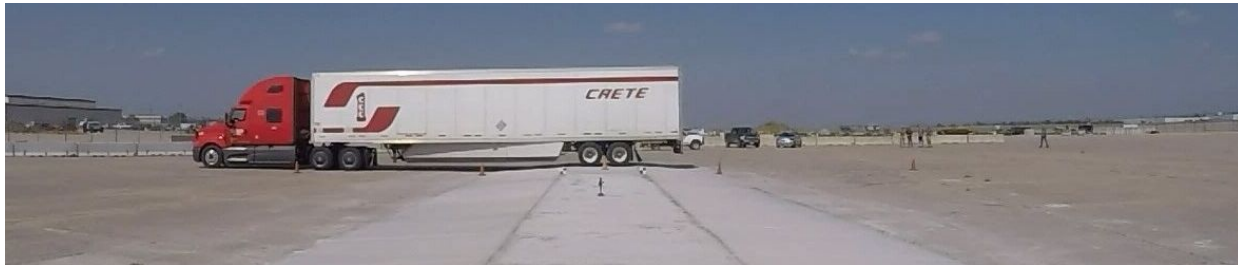
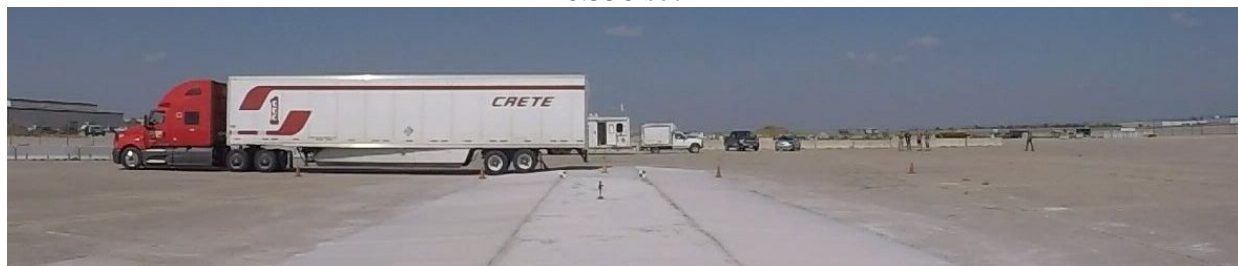
The tractor-trailer traversed the speed table at an average speed of 7.7 mph (12.4 km/h). A sequential description of the impact events is contained in Table 6 and sequential photographs are shown in Figure 61.

Figure 61. Sequential Photographs, Test No. UTCRS-2

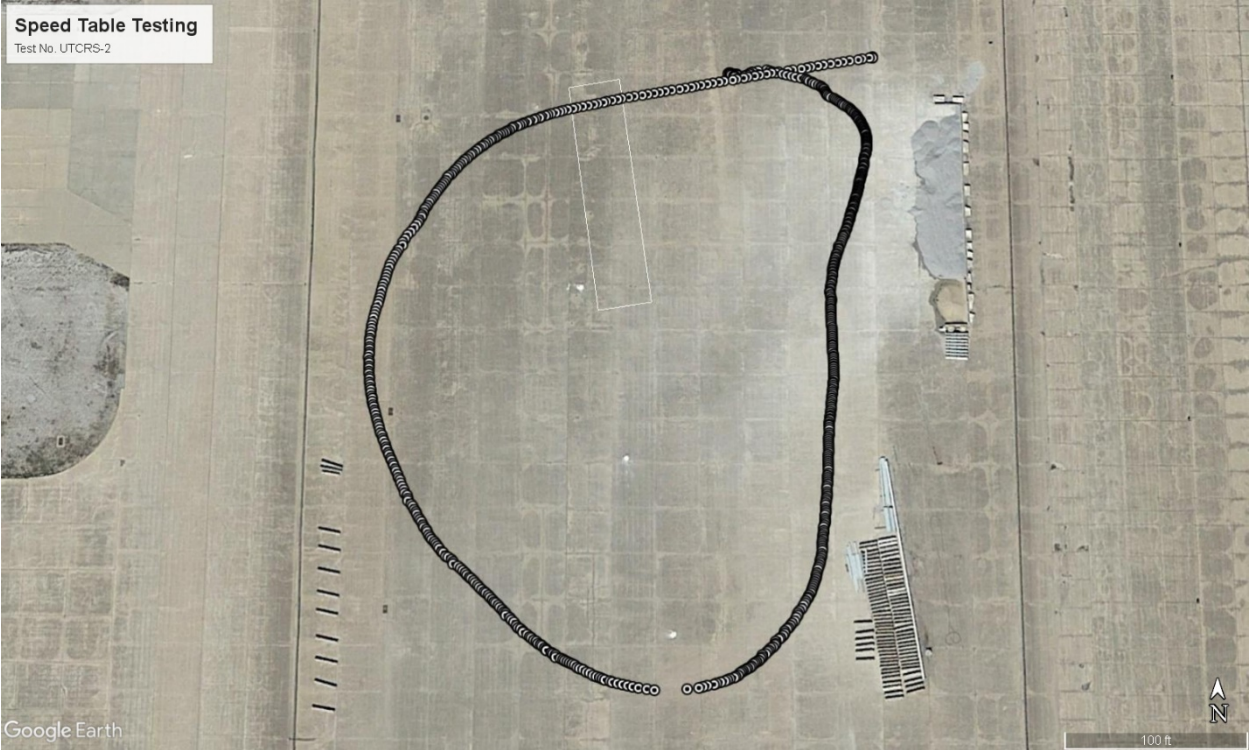
GPS longitude and latitude data was collected with the VC4000 and input into Google Earth. The position points were overlaid on a map of the test site to illustrate the vehicle trajectory, shown in Figure 62, in addition to an outline of the speed table's approximate location.

Figure 62. GPS Data Overlaid on Google Earth Image of the Test Site, Test No. UTCRS-2

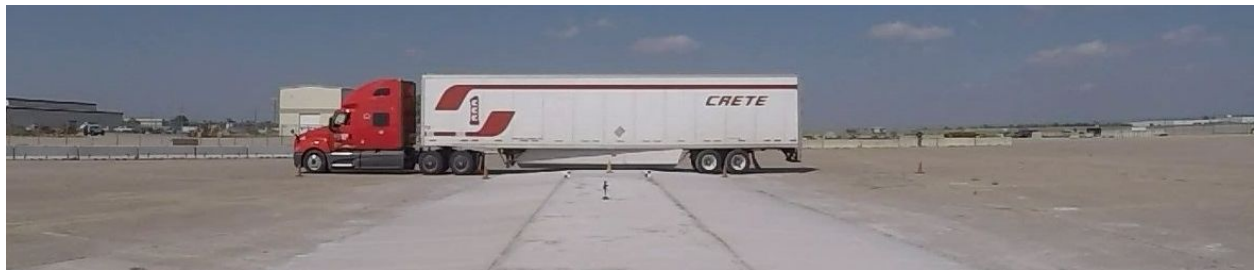
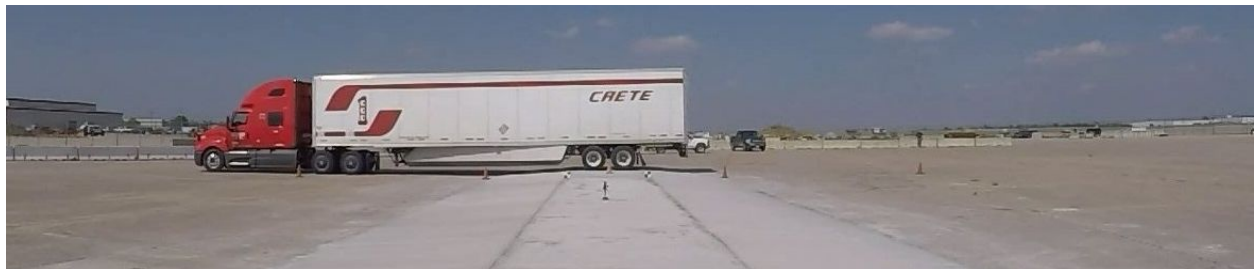
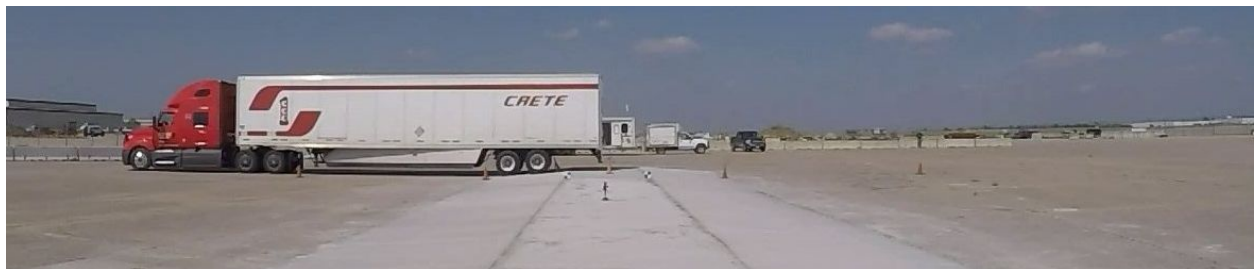
Figure 64. Sequential Photographs, Test No. UTCRS-3

The tractor-trailer traversed the speed table at an average speed of 11.7 mph (18.8 km/h). A sequential description of the impact events is contained in Table 7 and sequential photographs are shown in Figure 64.

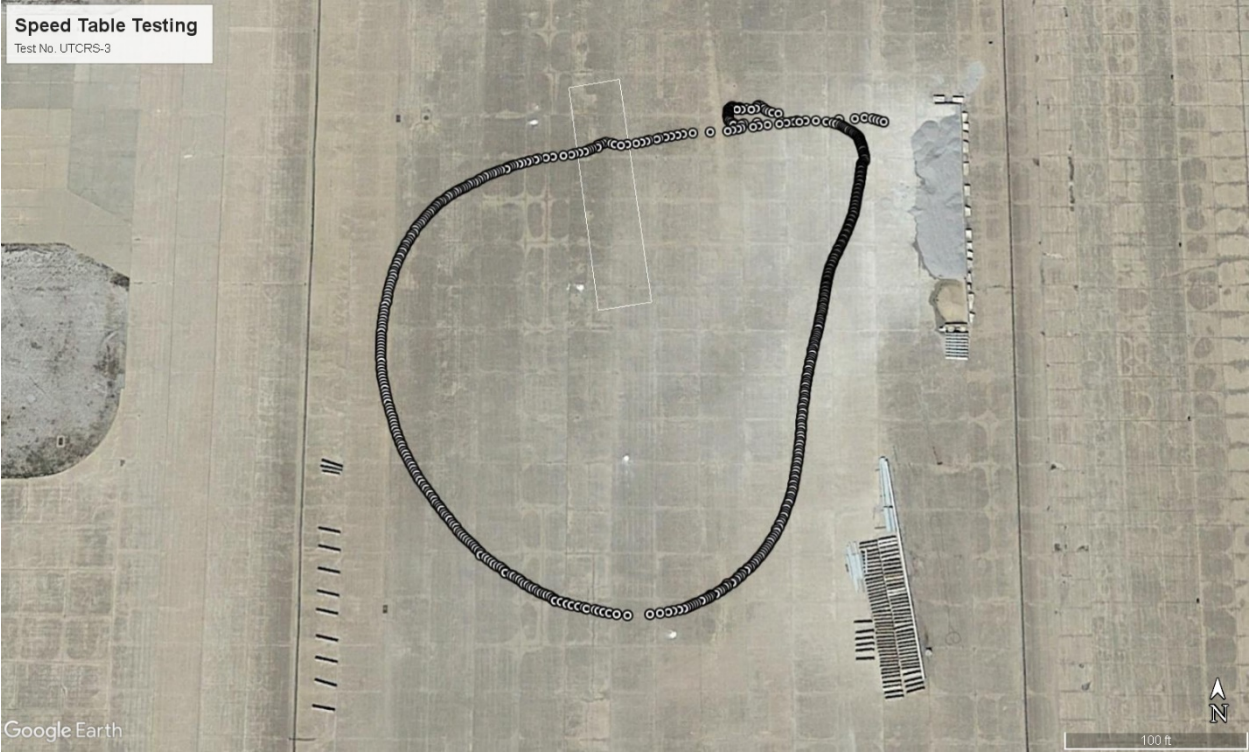
Figure 65. GPS Data Overlaid on Google Earth Image of the Test Site, Test No. UTCRS-3

GPS longitude and latitude data was collected with the VC4000 and input into Google Earth. The position points were overlaid on a map of the test site to illustrate the vehicle trajectory, shown in Figure 65, in addition to an outline of the speed table's approximate location.

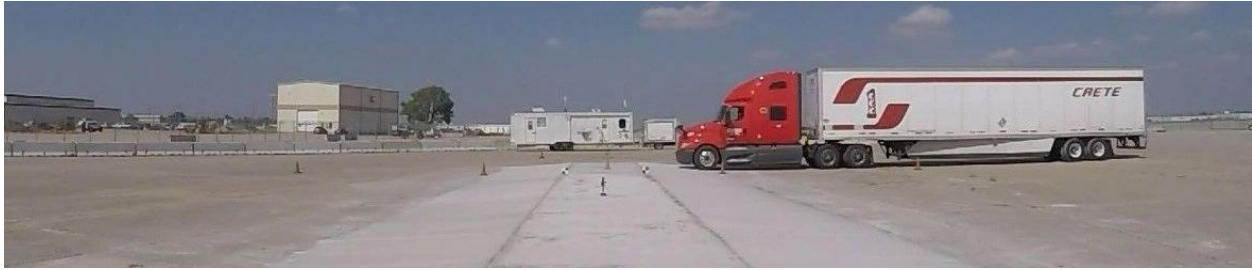
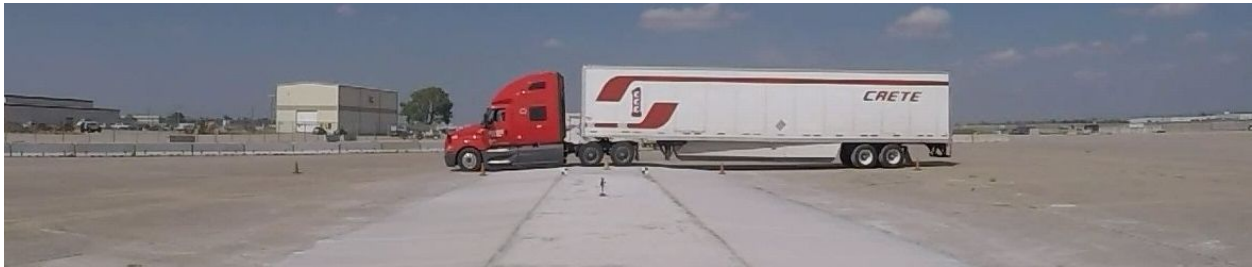
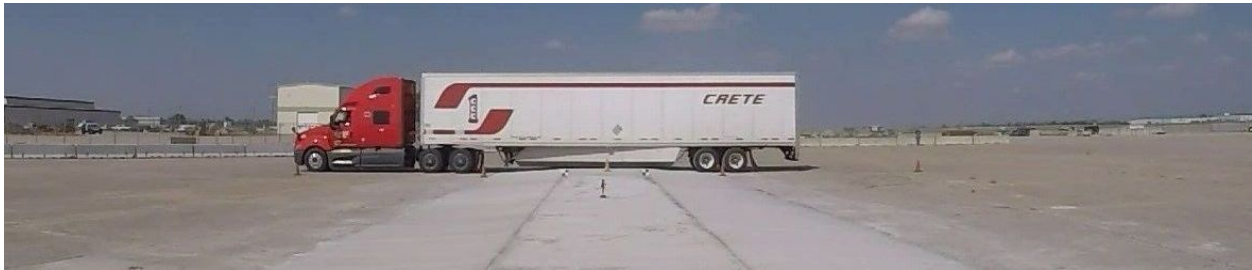
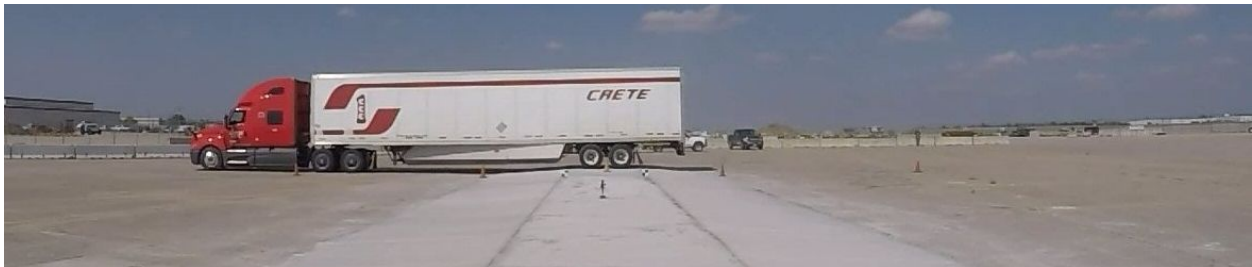
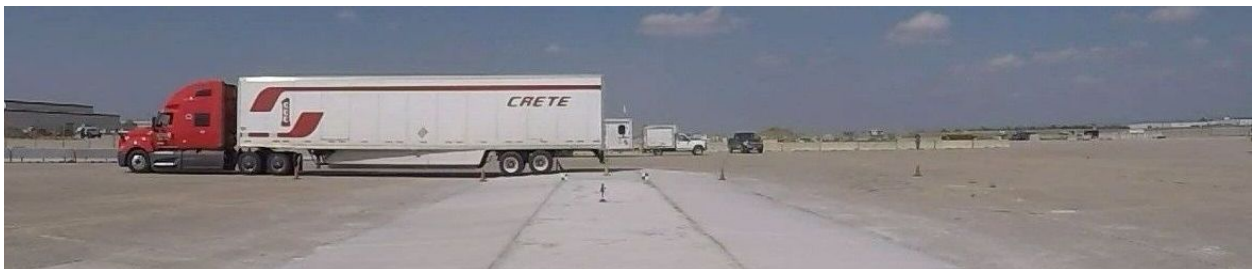
Figure 67. Sequential Photographs, Test No. UTCRS-4

The tractor-trailer traversed the speed table at an average speed of 12.8 mph (20.5 km/h). A sequential description of the impact events is contained in Table 8 and sequential photographs are shown in Figure 67.

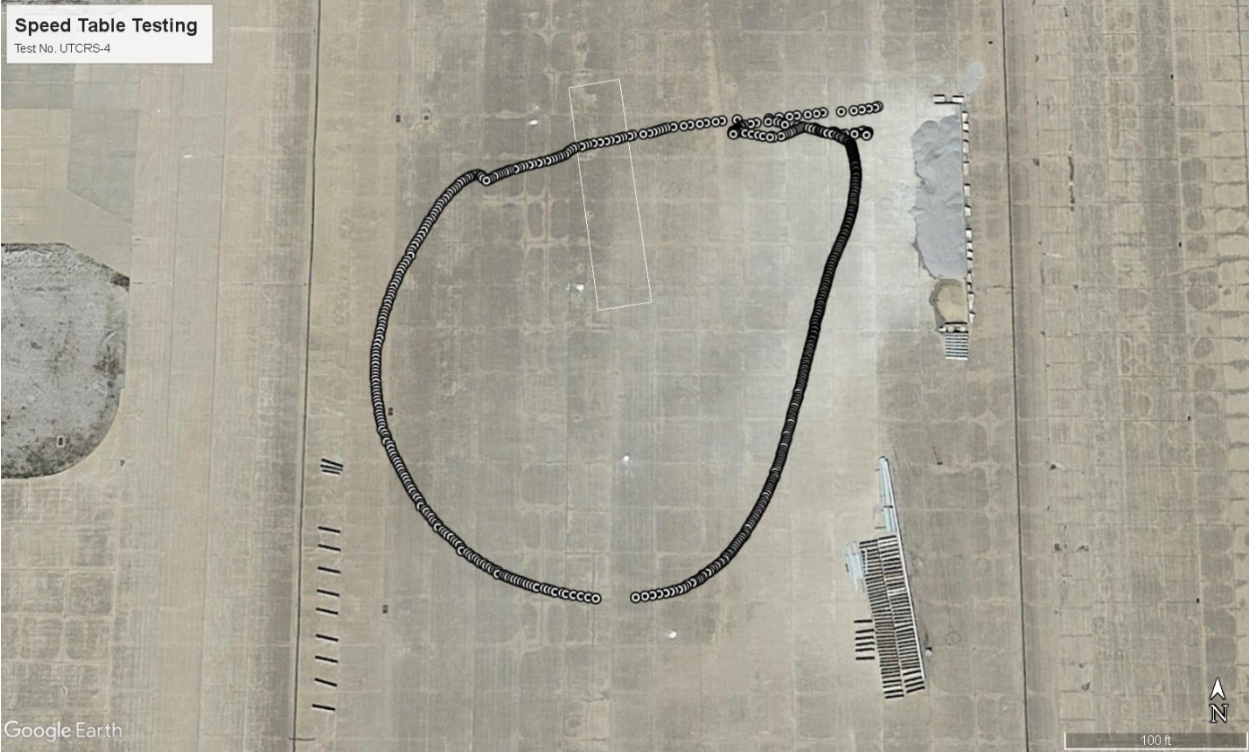
Figure 68. GPS Data Overlaid on Google Earth Image of the Test Site, Test No. UTCRS-4

GPS longitude and latitude data was collected with the VC4000 and input into Google Earth. The position points were overlaid on a map of the test site to illustrate the vehicle trajectory, shown in Figure 68, in addition to an outline of the speed table's approximate location.

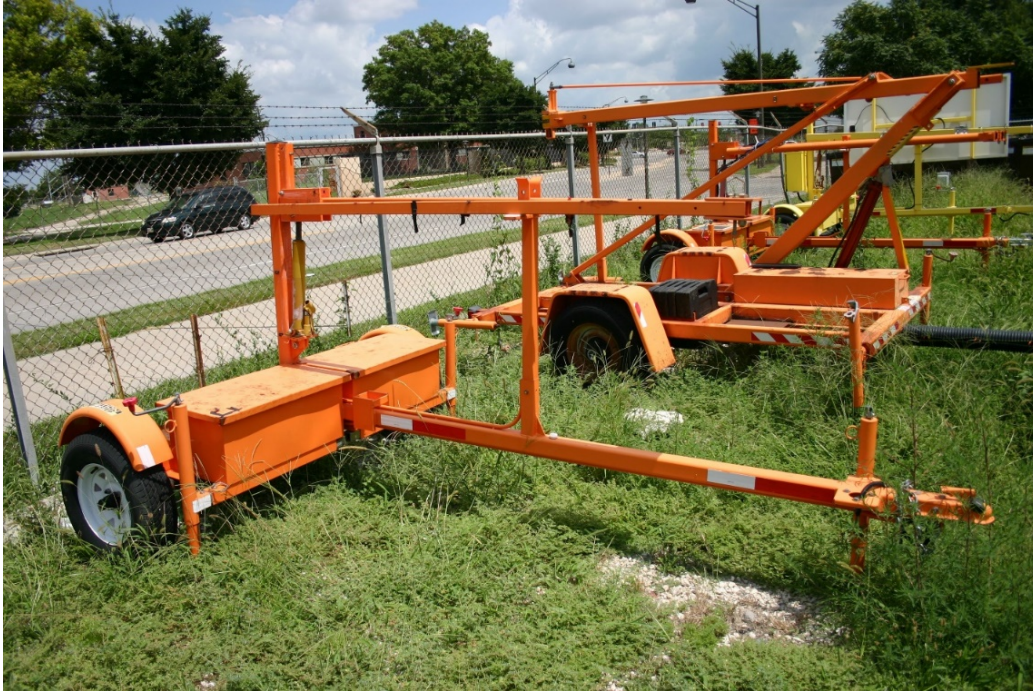
Figure 87. NTC Trailer with Extendable Pole

The Nebraska Transportation Center (NTC) provided MwRSF with a trailer that had an extendable pole attachment for scanning the crossings, as shown in Figure 87. The pole extends 15 ft (4.6 m) in the air. A mounting device for the Faro Focus X130 scanner was manufactured by MwRSF. The mount attaches to the top of the pole and allows the Faro scanner to be mounted upside down. The inverted attachment was necessary because the scanner has a blind zone extending conically around its mounting position. Thus, inverting the scanner allows ground data to be collected and places the blind zone above the scanner, toward the sky. Furthermore, mounting the scanner 15 ft (4.6 m) in the air allows the scanner to collect data over a larger area. The trailer, with the extendable pole raised and the scanner mounted, is shown in Figure 88.

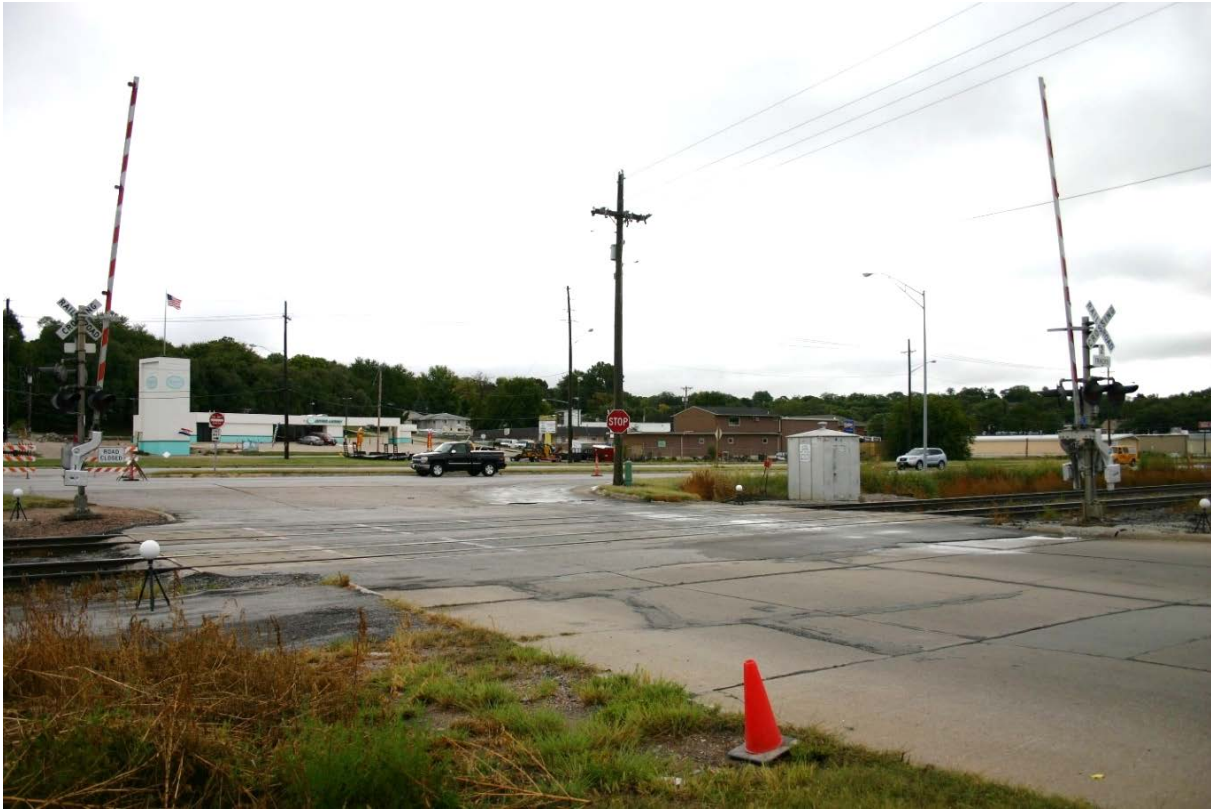
Figure 90. Crossing 817404F

Crossing 817404F, located on Kasper Street, was the first crossing scanned on September 26, 2017 and is shown in Figures 90 through 92. This crossing appeared flat and did not have any scrape marks on the asphalt. While scanning the crossing, a semi-truck and trailer traversed the crossing. The truck stopped at the stop sign before turning onto Fort Crook Road, and while stopped the trailer was parked over the railroad tracks. This problem of inadequate space for trucks at crossings is not the focus of this research, but is an important issue.

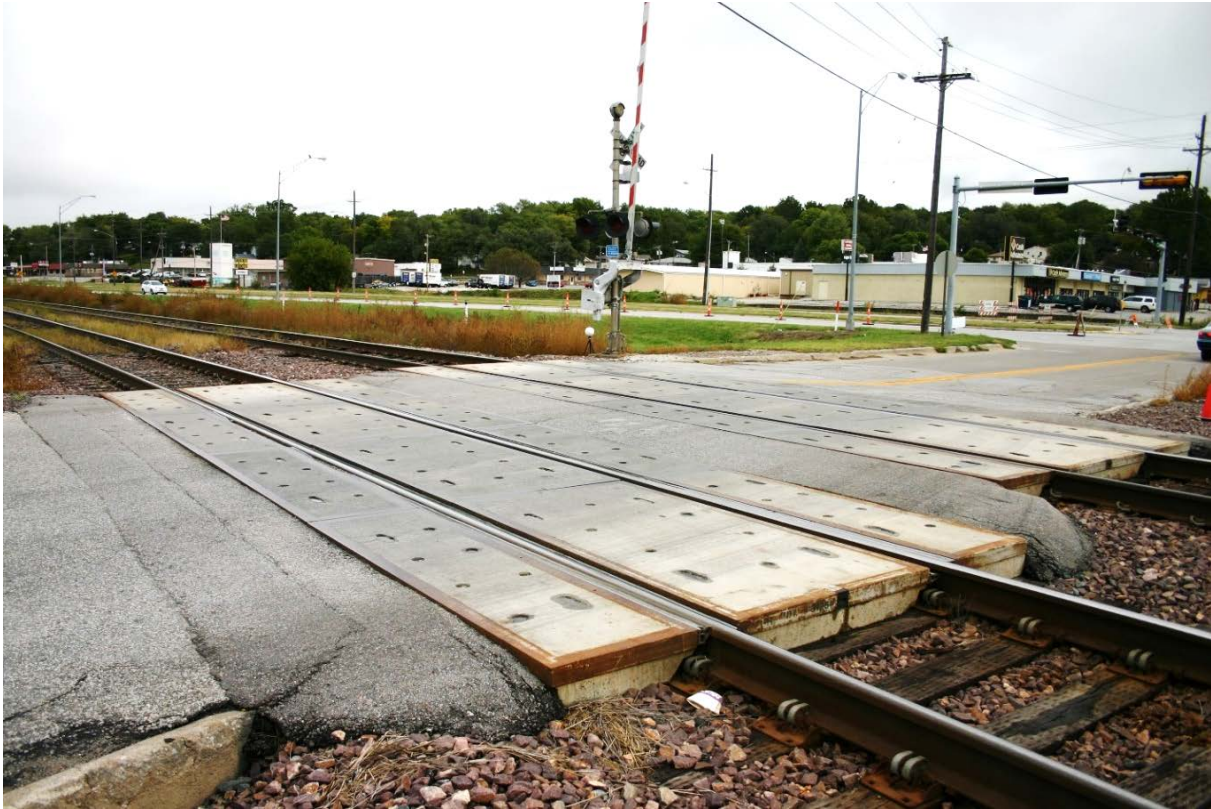
Figure 93. Crossing 817405M

Crossing 817405M, located on Avery Road, was the second crossing scanned and is shown in Figure 93. This crossing appeared somewhat steep and scrape marks are visible on the east approach, as shown in Figures 94 and 95. On the west approach, the crossing panels and roadway are not level, as shown in Figures 96 and 97.

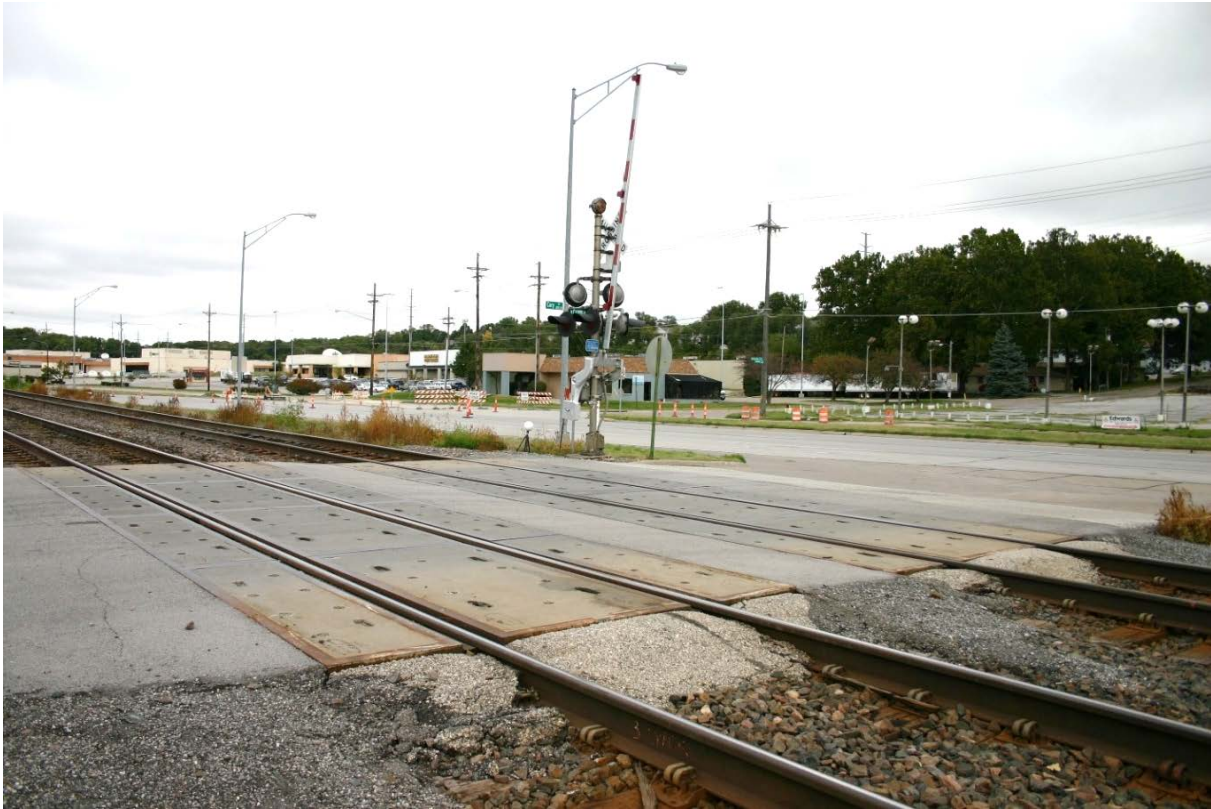
Figure 98. Crossing 816134F

Crossing 816134F, located on Cary Street, was the last crossing scanned and is shown in Figure 98. This crossing is steep and scrape marks are visible on both approaches, shown in Figures 99 through 102. While scanning the crossing, an auto transport trailer traversed the crossing. Though scraping could not be heard as the trailer crossed the tracks, the bottom of the trailer was observed to have minimal clearance to the roadway asphalt. Researchers did not anticipate the crossing of the auto transport and did not collect photographs in transit.

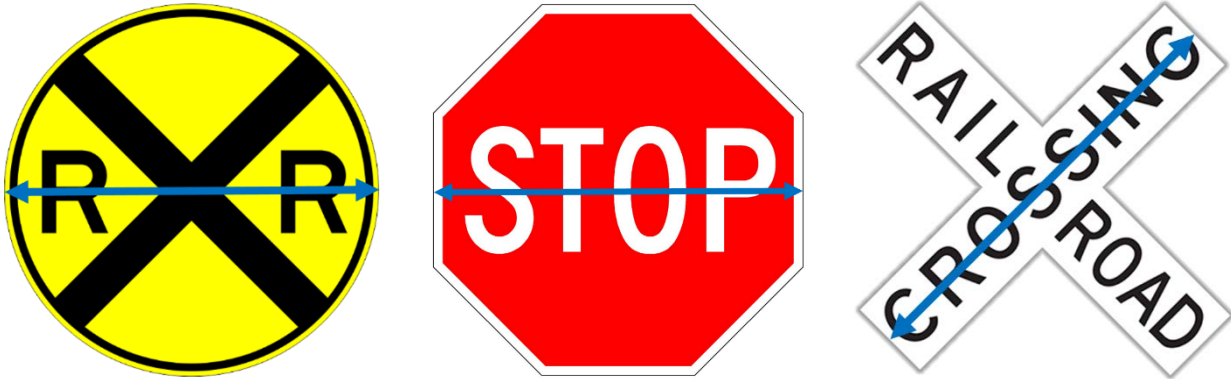
The accuracy of the 3D scans was determined by comparing known dimensions to dimensions measured in the three scans. Three measurements were taken from the 816134F crossing scan: the diameter of the grade crossing advance warning sign (W10-1), the width of the stop sign (R1-1), and the length of the crossbuck sign (R15-1), shown in Figure 103. In addition, the diameter of the W10-1 sign was measured in both the 817404F and 817405M crossing scans.

Figure 103. Measured Dimensions on W10-1 (left), R1-1 (middle), and R15-1 (right) Signs

Measured dimensions, actual dimensions [9], and percent errors for the three scans are shown in Table 9. The percent errors between the actual and the measured distances were small, with a maximum error of 3.6 percent. Therefore, the scans represent to-scale models of the three crossings and measurements taken from them were believed to be accurate.

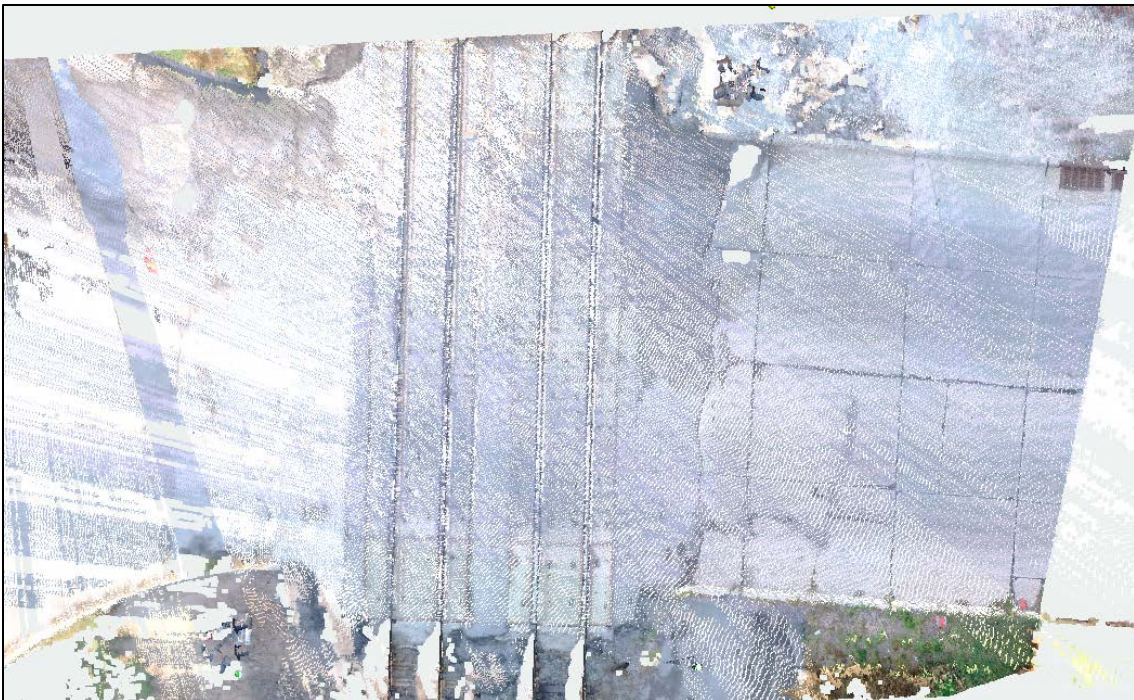
Figure 105. Crossing 817404F FARO Scan Top View

The results of the 3D scans are shown in Figures 104 through 106. Slope measurements were used to evaluate road grades adjacent to the crossings, and a comparison of the results of the road section with the AASHTO/AREMA (2015) geometric design recommendations [8] is shown in Figure 107. The approach slope has a grade of 1.80 percent and a track elevation of 5.44 in. (138 mm). The departure slope has a grade of 3.00 percent and a track elevation of 8.95 in. (227
