Heavy Truck and Bus Traversability at Highway-Rail Grade Crossings

HEAVY TRUCK AND BUS TRAVERSABILITY AT HIGHWAY-RAIL GRADE CROSSINGS

MwRSF Research Report No. TRP-03-392-18

June 29, 2018

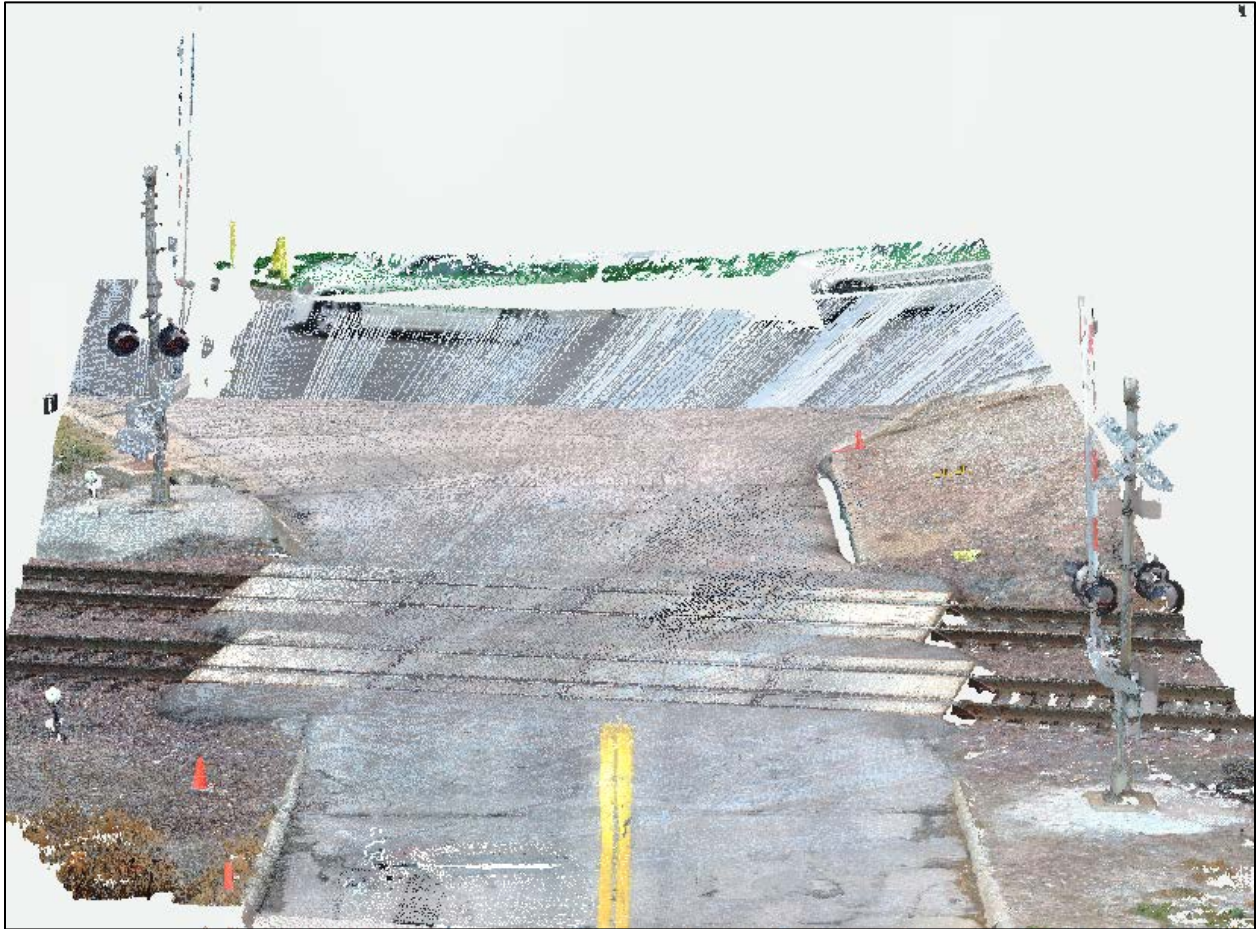
Figure 108. Crossing 817405M FARO Scan Front View

111. The approach slope has a grade of 2.88 percent and a track elevation of 8.69 in. (221 mm). The departure slope has a grade of 4.08 percent and a track elevation of 12.24 in. (311 mm). Based on slope and elevation results, crossing no. 817405M is not within the recommendations provided by AASHTO/AREMA (2015).

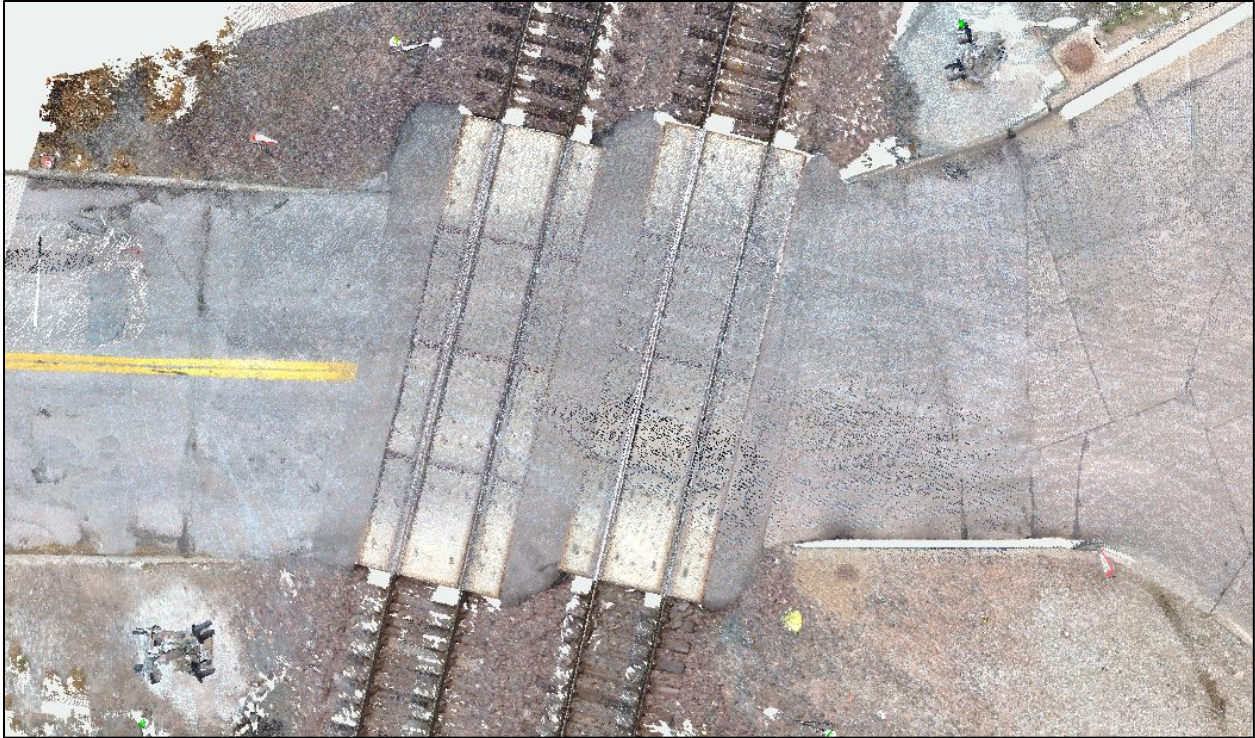
Figure 109. Crossing 817405M FARO Scan Top View

The results of the 3D scans are shown in Figures 108 through 110. A comparison of in-lane slope profiles of the track and the AASHTO/AREMA (2015) guidelines is shown in Figure

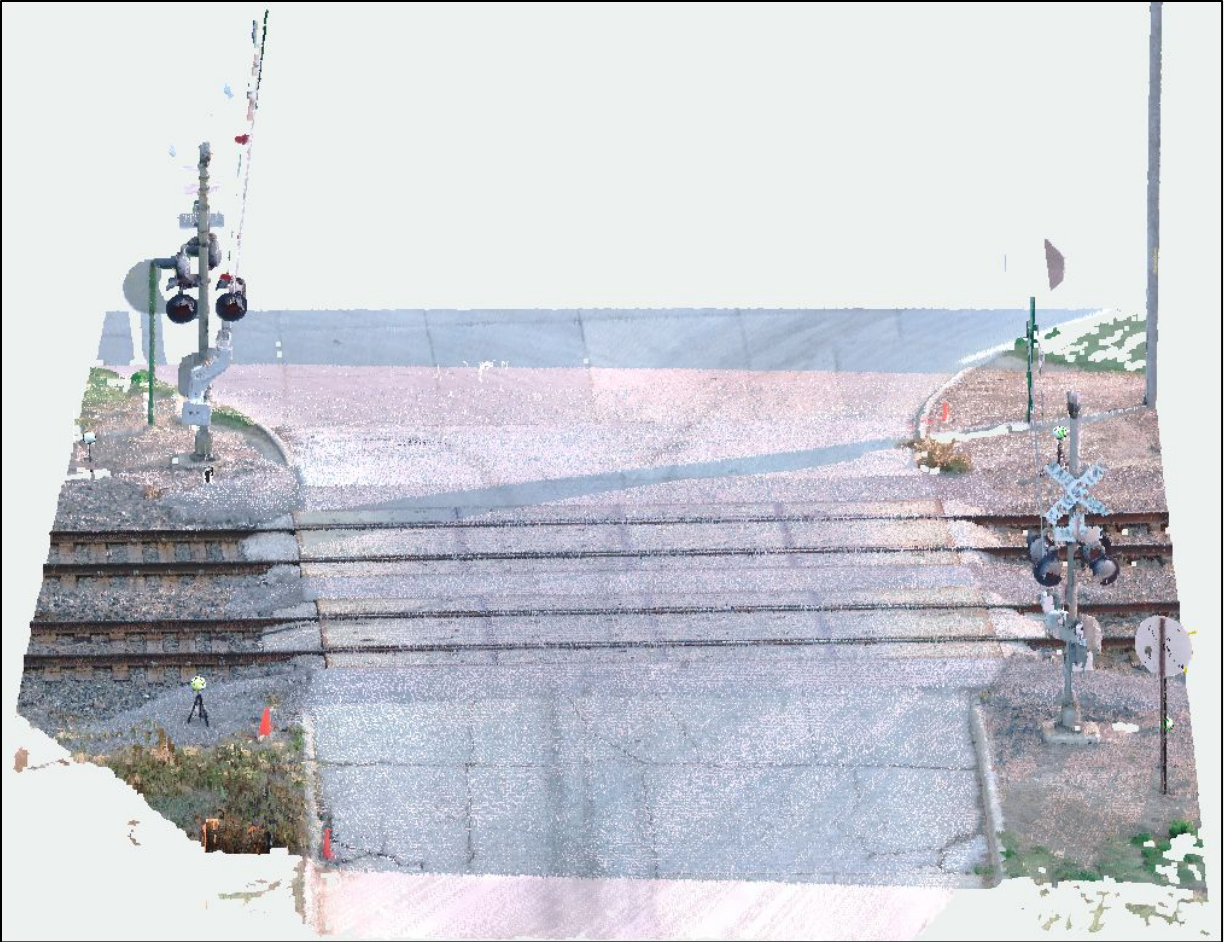
Figure 112. Crossing 816134F FARO Scan Front View

The results of the 3D scans are shown in Figures 112 through 114. Slope and elevations of the track determined using results of the 3D scan data was compared with ASHTO/AREMA (2015) guidelines, as shown in Figure 115. The approach slope has a grade of 2.88 percent and a track elevation of 8.70 in. (221 mm). The departure slope has a grade of 1.32 percent and a track elevation of 3.96 in. (101 mm). Based on slope and elevation measurements, crossing no. 816134F is not within the recommended guidelines provided by AASHTO/AREMA (2015).

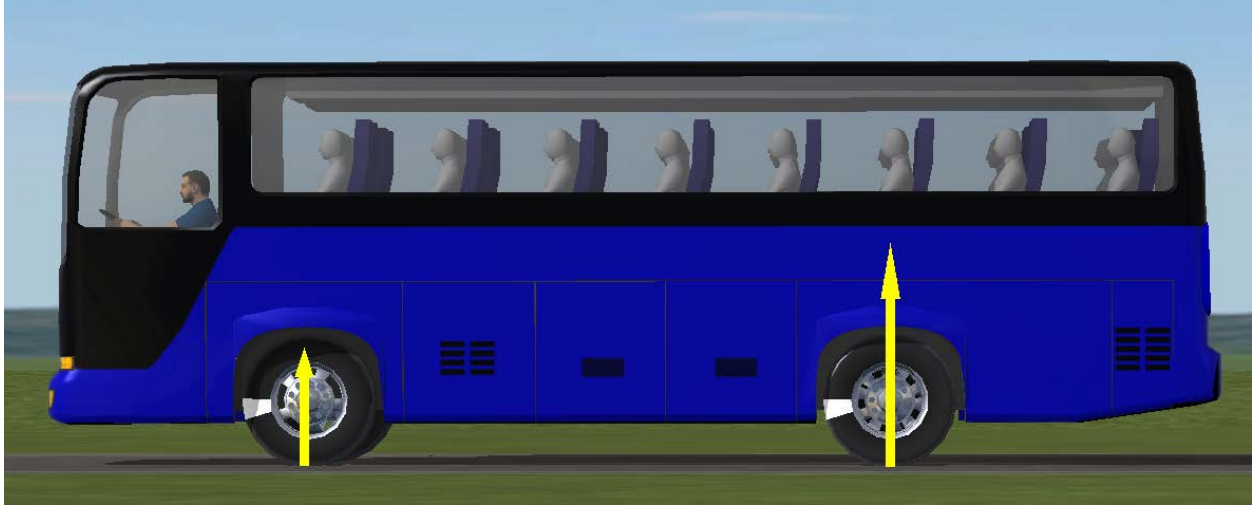
Figure 136. TruckSim Bus Model

The bus vehicle model was a two-axle tour bus loaded with passengers and had a ground clearance of 12.5 in. (318 mm). No test data was available to calibrate or evaluate the bus model; thus, default inertial, power, steering, and suspension properties of the bus model were not altered for any of the simulations. The bus vehicle model is shown in Figure 136.

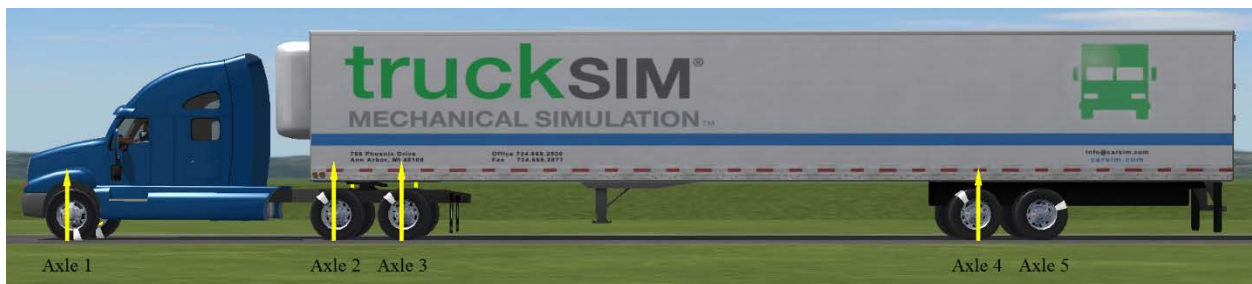
Figure 149. TruckSim Tractor-Van Trailer Model

To determine if suspension properties for vehicle models in TruckSim were accurate to model vehicles traversing crossings, four speed table simulations were performed. These simulations utilized identical traversal conditions as test nos. UTCRS-1 through UTCRS-4, which were discussed and analyzed in Chapter 3. Each test was simulated in TruckSim with a tractor-van trailer vehicle model similar to the vehicle which performed the live tests, shown in Figure 149. Vertical displacements and vertical acceleration of the trailer were collected and compared to those collected from the live speed table tests.
