**FATIGUE AND WEAR OF STEEL EYEBARS FROM HISTORIC RAILROAD  
TRUSS BRIDGES**

A Thesis

MASTER OF SCIENCE

May 2017

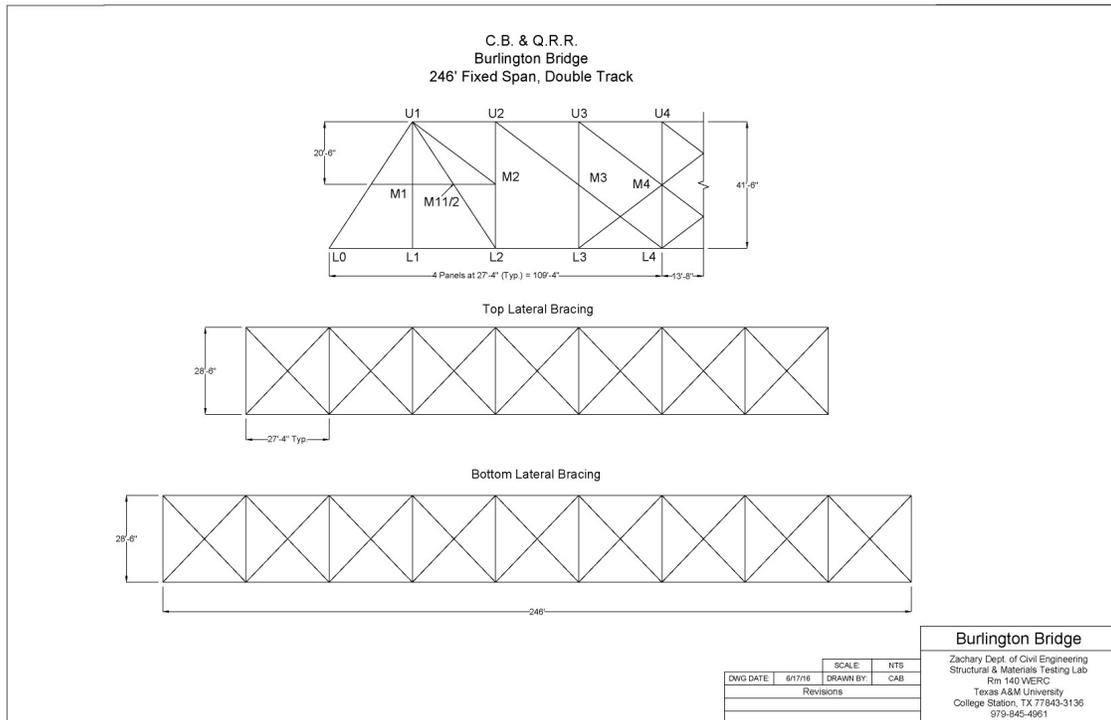
**Figure 2-1 – Burlington Bridge Superstructure**

The Burlington Bridge is a Pratt Truss Steel Bridge constructed in 1893 in Burlington, Iowa for the Chicago, Burlington, and Quincy Railroad. The chief engineer of the Burlington Bridge project was George S. Morison and contractor was the New Jersey Steel and Iron Company out of Trenton New Jersey (Morison 1893). The bridge stayed in service until late 2009 when work began to replace it with a new swing span and superstructure. The Burlington Bridge supported two tracks which replaced a single track structure constructed in 1867. Figure 2-1 on the next page shows the layout of the bridge superstructure as it was designed in 1893.

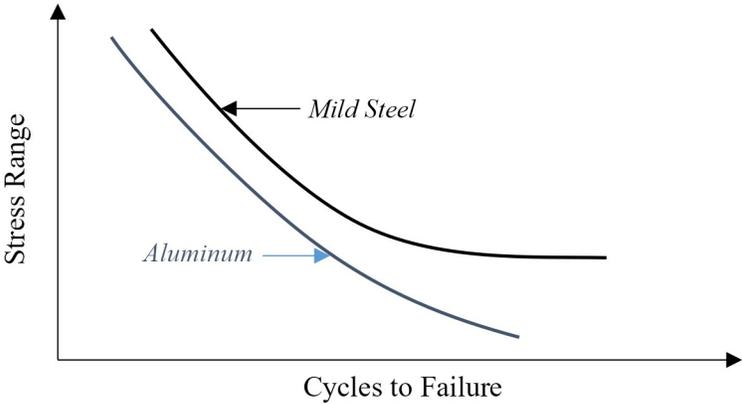
**Figure 2-2 – Typical S-N Curve**

The earliest study that Wöhler performed was on fatigue of railcar axles. From these investigations, he constructed the ubiquitous S-N curve, sometimes referred to as the Wöhler curve. The S-N curve shows the relationship between the applied stress range (constant amplitude) and the resulting fatigue life in N cycles to failure at the given amplitude. Fatigue cracks are created (nucleated) by the application of cyclic stresses, characterized here by stress range, which continue to grow the crack until fracture occurs at N cycles. Below, Figure 2-2 shows a typical S-N curve for two different materials. Ferrous materials like steel usually exhibit a fatigue threshold, sometimes called the endurance limit or fatigue limit, under which theoretical infinite

fatigue life can be obtained. Other materials with different molecular structure such as aluminum do not show this same behavior and will eventually fail at any cyclic stress range applied.

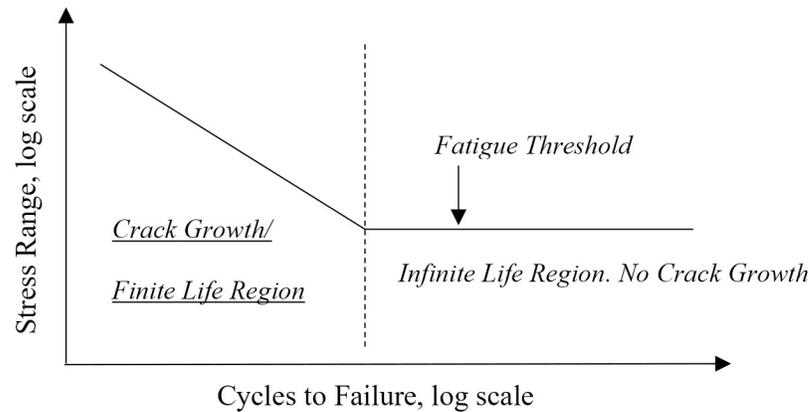
**Figure 2-3 – Crack Growth S-N Curve**

Figure 2-3 shows the relationship between the fatigue threshold and crack growth. Stresses ranges below the threshold do not nucleate or propagate cracks, however all stress ranges above the threshold do.

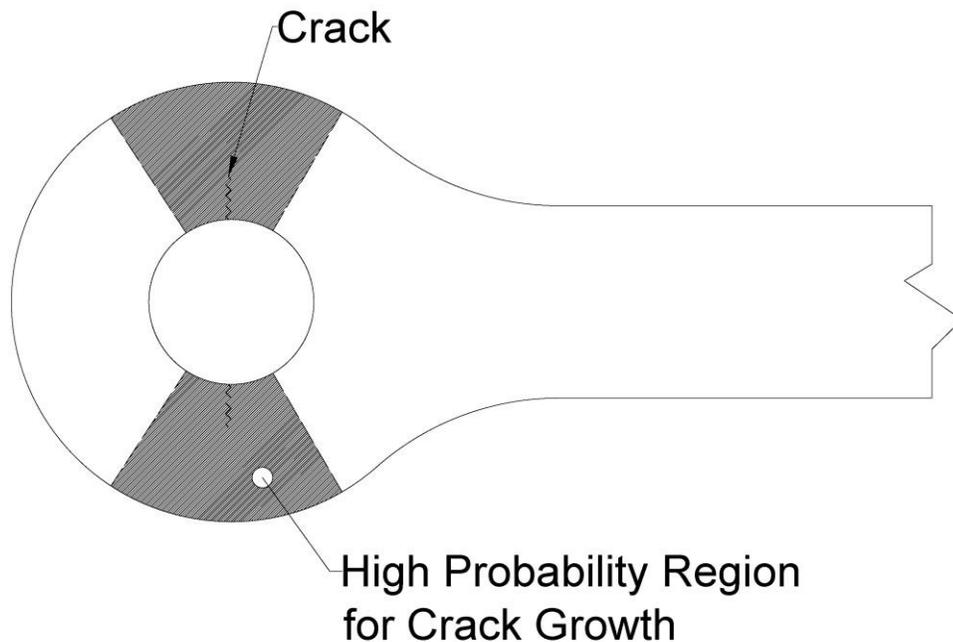
**Figure 2-4 – High Probability Region for Crack Growth**

Eyebars fall under fatigue design category E, a relatively low fatigue strength detail. In the case of the Burlington Bridge, the span between bridge piers is 246 ft, however that span is portioned into nine panels of 27' - 4" each. Additionally, the diagonal tension members never reach a length greater than 68' - 6". Therefore the span length  $L$  falls under the less than 100 ft category which gives  $N \geq 2,000,000$ . This provides a fatigue threshold of  $S_{Rfat} = 4.5$  ksi, where the stress is calculated either by the effective net area or the effective gross area. Eyebars are susceptible to crack formation in the area fanning out from the transverse sides of the head (Figure 2-4).

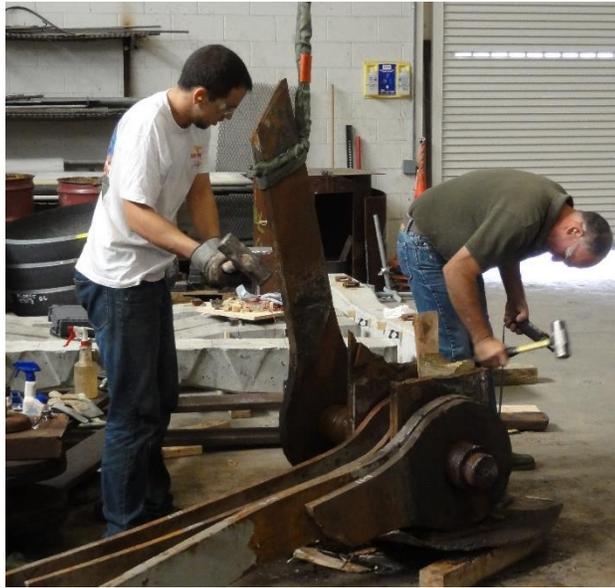
**Figure 3-1 – Eyebar Joint Dismantling**

Eleven joints were obtained for testing from the Burlington and Oregon Bridges together. Though the eyebar bridge joints are designed as pin connections, the state that they were in when the eyebars were first extracted from them was in some cases closer to a fixed joint due to the corrosion of the material. It is unclear whether this fusing corrosion occurred before or after the bridge demolition, but it is highly probable that it occurred after joint removal due to the length of time between demolition and testing and the combined effects that removal of the joint and transportation would have on them. Sledgehammers up to 20lbs in weight, levers, wedges, come-alongs, WD-40, and heating techniques were used to loosen the eyebars and remove them from the joints. Care was taken to impart as little damage as possible when extracting the eyebars, however some eyebar cut ends were physically deformed from the sledgehammers and subsequently removed before testing after the eyebar was free of the joint. The maximum temperature applied to the eyebars was 400 °F. Plastic deformation was avoided, and eyebars that could not be procured were simply left out of the test dataset. A number of eyebars were bent during the demolition or were cut too short to use for anything other than wear measurement. Figure 3-1 shows a representative scene during the joint extraction process.

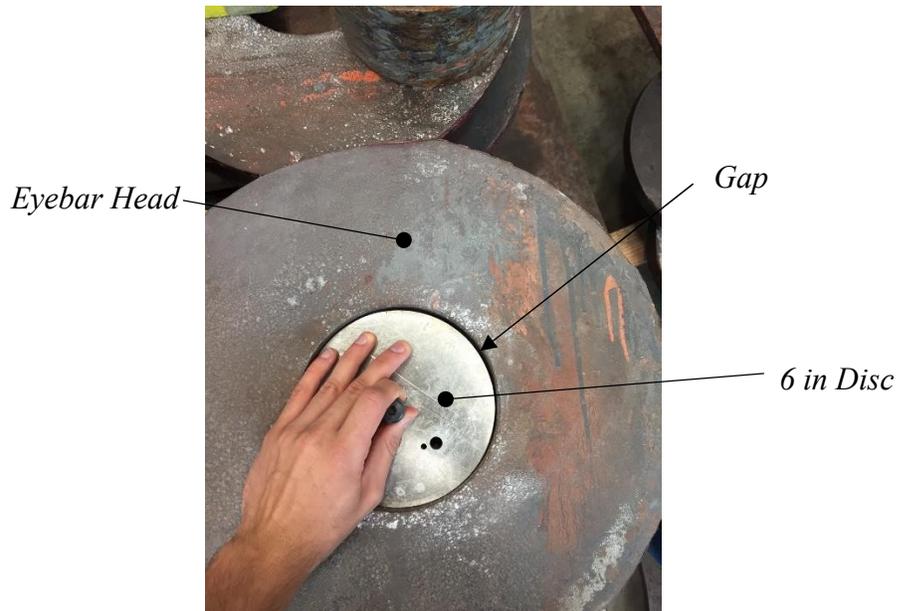
**Figure 3-2 – Wear Measurement Procedure**

Hole wear measurements for the eyebars were taken by measuring the gap between a 6 in diameter disc and the wall of the eyebar hole as shown in Figure 3-2.

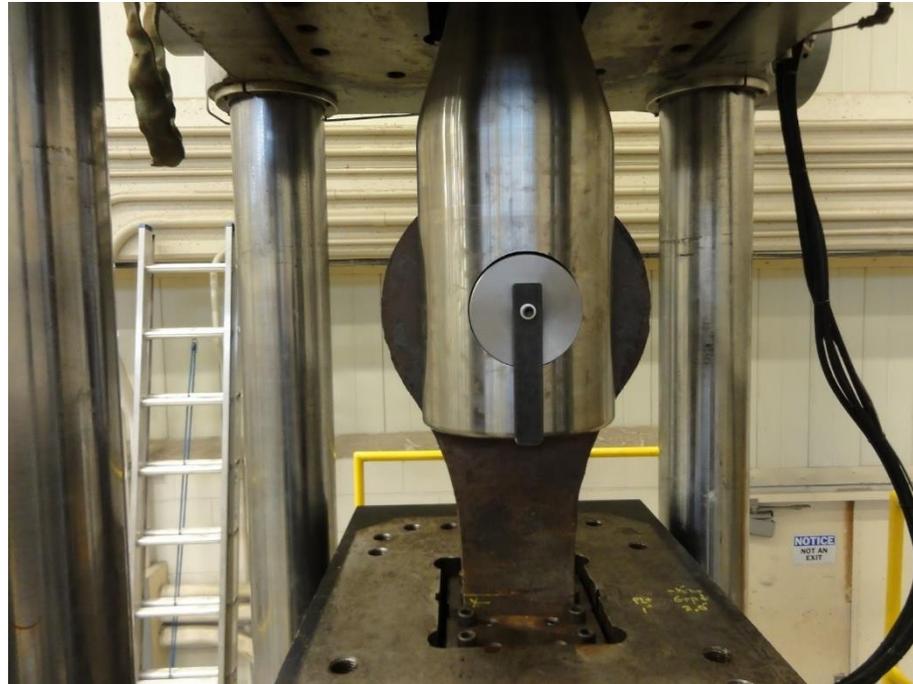
**Figure 3-3 – Fatigue Test Setup in 1500 kip frame**

After cleaning and measurements were taken on the eyebars, eyebars in the best condition were selected for fatigue testing. A 1500 kip capacity MTS test frame was employed in the Structural and Material Testing Laboratory of the Zachry Department of Civil Engineering, Texas A&M University in College Station, TX to fatigue test the eyebars. The 1500 kip frame was designed with interlocks to shut down automatically if the eyebar fractured or there was a mechanical/electrical problem that occurred. Data acquisition occurred continuously and 1200 cycles of data were saved to a file every 5

minutes during running. The cycles were recorded continuously. A specifically designed clevis and pin were used to attach the eyebar to the machine, the other end gripped in friction as shown in Figure 3-3.

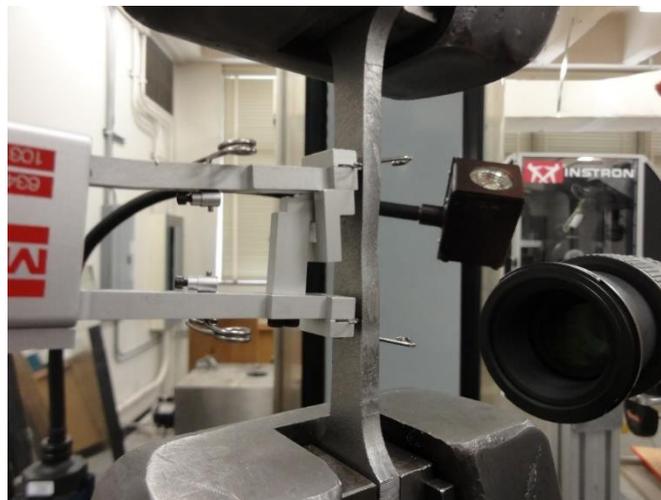
**Figure 3-4 – Tensile Testing Setup**

In order to determine the tensile yield strength and ultimate strength of the two bridge steel materials, tensile testing was performed on specimens taken from eyebars at the locations shown in figures A-1 and A-2 in Appendix A. After blocks were removed from the described locations, specimens were machined from the blocks in accordance with ASTM E8 standards for tensile testing specimens. In total, 24 specimens were tested at a strain rate of 0.05 in/in/min on an MTS tensile testing machine in the Structural and Material Testing Laboratory. The same strain rate was used in the elastic region as was used in the strain hardening and ultimate strength regions. All specimens were tested to ultimate failure. Figure 3-4 shows a typical tensile testing setup using the MTS machine.

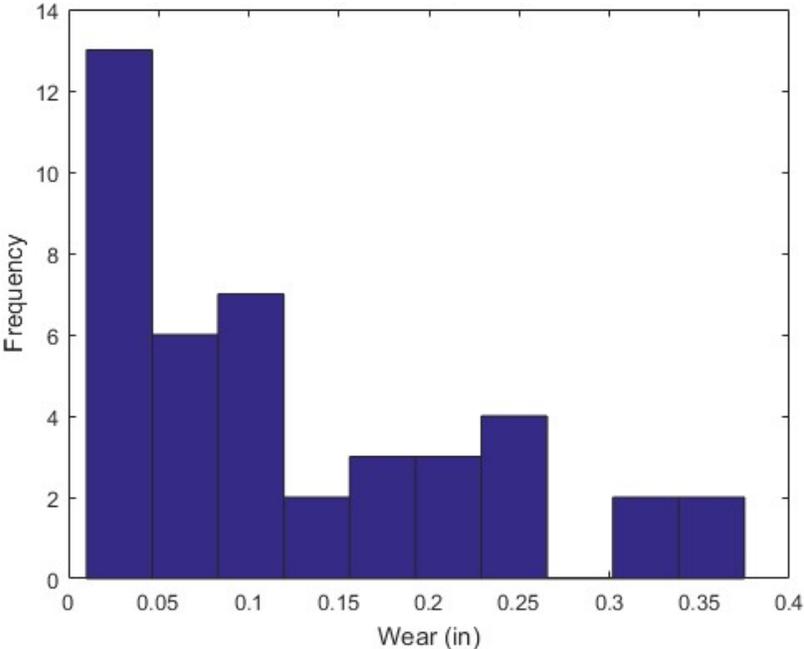
**Figure 4-1 – Histogram of Eyebar Wear**

The histogram shown in Figure 4-1 is skewed right and shows the wear data clustering towards small wear values. Inspection of the histogram data shows that only 38.1% of the wear values fall above the mean of 0.121 in, and correspondingly 61.9% fall below the mean. This shows the heavy influence of the tail data, not only for the mean, but in the later choice of distribution testing to identify the underlying statistical distribution (See Section 4.3). The data suggests very little differential movement between the eyebar and pin, i.e. small deflections because of the 100+ year service life as expected. The assumption that the pin and eyebar are constructed of the same material is verified through inspection of the specification from George Morison (Morison 1893). Dismantling of the bridge joints has shown extensive rusting between the eyebar heads and pins which has fused the two pieces together and has sometimes required large impact forces and the application of up to 400 °F of heat to loosen, being careful to avoid plastic deformation of the member. This corrosion joining some of the eyebars to the pins most likely occurred after the joint was removed from service. Table 4-1 provides summary statistics of the eyebar wear and pin wear.

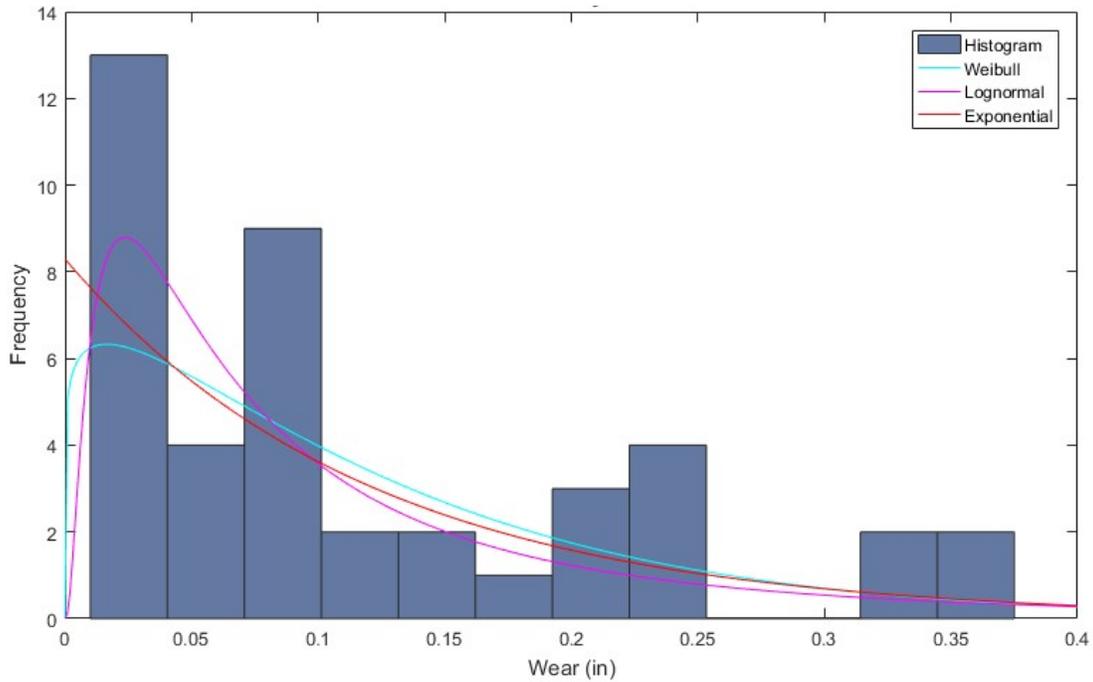
**Figure 4-2 – Distribution Fit of Eyebear Wear Data**

The Anderson – Darling test results show that the exponential distribution gives the best fit of our chosen models. The model not only relatively is better than the other compared models, but it gives a good objective fit for the data. The exponential distribution has the smallest AD statistic, the highest  $p$  value, and the best fit on a probability plot of any of the evaluated distribution. We also see that the Weibull is superior to the Lognormal. This can also be seen in Figure 4-2. Figures 4-3 and 4-4 show the probability plots for the lognormal and exponential distribution, respectively.

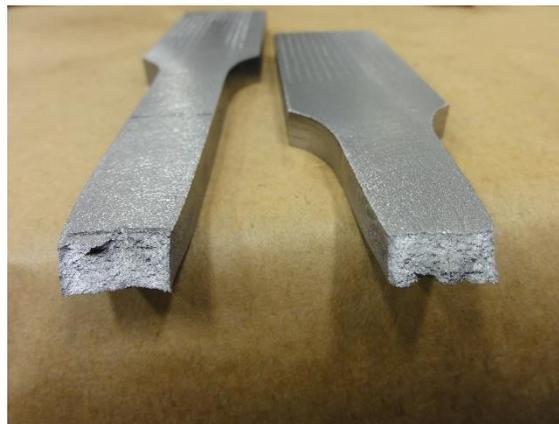
**Figure 4-5 – Tensile Test Specimen after testing**

Tensile tests, and material composition tests were run on selected specimens taken from each bridge. Specimens taken from the eyebars and pins of both bridges were sent to a material testing laboratory for analysis. Figure 4-5 shows a typical tensile specimen after testing. The original construction specification cites that the bridge in the most part, excepting...., was constructed with medium steel (Morison 1893). Both the acid and basic open hearth processes were utilized to produce the steel of the Burlington Bridge. While ASTM standards were not written until 1898, five years after the Burlington Bridge construction, the behavior of the Burlington steel still shows some patterns.

Initially, a sharp difference was noted in the tensile test results for specimens taken from the side of the eyebar head vs the neck area. The neck area showed much higher yield strength and ultimate strength than did the side areas. More specimens were prepared to verify this pattern, however no correlation was found with subsequent testing.

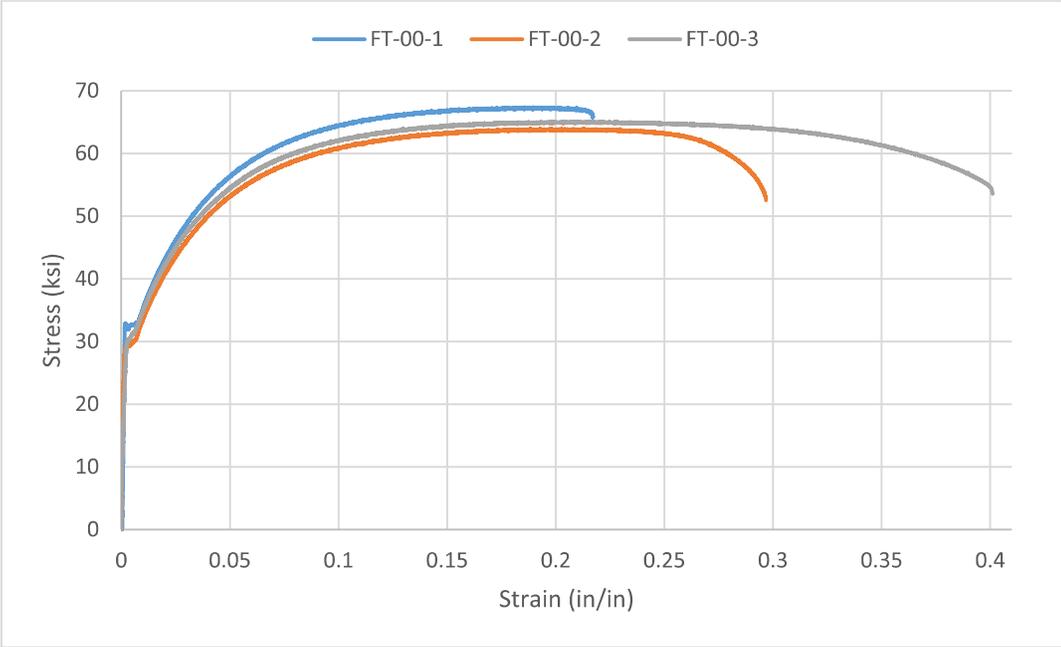
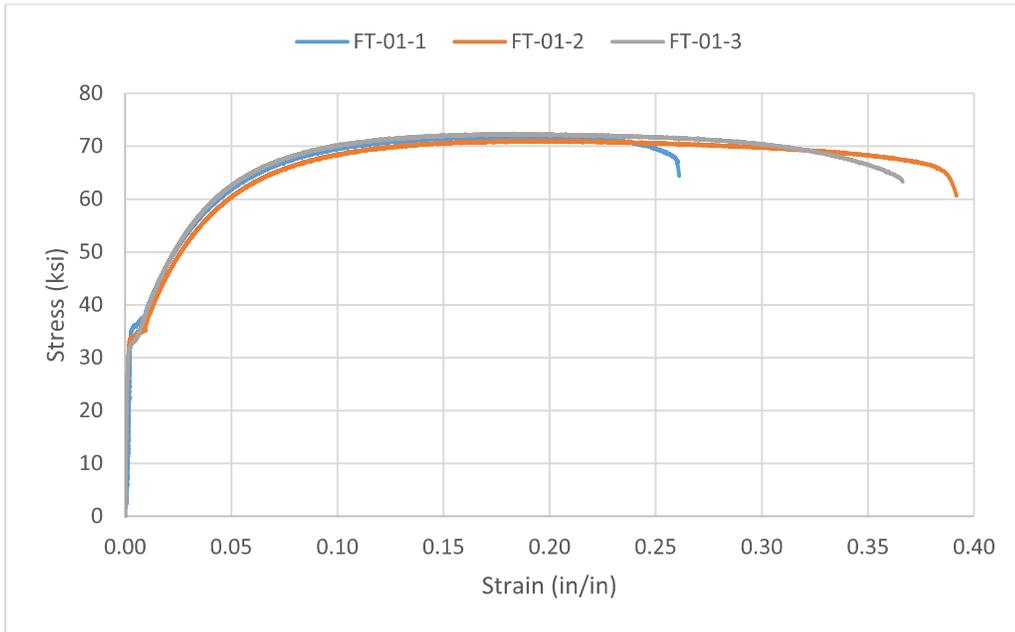
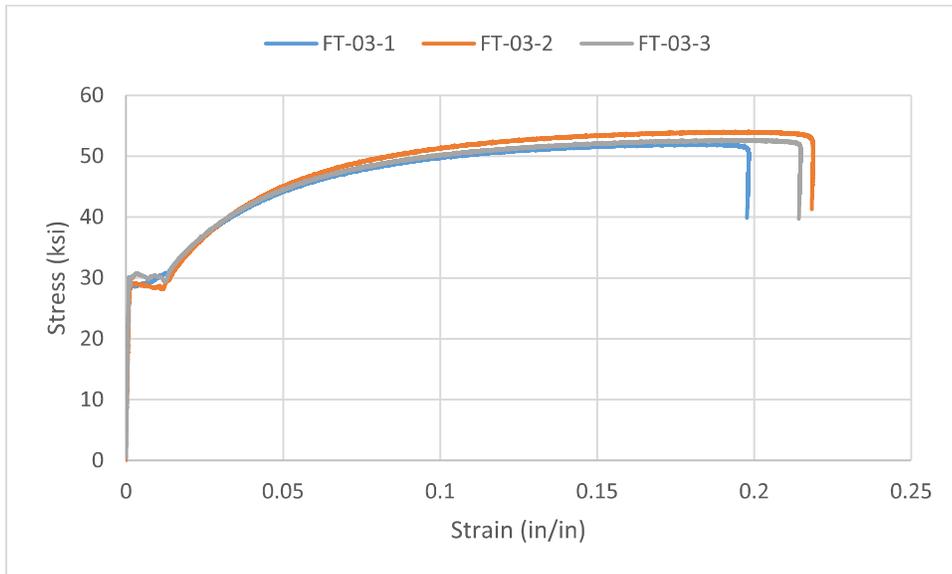
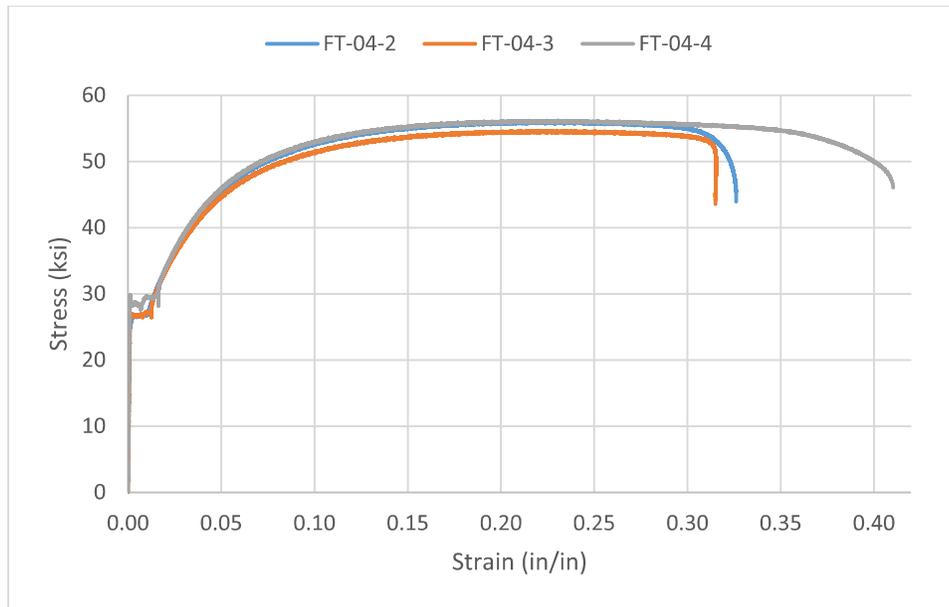
Figures 4-8 through 4-11 show the stress-strain curves of eyebars that were fatigue tested. Note that all stress-strain curves generated in this research show engineering stress, not true stress.

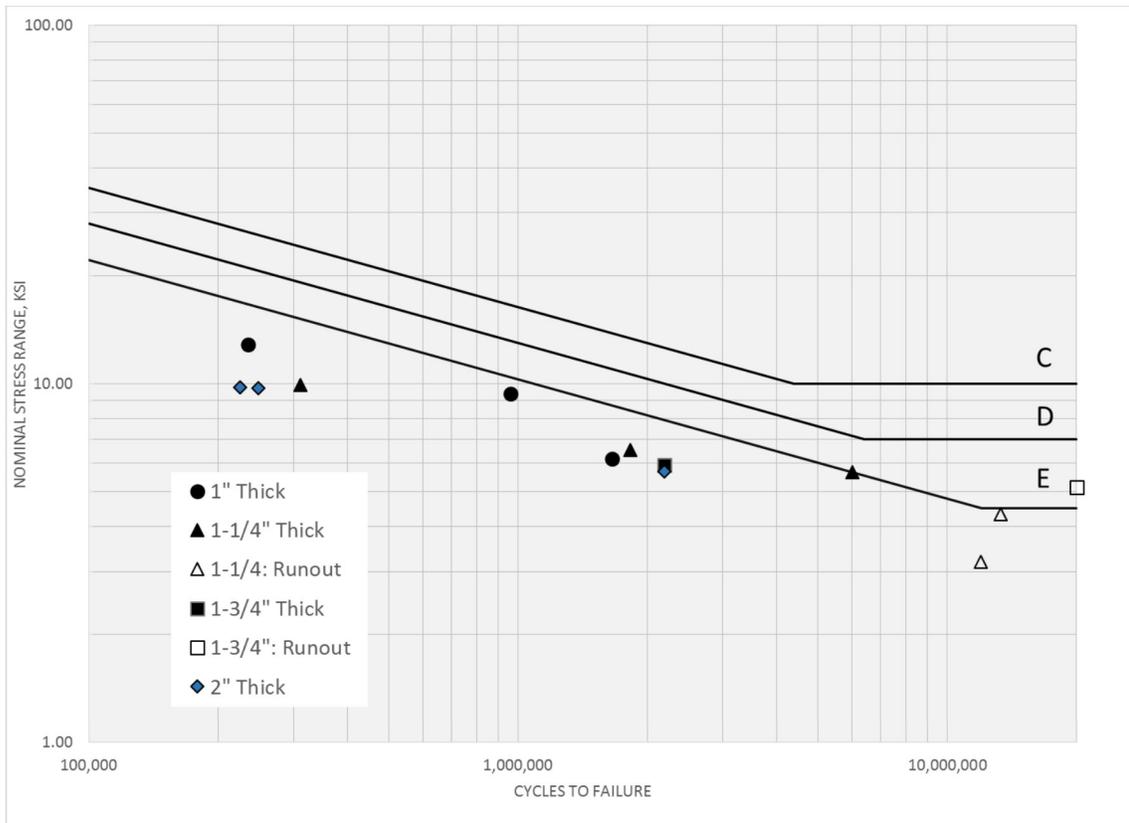
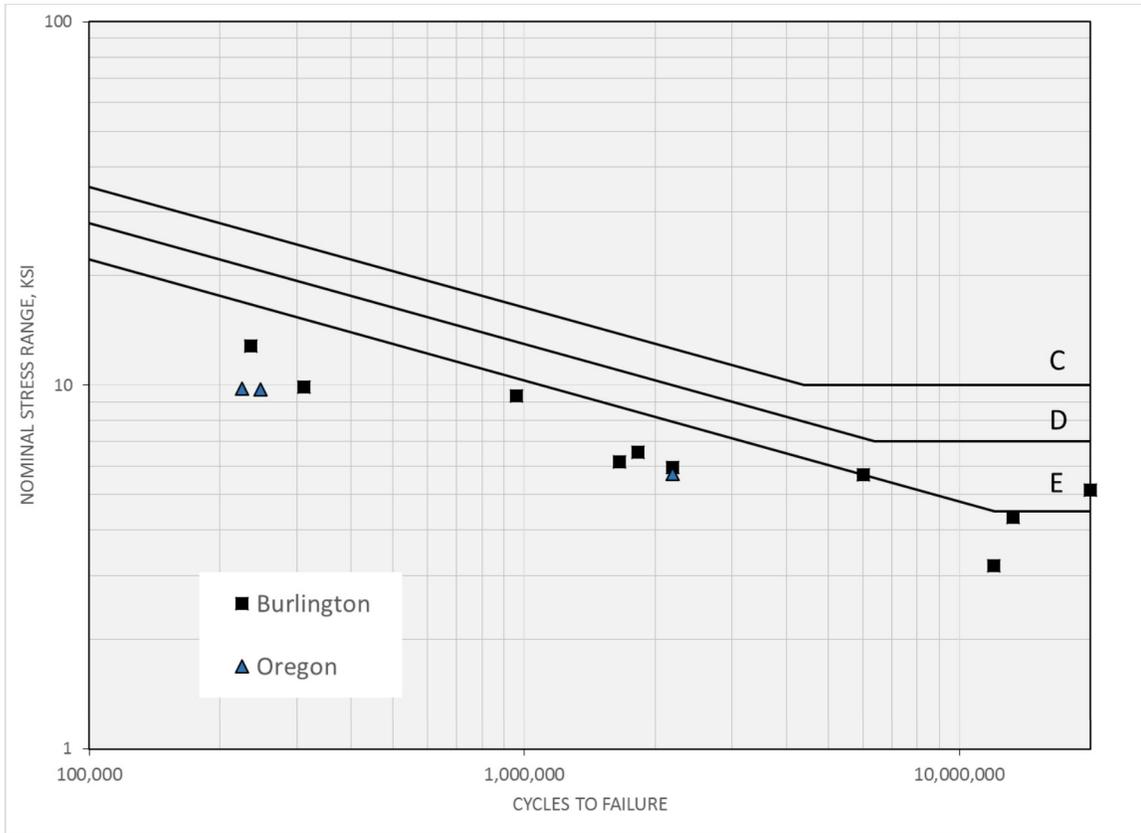
Figure 4-12 and 4-13 are plots of the fatigue test data from this study with AASHTO Fatigue Design Curves C, D, and E. Table 4-4 shows the fatigue test data for all specimens. Overall, the eyebars showed interesting fatigue behavior that deviated from the AASHTO fatigue design criteria. Refer also to Section 5.3 for in depth discussion of the fatigue test results.

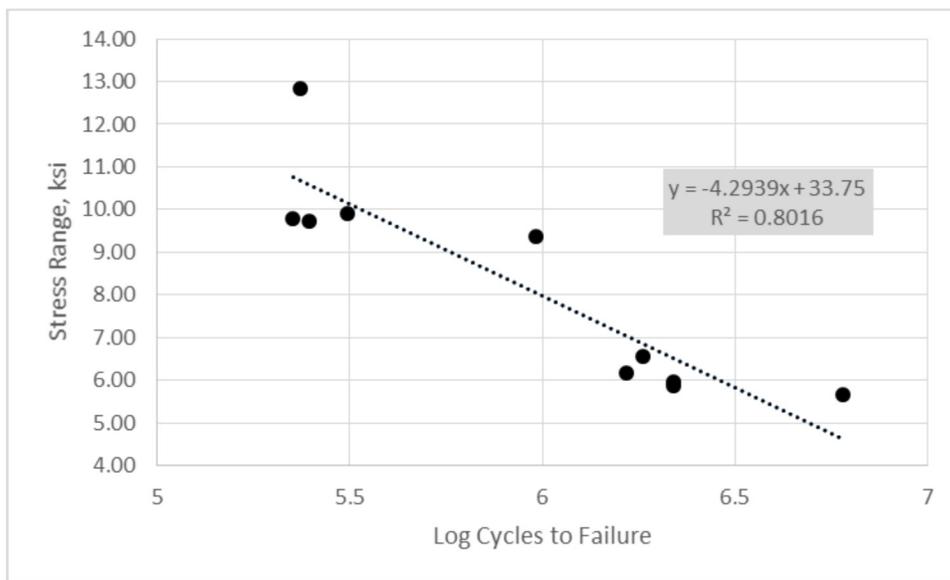
**Figure 4-14 - Eyebar Fatigue Linear Regression  
Finite Life Region**

Figure 4-15 shows a simple linear regression computed using the S-N curve data from the finite life region of the curve, meaning that any runout data is not included in building the model.

The model shown in Figure 4-15 can be used to predict future fatigue test results in the finite life region of the curve with reasonable accuracy. The current best estimate of the fatigue threshold for these eyebars is 5.1 ksi, corresponding to the highest stress range in testing that produced a runout.

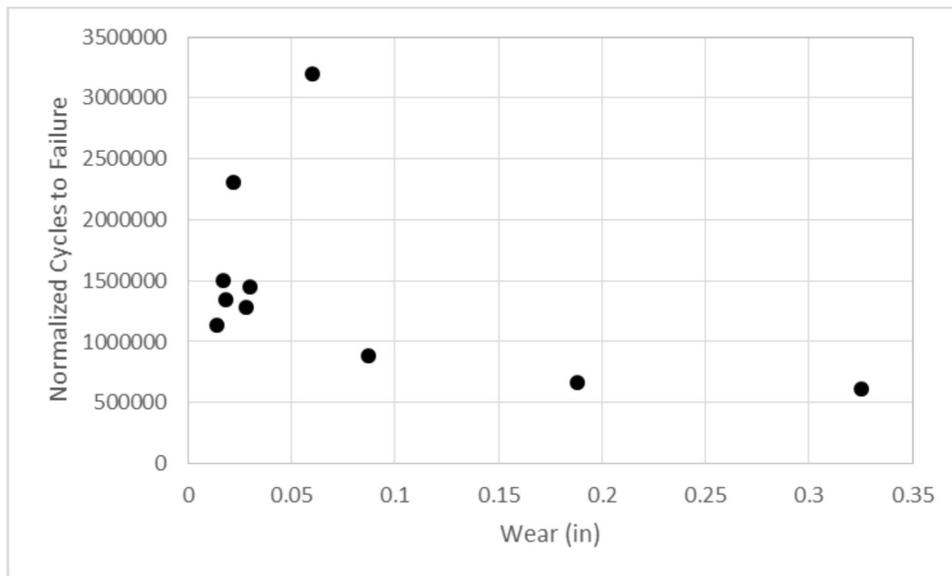
**Figure 5-1 – Wear vs Normalized Cycles to Failure**

Firstly, cycles to failure for eyebars in the finite life region of the S-N curve were normalized and plotted against wear, as shown in Figure 5-1. Cycles to failure required normalization to eliminate the effect of stress range on the relationship between wear and cycles. For low wear values on the curve, it can be seen that there is no correlation between wear and cycles to failure. However, cycles to failure appear to trend downward for the highest three wear values. Regardless, there is no clear trend between wear and cycles to failure by inspection of Figure 5-1 alone. It is prudent to seek out any possible relationships using other means besides Figure 5-1.

Secondly, lasso regression was run on the eyebar wear data and a very small correlation was found between wear and fatigue life, that as wear increased, it had a small decreasing effect on cycle count. However, the relation is very weak. It is postulated that the reason that the wear values have only a small effect on the remaining useful life is that the stresses experienced by the eyebars were less than the fatigue threshold during their service lives. Stress histories less than the endurance limit would not leave residual fatigue damage due to their infinite life by definition. Therefore, it is expected that there is little or no predictive value for wear in eyebars that experienced stresses below the fatigue threshold. After optimization of the Lambda parameter of the Lasso correlation, the Beta values, which are the correlation coefficients showing the strength of the relationship, were -3.456 and -0.185 for stress range and wear respectively. This means that besides the correlation between wear and cycles to failure being very weak, stress range is 19 times more powerful in predictive value than wear is. We can conclude that probably very few eyebars in these bridges were subjected to stresses that exceeded the fatigue threshold during their service lives, however more data would be needed to increase the robustness of this inference. Even if most eyebars did not experience stress ranges above their fatigue thresholds, it is probable that some did, as the data suggest this is the case.

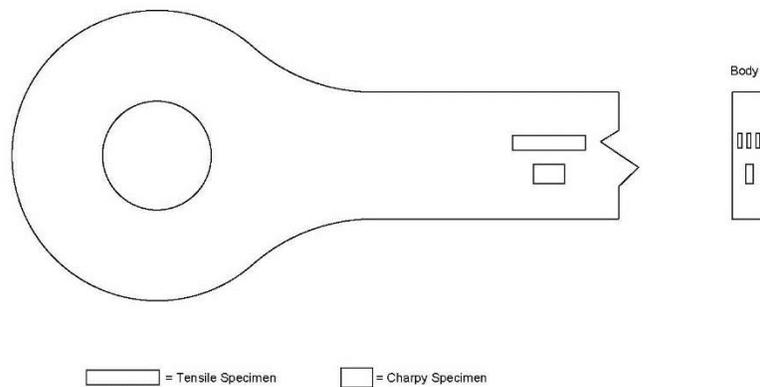
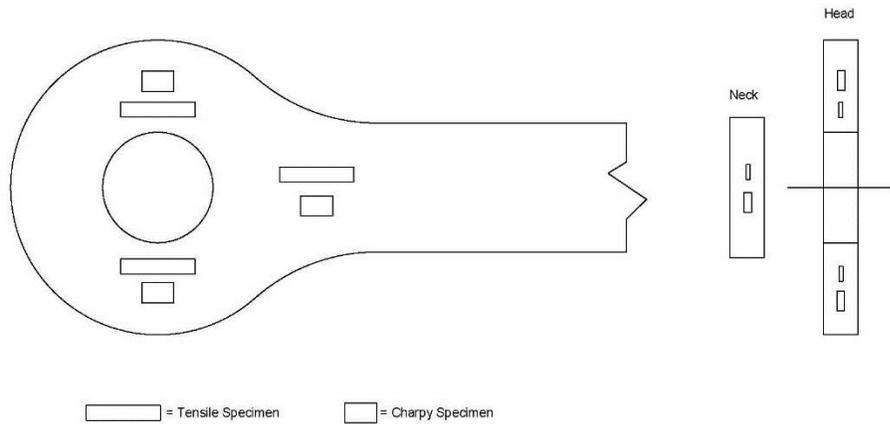
All force values are in kips, all dimensional values are in inches, and all stress values are in kips/in<sup>2</sup>, ksi. Test specimens were taken from the locations designated by Configurations 1 and 2 below. Configuration 0 denotes no test specimens taken from an eyebar.
