Development, optimization, and implementation of a vibration based defect detection algorithm for railroad bearings

A Thesis

MASTER OF SCIENCE

Major Subject: Mechanical Engineering

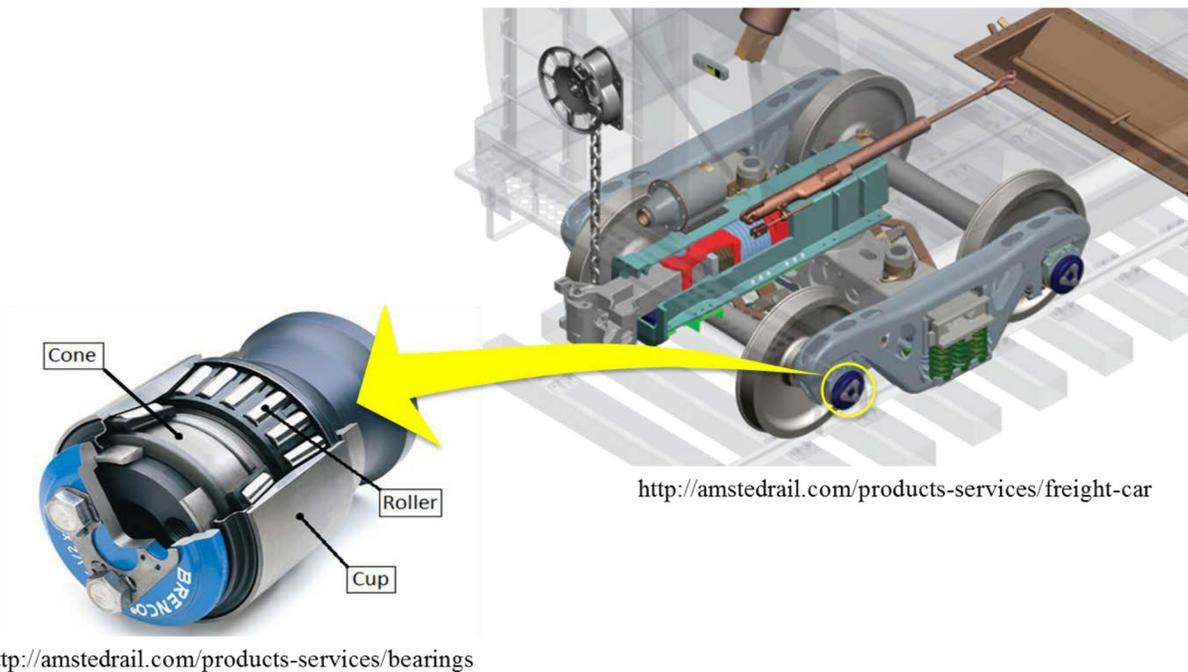
Figure 1 Typical tapered-roller bearing used on freight cars with annotated fundamental components (left) and its indicated location on a truck assembly (right).

axles, wheels, and bearings. However, the suspension component most susceptible to heavy cargo loads and high speeds is the tapered-roller bearing, located adjacent to the wheel, indicated in Figure 1. The tapered-roller bearing is comprised of three fundamental components: outer ring (cup), inner ring (cone), and roller (labeled in Figure 1).

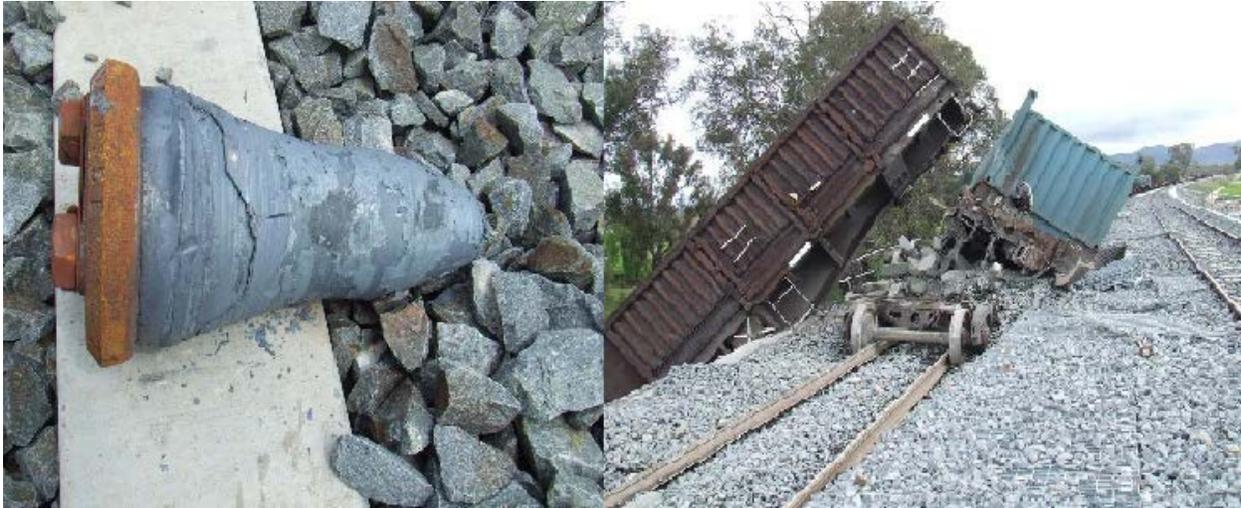
Figure 2 Derailment caused by bearing failure, photographs courtesy of Amsted Rail.

The purpose of a bearing is to sustain heavy loads and reduce friction, however, when those functions are compromised, failure of the bearing ensues. Failure in a bearing refers to the bearing's inability to freely rotate, resulting in extreme frictional heating. Repercussions of an occurrence such as this are displayed in Figure 2.

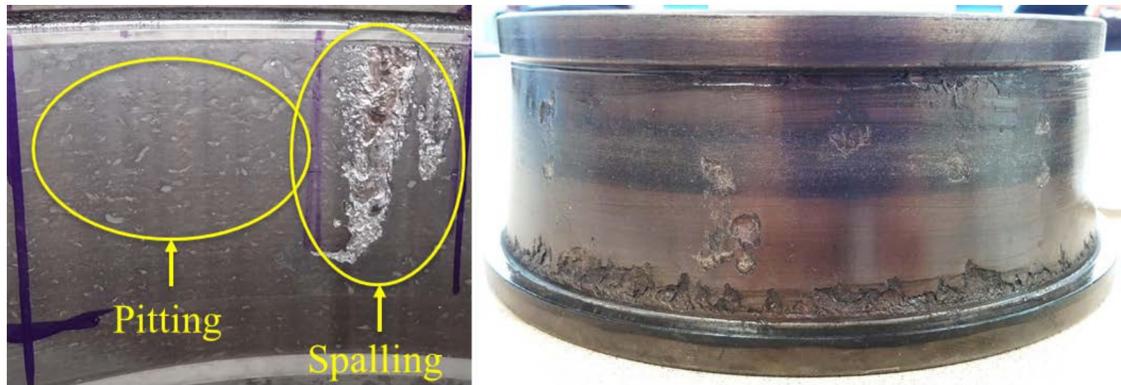
Figure 3 Photographs of a local cup defect exhibiting spalling and pitting (left) and water-etching on a cone raceway (right).

Most instances of bearing failure are due to defects present within the bearing. According to researchers, defects fall into one of two categories: ‘localized’ or ‘distributed’ [7]. Localized defects include spalls, pits, and cracks, to name a few, whereas distributed defects involve surface roughness, water-etch – the result of water seeping into the bearing, causing grease degradation and metal to wear away –, geometric inconsistencies, etc. The effects of spalling, pitting, and water-etching on bearing components are displayed in Figure 3.

Rolling contact fatigue (RCF) is one of the most common causes of bearing failure, which can lead to spalling. Spalling typically occurs on rolling surfaces of a bearing due to the presence of subsurface inclusions. RCF causes micro-cracks to form around the inclusion. Under continued cyclic fatigue, the cracks begin to propagate towards the surface, causing metal to flake off, forming a cavity known as a ‘spall’. The moment a spall initiates, metallic debris is introduced into the bearing lubricant, allowing the debris to become caught between the dynamic components of the bearing, forming dents and pits on raceway surfaces.

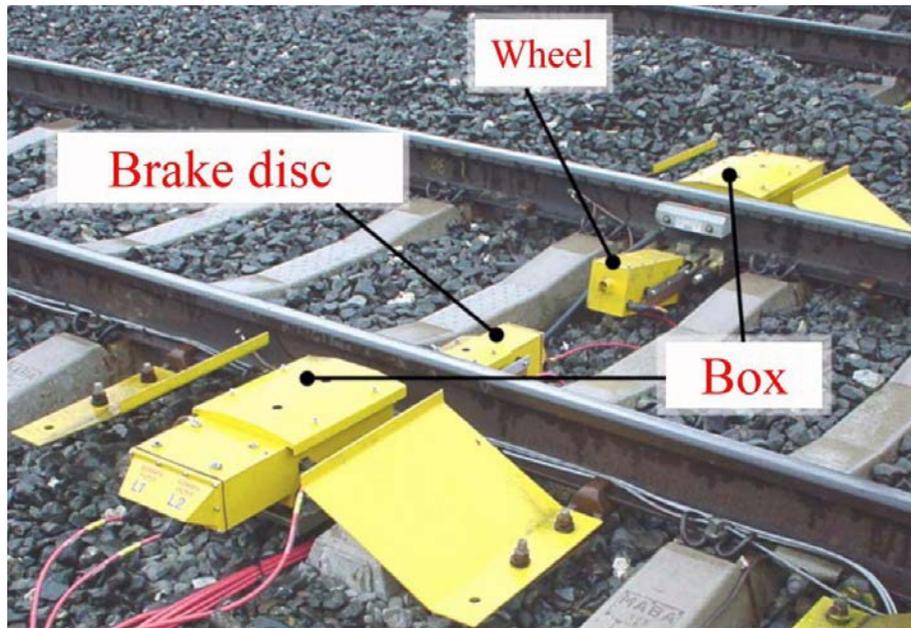
Figure 4 Photograph of a wayside hot box detector [13].

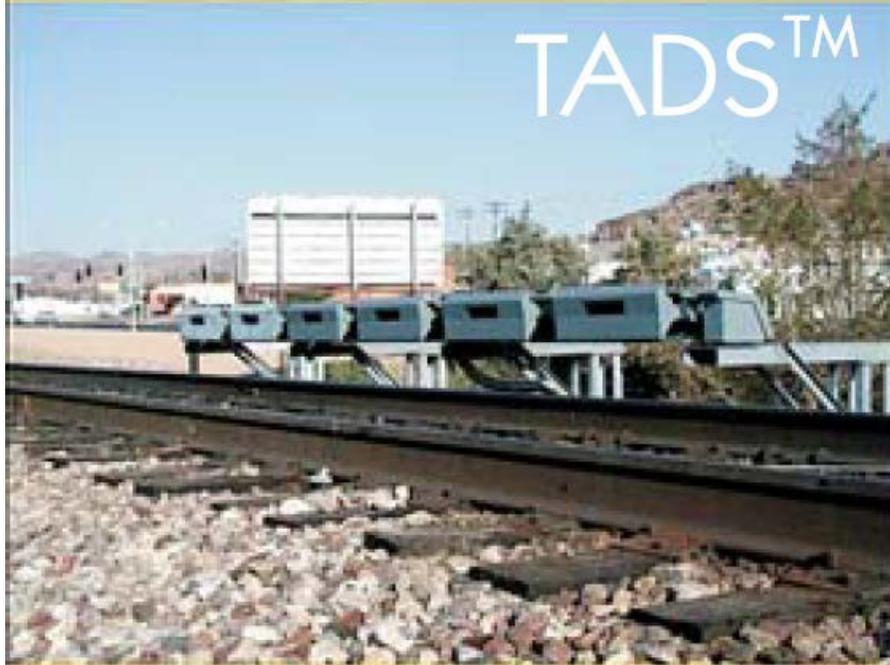
Figure 5 Photograph of a trackside acoustic detection system [15].

The trackside acoustic detection system (TADS), displayed in Figure 5, is comprised of a series of wayside microphones which monitor the sound emitted from bearing defects. In the early 1980s, acoustic bearing detection was developed to address the limitations of hot box detectors. Unfortunately, early implementations of these systems were unable to detect numerous defects. Once additional research was conducted, the acoustic bearing detectors were able to detect defects condemnable by the Association of American Railroads (AAR) standards.

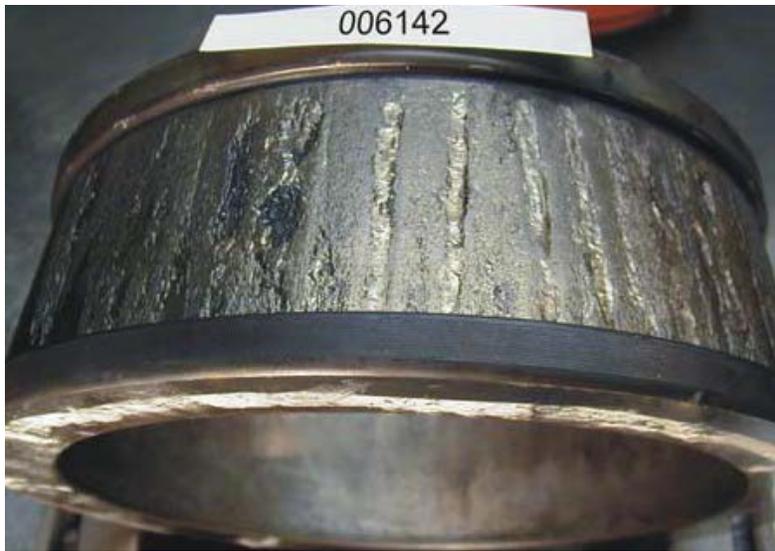
Figure 6 Photograph of a severe cone defect detected by TADS™ [14].

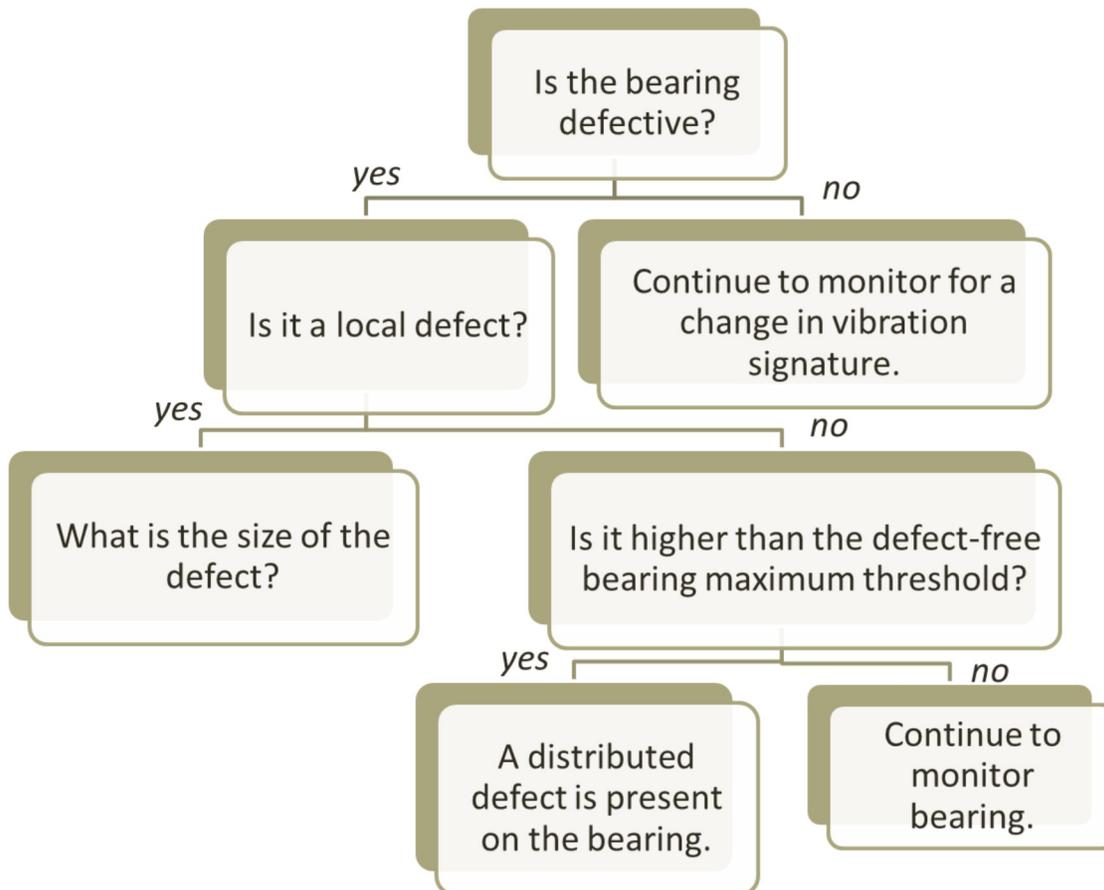
Figure 7 Flowchart of the defect-detection algorithm developed by Alvarado [16].

In 2012, Alvarado [16] developed a preliminary defect detection algorithm capable of identifying the presence of defects within bearings while also determining the defect-type (local, distributed, or geometric), and estimating the size of the defect. The developed algorithm utilized vibration signatures gathered from healthy and defective bearings in laboratory experiments. Alvarado [16] explored several vibration analysis techniques prior to coming up with the technique used in her algorithm. Time- and frequency-domain analysis of the recorded vibration data form the basis for the developed algorithm. The preliminary defect-detection algorithm operates in a series of decision-making steps, expressed in Figure 7. The first step in the algorithm identified whether the bearing in question was defective. The second step determined whether or not the detected defect was local – a defect localized on a single bearing component (i.e., cup, cone, or roller). Depending on the outcome of the second step, the third

step in the algorithm either estimated the area and perimeter of the detected local defect, or compared the magnitude of the vibration to an established threshold, which would determine whether the defect was distributed or a false positive – a falsely detected healthy bearing.

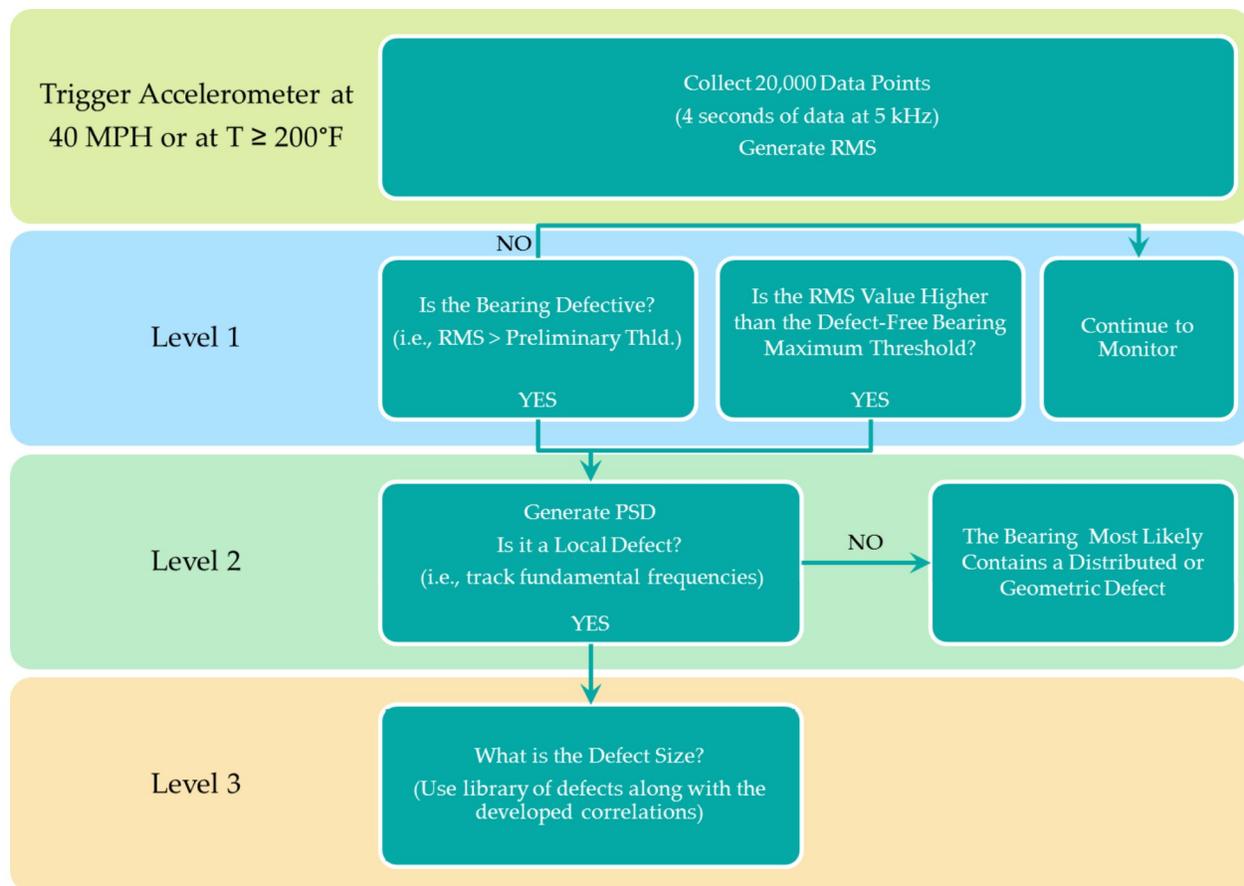
Figure 8 Flowchart of the optimized railroad bearing defect-detection algorithm.

The optimized defect detection algorithm depicted in Figure 8 is constructed to identify the presence of a defect within a bearing, determine the defect type, and estimate the defect size in terms of area. In a field setting, the algorithm will not initiate unless a trigger occurs. Triggers include a bearing operating temperature greater than 200°F (~ 93°C) or a train operating at a speed of at least 40 mph (~ 64.4 km/h). Subsequent to algorithm initiation, a data acquisition system will collect 4 seconds of vibration data at a sampling rate of 5 kHz (20,000 data points) from an accelerometer affixed to the bearing's adapter. Once data is collected, the root-mean-square (RMS) will be calculated, outputting a single *g* value. A description of each level within the algorithm is given hereafter.

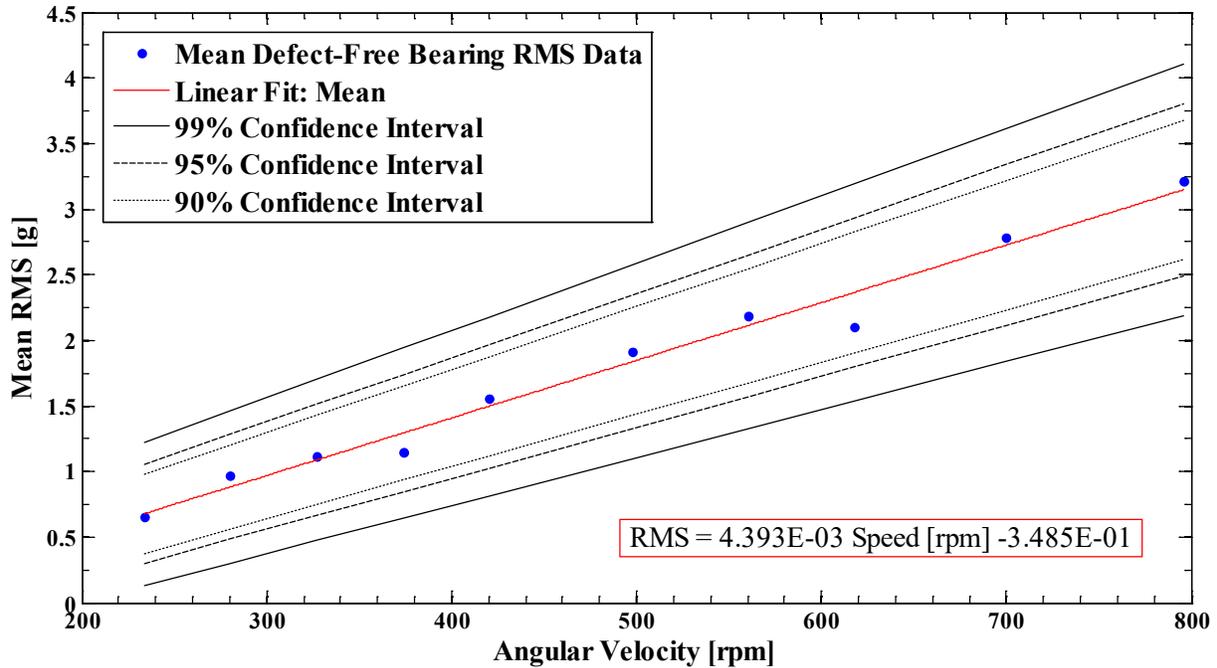
Figure 9 Plot of mean defect-free bearing RMS values correlated to angular velocity which includes a linear fit of the data with 90%, 95%, and 99% confidence intervals.

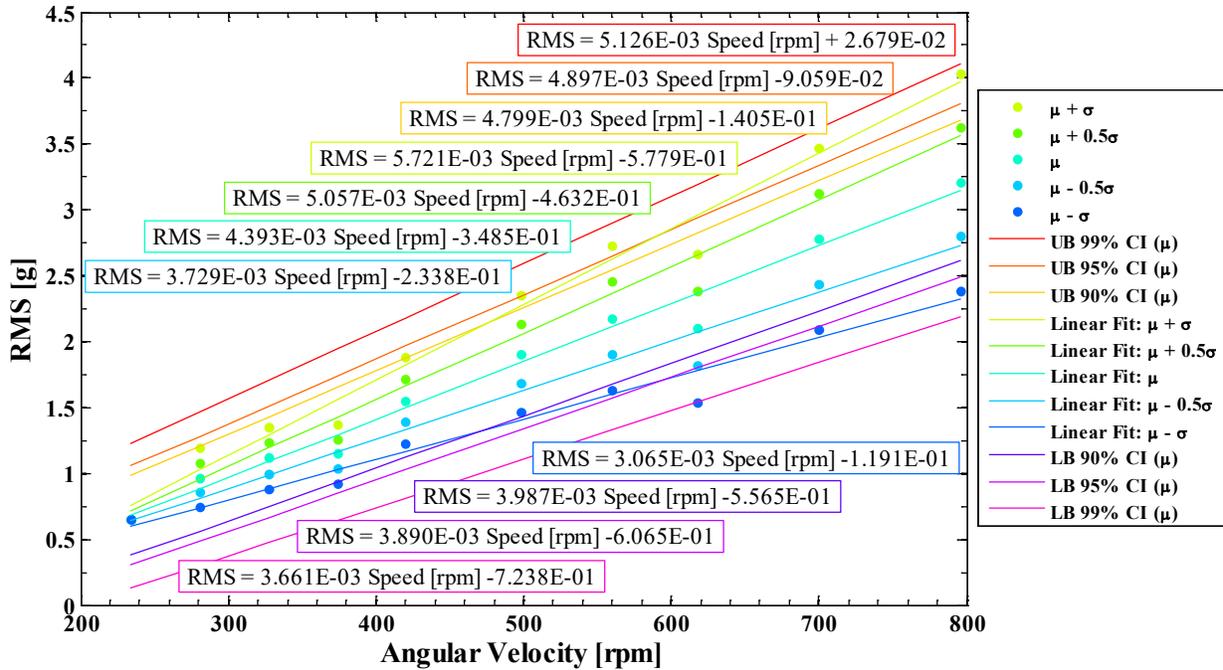
Figure 10 Possible speed-dependent statistical thresholds and their corresponding equations.

Several possible thresholds were explored based on the following statistics: μ , $\mu \pm \frac{1}{2}\sigma$, $\mu \pm \sigma$, and upper and lower bounds of the 90%, 95%, and 99% confidence intervals for the mean RMS in Figure 9. The confidence intervals represent a proportion of samples which contain the true mean of the population. The variables μ and σ represent the mean and standard deviation of defect-free bearing RMS values for each speed, respectively. All eleven possible thresholds and their corresponding correlations are displayed in Figure 10.

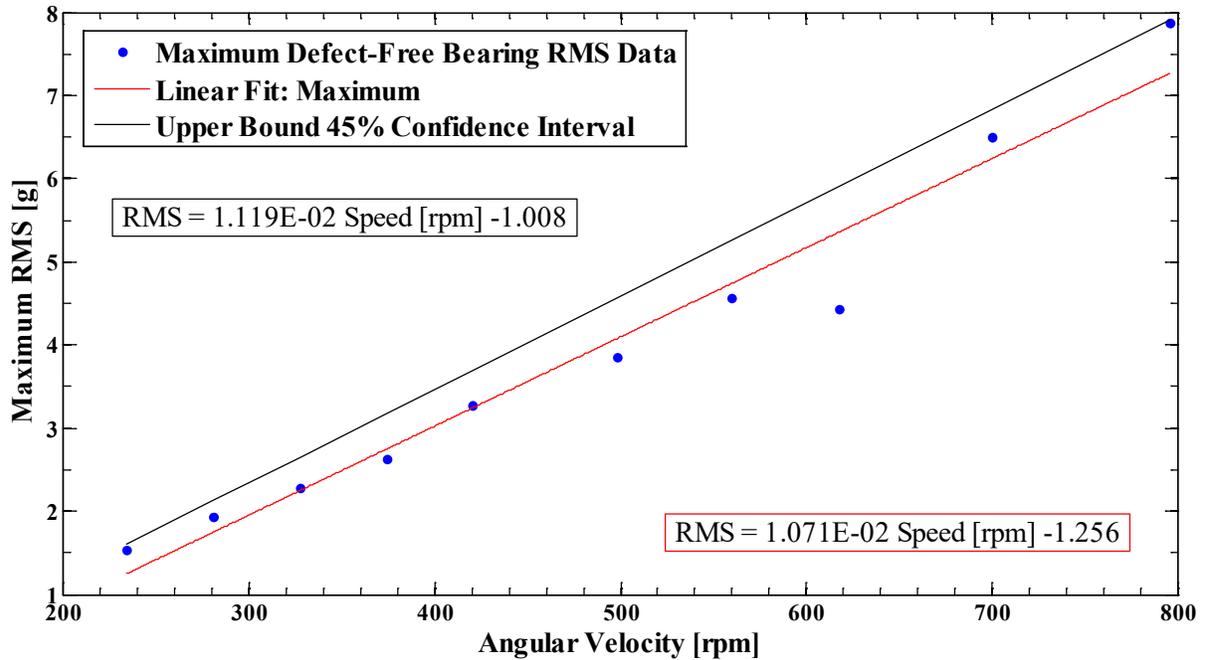
Figure 11 Plot of maximum defect-free bearing RMS values correlated to angular velocity including linear correlation line and upper bound of the 45% confidence intervals.

2.2.1.2 Maximum Threshold. The second threshold in Level 1 is the Maximum Threshold. This threshold was established with the criterion that 100% of all bearings with an RMS value above it would be defective. The Maximum Threshold is based on a correlation between the maximum defect-free bearing RMS values and the speed. Originally, the linear fit equation generated by the positive linear correlation between maximum RMS and speed, displayed in Figure 11, was to be the Maximum Threshold. Unfortunately, approximately 2% of defect-free bearing RMS values from the vibration library fell above this threshold. Rather than simply shifting the linear correlation line of the maximum RMS data in Figure 11 to encompass all maximum RMS values, the upper bound of the 45% confidence intervals shown in Figure 11 was utilized. The confidence intervals are based on the proportion of samples, from which the maximum RMS values were acquired, that contain the true maximum of the defect-free bearing RMS population.

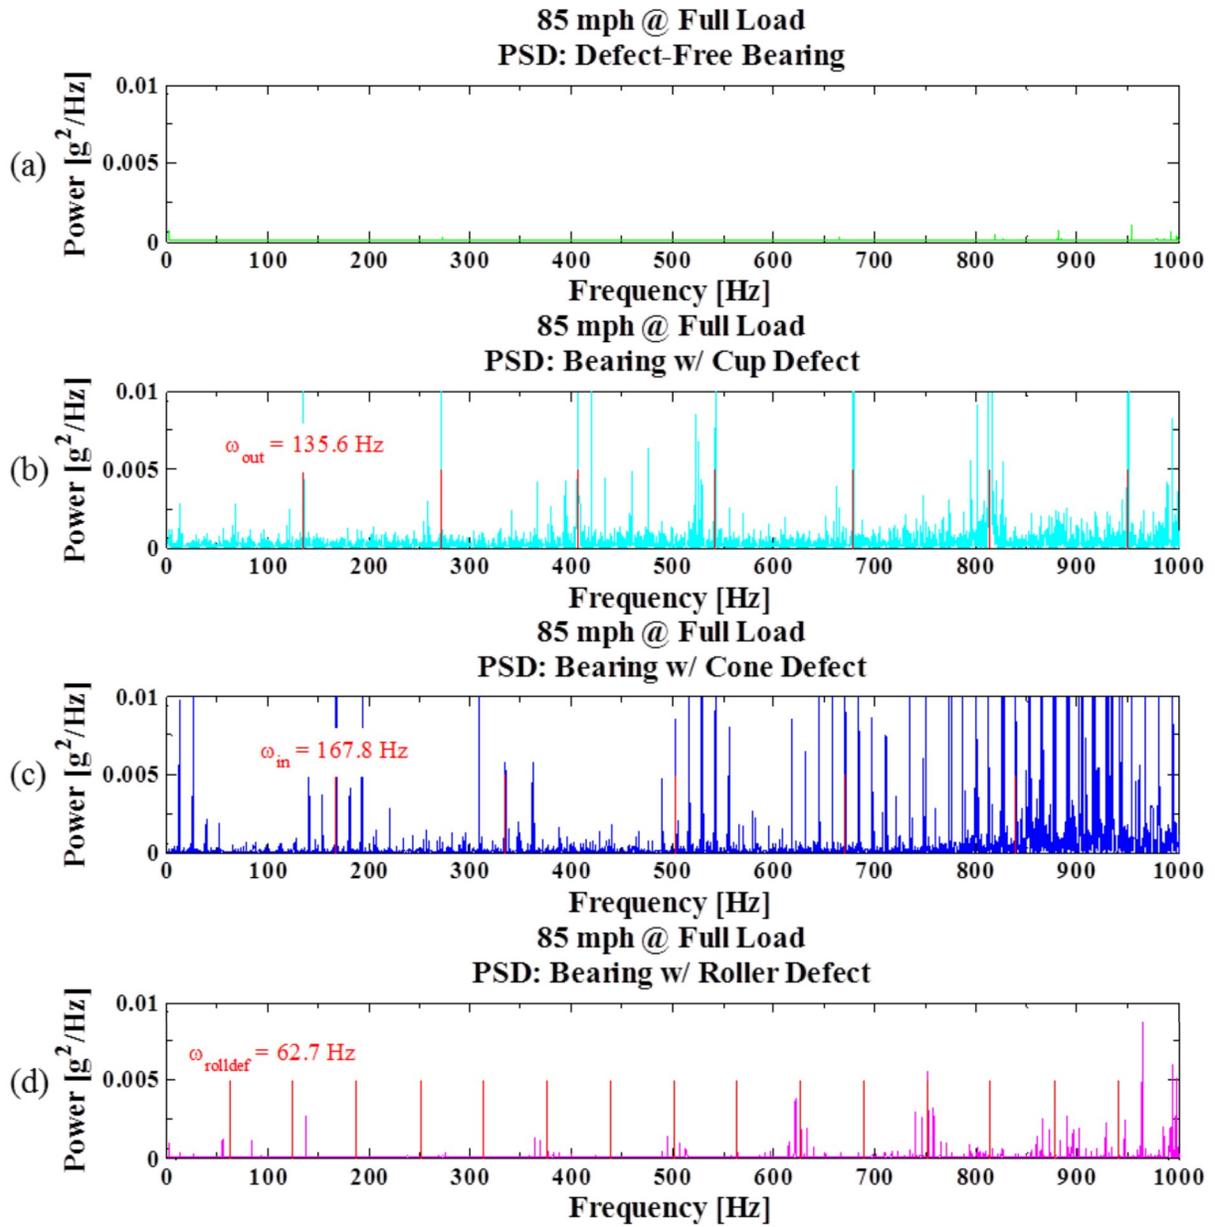
Figure 12 Frequency spectrum plots (0 – 1000 Hz) of (a) a defect-free bearing, (b) outer ring defect, (c) inner ring defect, and (d) a roller defect.

Figure 12 (d). Comparable to the cone-defect frequency spectrum, the roller-defect frequency spectrum also has numerous evenly-spaced peaks which are a cage frequency (ω_{cage}) apart.

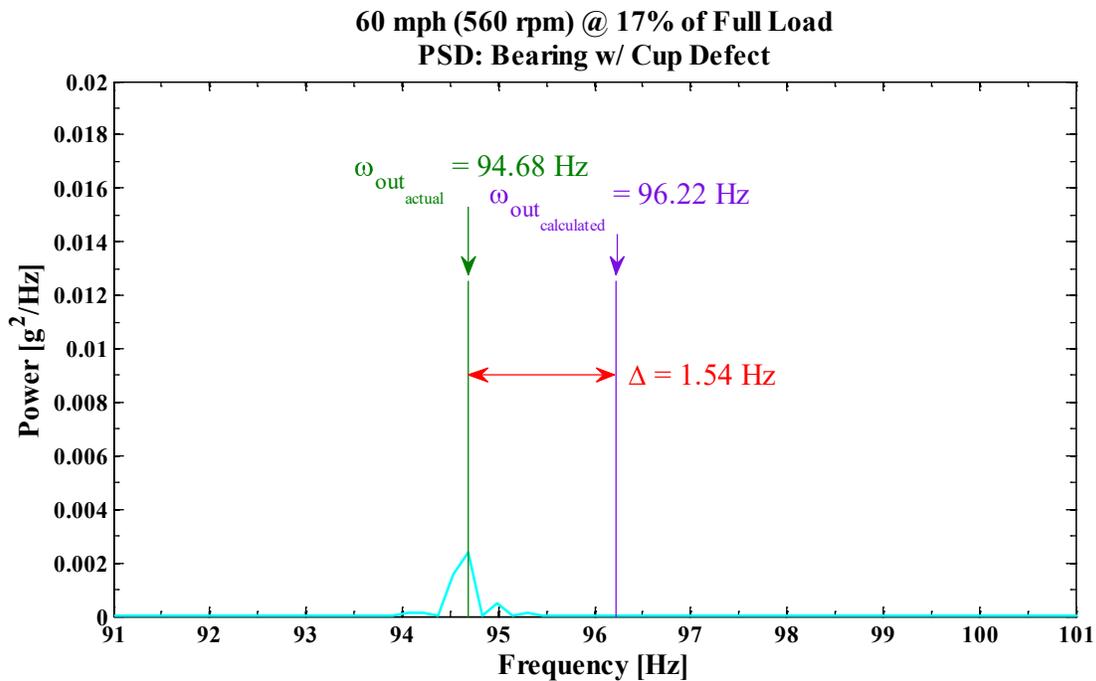
Figure 13 Power spectrum plot illustrating shifting of the cup defect frequency.

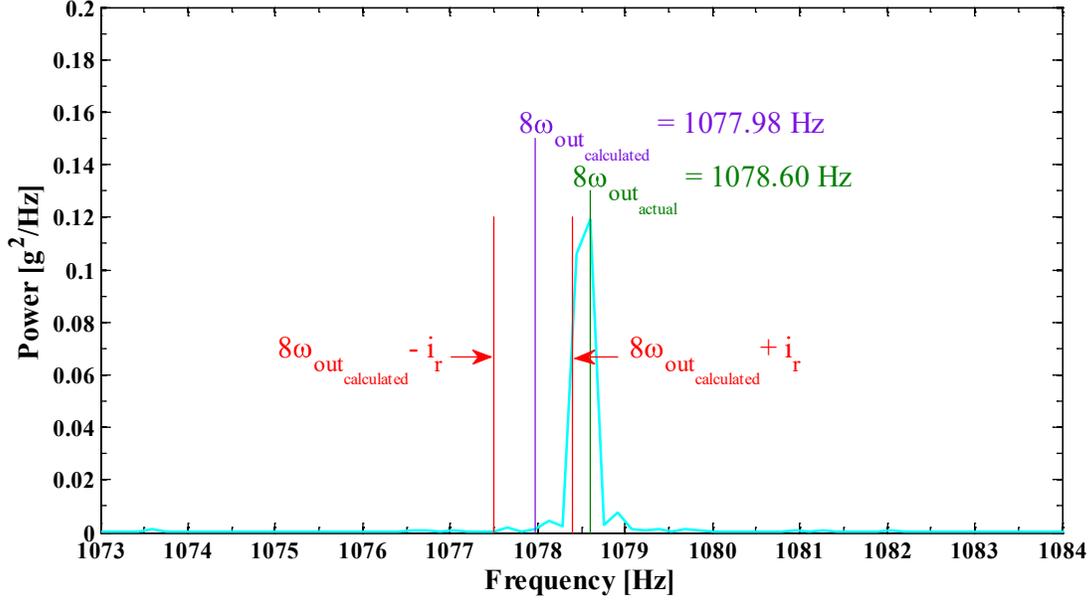
Figure 14 Power spectrum depicting shifting of the 8th harmonic of ω_{out} .

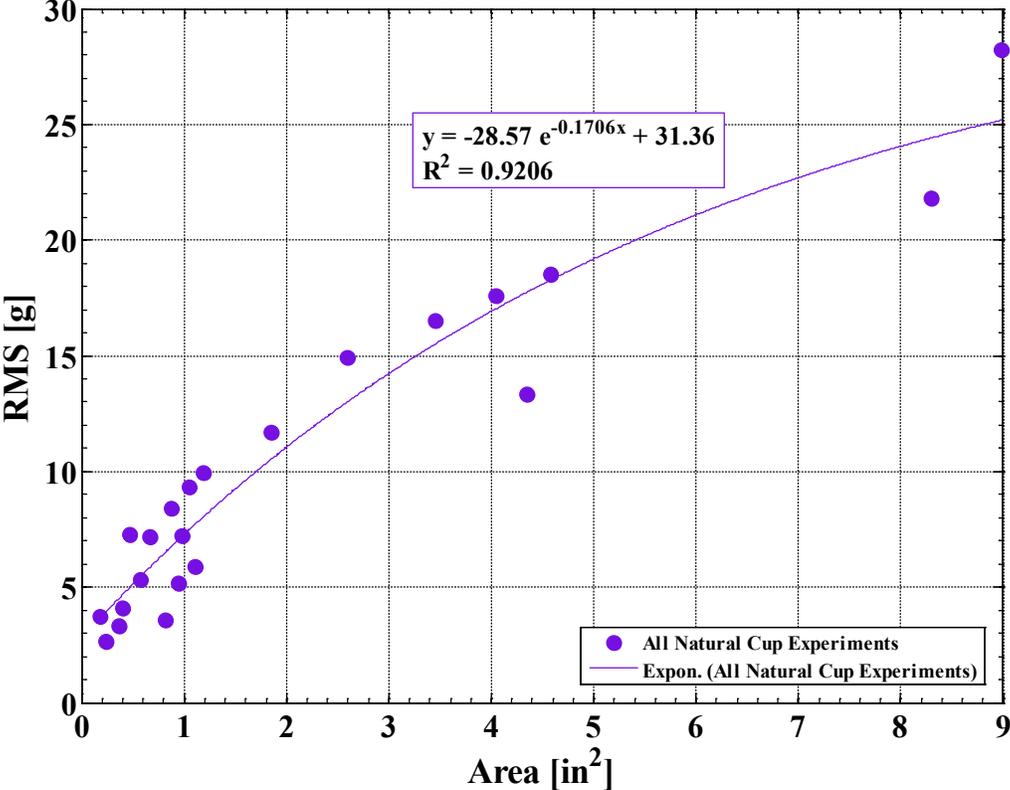
Figure 15 Cup defect size correlation at 85 mph and 100/125% of full load.

Utilizing the Cup Defect Size Correlation in Figure 15, an estimation of the localized defect's area is calculated. The RMS value at 85 mph and full load (refer to Table 3) is used to calculate the estimated defect area, which is 1.7 in.². Following teardown and disassembly the Chamber Tester, a thorough inspection of Bearing 2 was conducted. Upon inspection, a spall was discovered on Bearing 2, shown in Figure 21, which had a measured area of 1.9 in.². The predicted area underestimated the measured area of the cup spall detected in Bearing 2 with a percent error of 12%. The measured area in relation to the Cup Defect Size Correlation is displayed in Figure 22.

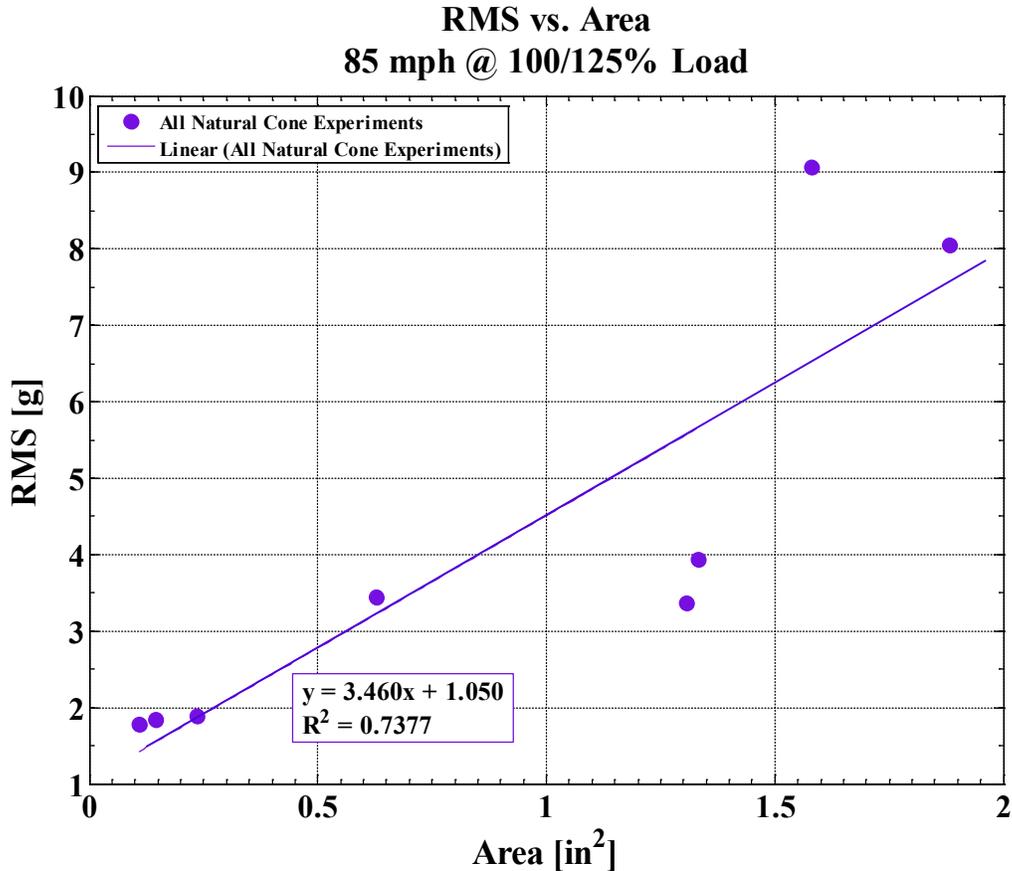
Figure 16 Cone defect size correlation at 85 mph and 100/125% of full load.

The defect area of the local defect detected in Bearing 2 is estimated using the Cone Defect Size Correlation in Figure 16. The RMS value at 85 mph and full load (refer to Table 6) is inputted into the defect size correlation equation, estimating the defect area as 1 in.². Following teardown and inspection of Bearing 2, a cone spall was discovered, depicted in Figure 23, which had a measured area of 0.4 in.². The predicted area overestimated the measured area of the cone spall detected in Bearing 2 with a percent error of 60%. Although this error seems significant, the algorithm still managed to detect a spall that occupies 0.9% of the cone raceway. The measured area in relation to the Cone Defect Size Correlation is exhibited in Figure 22.

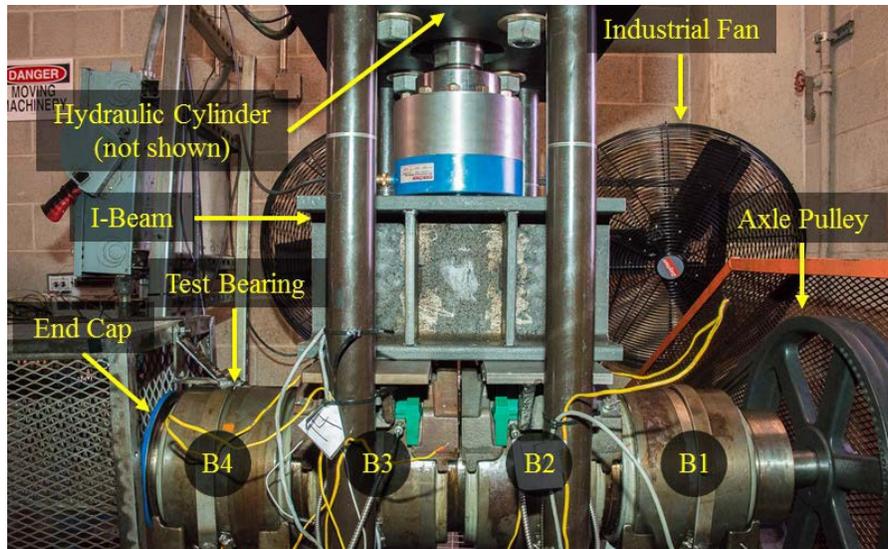
Figure 17: Photograph of Tester 1, a four-bearing dynamic test rig with a fixed-speed motor.

Because Tester 1, shown in Figure 17, is operated by a fixed-speed motor, different pulley sizes are required to change the test speed. Utilizing the four pulley sizes available in the laboratory, the test axle is able to rotate at angular velocities of 498, 562, 618, and 794 rpm, which correspond to train speeds of approximately 53, 60, 66, and 85 mph, respectively. Unlike Tester 1, Tester 2, depicted in Figure 18, utilizes a variable-speed drive motor which has a maximum speed of 85 mph based on the largest pulley size available in the laboratory, and is controlled by a variable frequency drive. Hence, Tester 2 is able to provide testing speeds ranging anywhere from 0 to 85 mph. Table 2 lists the ten speeds that were used to run the experiments for this study. For cooling, both testers employed two large industrial fans to provide cross-flow over the test axle, which simulated the airflow created by a moving train. Additionally, Tester 2 is enclosed within a temperature-controlled environmental chamber capable of producing ambient temperatures ranging from -40°C to 50°C . However, the majority of experiments were carried out in ambient temperatures ranging from 20 to 30°C .

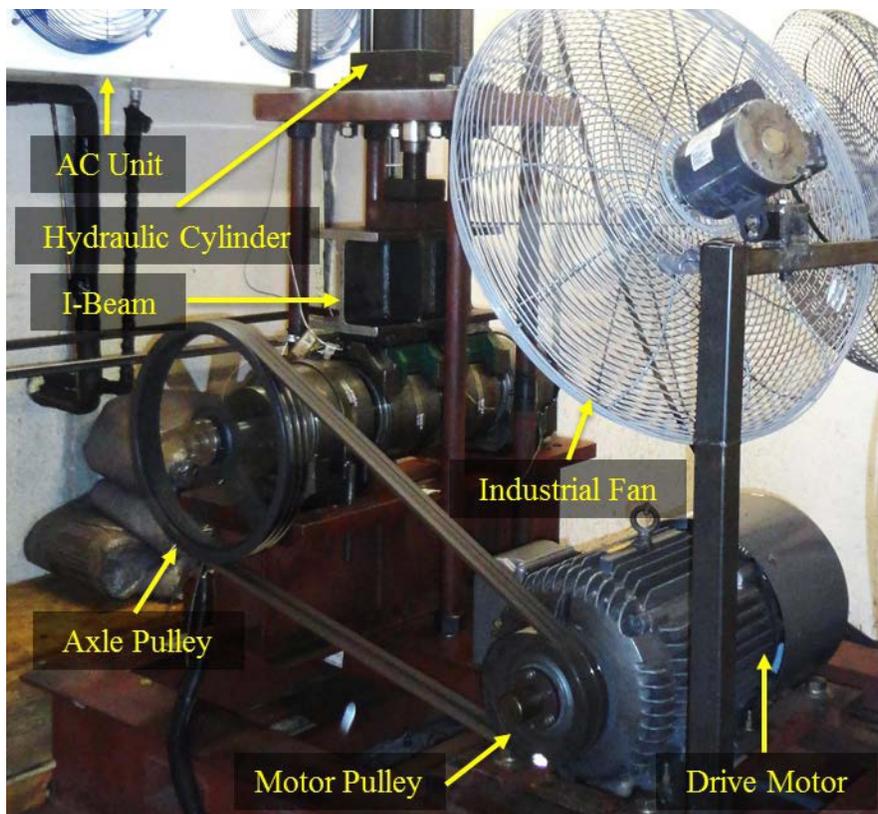
Figure 18: Photograph of Tester 2, a four-bearing dynamic tester with a variable-speed motor enclosed in a temperature-controlled environmental chamber.

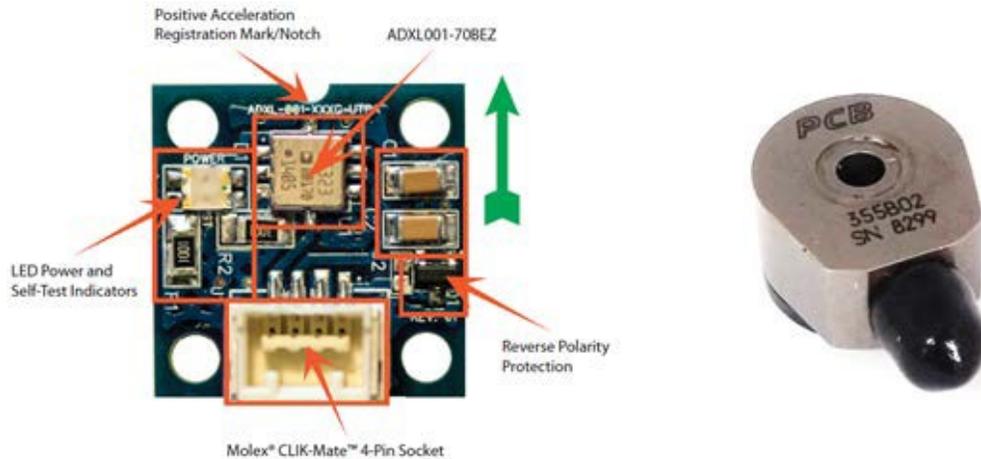
Figure 19: Labeled custom-built ADXL001-70 accelerometer courtesy of James Bantz (left), and PCB 355B02 accelerometer (right).

the ADXL required post-signal filtering, which was accomplished utilizing a sixteenth-order, low-pass filter with a 2.38 kHz cutoff frequency designed and manufactured by James Bantz.

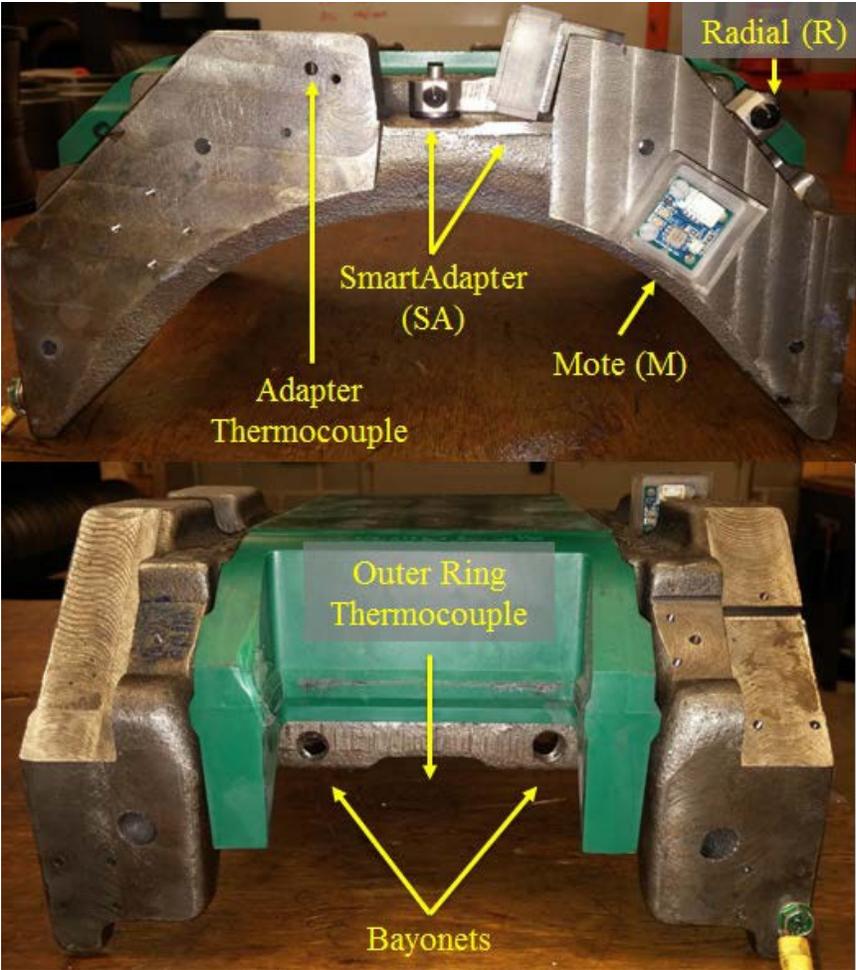
Figure 20: Photograph of indicated accelerometer and thermocouple locations on AdapterPlus™ bearing adapter.

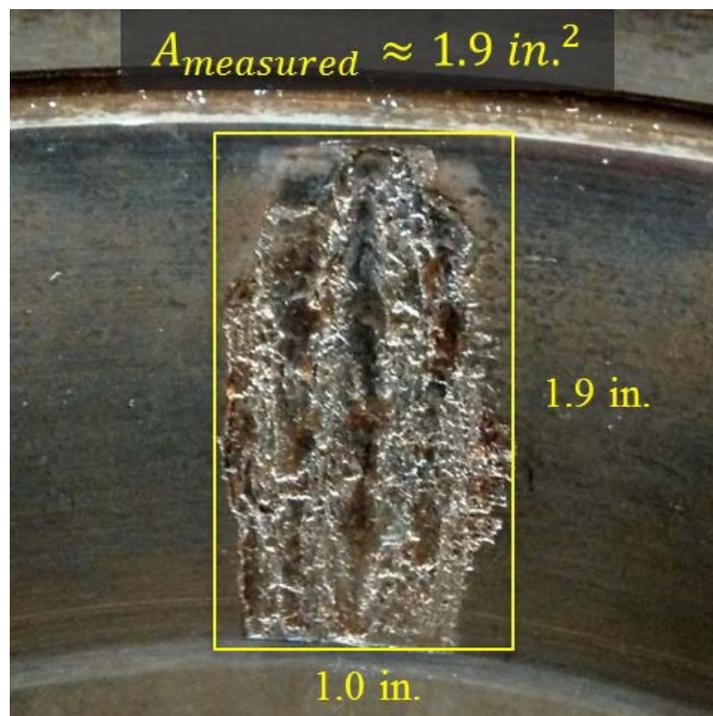
Figure 21 Photograph of the cup spall discovered in Bearing 2 following teardown.

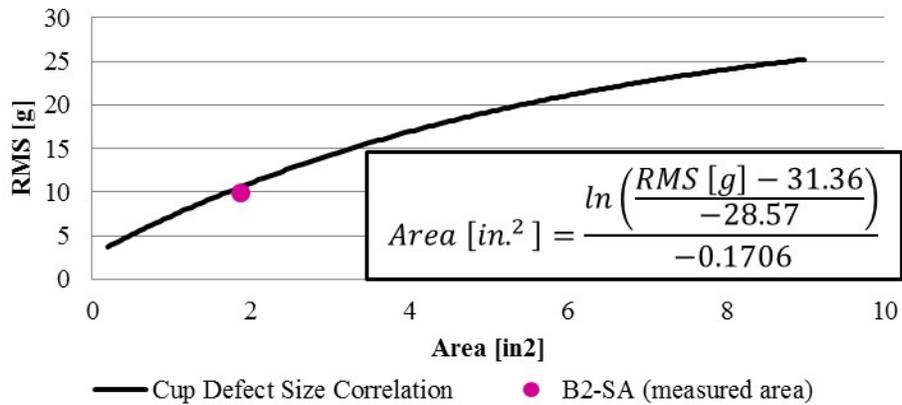
Figure 22 Measured area of Bearing 2 cup spall in relation to Cup Defect Size Correlation.

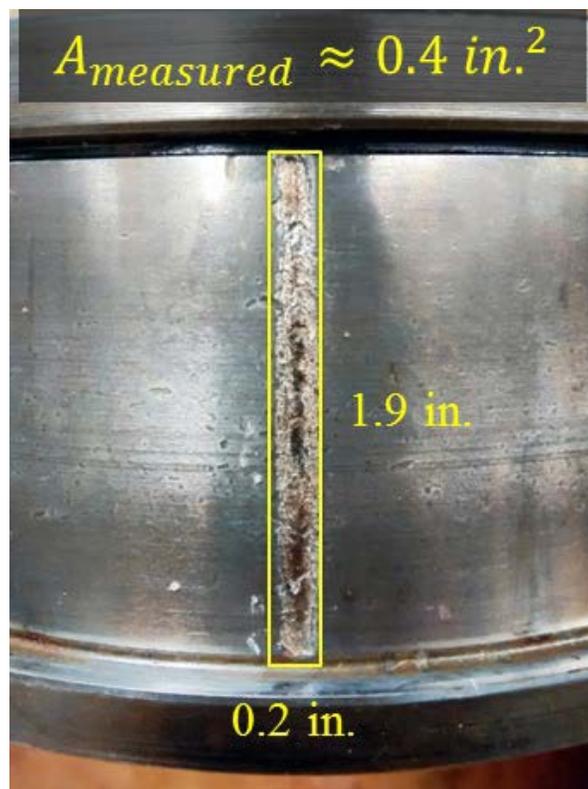
Figure 23 Photograph of cone spall detected in Bearing 2 following inspection.

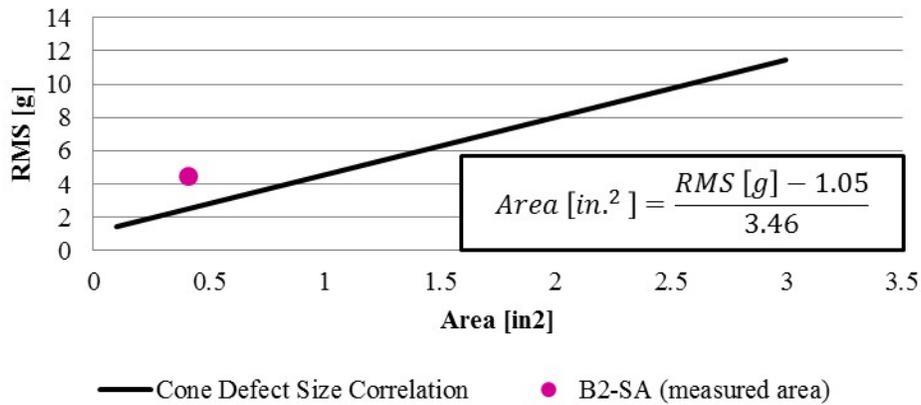
Figure 24 Measured area of Bearing 2 cone spall in relation to Cone Defect Size Correlation.

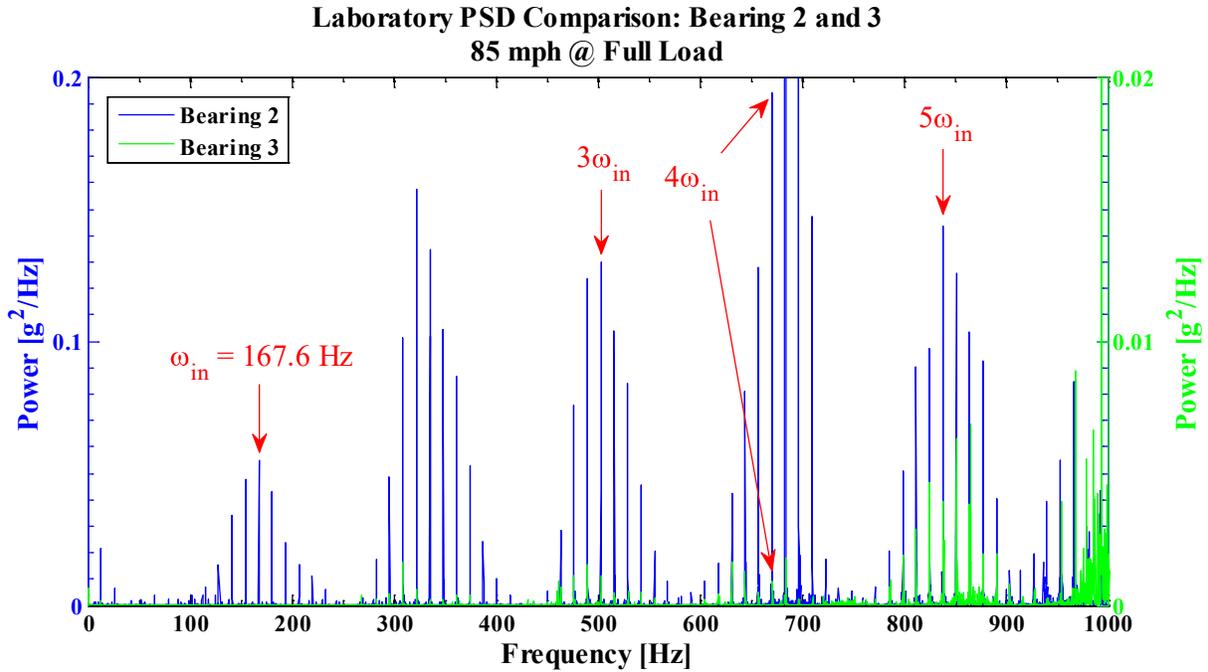
Figure 25 Transposed PSD plots of Bearing 2 and Bearing 3 demonstrating cross-talk at the indicated ω_{in} harmonics.

Inspection of Bearing 3, revealed the absence of a defect. The results in Level 2 can be explained by a phenomenon known as cross-talk – “the ability of a defective bearing to ‘share’ vibration signatures with the neighboring defect-free bearing” [16]. To demonstrate cross-talk between Bearing 2 and 3, PSDs of each bearing, generated with data collected at 85 mph and full load, are compared in Figure 25. The scaling of the PSD of Bearing 3 was minimized to 0.02 g^2/Hz so that the peaks corresponding to those of Bearing 2 would be distinguished. The red arrows in Figure 25 indicate the instances when ω_{in} harmonics of Bearing 2 are also seen in Bearing 3. The fundamental cone defect frequency of Bearing 2 is indicated for reference.

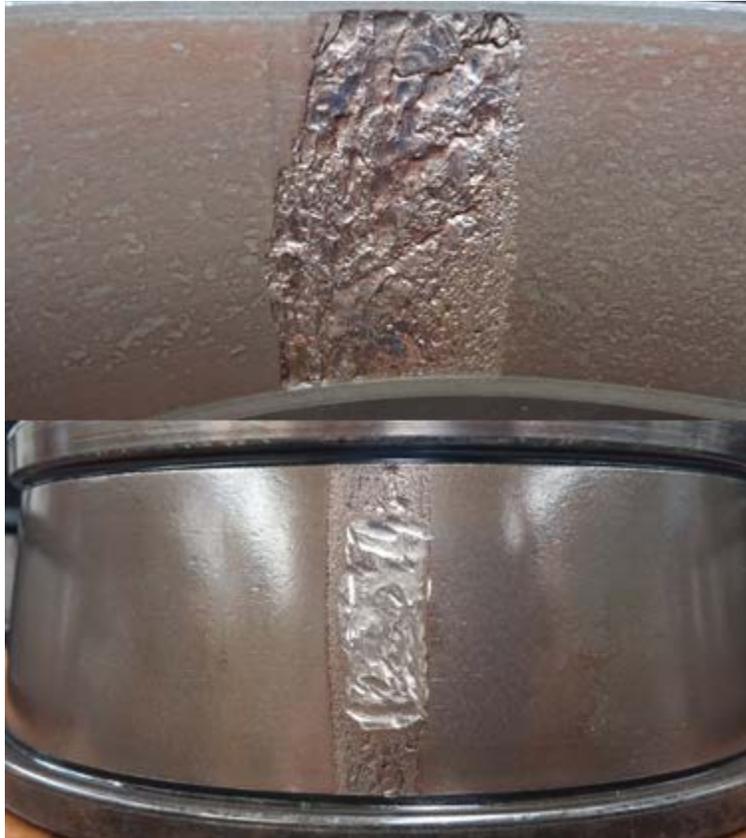
Figure 26 Photographs of the cup (top) and cone (bottom) defects discovered in Bearing 2 following inspection.

Upon teardown and disassembly of Bearing 2, inspection revealed defects present on the inner and outer rings, shown in Figure 26. Pitting was observed in the loaded region of the cup spall and across the surface of the cone raceway. The combined defect area of both asperities was measured as 3.5 in.².

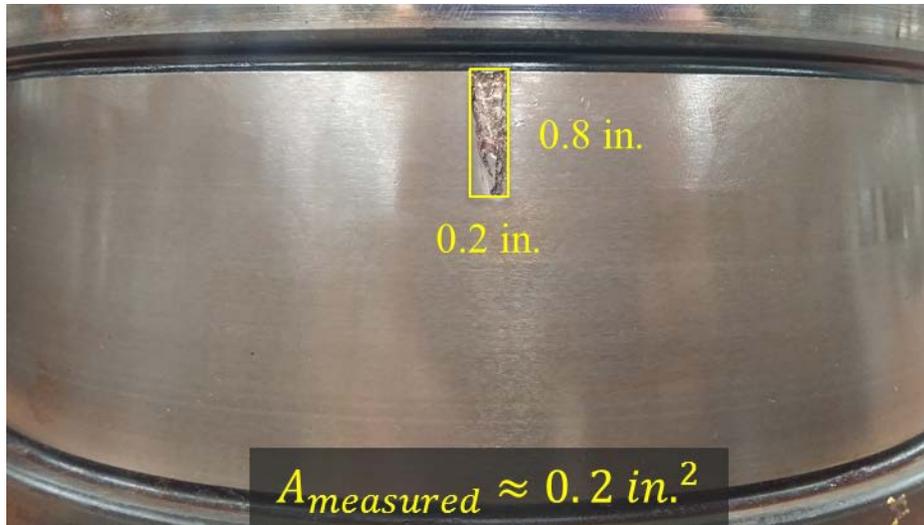
Figure 27 Photograph of cone defect identified in Bearing 3 following teardown and inspection.

Inspection of Bearing 3 unveiled a cone spall, which is seen in Figure 27. Measurement of the area was 0.2 in.². Difficulty in identifying the defect type may have been a consequence of the defect's small size and cross-talk from the neighboring bearing. Validation of cross-talk is provided in Figure 28, where the arrows indicate instances of cup defect harmonics witness by Bearing 3 from the adjacent top-loaded bearing.
