Development, optimization, and implementation of a vibration based defect detection algorithm for railroad bearings

A Thesis

MASTER OF SCIENCE

Major Subject: Mechanical Engineering

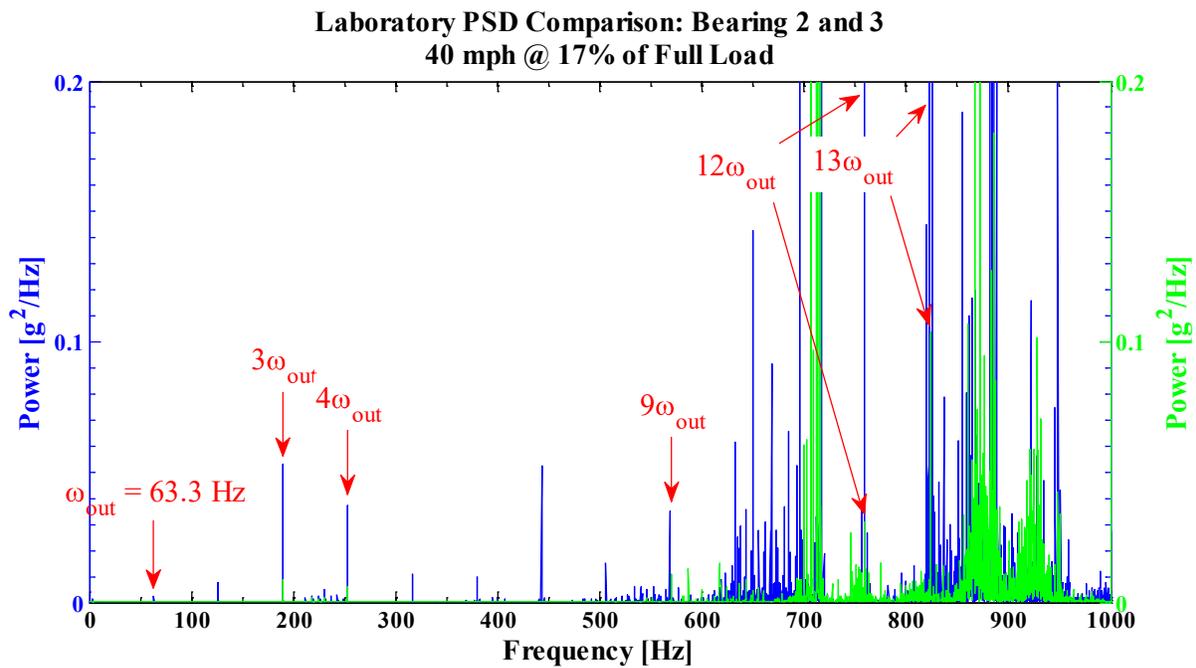
Figure 28 Transposed PSD plots of Bearing 2 and Bearing 3 demonstrating cross-talk at a few of the indicated ω_{out} harmonics.

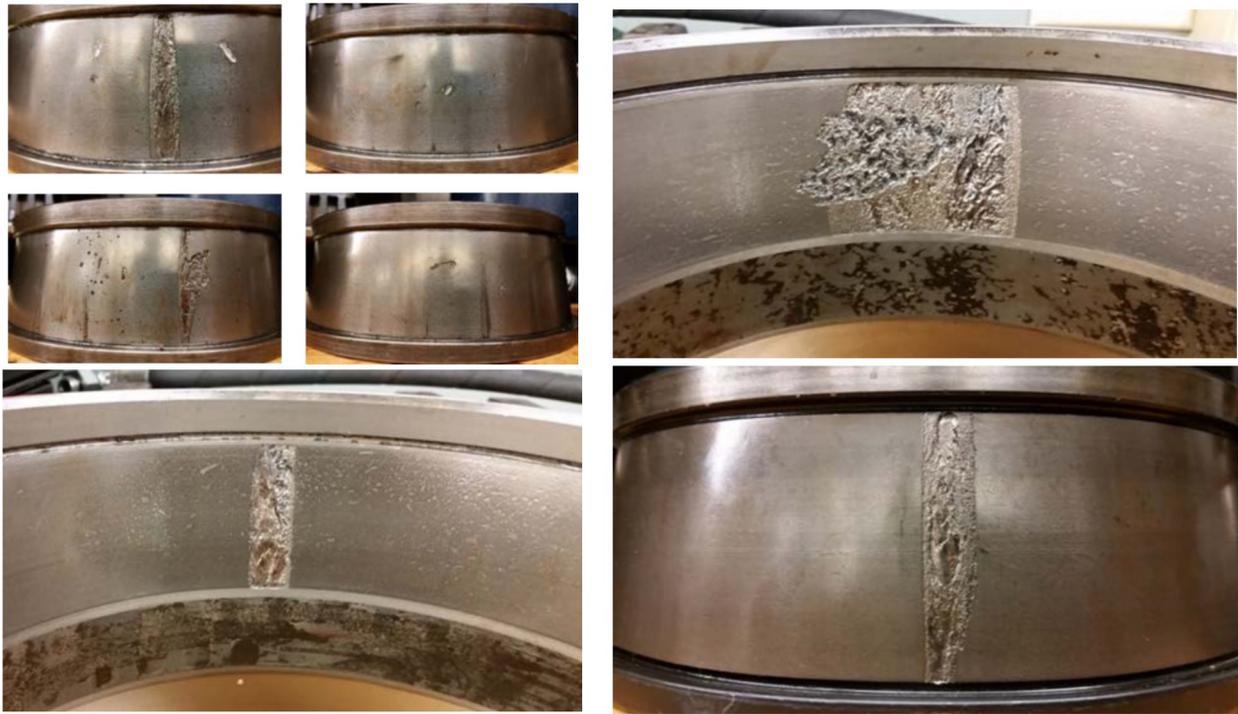
Figure 29 Photographs of Bearings L1 cone defect (227623-IB, top left), R2 cup defect (D-01-01397, top right), L3 cup defect (C-10-23446, bottom left), and R4 cone defect (MT-32, bottom right).

In total, four defective bearings (two containing cup defects and two containing cone defects) were used in the field test. Photographs of the four defective components are provided in Figure 29. The defect area for each of the bearings can be found in Table 14.

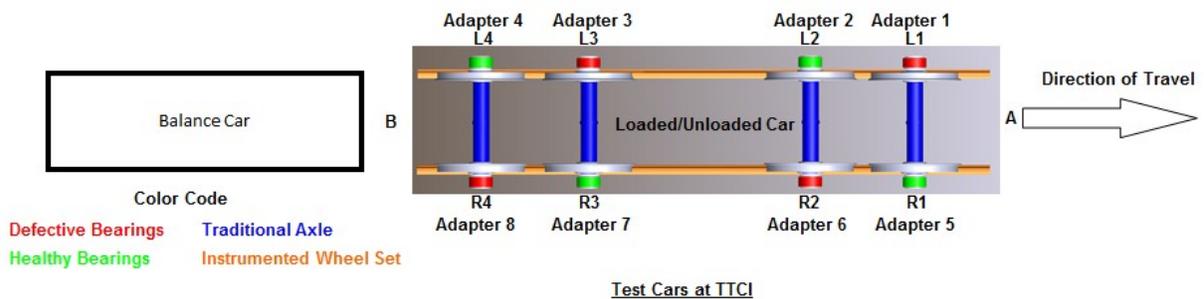
Figure 30 Top view depiction of bearing and adapter locations.

simultaneously. Due to this limitation, the location of the filter varied between Ends A and B of the railcar, refer to Figure 30, in order to capture the vibration signatures of all eight bearings. Two LabVIEW™ operated National Instruments (NI) data acquisition systems (DAQs) were employed to sample and collect data from the nine thermocouples and sixteen accelerometers. The sampling rates (SR) of the ADXLs and PCBs were 5.556 kHz and 25.6 kHz, respectively. Thermocouple data was averaged and sampled every 15 seconds. Data was recorded continuously to ensure all pertinent testing conditions were captured. New data files were created the moment a desired test speed was reached in an effort to better organize the acquired data. In addition to recording acceleration and temperature data, the locomotive's tachometer data was also collected and monitored, which helped determine when steady state speed was achieved.

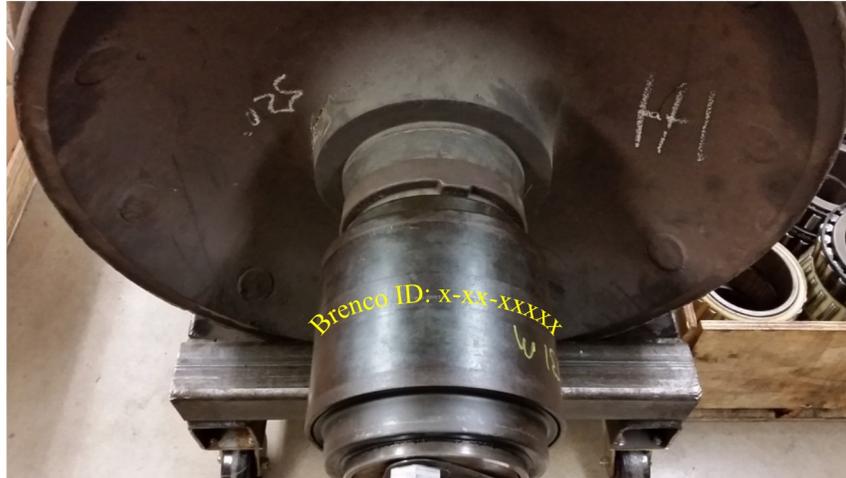
Figure 31 Typical bearing installation.

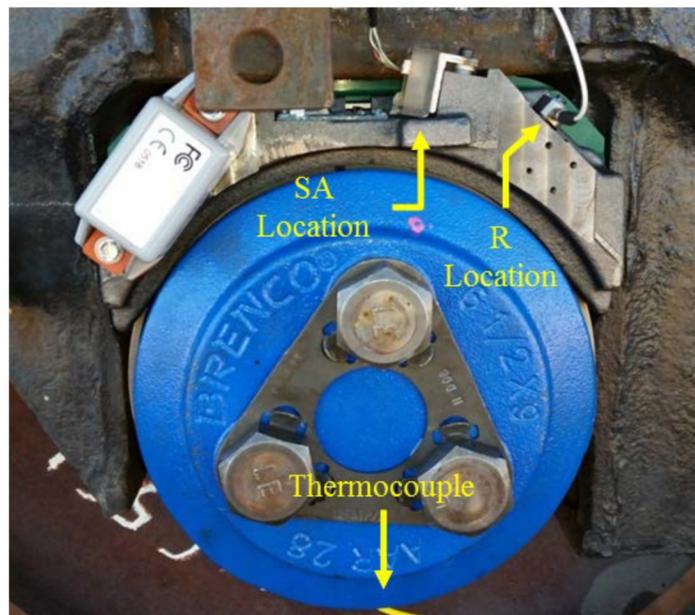
Figure 32 Sensor locations.

Sensors were placed outboard (OB) on the bearing adapters. ADI ADXL001-70g and PCB 355B02 accelerometers were secured in the SmartAdapter (SA) and Radial (R) location, respectively, as indicated in Figure 32. A K-type thermocouple was secured mid-length of the bearing on the surface of the lower hemisphere with military grade duct tape.

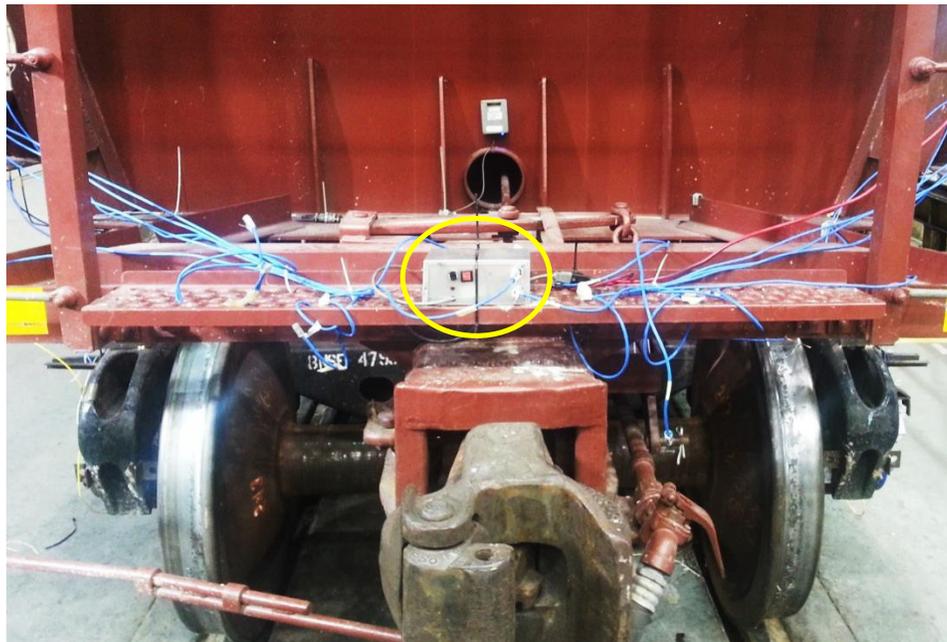
Figure 33 Location of sixteenth order, low pass filter for ADXL accelerometers.

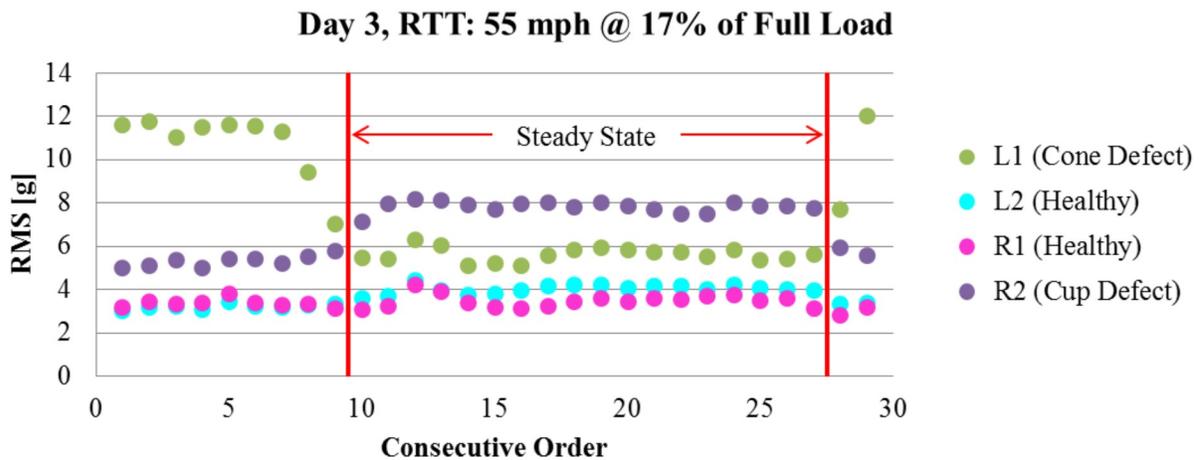
Figure 34 RMS values of the bearings located on End A of the railcar while operating at 55 mph under 17% of full load (unloaded or empty railcar) on the RTT plotted in consecutive order.

Initial analysis of the acquired data revealed high variations in RMS values at the beginning and end of various test segments run exclusively on the RTT, as depicted in Figure 34. This event was observed in End A at 17% of full load for speeds of 40, 50, 55, 60, and 65 mph, and End B at 17% of full load for tests run at 55 and 65 mph, and full load at 55 and 60 mph. Cause of these variations in vibration may be due to track related inconsistencies. The region where RMS values were representative of the majority of RMS values recorded, referred to as the “steady state” region, were analyzed in addition to the values recorded on the PTT. An example of the “steady state” region is displayed in Figure 34 bordered by two parallel red lines. An updated summary of the sample windows analyzed is provided in Table 20.

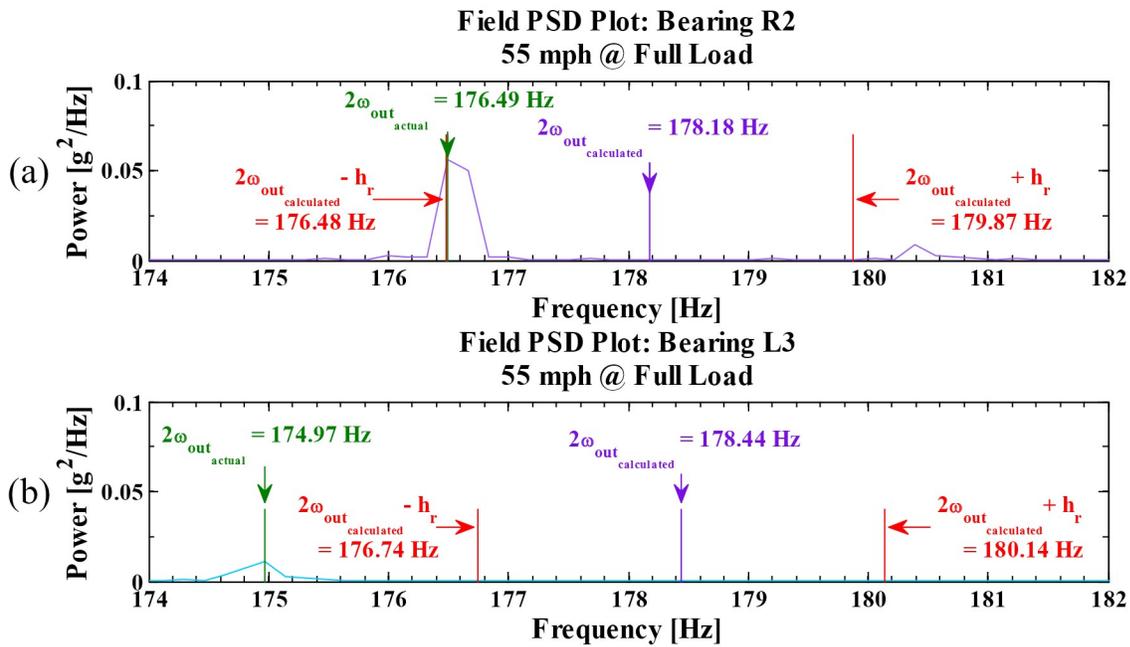
Figure 35 PSD plots of (a) Bearing R2 and (b) Bearing L3 with indicated cup defect frequency locations and hunting ranges.

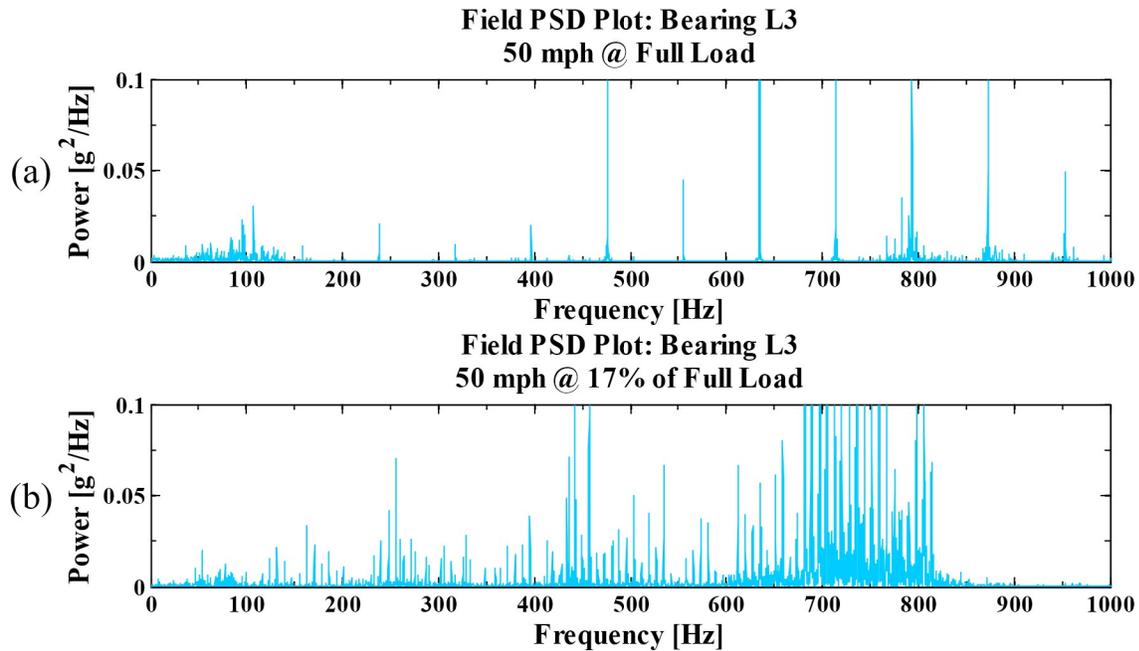
Figure 36 PSD plots of Bearing L3 operating at 50 mph under (a) full load and (b) 17% of full load.

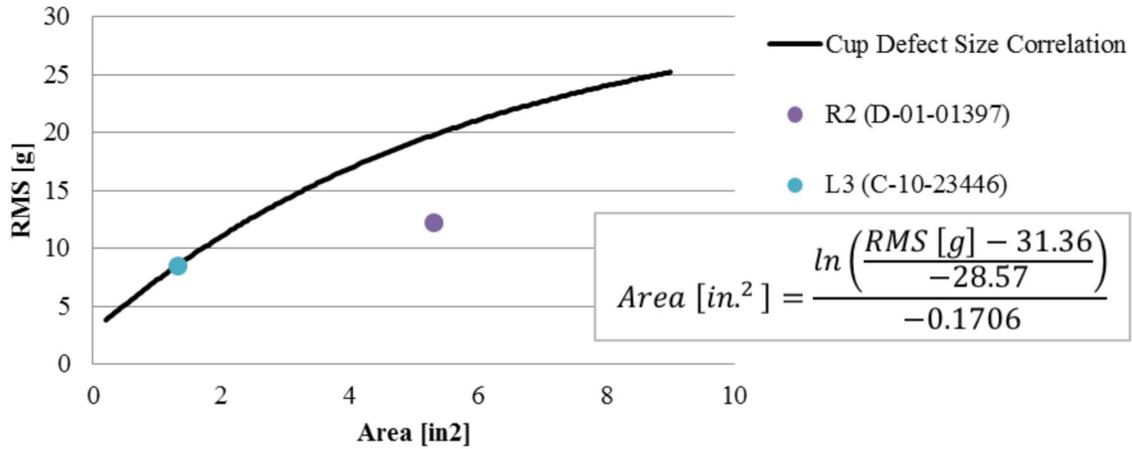
Figure 37 Location of L3 and R2 measured defect areas and their corresponding RMS values on the Cup Defective Size Correlation for 85 mph and 100/125% of full load.

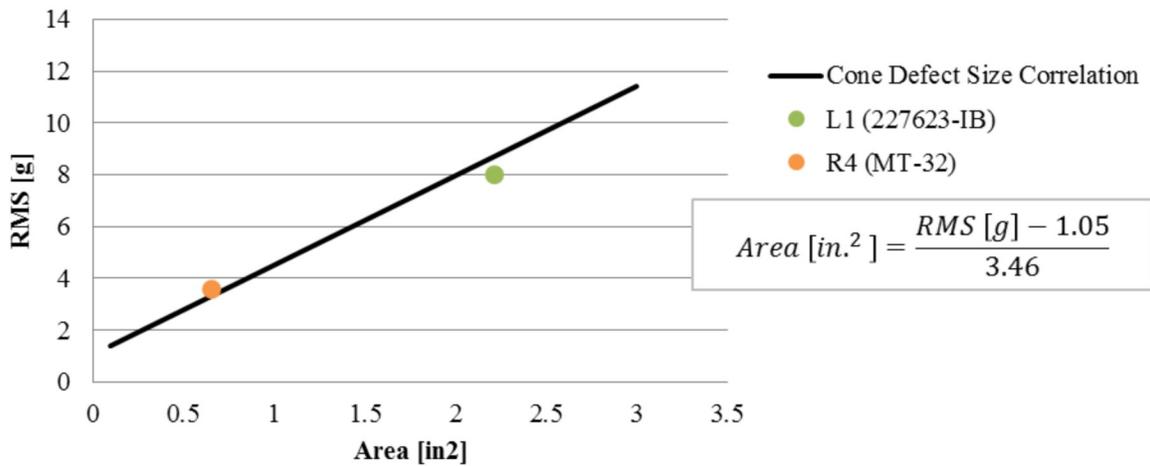
Figure 38 Location of L1 and R4 measured defect areas and their corresponding RMS values on the Cone Defective Size Correlation for 85 mph and 100/125% of full load.

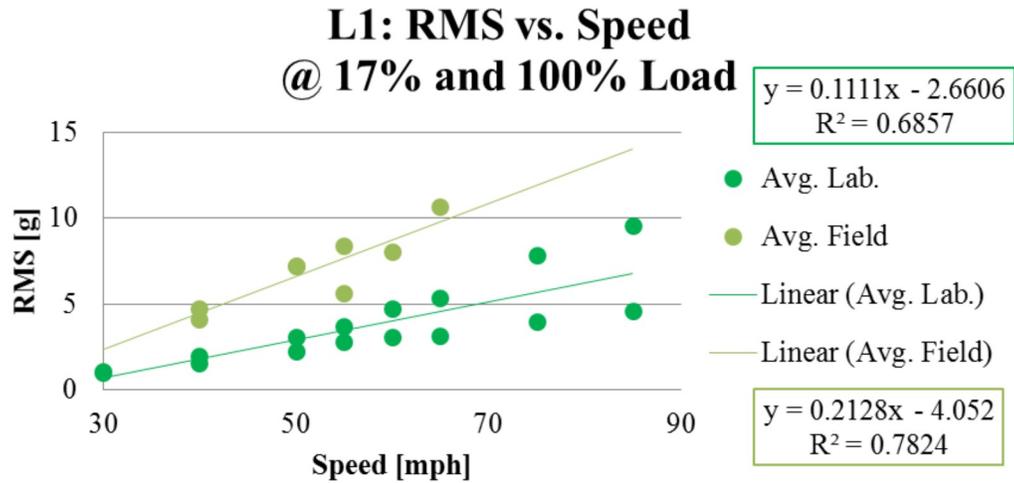
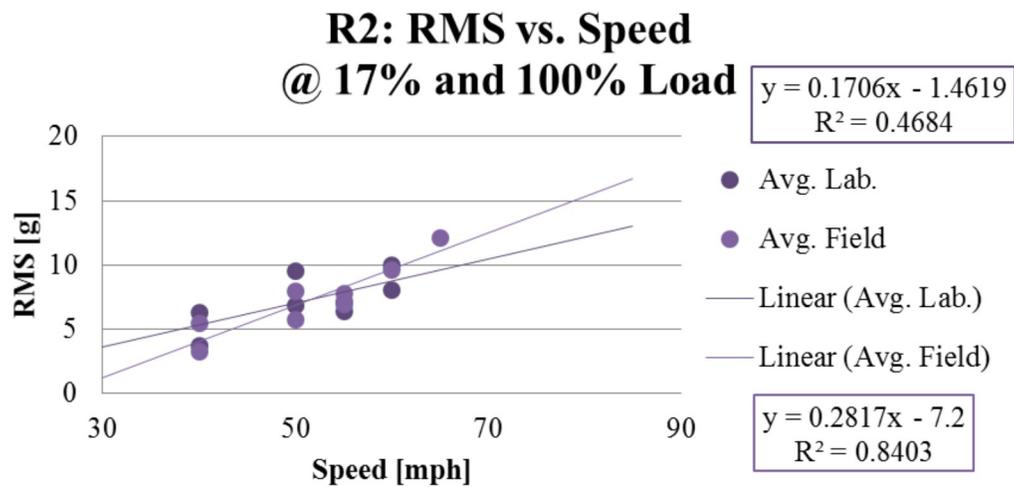
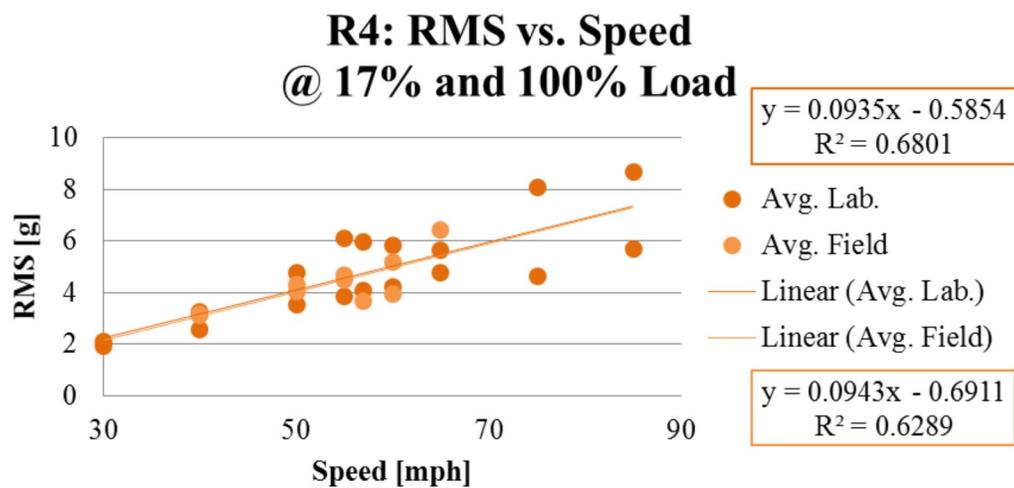
Figure 39 Comparison plots of laboratory- and field-acquired RMS values for Bearings L1 (top), R2 (middle), and R4 (bottom).

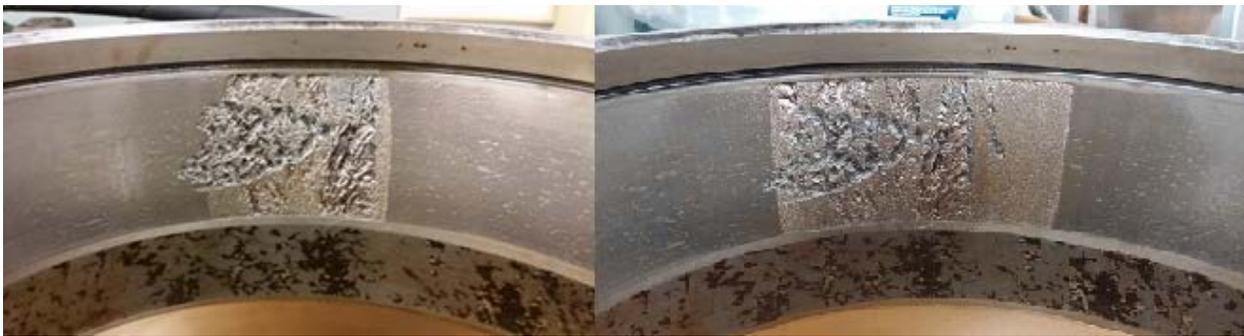
Figure 40 Photograph of Bearing R2 cup defect prior to field testing (left) and following completion of laboratory testing (right).

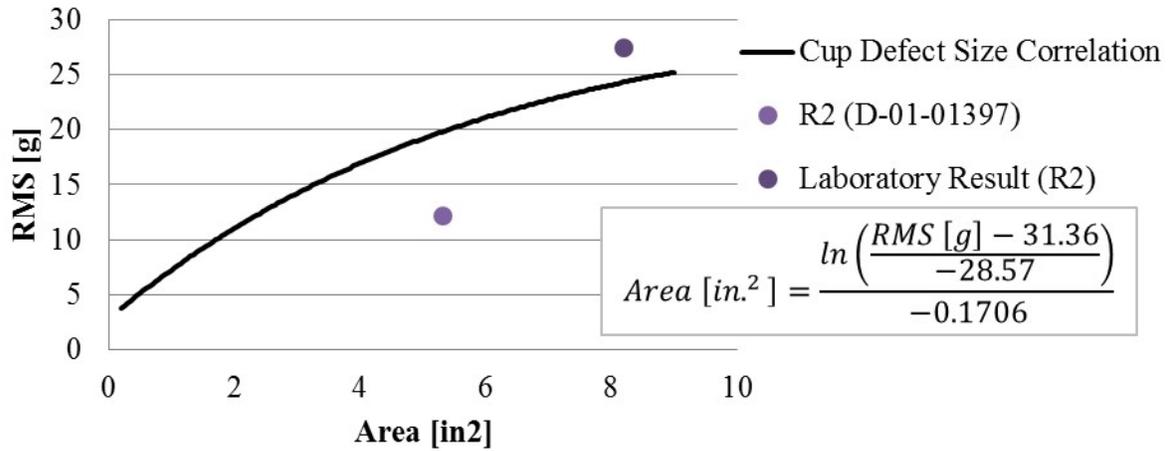
Figure 41 Locations of Bearing R2 cup defect area measurements prior to field testing and following completion of laboratory testing.

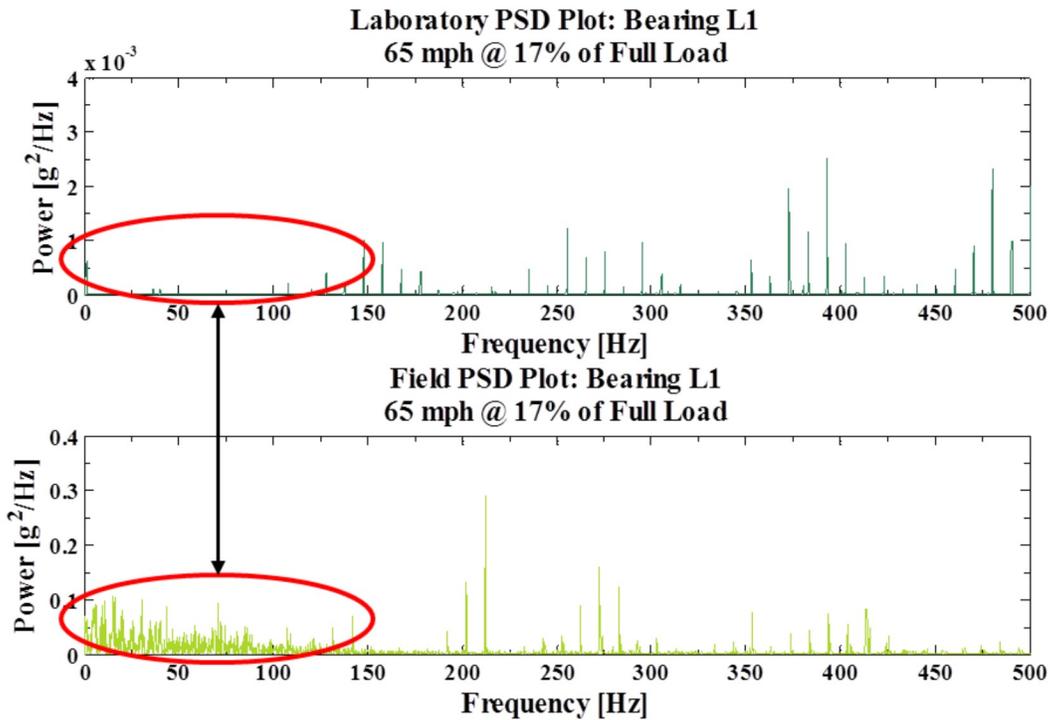
Figure 42 Bearing L1 PSD plot comparison between (a) laboratory-generated data and (b) field-generated data at 65 mph and 17% of full load.

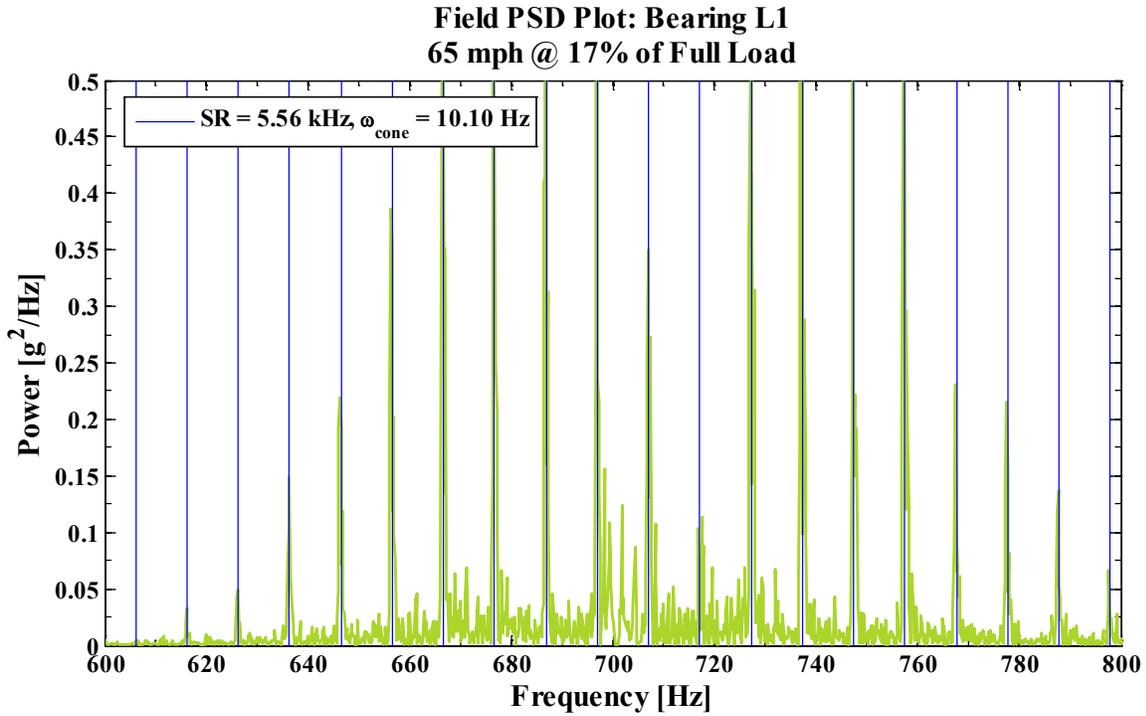
Figure 43 Field PSD plot of L1 at 65 mph and 17% of full load with ω_{cone} defined harmonic lines within 600 and 800 Hz.

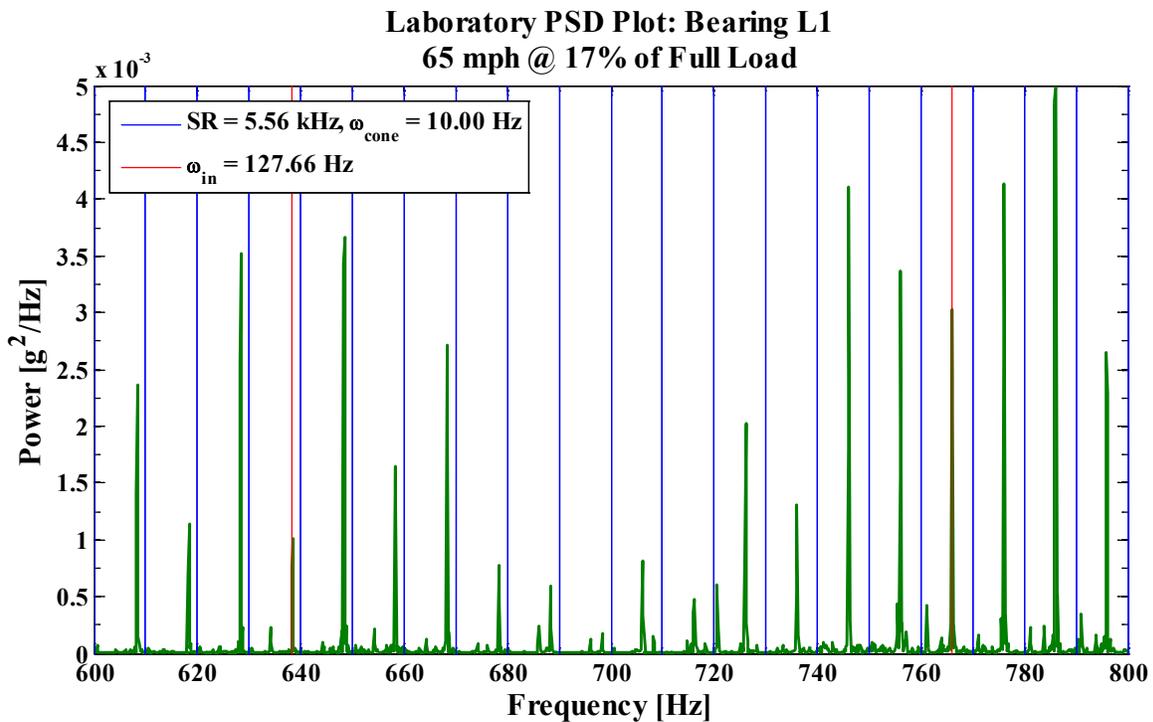
Figure 44 Laboratory PSD plot of L1 at 65 mph and 17% of full load with ω_{cone} and ω_{in} defined harmonic lines within 600 and 800 Hz.

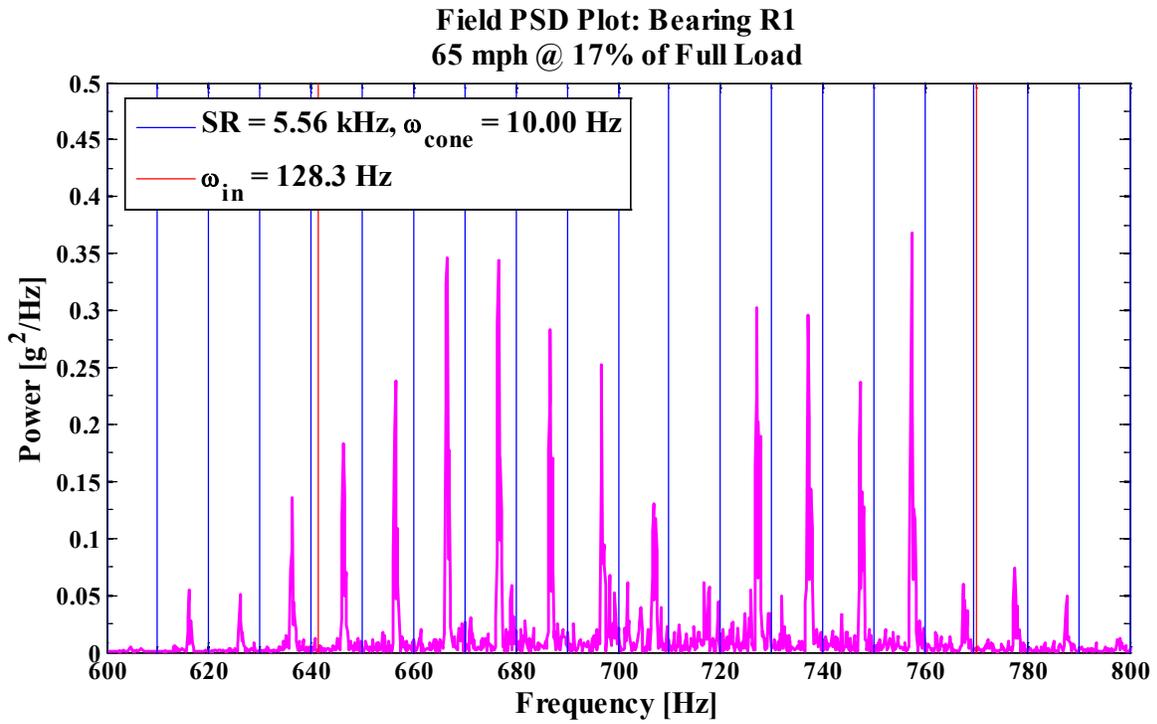
Figure 45 Field PSD plot of R1 (healthy) at 65 mph and 17% of full load with ω_{cone} and ω_{in} defined harmonic lines within 600 and 800 Hz.
