Assessing the Performance of Reconditioned Railroad Tapered-Roller Bearings Used in Freight Rail Service

A Thesis

MASTER OF SCIENCE IN ENGINEERING

Major Subject: Mechanical Engineering

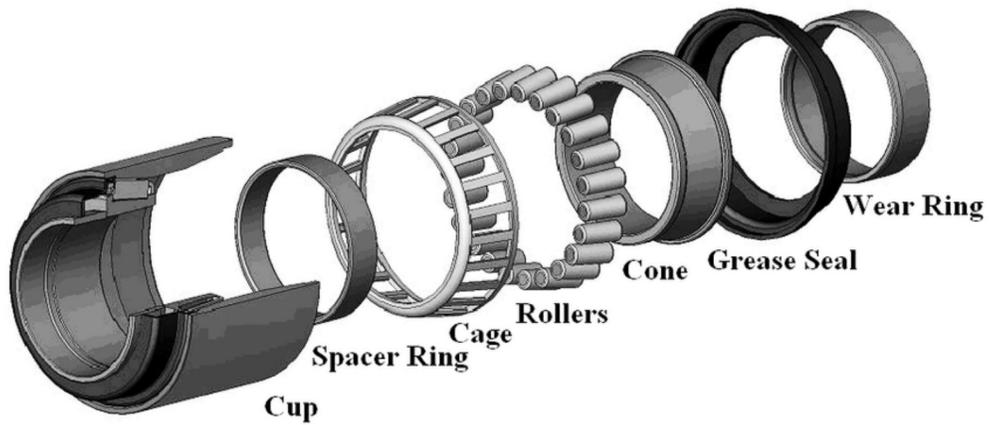
Figure 1. Typical railroad tapered-roller bearing components

Rail freight transportation has been one of the largest utilized methods of transporting cargo in the United States. The modern trains can haul 100 railcars or more with each freight railcar weighing between 30 to 130 tons. Each railcar is equipped with two bogies that are located at each end of the railcar. The bogies consist of the suspension components that include the springs, dampers, wheels, axles, and tapered-roller bearings to support the weight of the railcar. A single bogie contains two wheel-axle assemblies, corresponding to a total of eight tapered-roller bearings per freight railcar. The tapered-roller bearing is comprised of three essential components including the inner ring (cone), outer ring (cup), and the rollers. Each cone holds 23 rollers which are secured via a cage, thus producing one cone assembly. A single tapered-roller bearing consists of one cup that houses two cone assemblies, separated with a spacer ring. To prevent any foreign materials or debris from contaminating the lubricant in the bearing, each bearing is secured with two seals. An exploded view of the modern freight tapered-roller bearing and its components is shown in Figure 1.

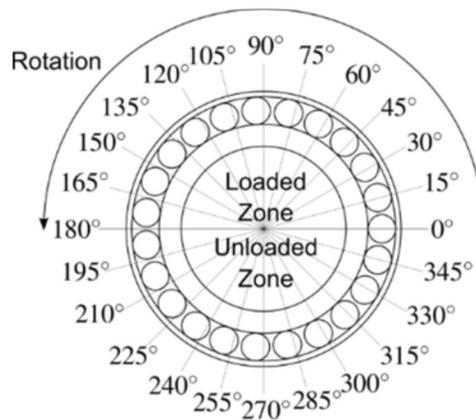
Figure 2: Schematic showing the loaded and unloaded zones with the rotation of the inner ring

The load of a freight railcar is applied onto the bearing outer ring (cup), causing the cup to stay stationary when in transit. As the freight train is in motion, the cup stays static while the inner rings (cones) are able to rotate freely in the cup. This causes the cone to cycle in and out of the loaded and unloaded zones, as depicted in Figure 2. Due to the cone cycling through the loaded zone, the cone experiences lower stresses and wear when compared to a bearing cup. The rollers receive the least amount of wear and stress because they revolve and rotate around the cone. Thus, the cup is the most susceptible to spalling because it sustains the most stress and wear.

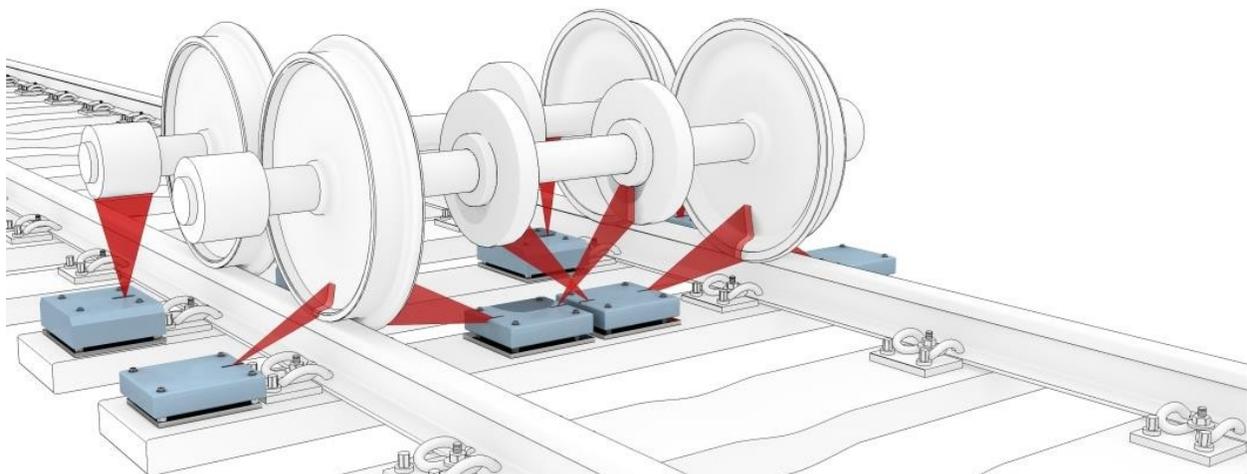
Figure 3: Example of a wayside Hot-Box Detector (HBD) [8]

Hot-box detectors (HBDs), displayed in Figure 3, use non-contact infrared sensors to measure the temperature emitted from the bearings, axles, brakes, and wheels when they roll past the detector. In North America, there are over 6,000 HBDs in use, making HBDs the most utilized bearing condition monitoring systems [2]. Each HBD is placed every 40-rail km (25 mi) to 64-rail km (40 mi) on average depending on the rail-track traffic. If any bearing is operating at a temperature of 94.4°C (170°F) above the ambient temperature or at a temperature that is 52.8°C (95°F) above the operating temperature of the mate bearing that shares the same axle, the HBD will alert the train operator. Some railroads have adapted the use of HBDs to look for bearings operating at temperatures hotter than the average temperature of all bearings on the same side of the train. These bearings are identified as “warm trending” bearings and are flagged without triggering an HBD alarm [3]. They are removed from service via wheelset replacement

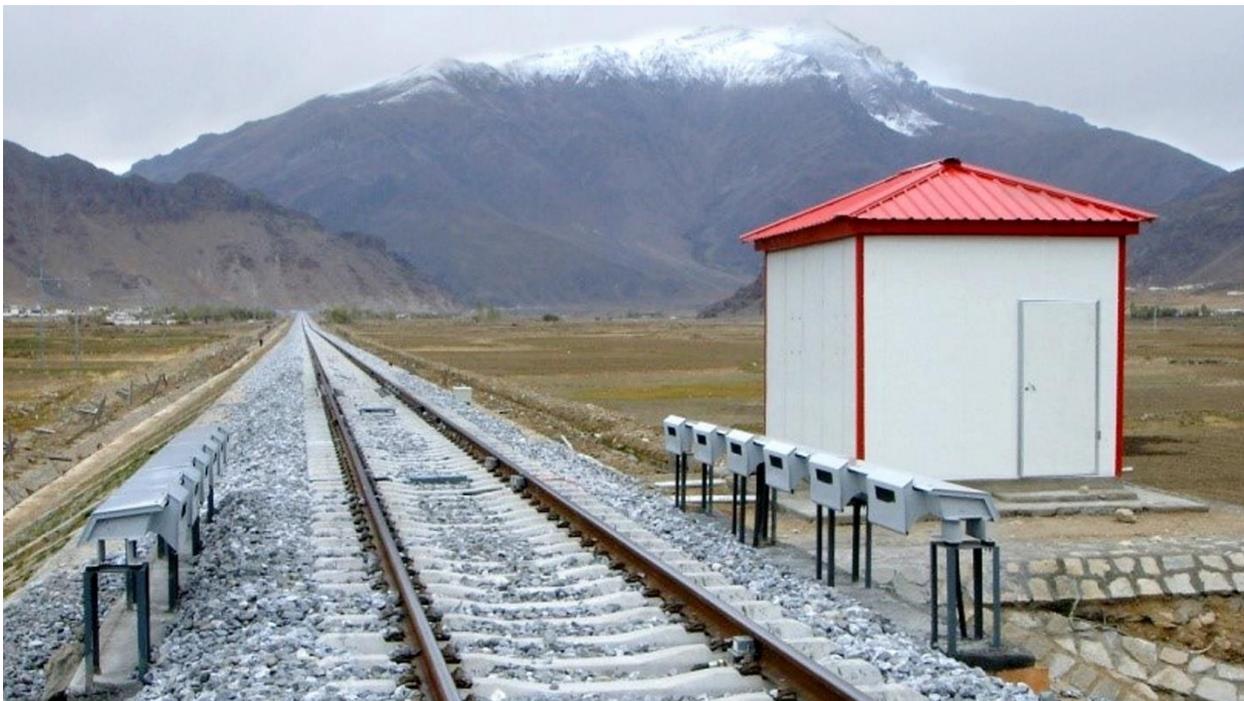
Figure 4: Photograph of Trackside Acoustic Detection System site [10]

The Trackside Acoustic Detection System (TADS™), pictured in Figure 4, alerts the conductor of high-risk bearings. While TADS™ are reliable in detecting end-of-life bearings, they are not capable of detecting bearings with small defects that are in the early stages of initiation and propagation [9]. Many defective bearings may never be detected by TADS™ because: (1) a high-risk defect is one that spans almost 90% of a bearing's raceway (i.e., a growler), and (2) there are less than 30 systems in service throughout North America, which means that many bearings may spend their entire service life without passing through a TADS™ station.

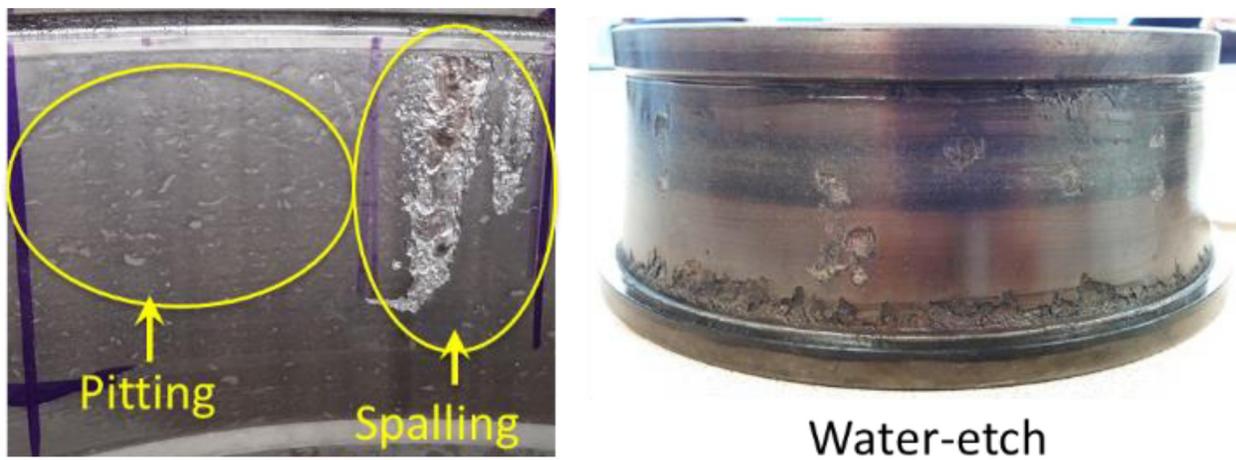
Figure 5: An example of localized defects (left) and distributed defect (right)

There are three main categories for classifying bearing defects, which include distributed, geometric, and localized. A distributed defect example is a water-etch on an inner ring (cone) raceway, shown in Figure 5 (right). A water-etch defect is caused when water enters the bearing

due to a defective seal. When moisture enters a bearing, the grease begins to degrade, resulting in metal-to-metal friction which will cause the raceways to wear at a faster rate. Geometric defects occur when there are inconsistencies in the manufacturing process that causes one or more of the bearing components to be out of tolerance. A bearing that has a geometric inconsistency can show no sign of surface flaw while still running at a higher operating temperature. Localized defects, shown in Figure 5 (left), are defects including cracks, pits, and spalls on one of the rolling components of the bearing.

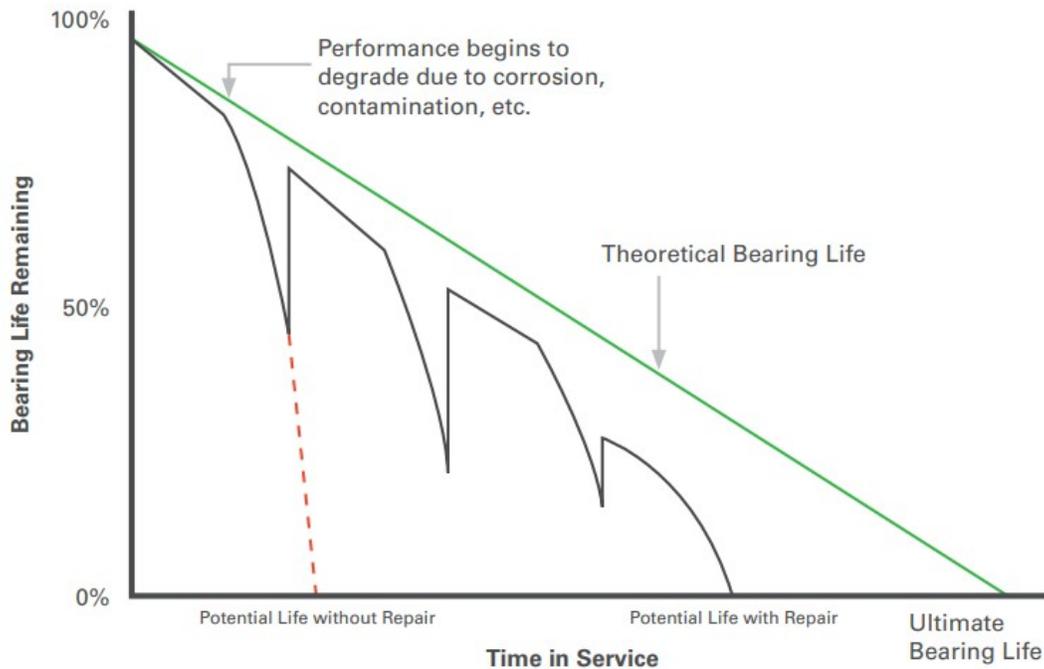
Figure 6: Potential life of a bearing with and without repair [15]

The reconditioning process has some valuable advantages that help benefit the railroad industry. One of the benefits is reduction of cost, with a repaired bearing having a savings of up to 70 percent off the total cost of a new bearing [14]. A reconditioned bearing is considered to have a better product quality because of repairs made on any worn parts that can cause unnecessary vibrations. If a bearing causes damage, this can affect the freight train during transport with downtime, maintenance and delivery schedules. A bearing's performance will reduce overtime due to any contamination or corrosion in the bearing. The life of a bearing can be extended by performing a bearing repair, shown in Figure 6, extending the life of the bearing closer to the theoretical bearing life. While a bearing is being inspected for the reconditioning process, any problem with the bearing can be found, mitigated, and prevented to avoid problem recurrence. Overall, the reconditioning process requires less lead time, less material, and less energy to repair a bearing than the time it takes to manufacture a new one.

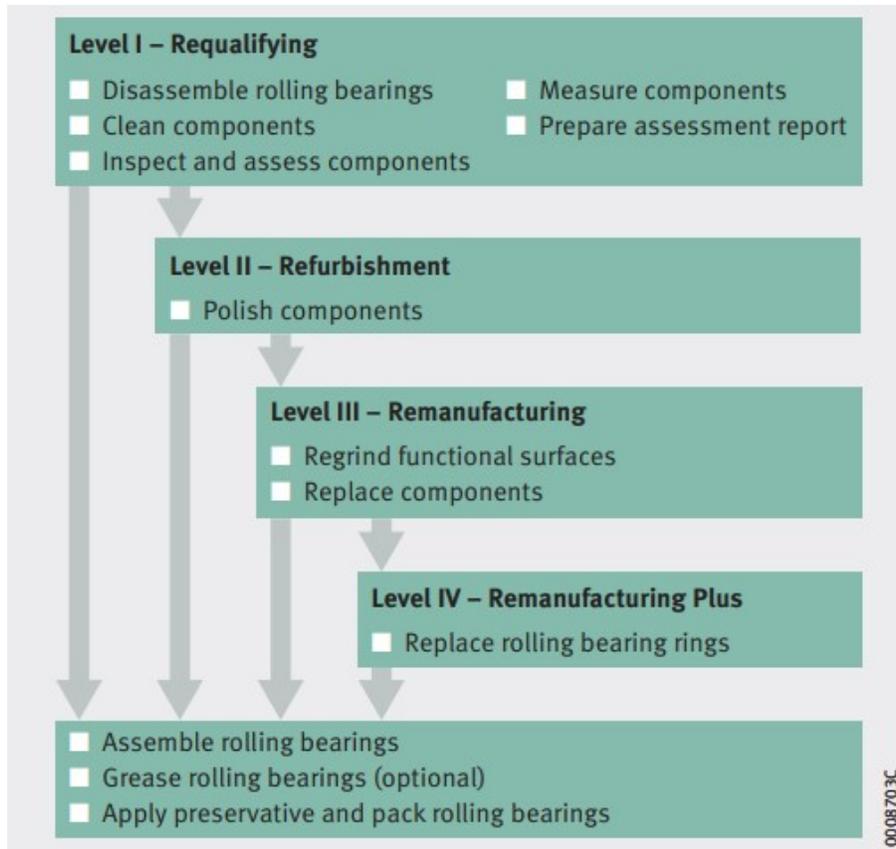
Figure 7: Reconditioning levels for rolling bearings [17]

There are four reconditioning levels, stated by Schaeffler Technologies, to determine which reconditioning steps are needed, shown in Figure 7. Level I is called “Requalifying” which includes, disassembling, cleaning, inspecting and assessing, measuring, and preparing and assessment for an assessment report for the bearing and its components. Level II, Level III, and Level IV are called, “Refurbishment”, “Remanufacturing”, and “Remanufacturing Plus”, respectively. All bearings undergoing a reconditioning process must go through the first level of reconditioning steps.

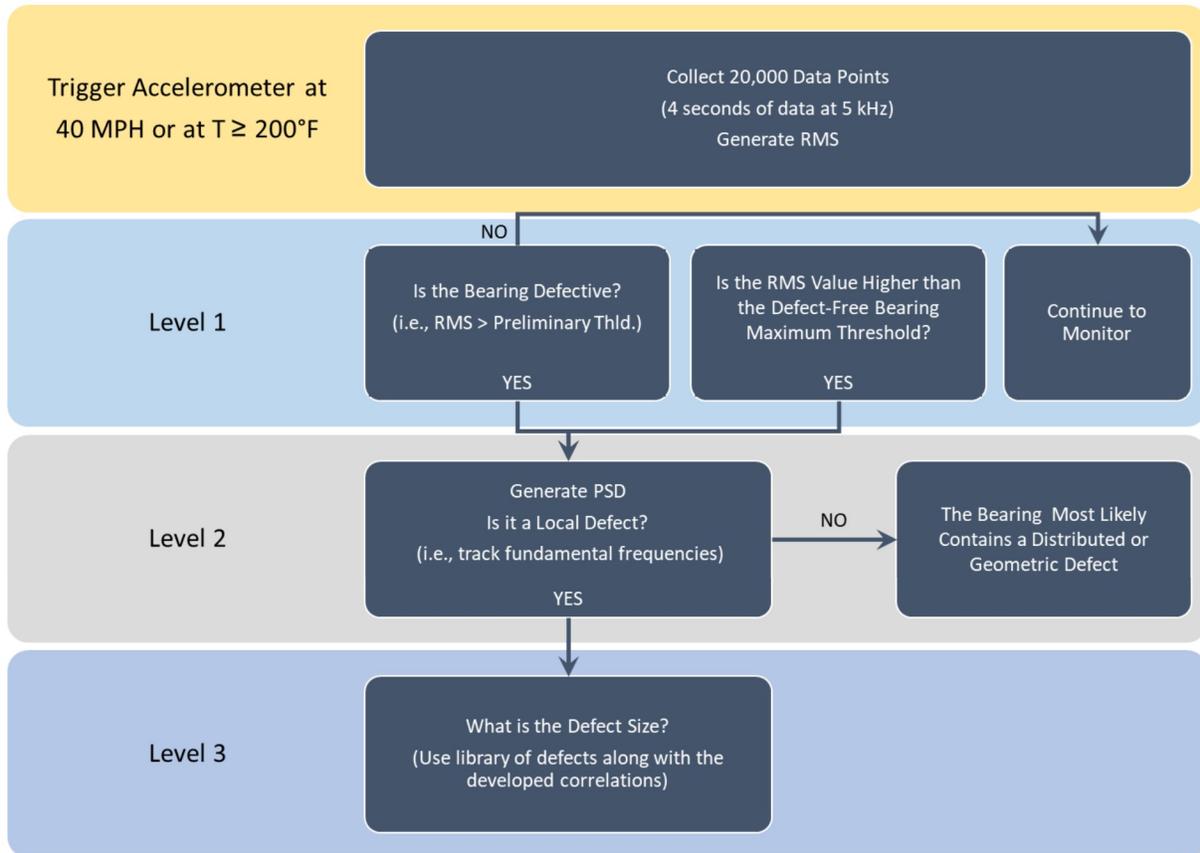
Figure 8: Defect Detection Algorithm Flowchart [19]

A field-tested bearing defect detection algorithm was developed in 2015 by Gonzalez [19] that can detect tapered-roller bearing defects. The algorithm determines which component of the bearing has the defect and can estimate the size of the defect. For field implementation and to save in battery power consumption, the algorithm is triggered when the bearing’s operating temperature is above 93°C (200°F) or if the operating speeds are above 65 km/h (40 mph). However, for the purposes of the laboratory testing performed for this study, the algorithm was triggered continuously since it was powered via a designated power supply. After the accelerometer is triggered, the algorithm will run through an analysis consisting of three levels. The algorithm, will check for vibration levels that indicate the presence of a spall, classify the defect, and approximate the defect size, as demonstrated in the flowchart of Figure 8. A description of each level of analysis is provided hereafter.

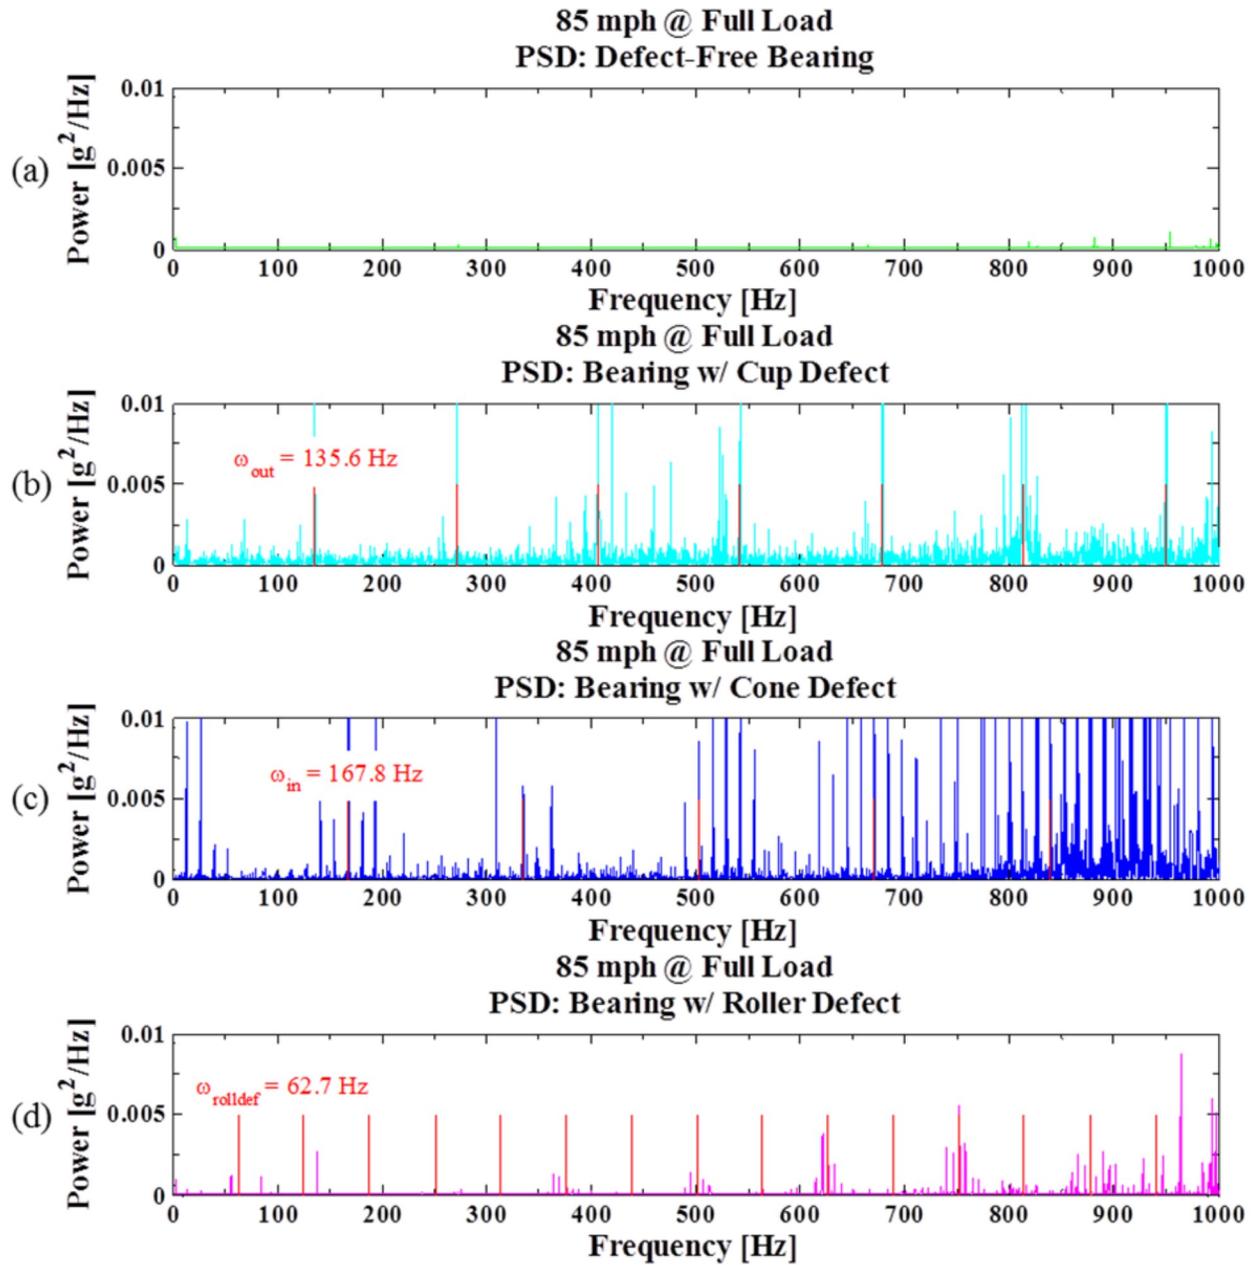
Figure 9: Power Spectral Density (PSD) plot of (a) a healthy bearing, (b) a bearing with an outer ring (cup) defect, (c) a bearing with an inner ring (cone) defect, and (d) bearing with a roller defect.

The six frequencies are based on the rotational speed of the tapered-roller bearing components. D_r and R_r refer to the diameter and radius of the roller, respectively, and R_{cn} and R_{cp} refer to the radii of the inner ring (cone) and outer ring (cup), respectively. The last three equations, Eq (7) – Eq (9) give the defect frequencies for a defective outer ring (cup), inner ring (cone), and roller, respectively. When there is a localized defect, there will be a peak in power for the defect frequency in the PSD plot. Figure 9 shows examples of PSD plots for a healthy (defect-free) bearing versus bearings with a cup, cone, or roller defect. The vertical red lines in Figure 9 indicate the defect frequencies and their harmonics up to 1000 Hz.

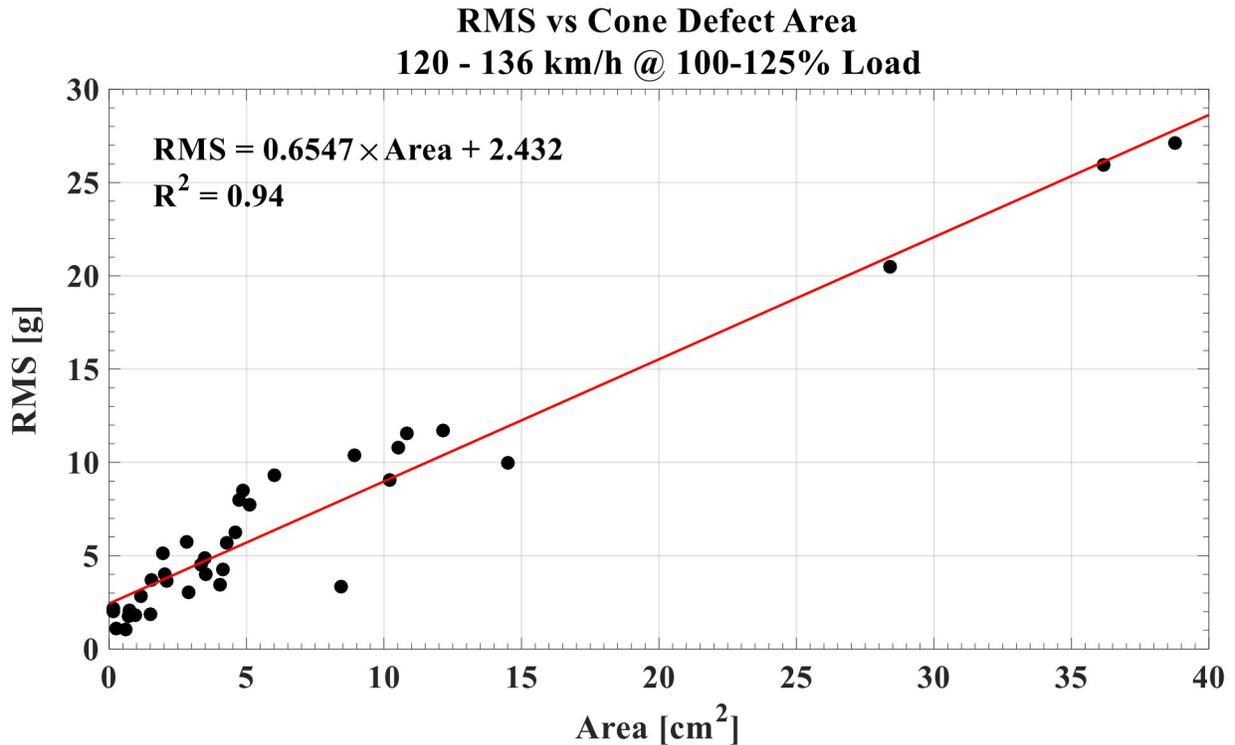
Figure 10: Improved Cone defect size correlation at 137 km/h (85 mph) and full load [22]

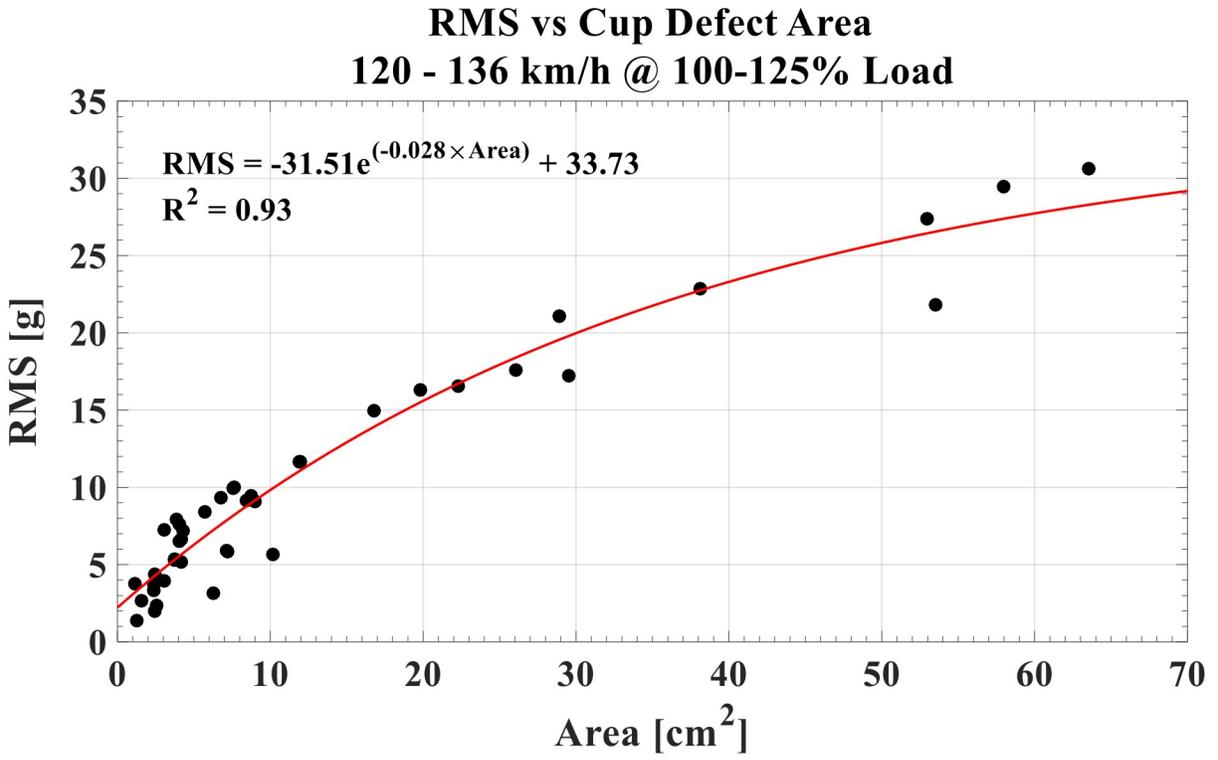
Figure 11: Improved Cone defect size correlation at 137 km/h (85 mph) and full load [22]

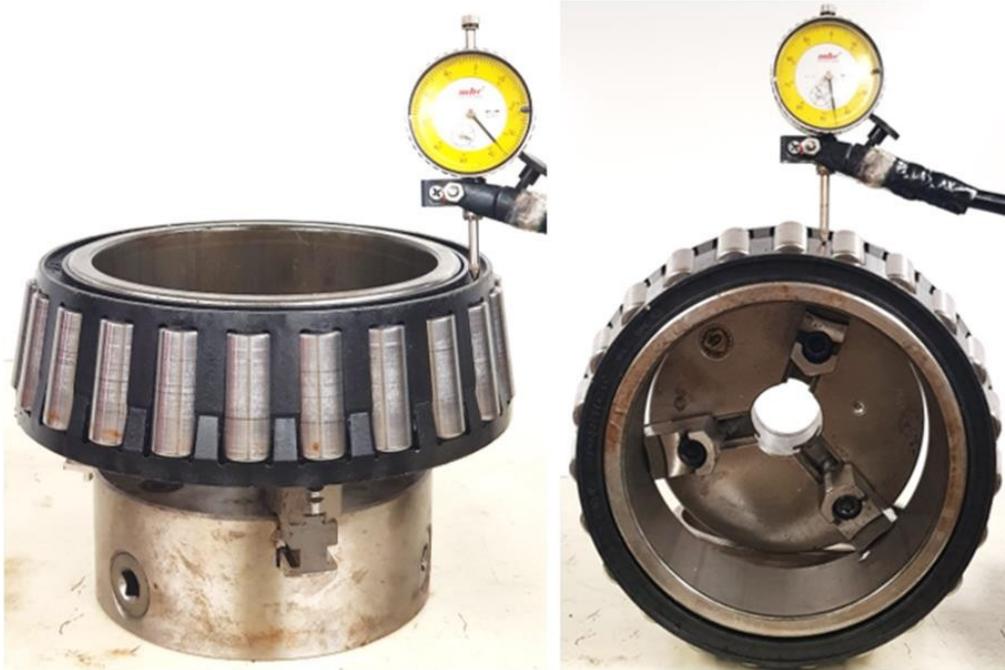
Figure 12. Inner ring (cone) assembly measurements: cage lift (left) and cage shake (right)

The abovementioned measurements were taken to minimize the possibility of roller misalignment due to abnormal spacing. Additionally, bearing lateral measurements were taken before the bearing was sealed. The minimum and maximum lateral measurements for each test bearing were recorded to ensure the correct size spacer ring was selected. This lateral measurement was performed using a dial gauge with the desired measurement ranging between 0.0584 cm and 0.711 cm (0.023 in to 0.028 in). The spacer ring serves a significant role in preventing the bearing from rolling slightly skewed.

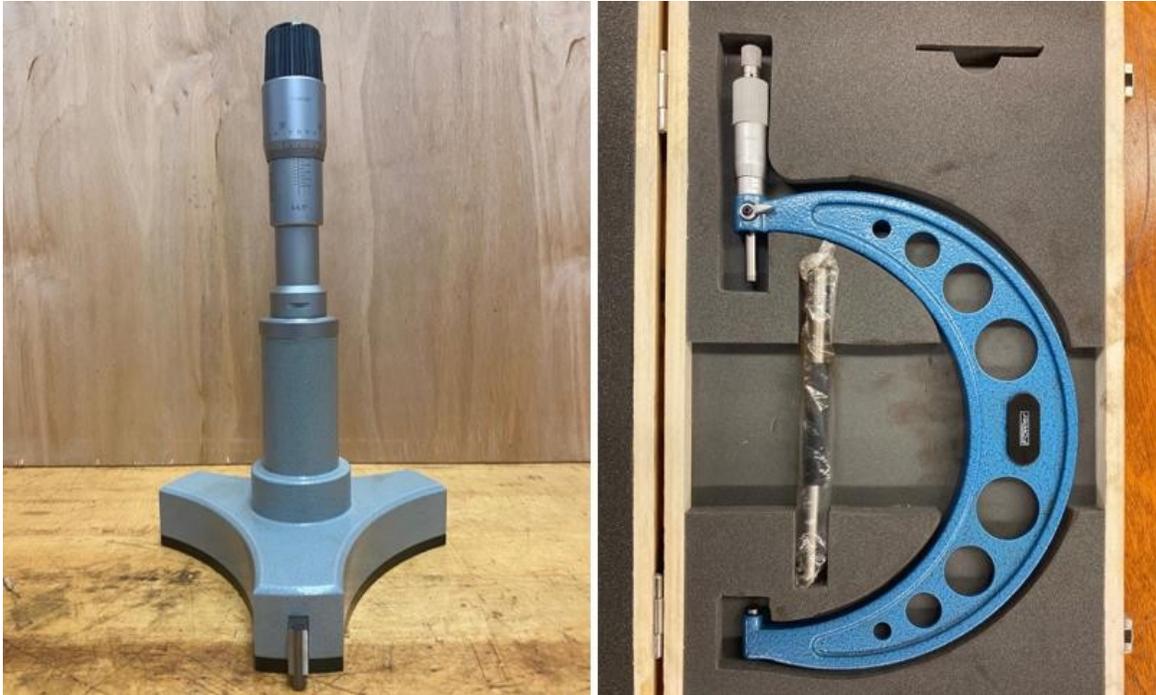
Figure 13. Three-point internal micrometer (left) and outside micrometer (right)

The inside diameter of the cones and the outside diameter of the test axle were also carefully evaluated before the bearings were pressed onto the test axle. The inside diameter of each cone was measured using a 3-point internal micrometer, shown in Figure 13 (left), to ensure the cone diameter was within the AAR tolerance of 15.7150 to 15.7188 cm (6.1870 to 6.1885 in) [18]. Each axle shaft was measured using a 15.24 to 17.78 cm (6 to 7 in) outside micrometer, shown in Figure 13 (right). A total of eight measurements were recorded around each of the four cone assembly locations to verify that the axle was within the AAR tolerance of 15.7239 cm to 15.7264 cm (6.1905 in to 6.1915 in). The recorded measurements for the cones and axles utilized in this study are given in Appendix A.

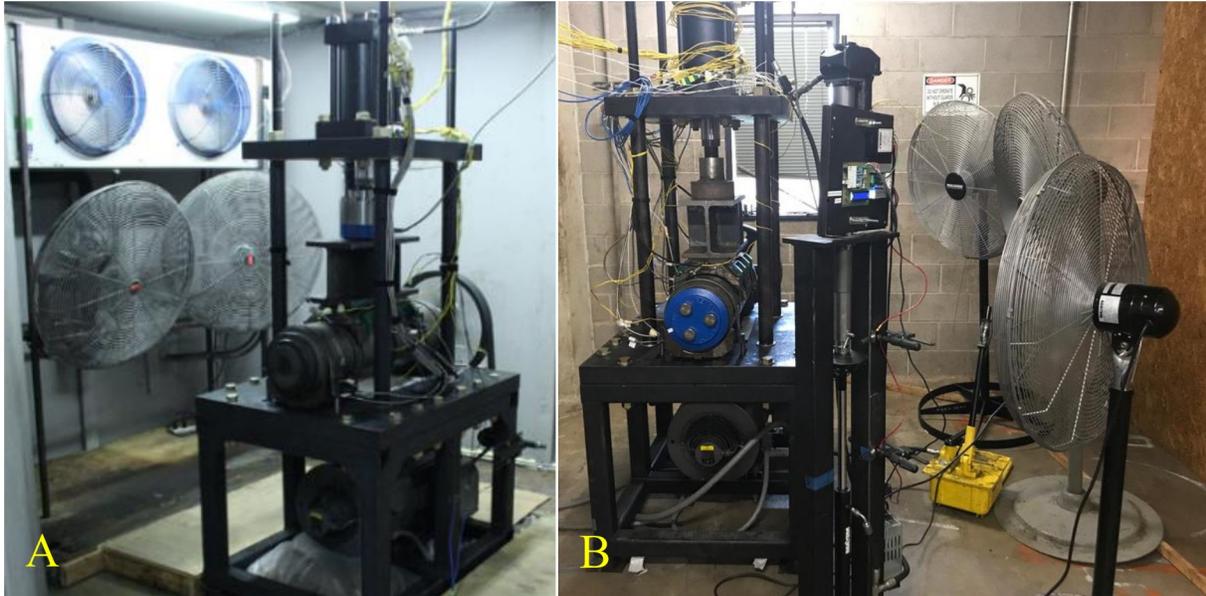
Figure 14. A) Chamber Four-Bearing Tester (C4BT). B) Four-Bearing Tester (O4BT).

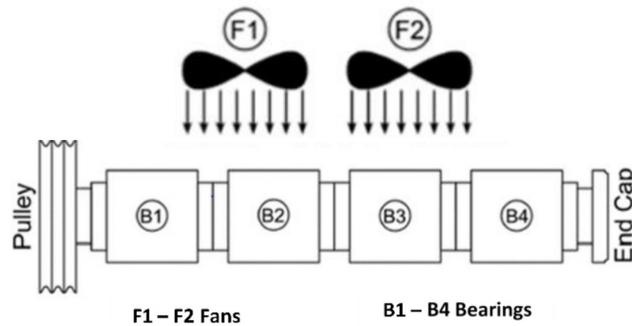
Figure 15. Top view of C4BT/4BT with bearing locations labeled.

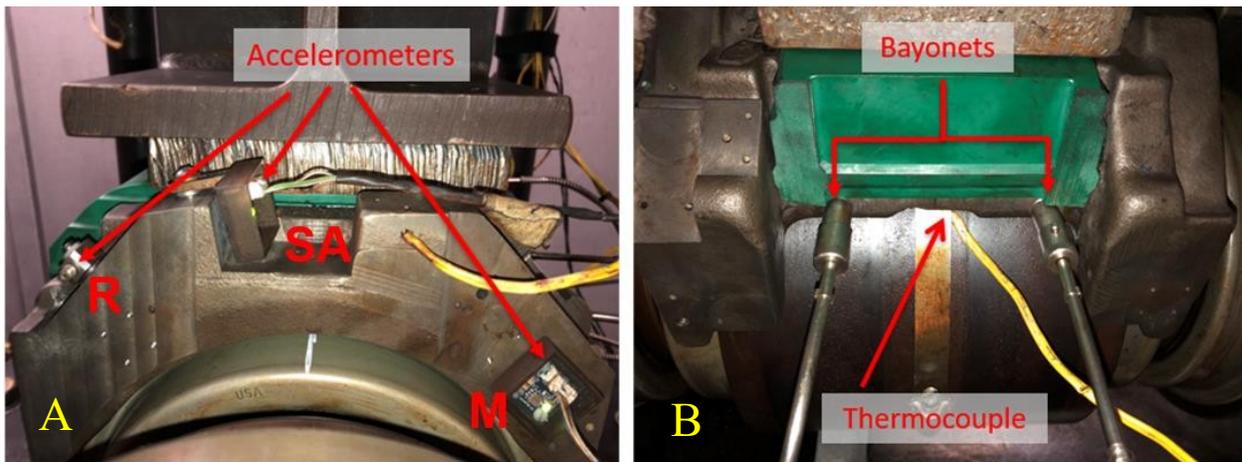
Figure 16. Modified C4BT/4BT adapters showing: A) Vibration Sensors B) Temperature Sensors

raceway. Additionally, each bearing was also equipped with a K-type thermocouple that is placed between the two bayonet thermocouples and held in place with a hose clamp. The 500g PCB accelerometer was placed in the radial (R) location, and the two 70g accelerometers were placed in the Smart Adapter (SA) and Mote (M) location, shown in Figure 16. Two additional thermocouples were placed on the fan and non-fan side of the test rigs to record the surrounding ambient temperature.

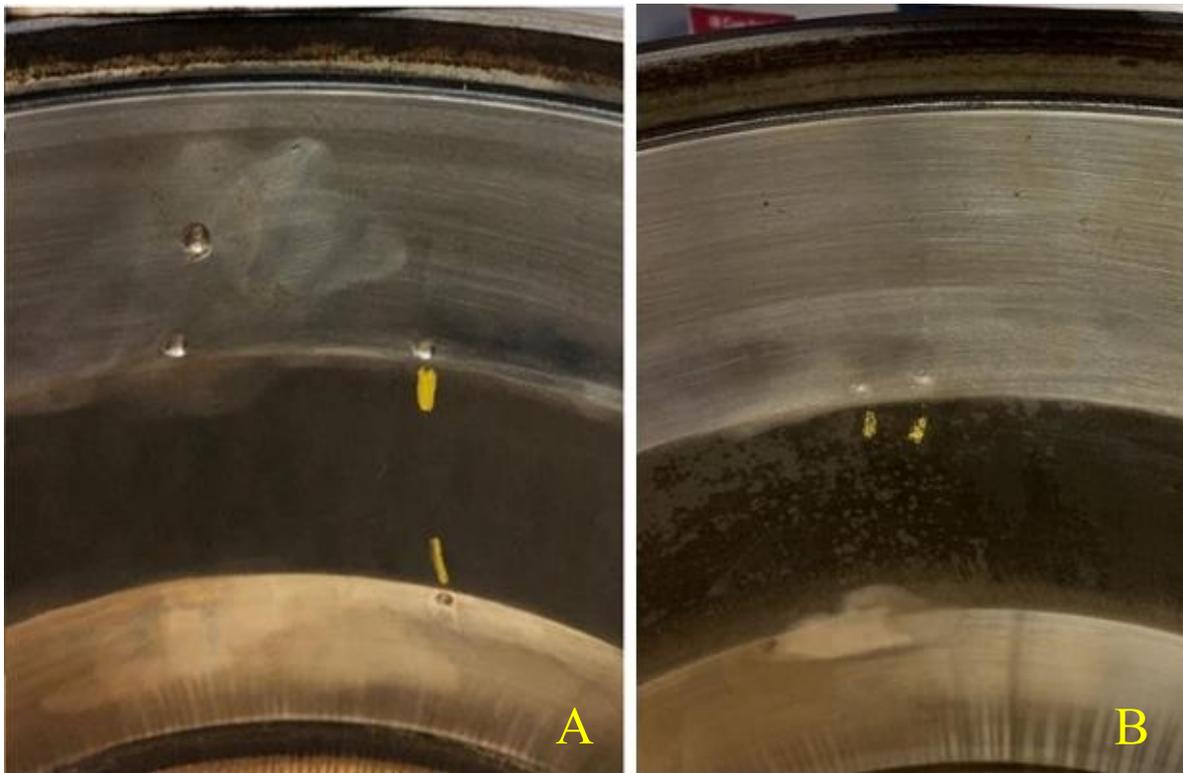
Figure 17. Stress-relief holes for batch 1: A) Stress-relief holes in the middle of the raceway and near the edge of the spacer ring region, B) Two circular closely grouped stress-relief holes near the edge of the spacer ring region

located near the edge of the spacer ring region with some cups also having stress-relief holes in the middle of the raceway, as pictured in Figure 17. These stress-relief holes were mostly circular in shape and noticeably larger than those from batch 2. The cup stress-relief holes from batch 2 were smaller in size and mostly located close to the middle of the raceway. These stress-relief holes were both circular-shaped and oval-shaped, as depicted in Figure 18.

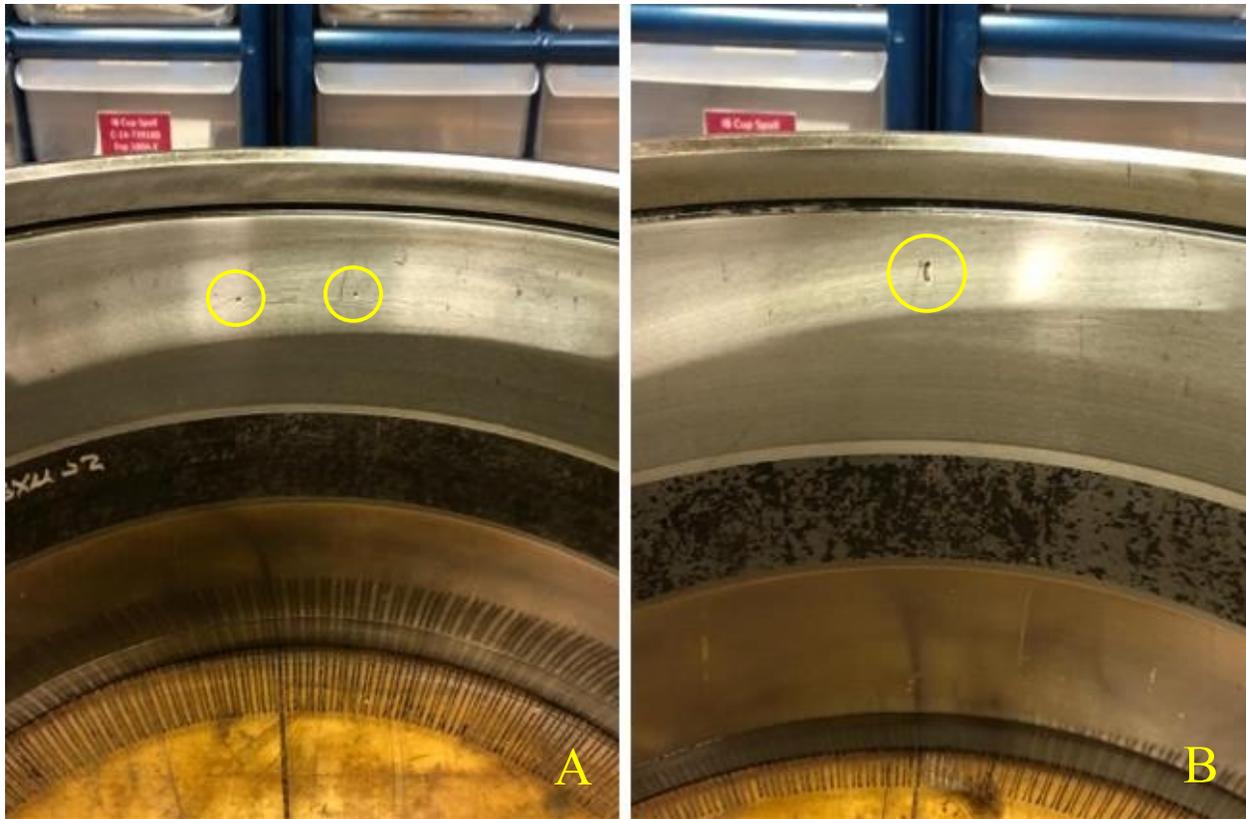
Figure 18. Types of stress-relief holes for batch 2: A) Two closely grouped circular stress-relief holes near the middle of the cup raceway, B) A singular oval-shaped stress-relief hole near the middle of the cup raceway

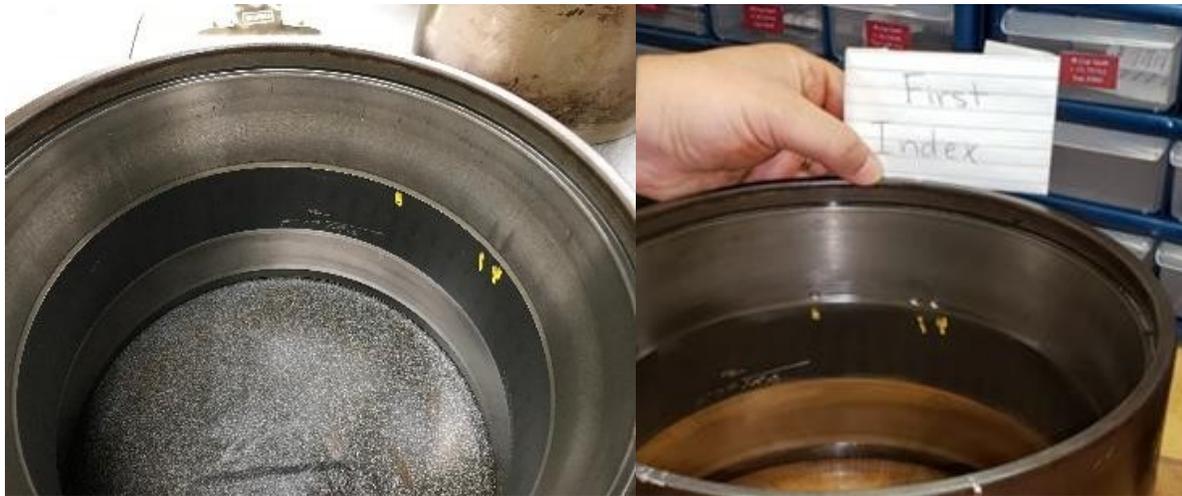
Figure 19: Picture on the left side shows test bearing 2 (B2) before the reconditioning process. The picture on the right shows test bearing 2 (B2) after it was reconditioned with the “Index I” region shown.

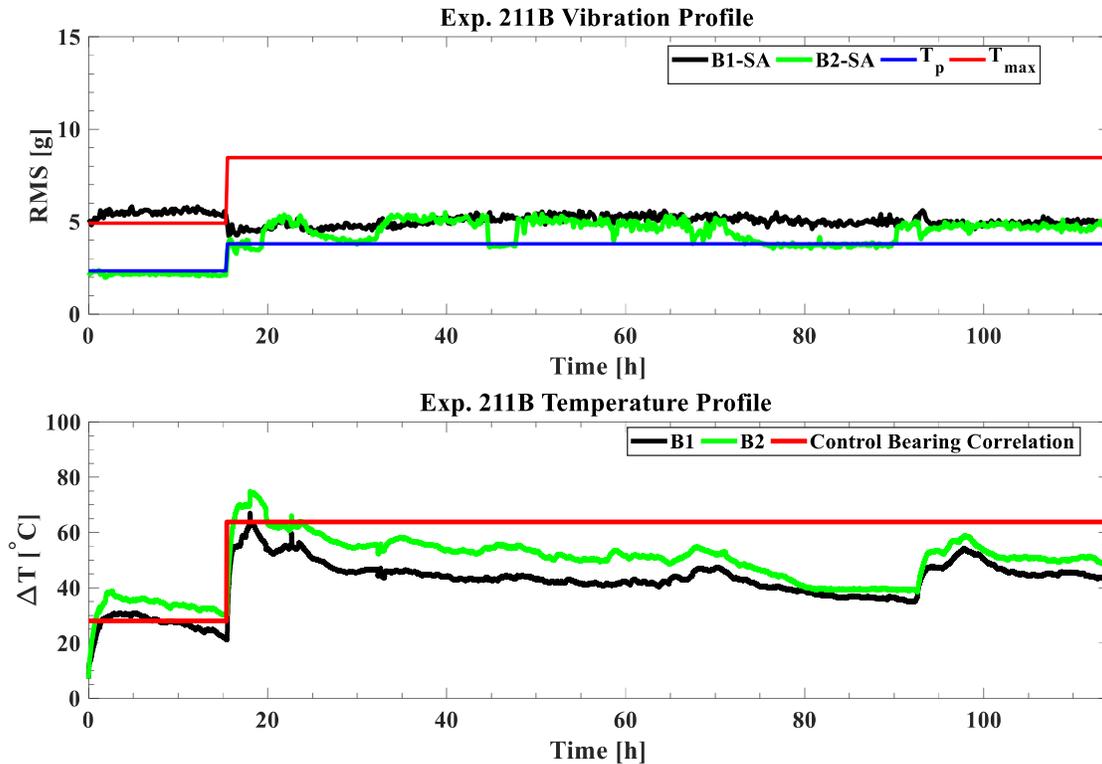
Figure 20: Vibration and temperature profiles for Experiment 211B

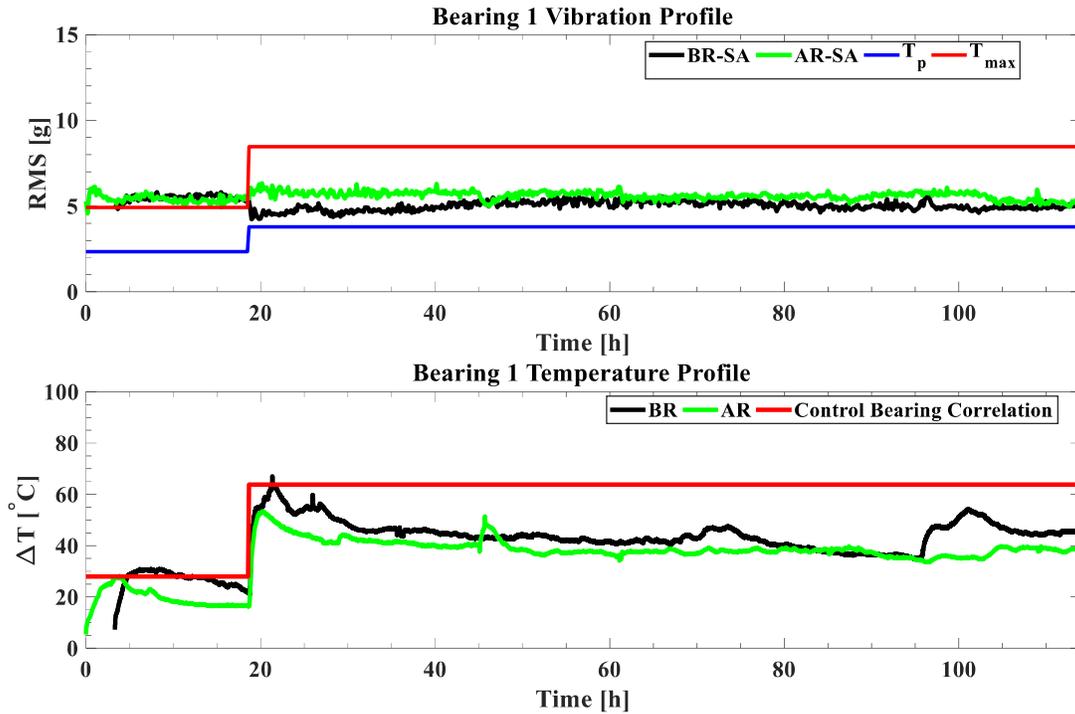
Figure 21: Vibration and temperature profiles for test bearing 1 (B1) before (BR) and after (AR) the reconditioning process

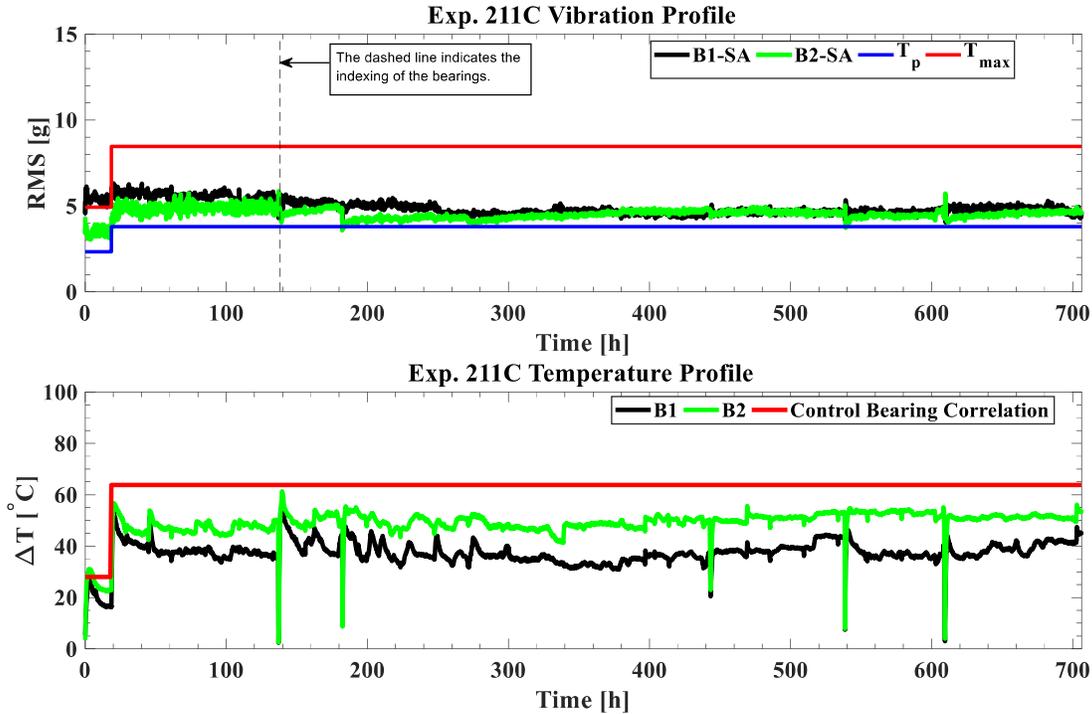
Figure 23: Vibration and temperature profiles for Experiment 211C before the complete teardown and inspection. The cups of the two test bearings were oriented with “Index I” in the top center location after 21,905 km (13,611 mi) of operation

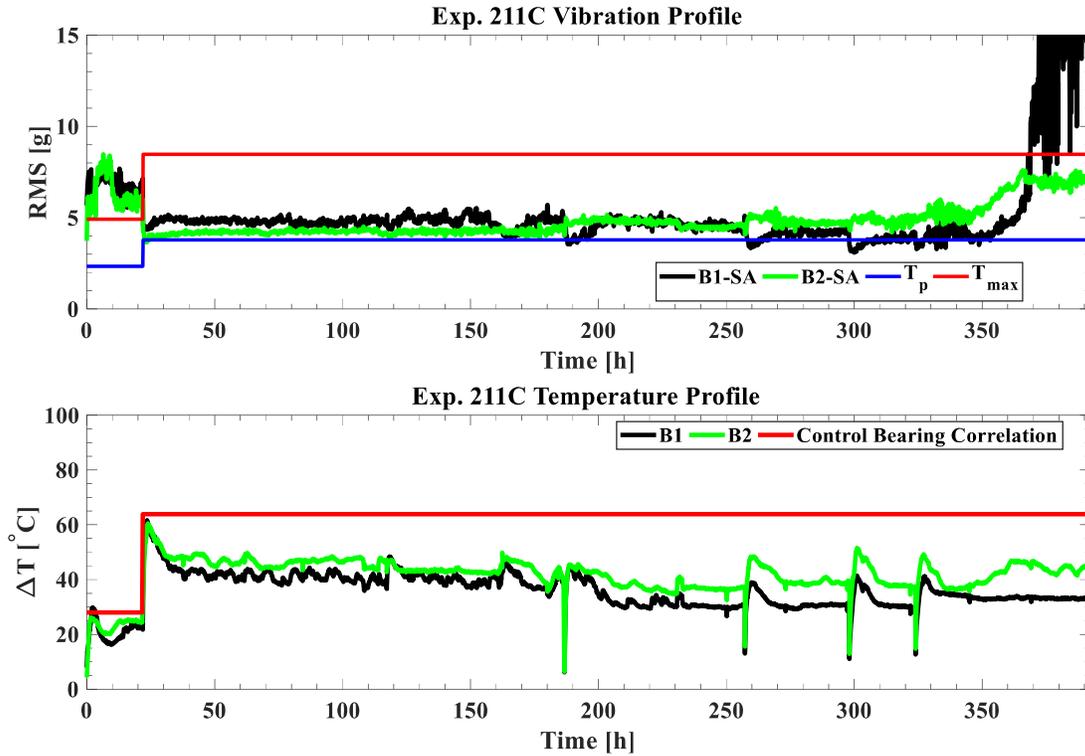
Figure 24: Vibration and temperature profiles for Experiment 211C after the completion of the first teardown and inspection

After the test bearings ran an additional 45,866 km (28,500 mi), the bearing condition monitoring algorithm indicated that a defect had initiated on one of the cup raceways of test bearing 2 (B2). The defect initiation was indicated by the sudden increase in the vibration levels of B2 around 350 hours into the experiment, as can be observed in Figure 24. Note that the sudden increase in the vibration levels of test bearing 1 (B1), that lags by a few hours, is a direct consequence of crosstalk between the two test bearings, where B1 picks up the loud vibrations from B2. Interestingly, the operating temperatures of both B1 and B2 remain well below the average operating temperature of defect-free (healthy) bearings at the same load and speed, with B2 running, on average, about 12°C (22°F) hotter than B1.

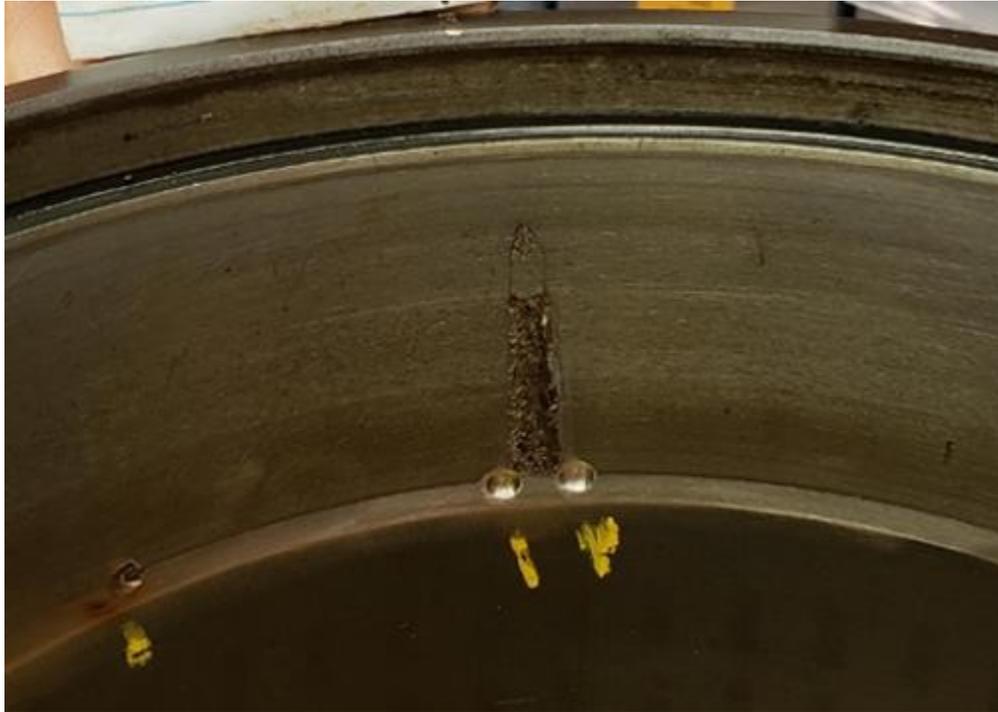
Figure 25: A picture of the defect that developed on test bearing 2 (B2) after 151,154 km (93,923 mi) of total operation since the bearing was reconditioned

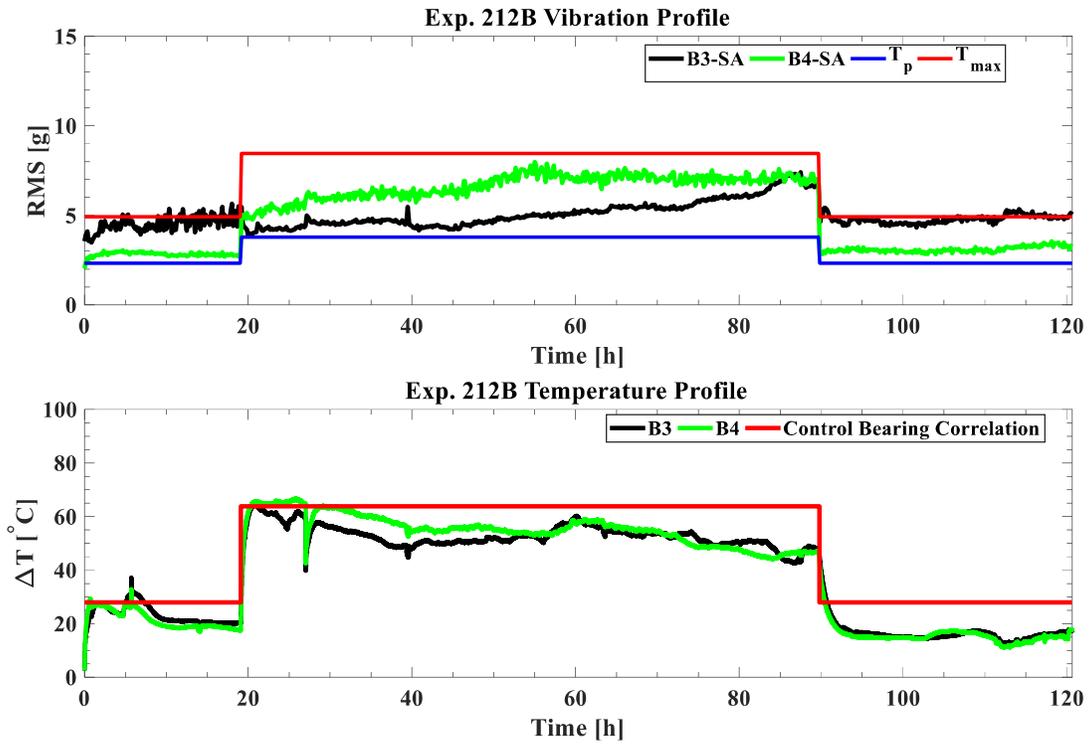
Figure 26: Vibration and temperature profiles for Experiment 212B where bearings 3 and 4 were tested
