Assessing the Performance of Reconditioned Railroad Tapered-Roller Bearings Used in Freight Rail Service

A Thesis

MASTER OF SCIENCE IN ENGINEERING

Major Subject: Mechanical Engineering

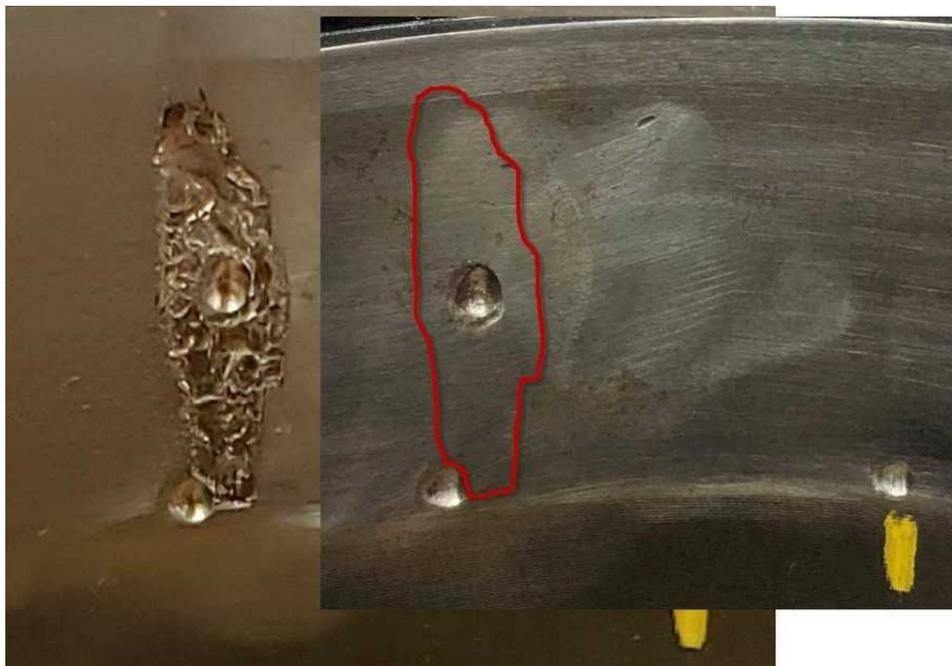
Figure 27: A picture of the defect that developed on test bearing 3 (B3) after 14,001 km (8,700 mi) of total operation since the bearing was reconditioned

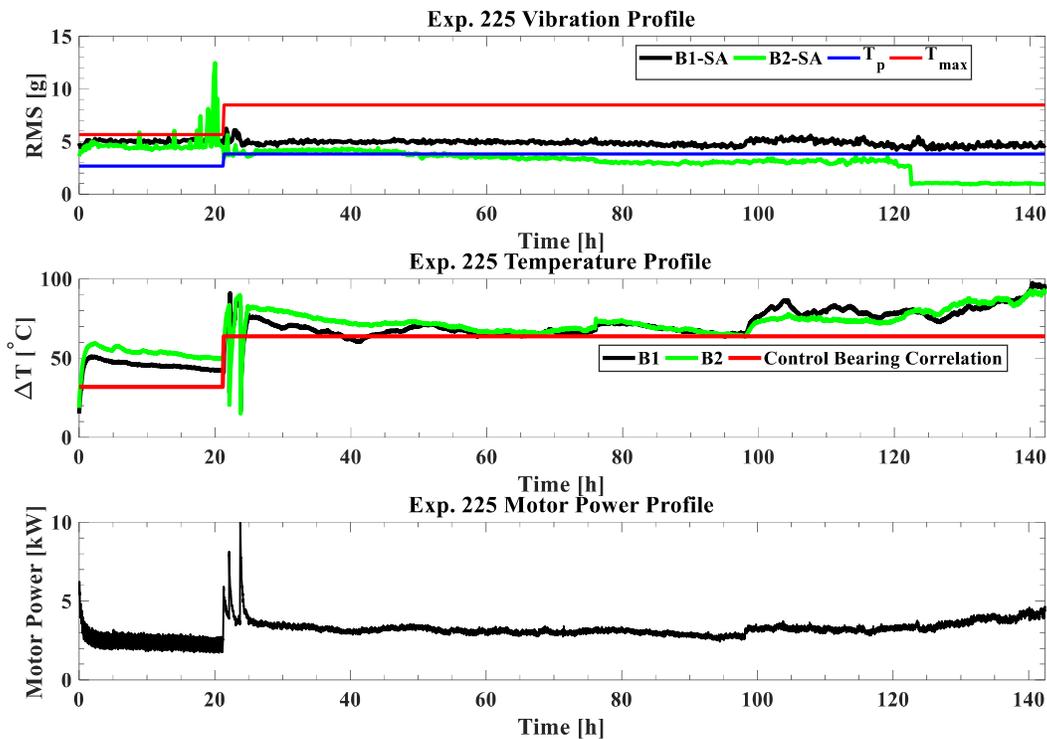
Figure 29: Vibration, temperature, and motor power profiles for Experiment 225

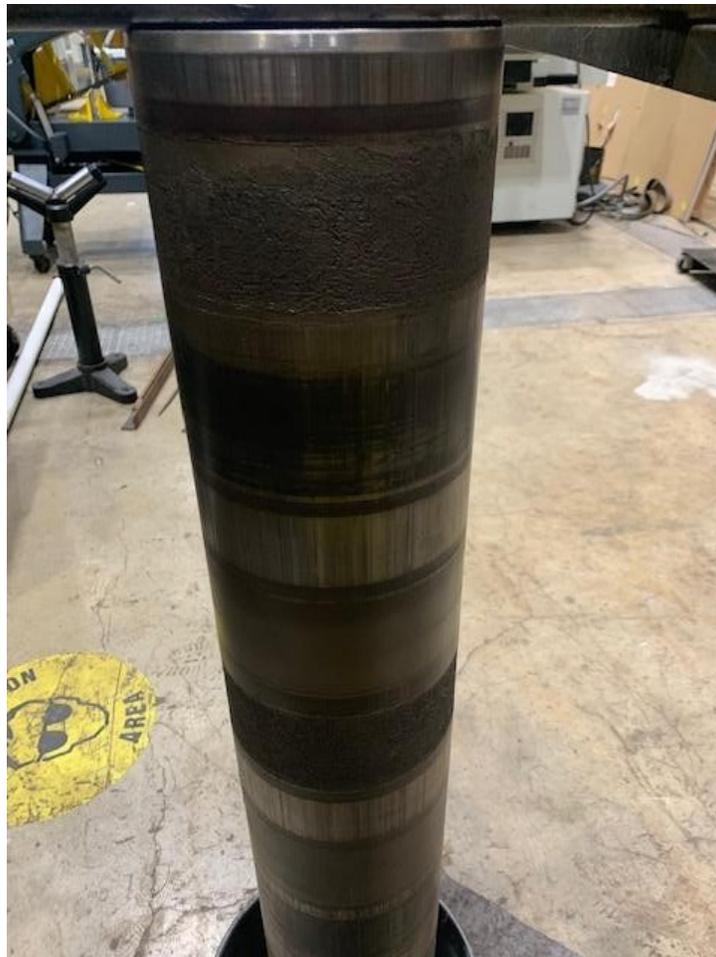
Figure 30: Experiment 225 axle damage

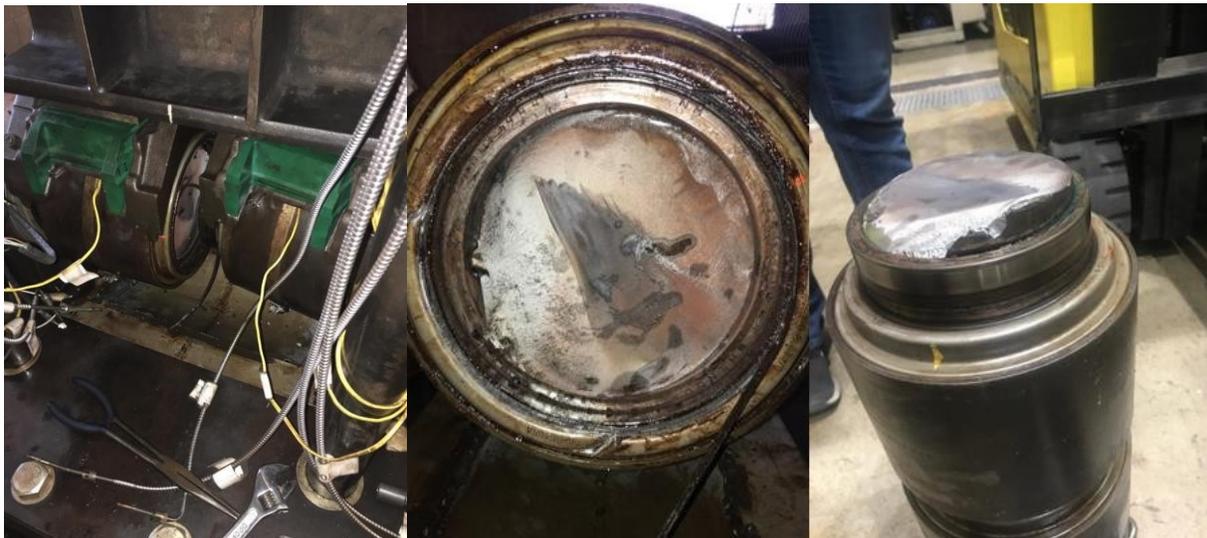
Figure 31: Experiment 227E axle damage

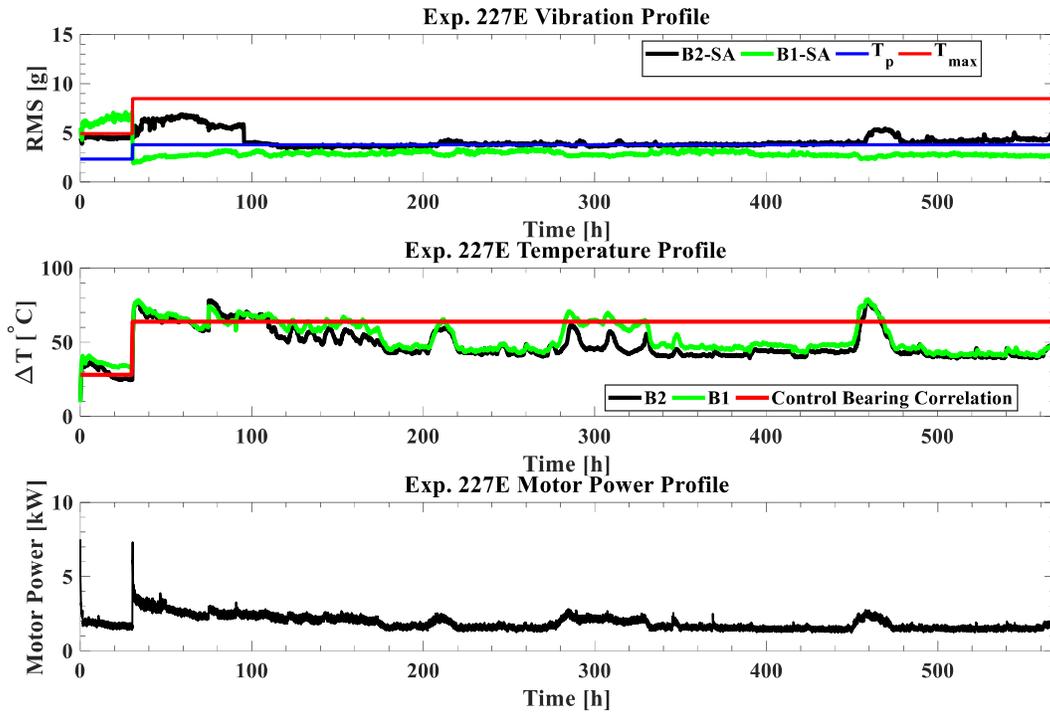
Figure 32: Vibration, temperature, and motor power profiles for Experiment 227E

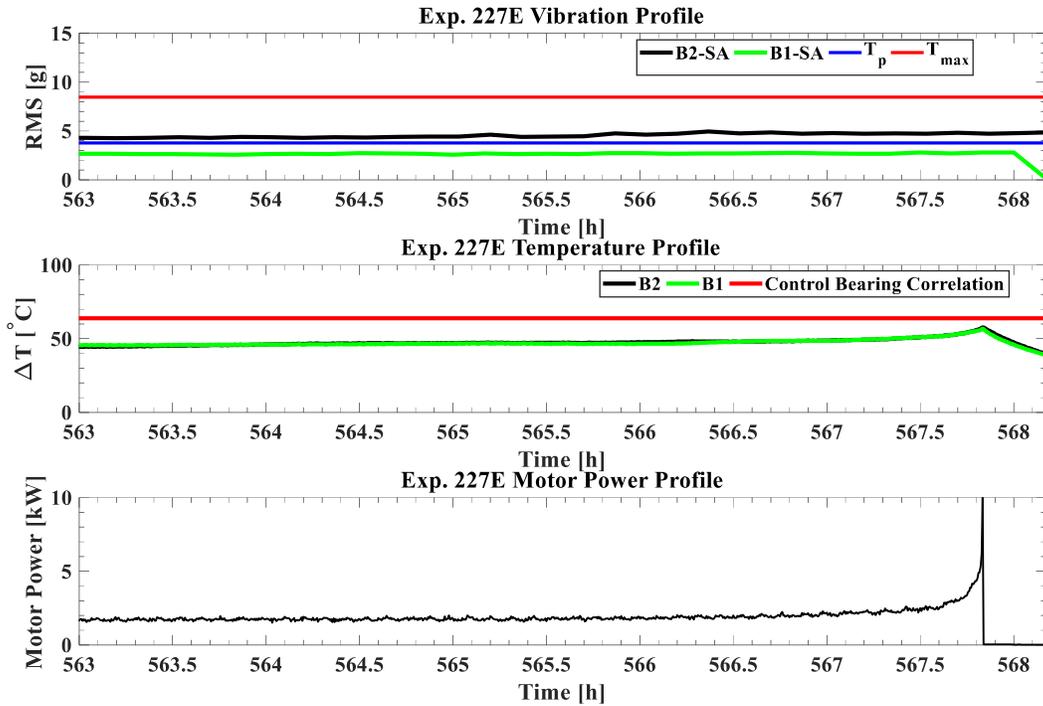
Figure 33: Vibration, temperature, and motor power profiles for Experiment 227E for the last 5 hours of operation

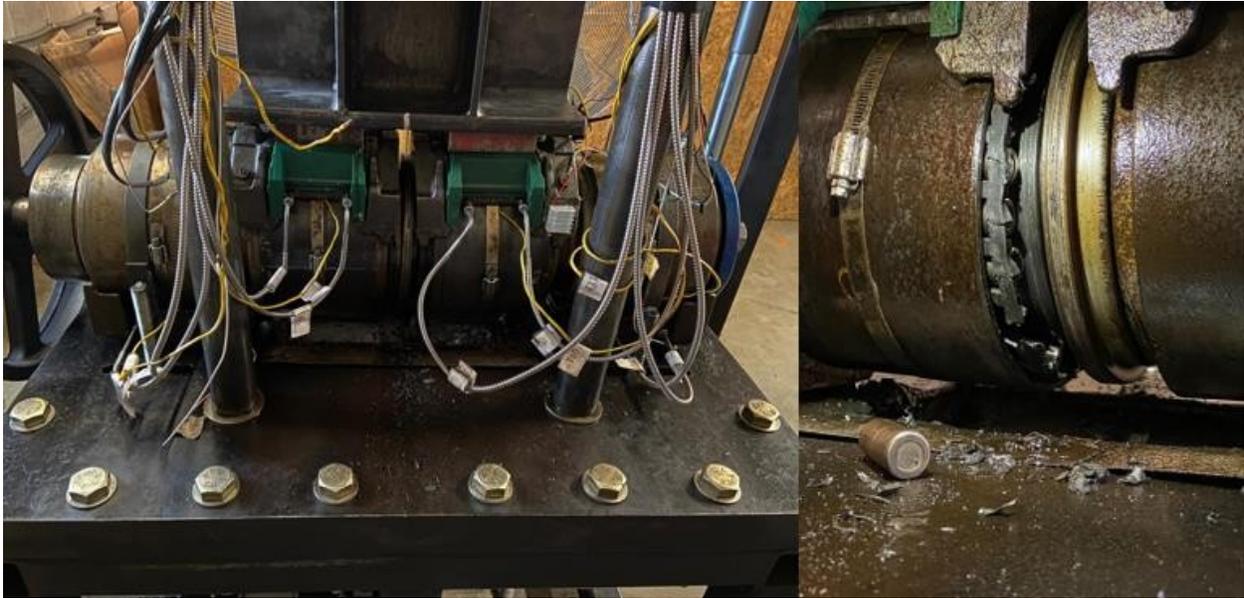
Figure 36: Experiment 229B four-bearing tester inspection

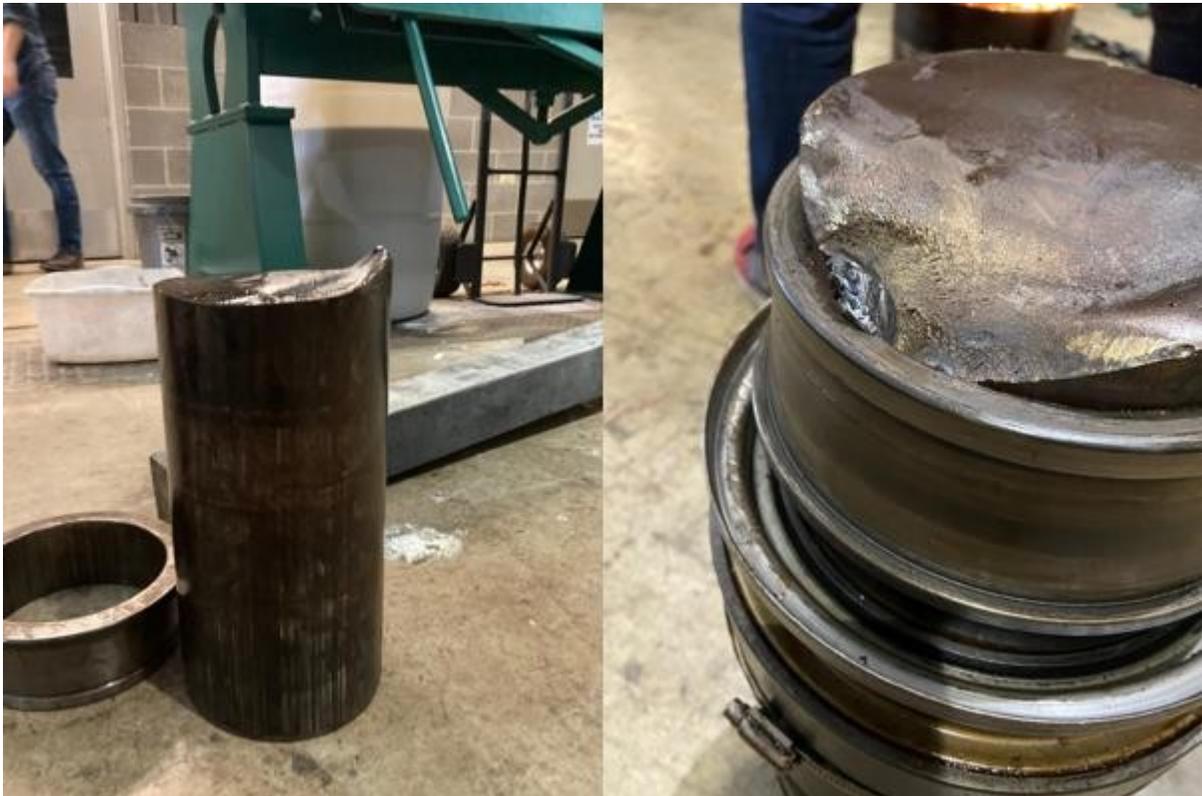
Figure 37: Experiment 229B axle damage

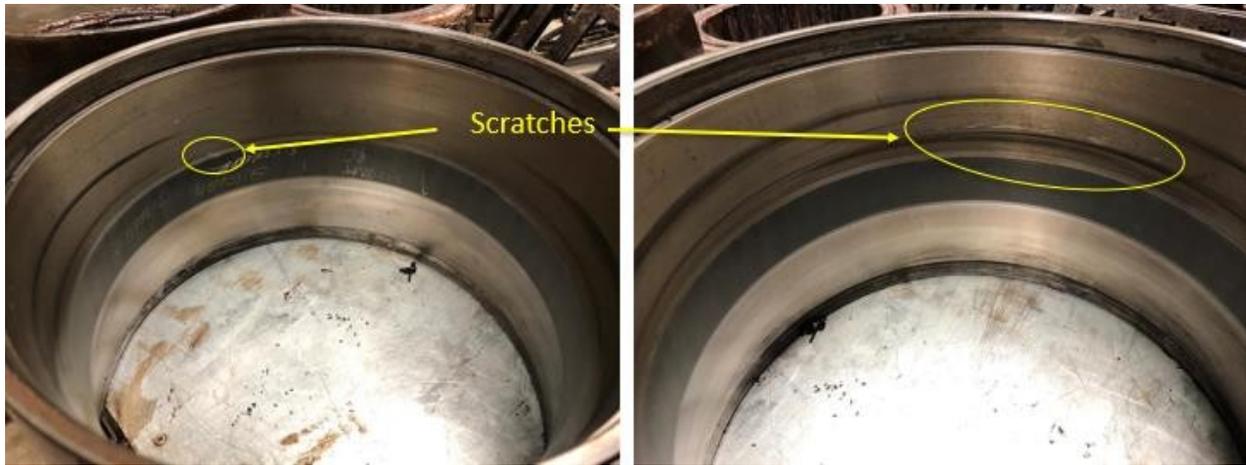
Figure 38: Damage on cup raceways of test bearing 6 (B6)

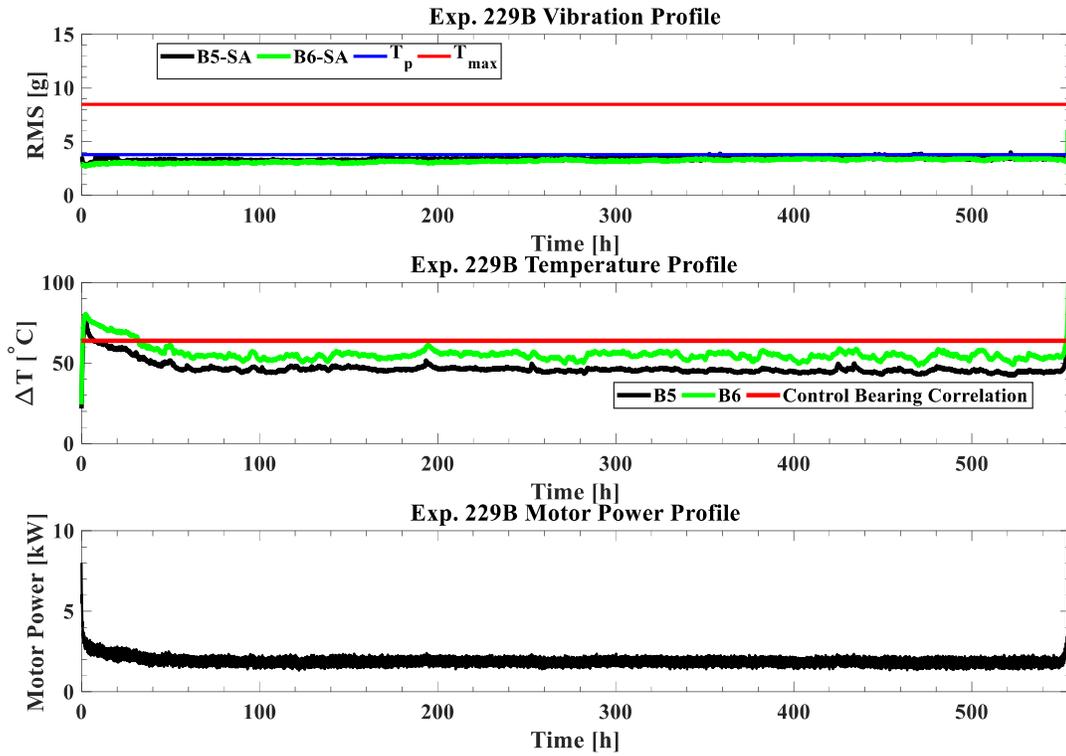
Figure 39: Vibration, temperature, and motor power profiles for Experiment 229B

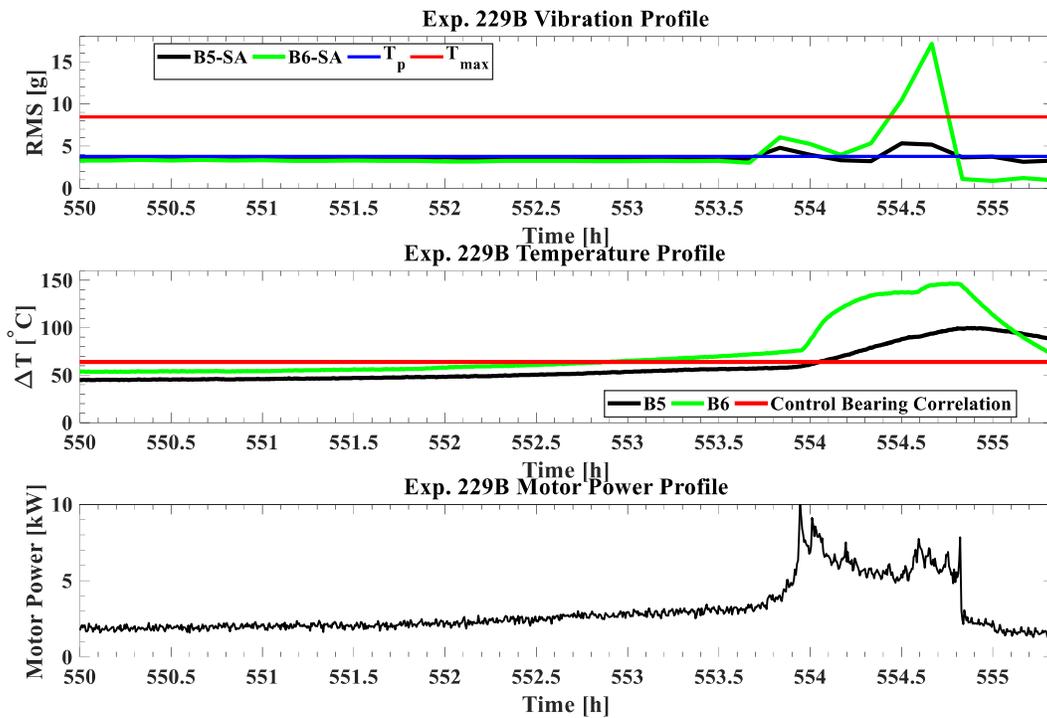
Figure 40: Vibration, temperature, and motor power profiles for Experiment 229B over the last five hours of operation

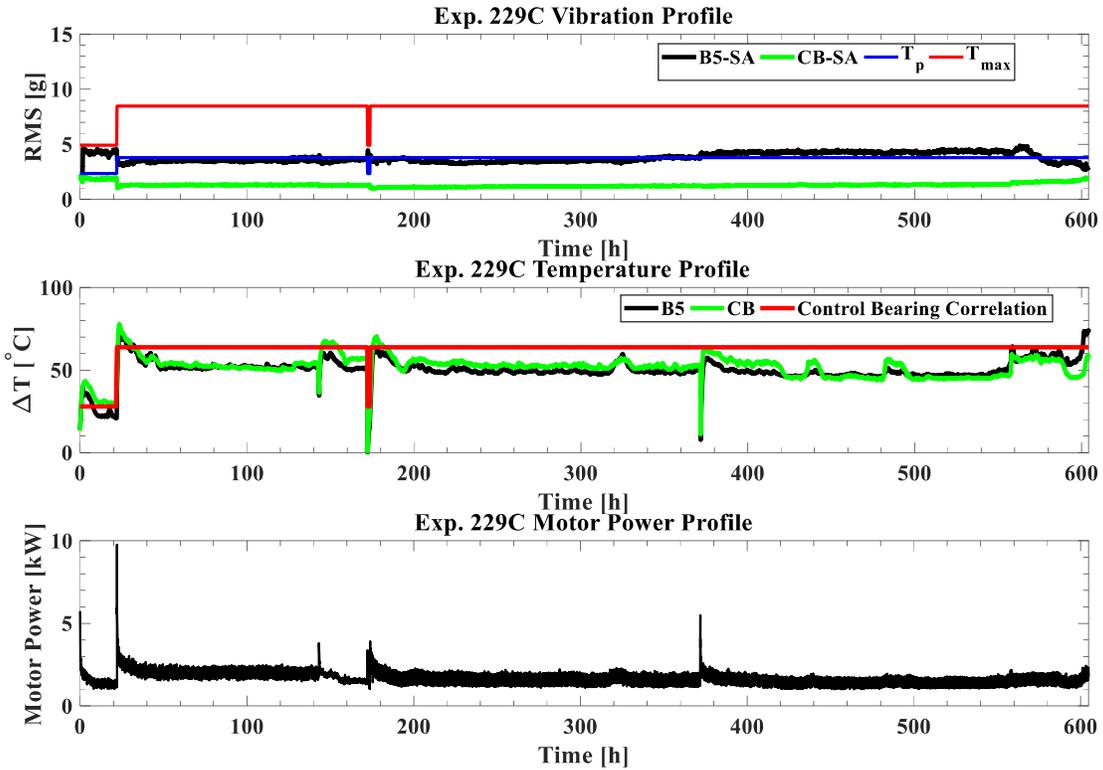
Figure 41: Vibration, temperature, and motor power profiles for Experiment 229C

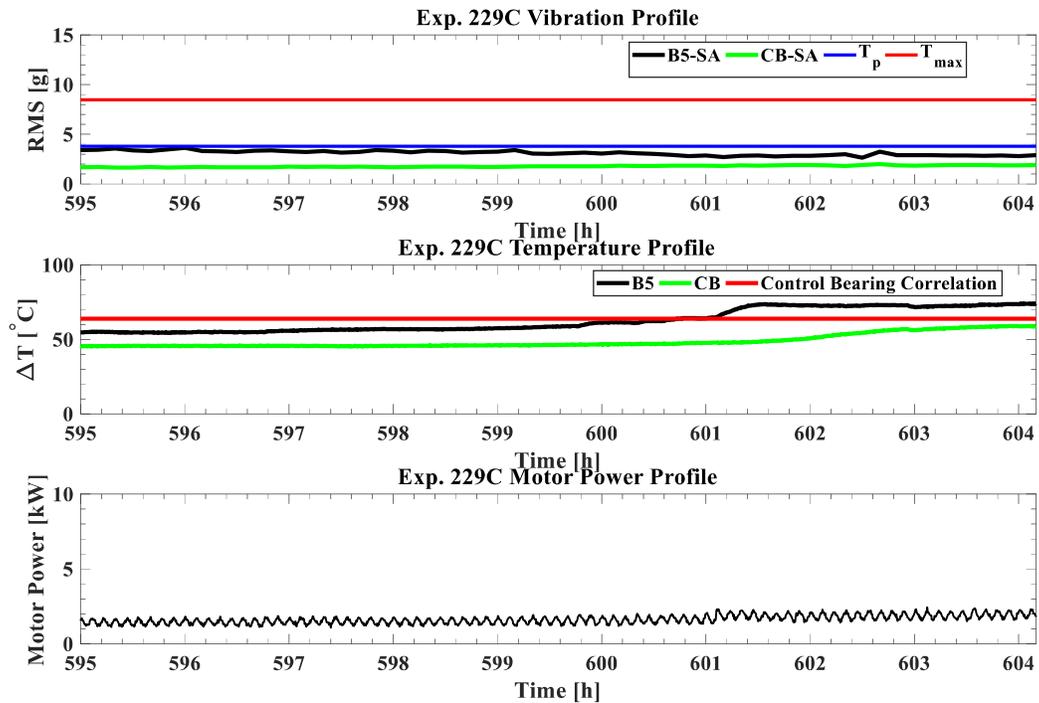
Figure 42: Vibration, temperature, and motor power profiles for Experiment 229C for the last 10 hours of operation

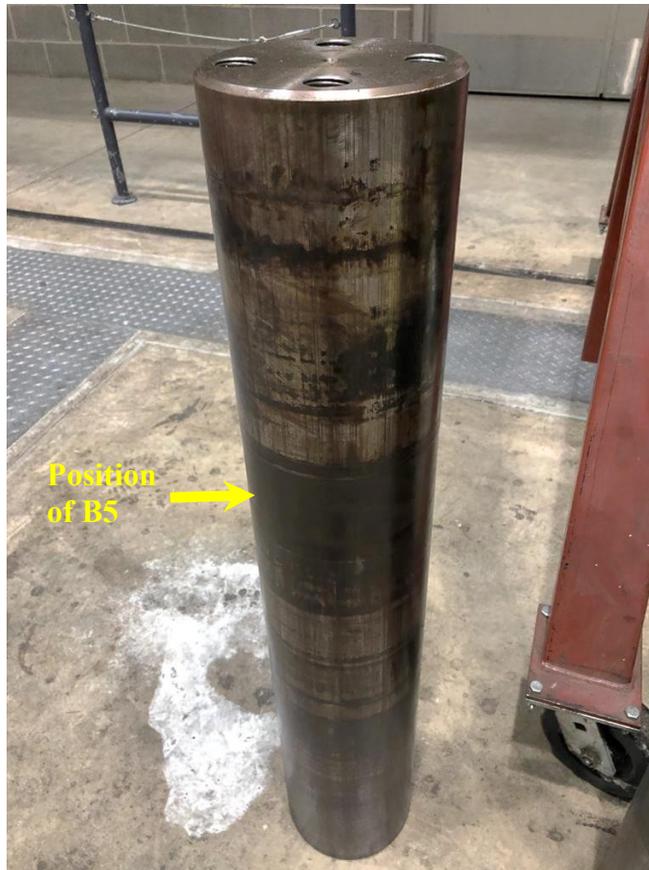
Figure 43: Experiment 229C axle damage

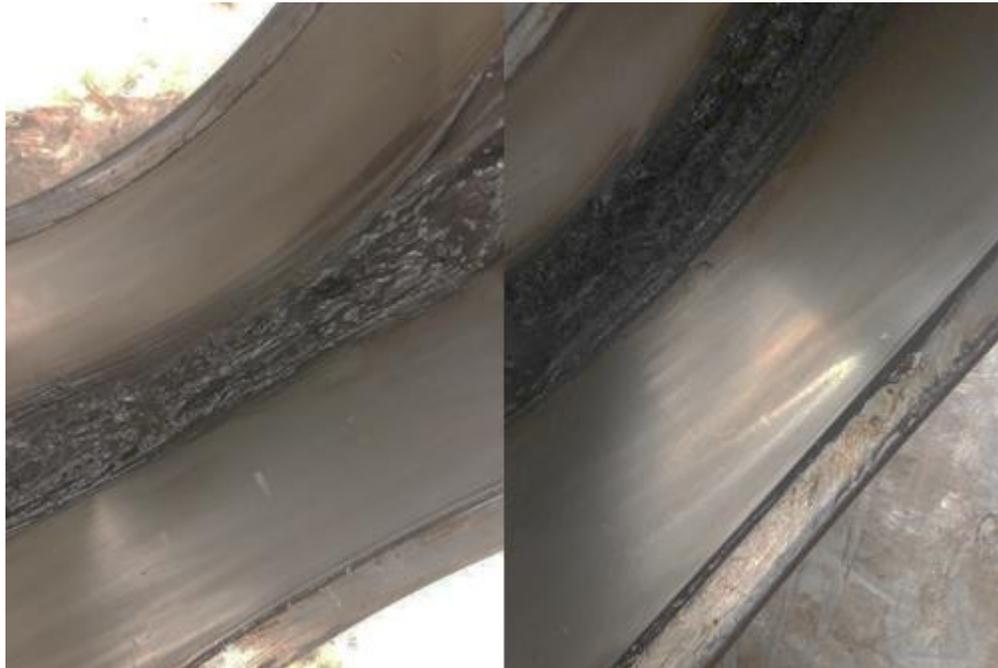
Figure 44: Abnormal wear on cup raceways of test bearing 5 (B5)

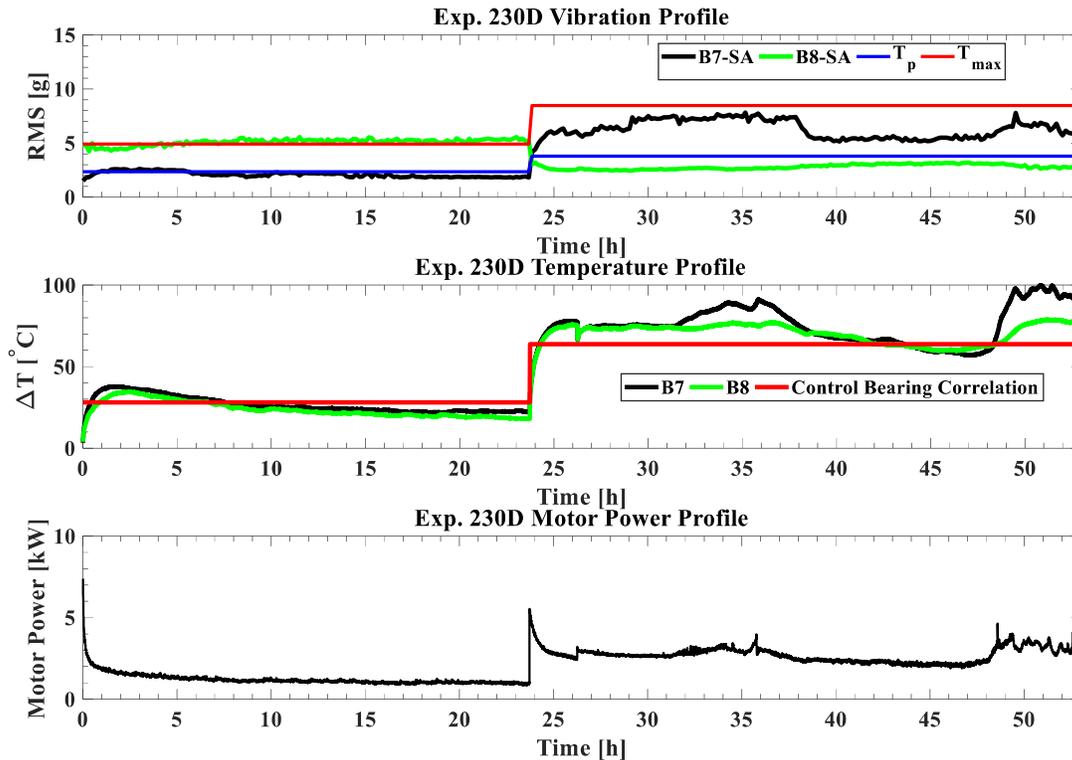
Figure 46: Vibration, temperature, and motor power profiles for Experiment 230D

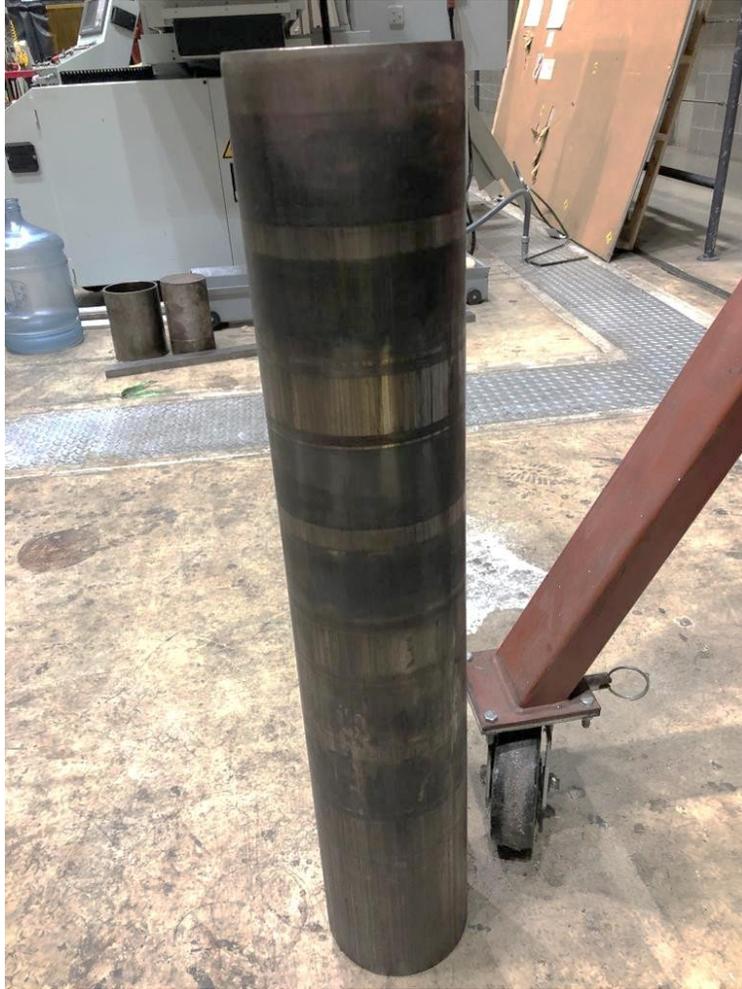
Figure 47: Experiment 230D axle damage

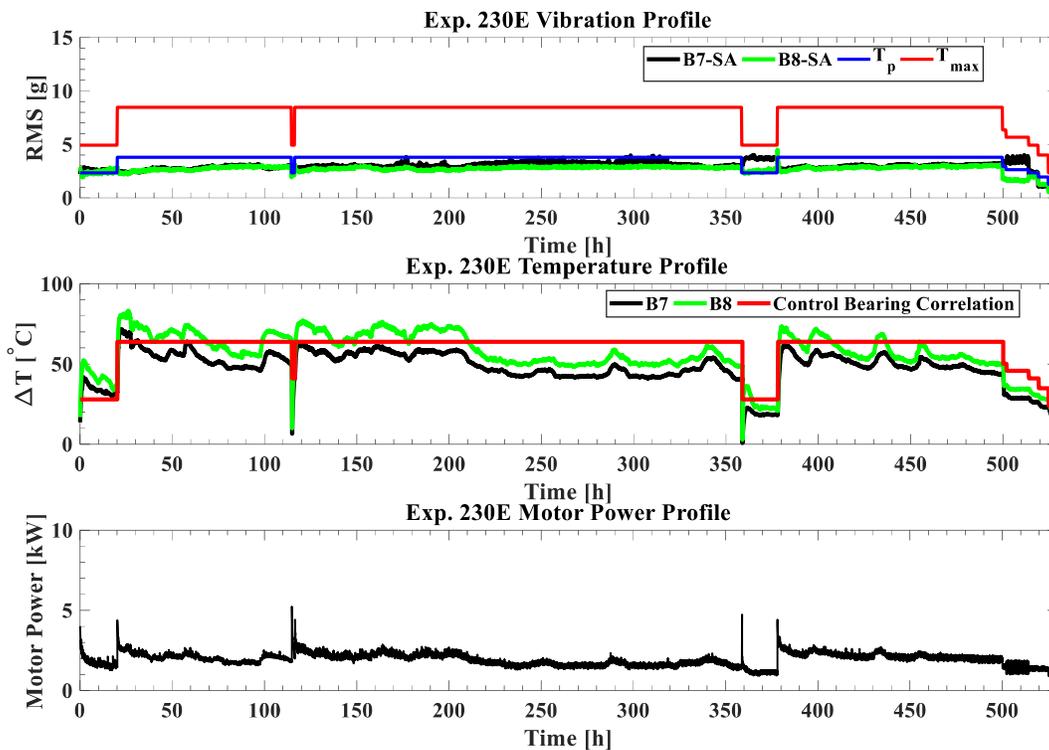
Figure 48: Vibration, temperature, and motor power profiles for Experiment 230E

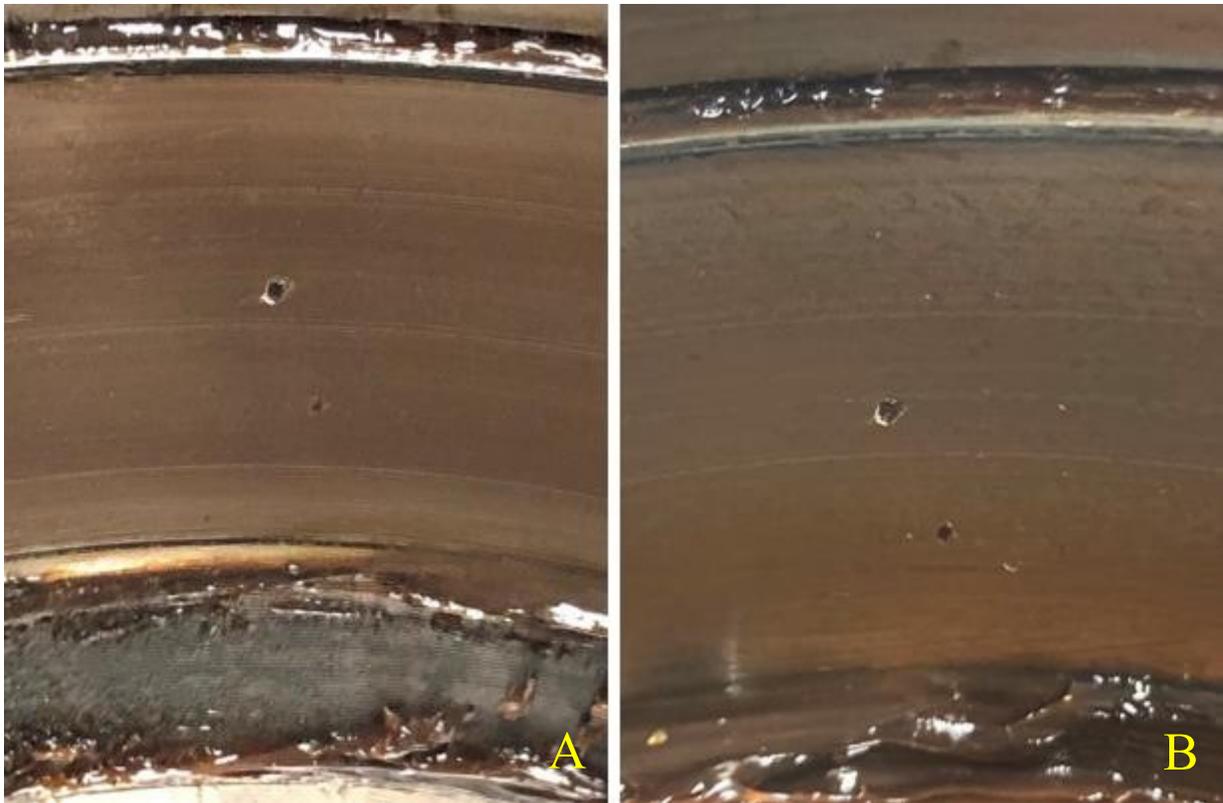
Figure 49. Test bearing B1 pit development: A) after 169,154 km (105,108 mi), and B) after 354,238 km (220,114 mi)
