VIBRATION-BASED ALGORITHM FOR DIAGNOSTIC AND PROGNOSTIC CONDITION  
MONITORING OF RAILROAD BEARINGS AND WHEELS

A Thesis

Major Subject: Mechanical Engineering

The University of Texas Rio Grande Valley

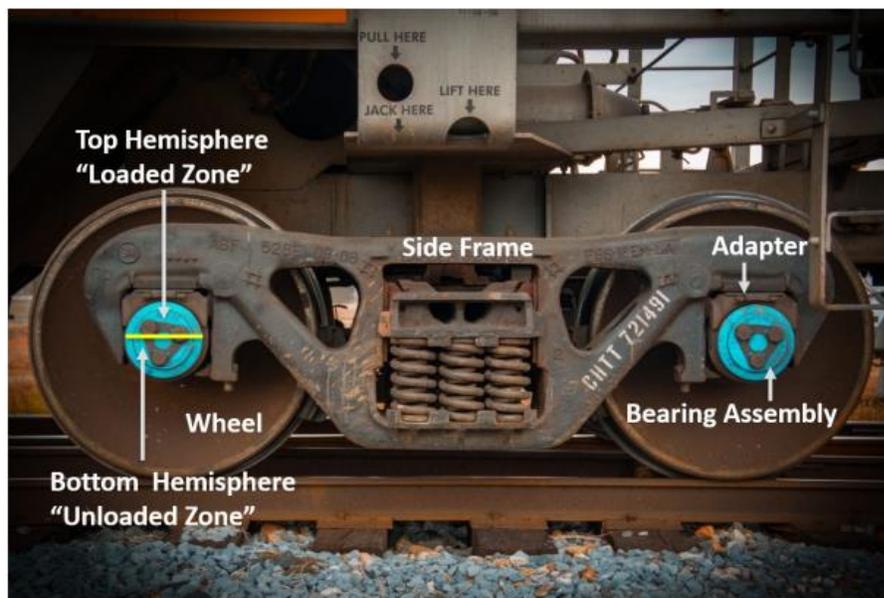
Figure 1: Side profile of railcar bogie assembly [1]

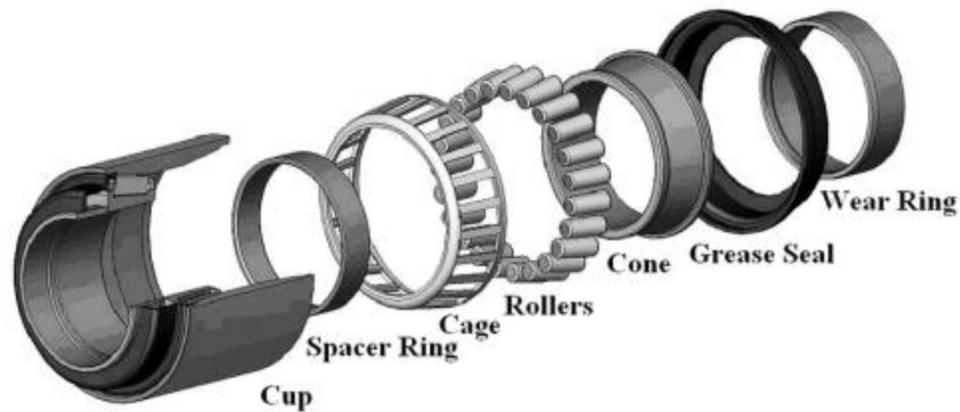
Figure 2 displays the components of a freight railcar tapered-roller bearing assembly. These components include the outer ring (cup), two inner ring (cone) assemblies, the spacer ring, two grease seals, and two wear rings. The cone assembly is further subdivided into the cage, tapered rollers, and the cone itself.

Figure 2: Components of a railway tapered-roller bearing [2]

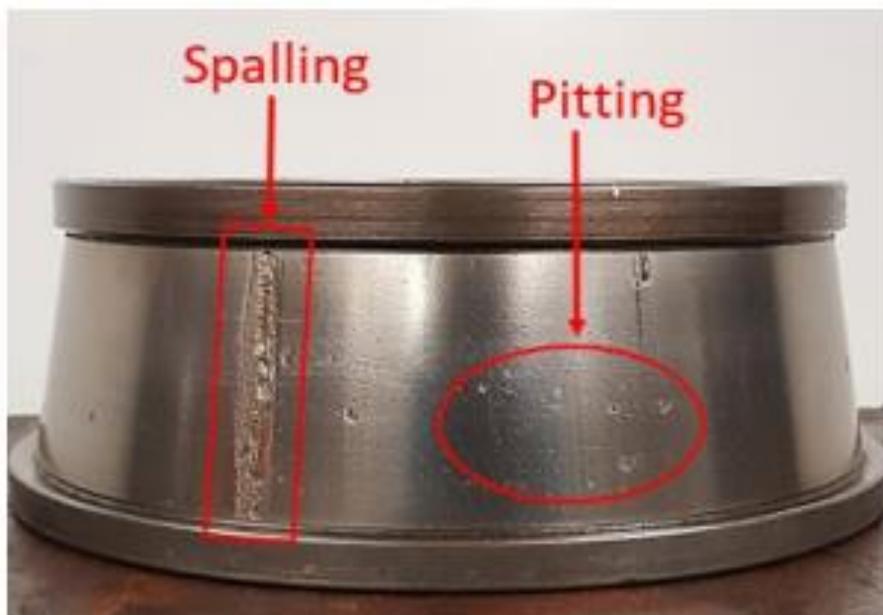
severely detrimental to the bearing service life. After many cycles, microcracks can initiate at these inclusions and propagate to the surface, forming small pits. This leads to spalling, a phenomenon where flakes of metal break away from the surface. The aforementioned typically occurs on the raceways of the bearing rings and on the rollers. Figure 3 displays an example of spalling and pitting damage on a bearing cone.

Figure 3: Fatigue spalling and pitting on a cone raceway [2]

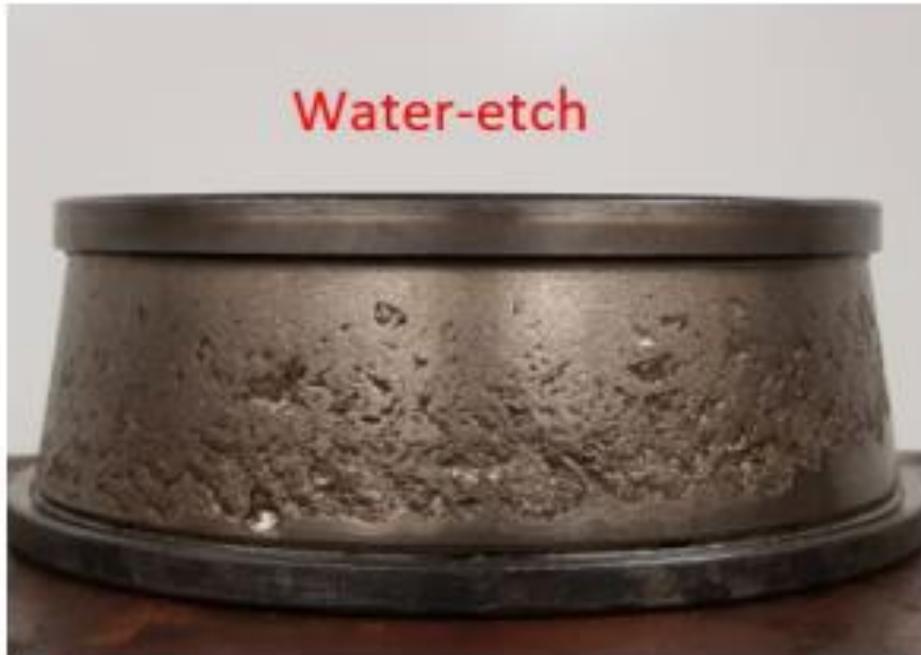
Lubricant contamination is also a leading cause of bearing damage and subsequent failure. Faulty seals can allow contaminants, such as dirt or water, to enter the grease and degrade its lubricating ability. This leads to accelerated wear on the bearing components and decreases service life. Water contamination is especially common in field service. Water reacts with the grease and corrodes the raceway surface in patterns corresponding to the spacing of the rollers. This phenomenon, known as water-etching, creates etch marks that severely weaken the raceway material, which allows the damage to propagate as the bearing continues operating. An example of water-etch damage can be observed in Figure 4.

Figure 4: Water-etch damage on a cone raceway [2]

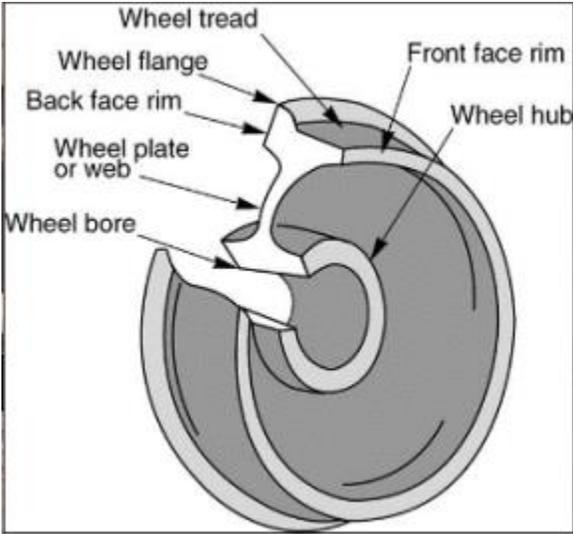
Railcar wheels are designed in such a way to ensure that the train remains on the track during operation. The components of a wheelset include the axle, two wheels, and two tapered-roller bearings mounted on the ends of the axle. The wheels themselves are subdivided into the wheel tread, wheel flange, wheel hub, wheel bore, wheel web, and the front and back face rims. A diagram labelling the wheel components is depicted in Figure 5.

Figure 5: Diagram of railcar wheel [3]

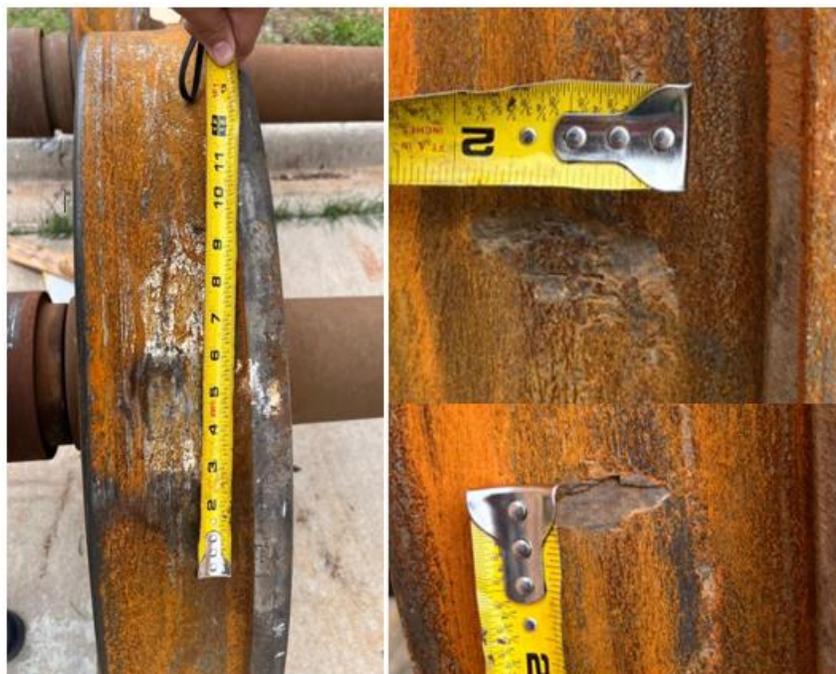
Railcar wheels are especially prone to defects due to the demanding conditions they experience in field service. These defects can be categorized into three main categories: visually evident, geometric, and subsurface defects. Visually evident defects include wheel flats, shelling, and thermal cracks, with examples depicted in Figure 6. Wheel flats occur as a result of localized wear on the wheel tread due to sliding friction typically from braking. Shelling, like spalling in bearing raceways, is characterized by the flaking of metal fragments from the wheel surface as a result of surface RCF. Thermal cracks originate from fatigue induced by thermal stresses experienced in operation.

Figure 6: Wheel flat (left) and wheel tread shelling (right)

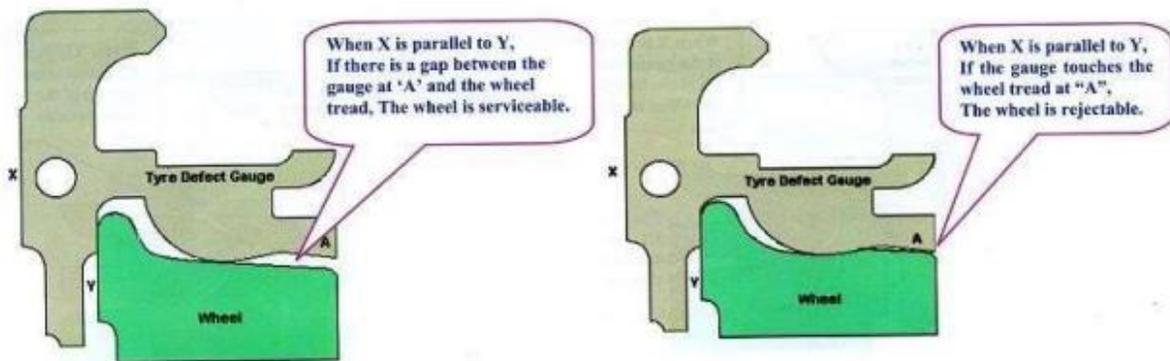
Figure 7: Hollow tread [4]

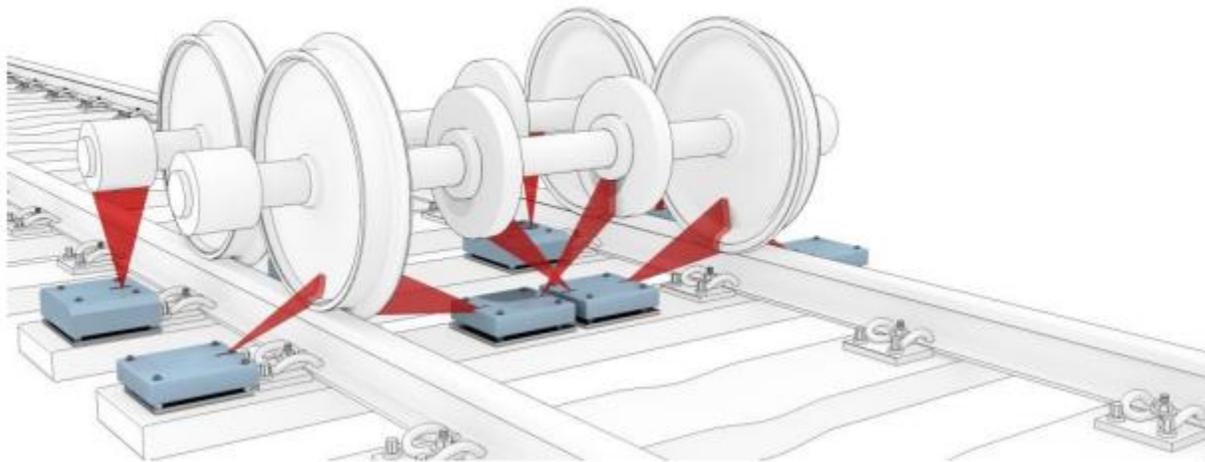
Hot Bearing Detectors, pictured in Figure 8, utilize infrared sensors to measure the temperature radiating from bearings in operation. According to standards set by the Association of American Railroads (AAR), HBDs will alert train operators if a bearing is operating at a temperature higher than 94.4°C (170°F) above ambient or higher than 52.8°C (95°F) above the temperature of the mate bearing on the opposite side of the axle [6].

Figure 8: Illustration of a Hot Bearing Detector site [9]

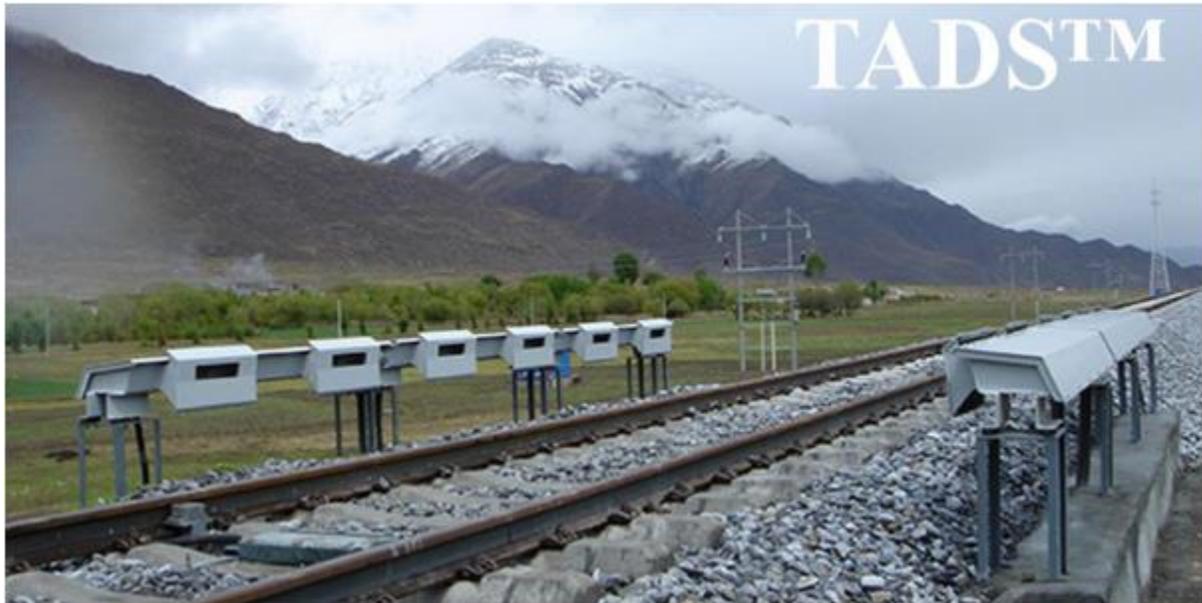
Trackside Acoustic Detection Systems, pictured in Figure 9, employ microphones to detect the acoustic emissions of bearings in operation. Bearing defects generate elevated vibrations that are transmitted through the air as acoustic signals that can be detected by the TADS™. These systems are effective in detecting bearings that are nearing the end of their service life. However, these systems are rare along North American railways, meaning a bearing can spend its entire service life without passing through a TADS™ site [14]. Moreover, their current configuration/thresholds have shown to not be proficient in identifying bearings with defects on the inboard raceways (closest to the railcar) [15] without increasing the false positive

Figure 9: TADS™ site [13]

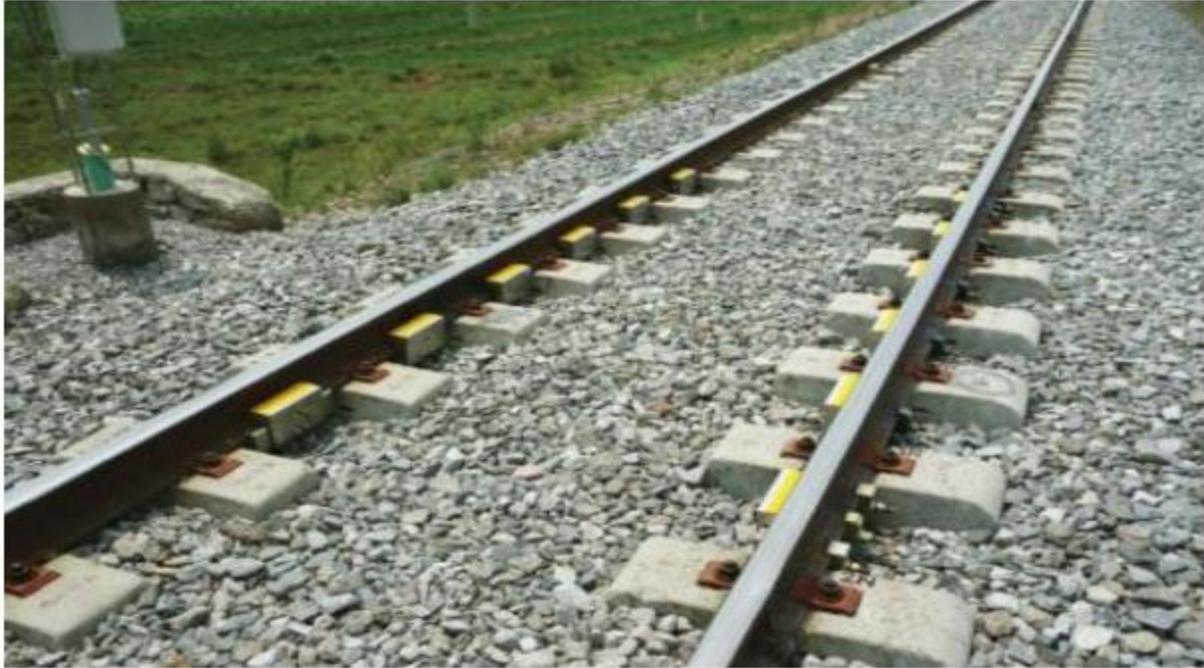
The most common wayside detectors for wheel monitoring are Wheel Impact Load Detectors, an example of which can be seen in Figure 10. These systems consist of strain gauges mounted to the track that are designed to measure the forces generated by wheel-rail interactions. Table 2 summarizes the AAR standards regarding WILD measurements and the corresponding recommended maintenance practices.

Figure 10: WILD site [16]

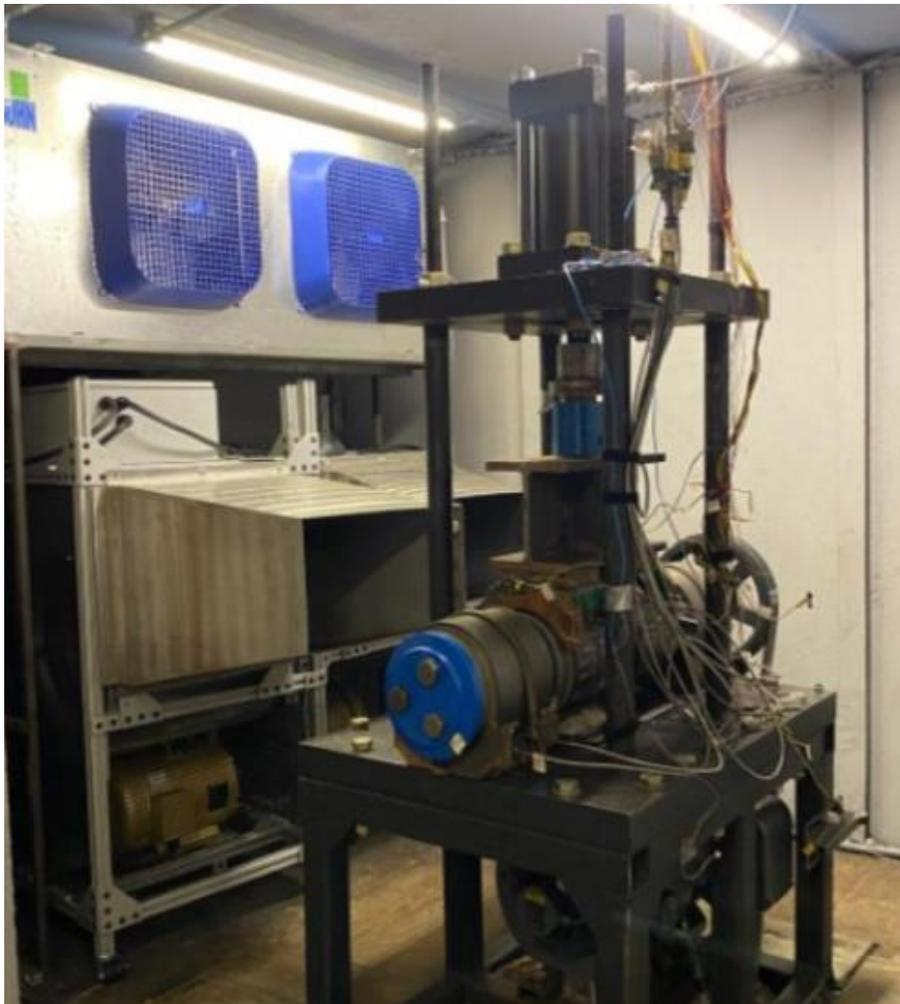
load controller systems that monitor the load and adjust the pressure of the hydraulic cylinder as necessary to maintain a constant load throughout testing. The drivetrain for each tester consists of a 22 kW (30 hp) variable-speed electric motor controlled by a Variable Frequency Drive (VFD) and a pulley-belt system that transmits the rotation of the motor to the axle. This system enables the simulation of train speeds up to 137 km/h (85 mph). The bearings are cooled in operation by two blowers that can provide a variable speed airflow ranging from 1 to 36 m/s (~2-80 mph).

Figure 11: Four-Bearing Tester (4BT)

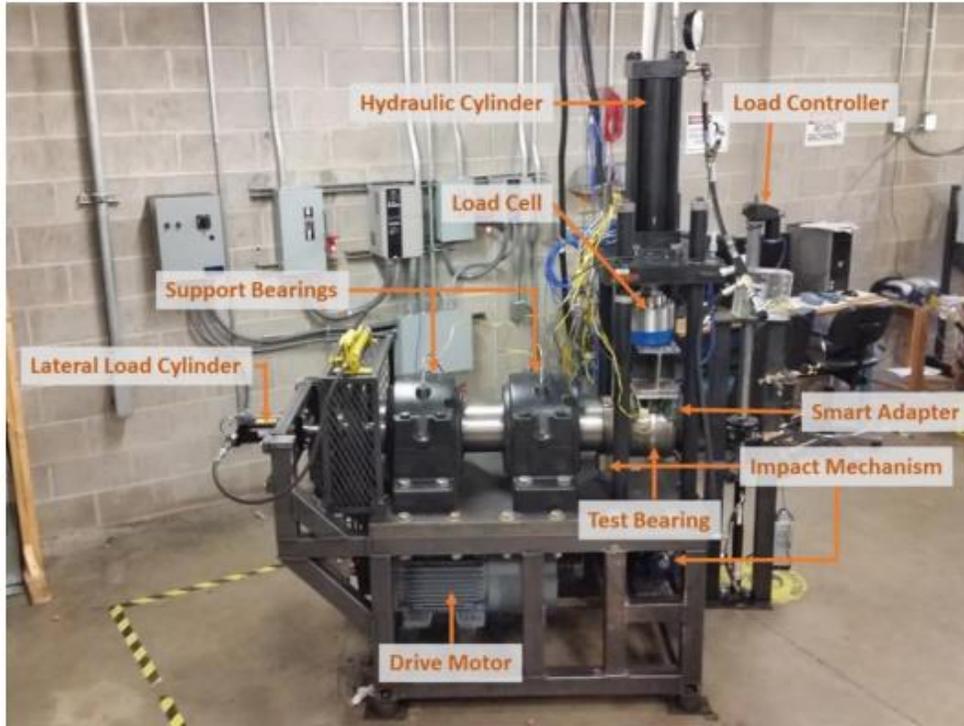
Figure 12: Single-Bearing Tester (SBT)

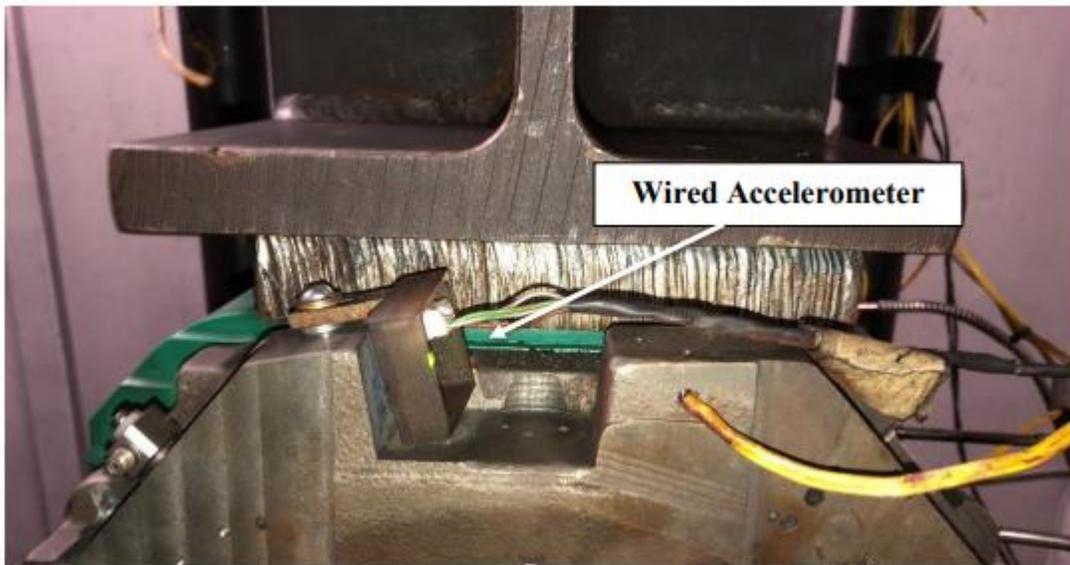
The vibration data used in this study was measured utilizing a uniaxial microelectromechanical system (MEMS) accelerometer with a measuring range of 100 g. These accelerometers are mounted to specially machined railway adapters as seen in Figure 13. Data was collected for 16 seconds every 10 minutes over the duration of an experiment. NI cDAQ-9174 chassis, NI 9215 and NI 9239 DAQ modules, and NI LabVIEW were used to collect data from the accelerometers. Temperature, load, and motor power were also recorded using K-Type thermocouples, load cells, and the VFD outputs, respectively. These measurements helped monitor the bearing and tester condition for abnormalities. However, the data from these measurements was not pertinent for this thesis.

Figure 13: Accelerometer placement

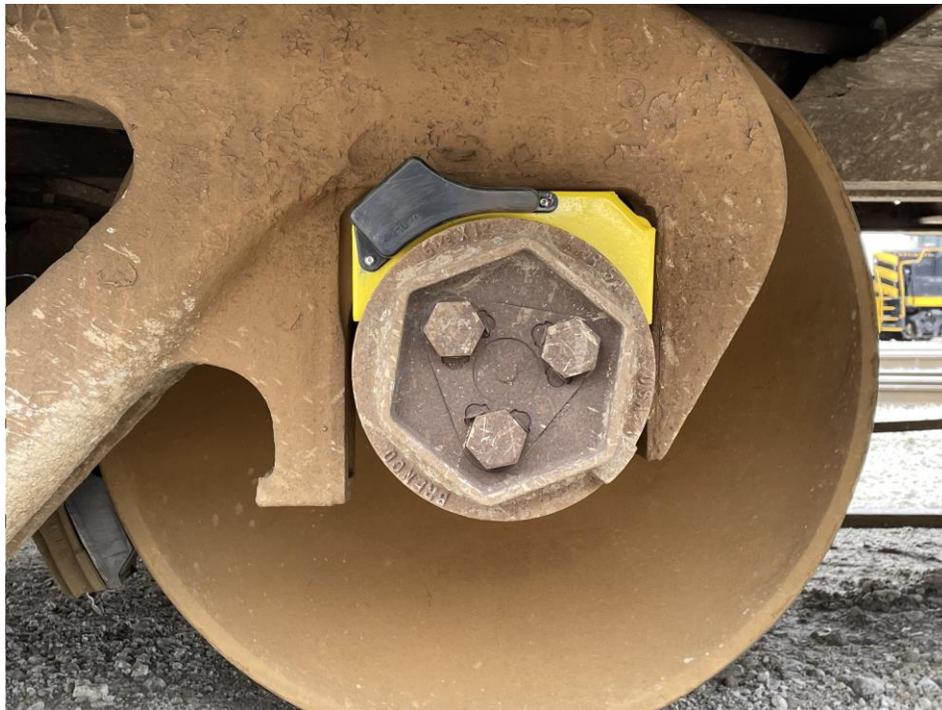
The Boomerangs are designed to be mounted to the railcar bearing adapters to optimize the capture of vibration data from bearings and wheels in field service. The adapters are machined utilizing drill and tap methods to facilitate the mounting of the Boomerang case with steel screws as shown in Figure 14. Eight Boomerangs are installed per railcar and are designated by their position as per AAR nomenclature (Figure 15). For instance, the left wheel/bearing on the frontmost axle would be designated as L4. The eight Boomerangs are assigned to a single Gateway that is mounted in a strategic location on the railcar to optimize sunlight exposure (Figure 16).

Figure 14: V5 Boomerang mounted on railcar bearing adapter

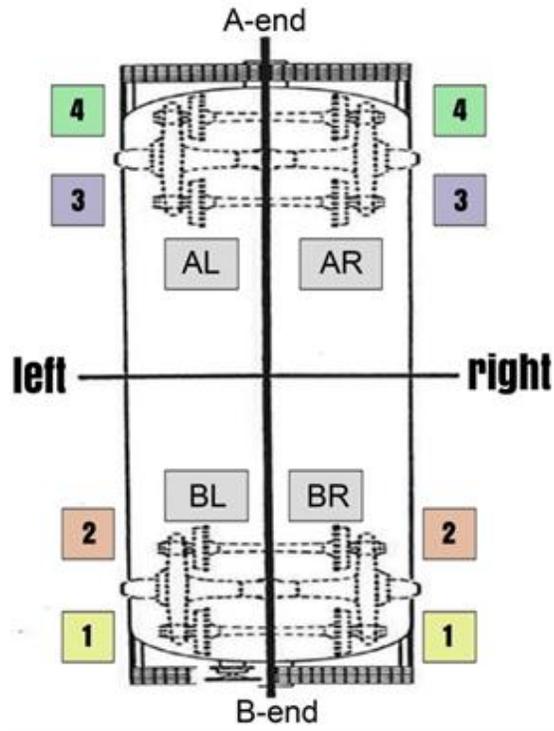
Figure 15: AAR wheel identification diagram

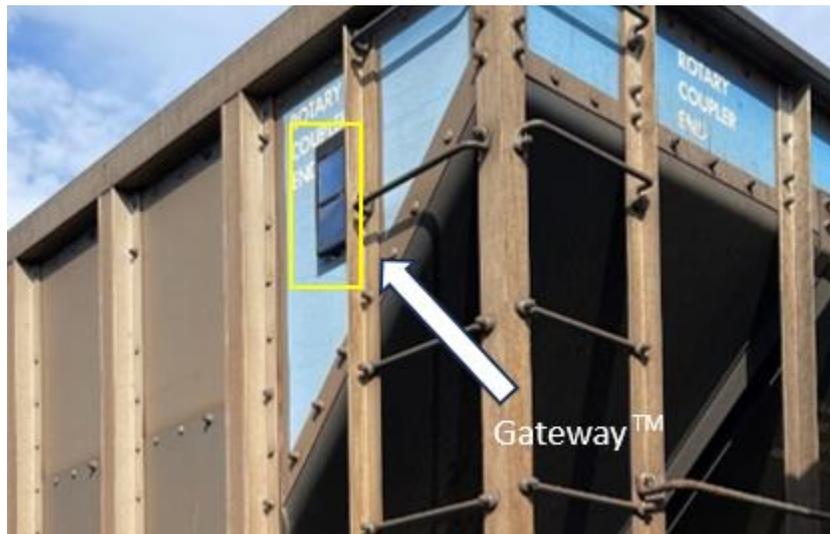
Figure 16: Gateway installation

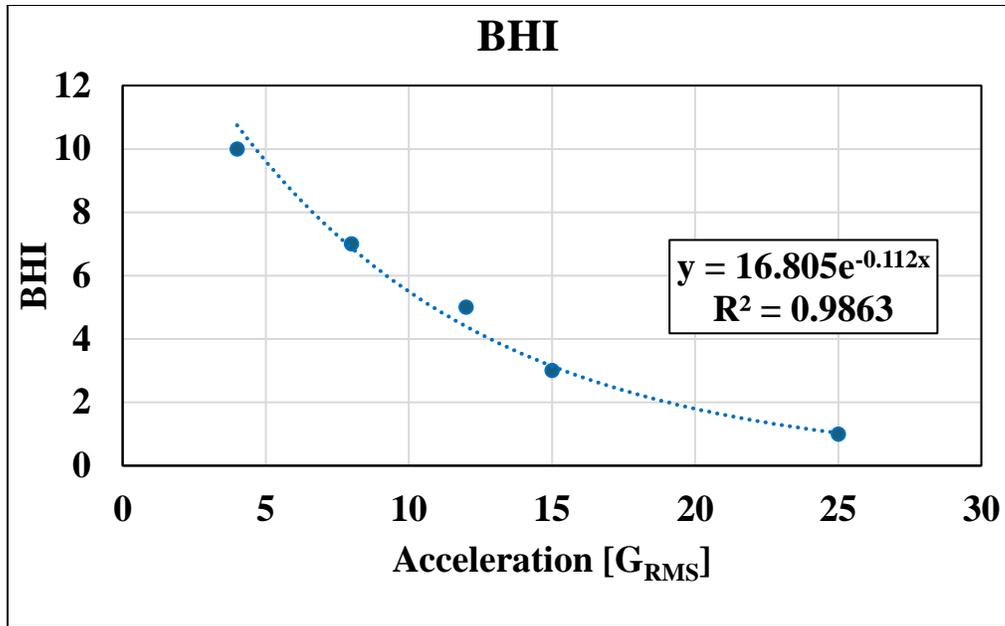
The values selected for model development were based on statistical analysis of two decades' worth of bearing vibration data. Specifically, the first two values are based on the speed-dependent thresholds developed and optimized by the UTCRS. The preliminary threshold (at 85 mph) corresponds to a 4 GRMS acceleration. Bearings that exhibit vibration levels that are at or below this threshold are considered healthy (defect-free). Therefore, any measured values at or below this value correspond to a BHI of 10, indicating that the bearing is at full health. The maximum threshold (at 85 mph) corresponds to an 8 GRMS acceleration, where bearings that exhibit vibration levels above this threshold are deemed defective. However, bearing vibration levels falling between the two thresholds introduce uncertainty in determining whether the bearing is healthy but running at elevated vibration levels or contains a defect in its early stages of development. Thus, the range between these two thresholds (4 GRMS - 8 GRMS) has been designated the "gray zone" and corresponds to BHI values between 10 and 7. The latter acceleration values in Table 3 were chosen based on extensive research in defect propagation patterns through testing performed at the UTCRS and correspond to defect sizes based on correlations developed by Montalvo [21]. Figure 17 displays the exponential model generated utilizing the values in Table 3.

Figure 17: BHI correlation

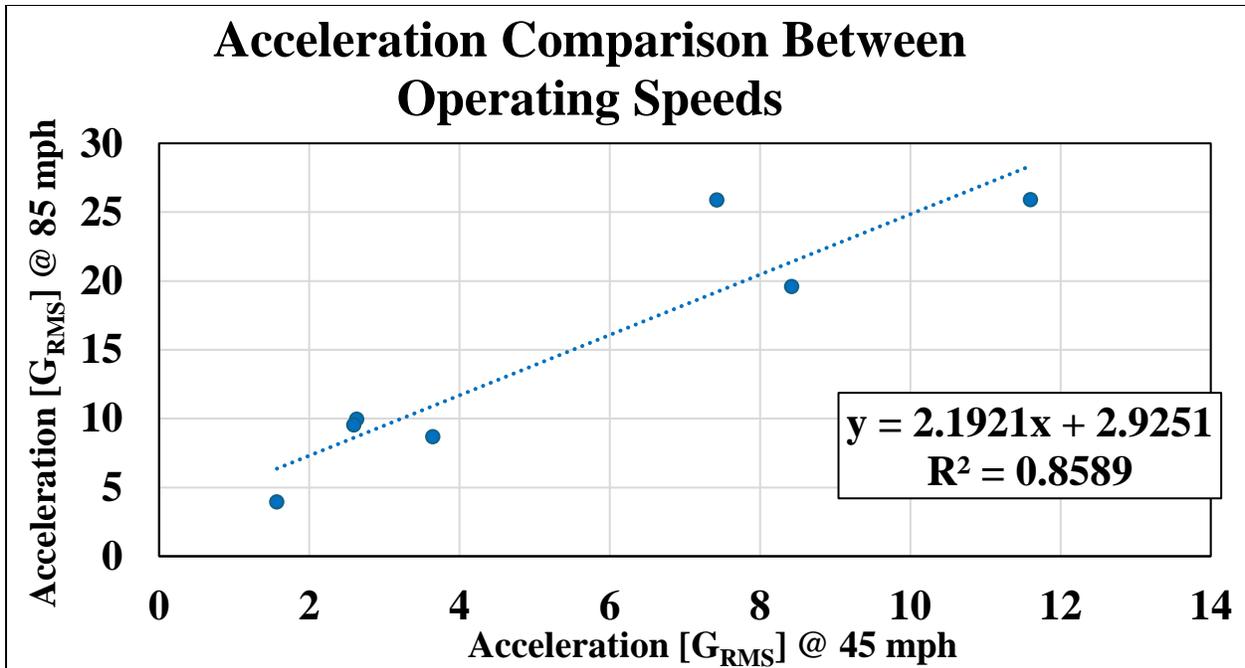
The BHI correlation was developed with vibration data collected from fully loaded bearings operating at 136.8 km/h (85 mph). However, these conditions are uncommon in freight rolling stock and train speeds can vary significantly. Therefore, in order for the BHI to reflect bearing condition independent of speed, the measured vibration levels must be normalized. This process is done by converting the acceleration measured at the actual speed to the acceleration that would be expected at 136.8 km/h (85 mph). Correlations were developed using data from experiments with defective bearings running at speeds ranging from 40.2-136.8 km/h (25-85 mph). Only experiments where the defect did not propagate during testing were considered as to not bias the model with the effects of spall propagation. Figure 18 provides an example of a correlation relating the acceleration at 72.4 km/h (45 mph) to the acceleration at 136.8 km/h (85 mph). Similar correlations have been developed for the other operating speeds.

Figure 18: Correlation relating the acceleration values at 45 mph to those at 85 mph

It should be noted that these normalization correlations are still in development and will be further optimized as more data becomes available.

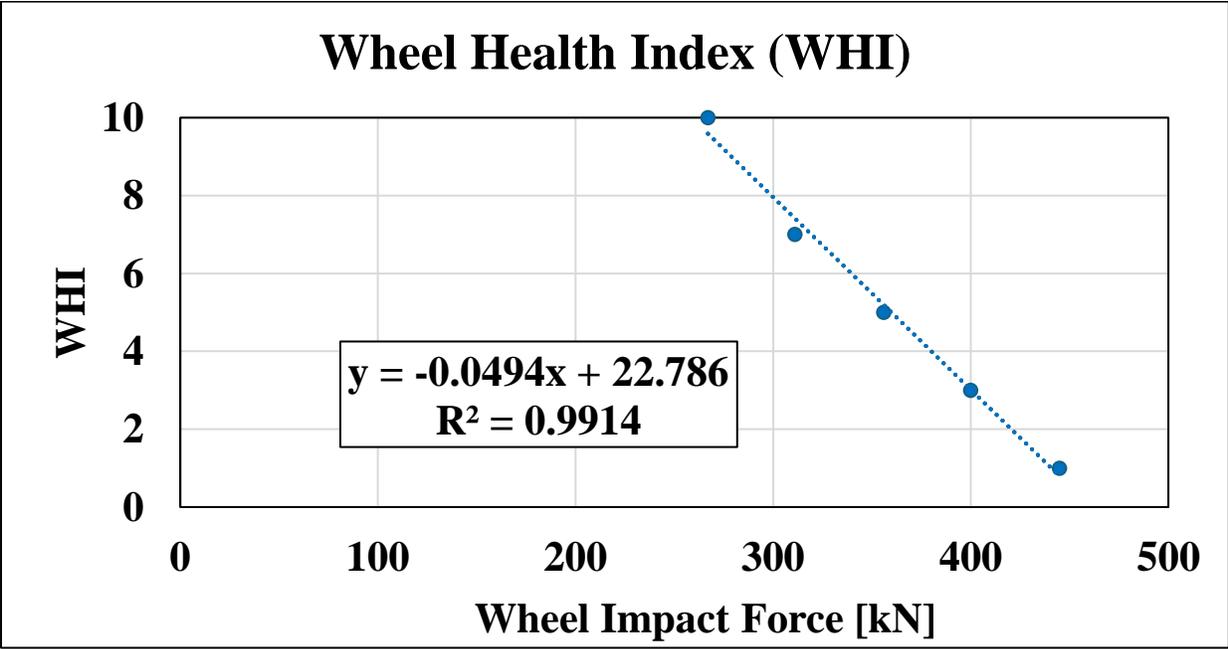
Impact Force [kN]	Impact Force [kip]	WHI
267	60	10
311	70	7
356	80	5
400	90	3
445	100	1

Figure 19: WHI correlation

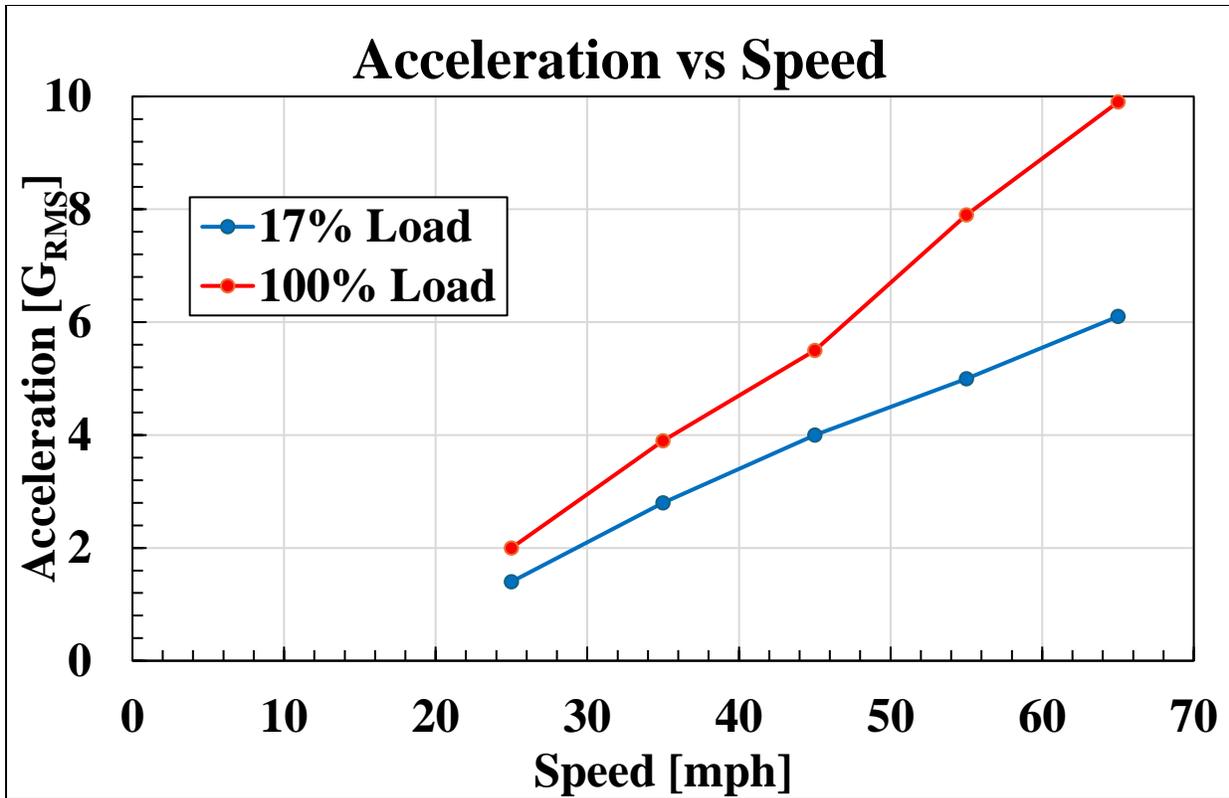
Previous experimentation has shown that vibration signatures of defect-free bearings vary minimally with loading condition [19]. However, the same is not true for defective bearings. Increased loading results in an increased contact area between the roller and raceway. If the raceway contains a spall, the roller impacts the spall with a higher force, leading to elevated vibration levels. Figure 20 plots the laboratory acceleration as a function of speed of a bearing with a cup defect at unloaded (17%) and loaded (100%) conditions. It is evident that the vibration levels at each loading condition differ substantially as speed increases. Therefore, it is imperative to account for the load to characterize the condition of a bearing.

Figure 20: Acceleration vs speed for a bearing with a cup defect (31.2 cm<sup>2</sup>)

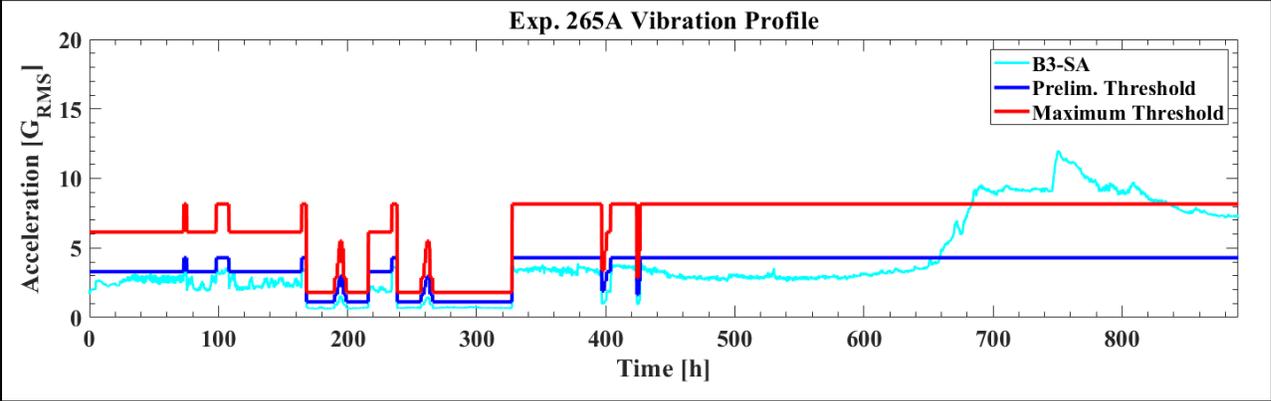
rollers. Figure 21 provides an example of laboratory vibration data taken from a bearing that initiated a cup defect that propagated throughout the duration of the experiment. Note that the vibration levels rose above the maximum threshold (red line) indicating a defective bearing and eventually settled below it. As the BHI is based on the measured vibration levels, the BHI would increase as the vibration decreased, leading to a false indication of bearing health improvement. Thus, the algorithm retains the lowest BHI if the subsequent vibration data results in a higher BHI. Figure 22 compares the BHI and vibration profiles of the bearing from Figure 21. Note that the BHI does not improve even if the vibration levels decrease, which represents a more realistic depiction of bearing health, i.e., once the bearing develops a defect, it cannot heal itself.

Figure 21: Vibration profile of a bearing that initiated a cup defect

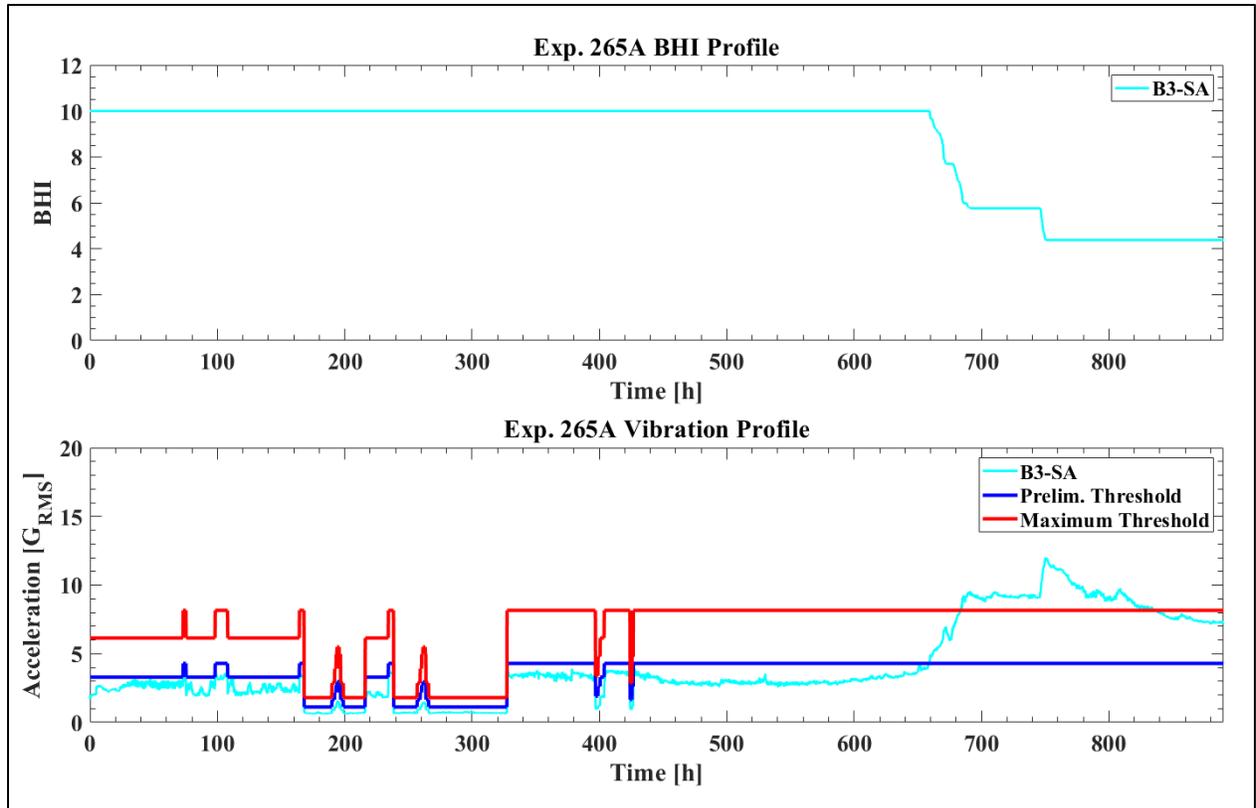
Figure 22: BHI and vibration profiles of bearing that initiated a cup defect

The final BHI calculated for this bearing was 4.38, which translates to an estimated spall size of  $14.59 \text{ cm}^2$  ( $2.26 \text{ in}^2$ ). However, the actual size of the spall (seen in Figure 23) was measured to be  $7.03 \text{ cm}^2$  ( $1.09 \text{ in}^2$ ), resulting in an error of 108%. This error in defect size estimation is likely due to three reasons. The first reason has to do with the spall measurement process, which only accounts for the main spall area and ignores the pitted regions that surround the spalled region. These pits can contribute to the vibration of the bearing, leading to an overestimation of the main spall area. The second reason is the inherent error in the normalization of the measured vibration values, and the third reason is that, in this particular example, the BHI was calculated using the highest normalized  $G_{RMS}$  value generated by the bearing. The issue with doing so is that the maximum  $G_{RMS}$  value may not be representative of

the true defect size. As defects develop and propagate, they produce debris (i.e. metal shards) that can temporarily generate higher levels of vibration that eventually settle as the debris is ground down by the rotating rollers.

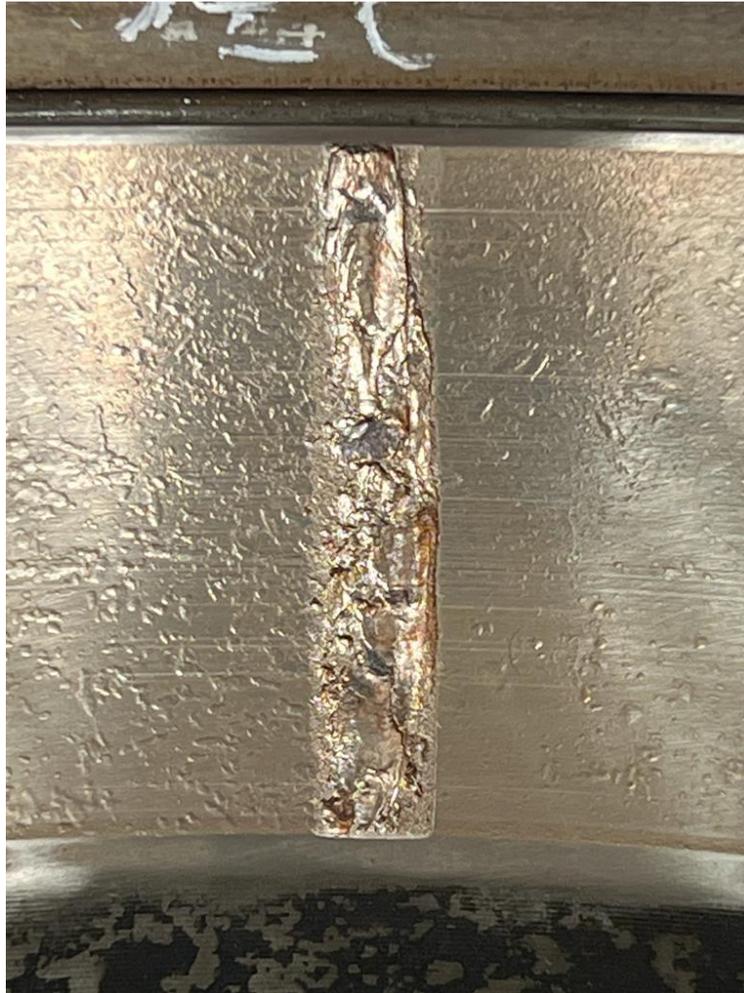
Figure 23: Cup spall initiated during Exp 265A

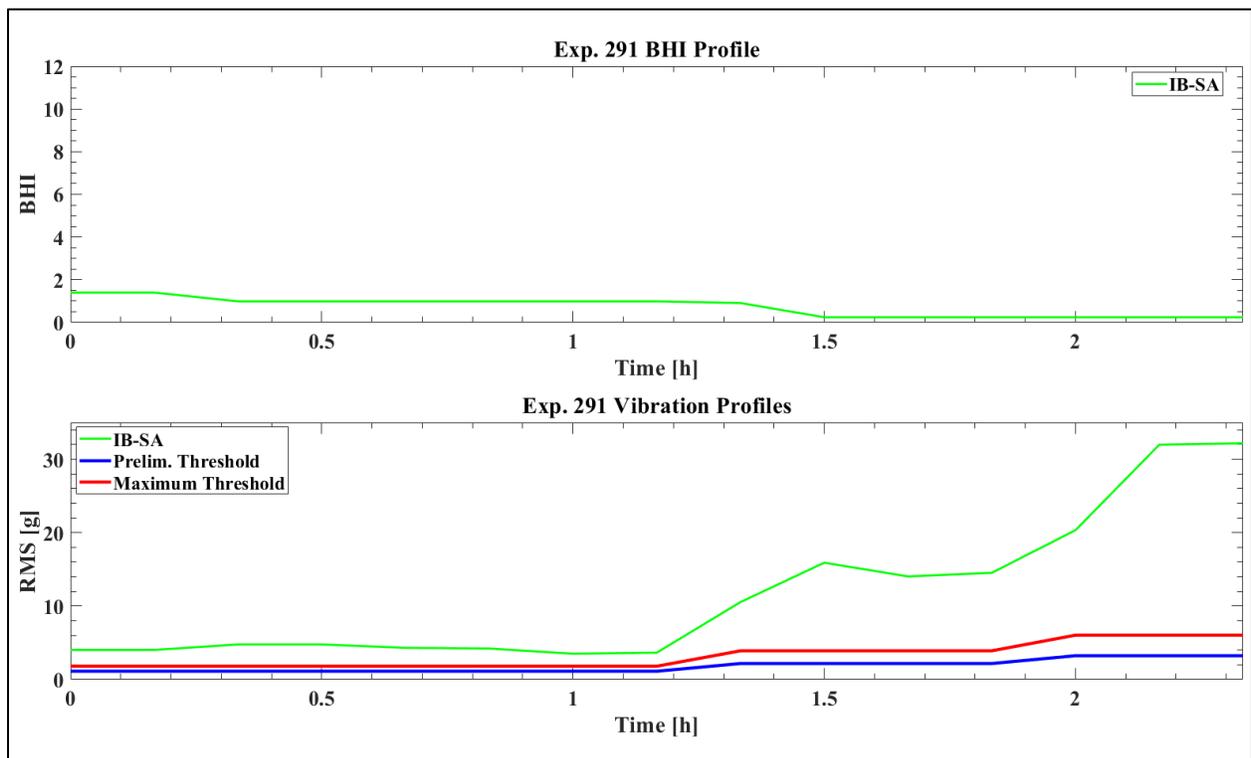
Figure 24 provides another example showcasing the vibration and BHI profiles of a bearing with a severe cup defect. The spall, pictured in Figure 25, was measured to be  $62.58 \text{ cm}^2$  ( $9.70 \text{ in}^2$ ). The BHI was calculated to be 0.244 which translates to an estimated spall size of  $95.57 \text{ cm}^2$  ( $14.81 \text{ in}^2$ ). This again resulted in an overestimation of the defect severity by 52.7%. The overestimation of the defect size necessitated a method to account for the variability

resulting from the normalized acceleration and defect propagation. In this particular example, if, instead of using the highest normalized acceleration, the average of the normalized  $G_{RMS}$  acceleration values was used to calculate the BHI, then the resulting BHI would be 0.762. This BHI value translates to an estimated spall size of  $60.72 \text{ cm}^2$  ( $9.41 \text{ in}^2$ ), a difference of only 3% from the actual measured defect size, which represents a significant improvement in the accuracy of the BHI's diagnostic capability. Thus, for field service applications, the condition monitoring algorithm will be set to take the average normalized  $G_{RMS}$  from a day's worth of vibration data to calculate the BHI that best characterizes the bearing condition.

Figure 24: BHI and vibration profiles from a bearing with a severely defective cup raceway

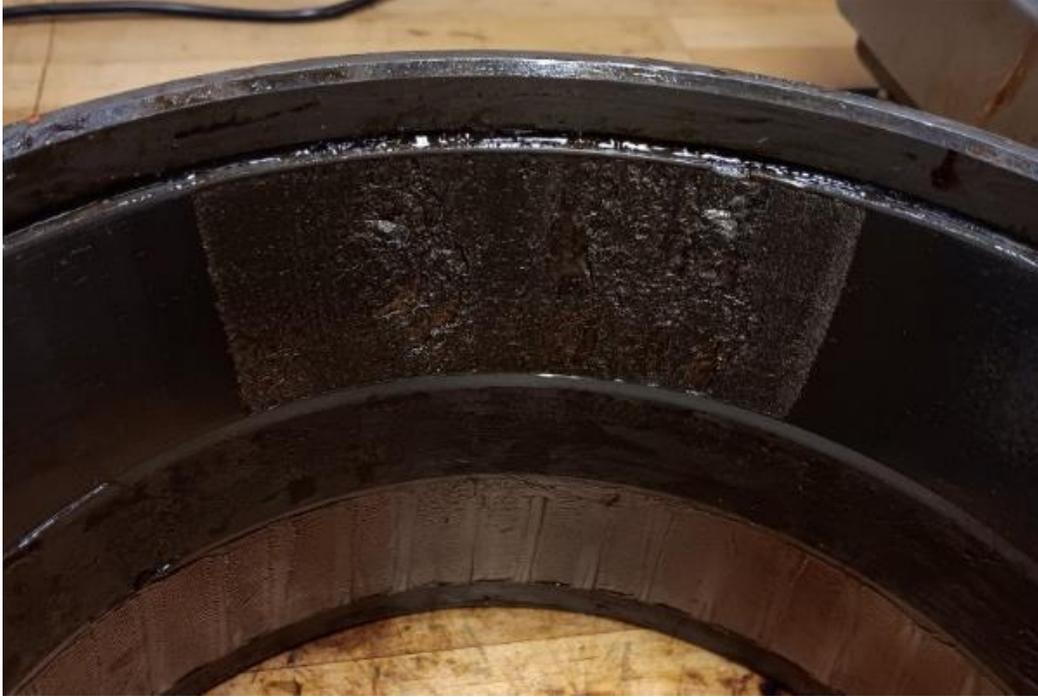
Figure 25: Cup spall from Exp 291

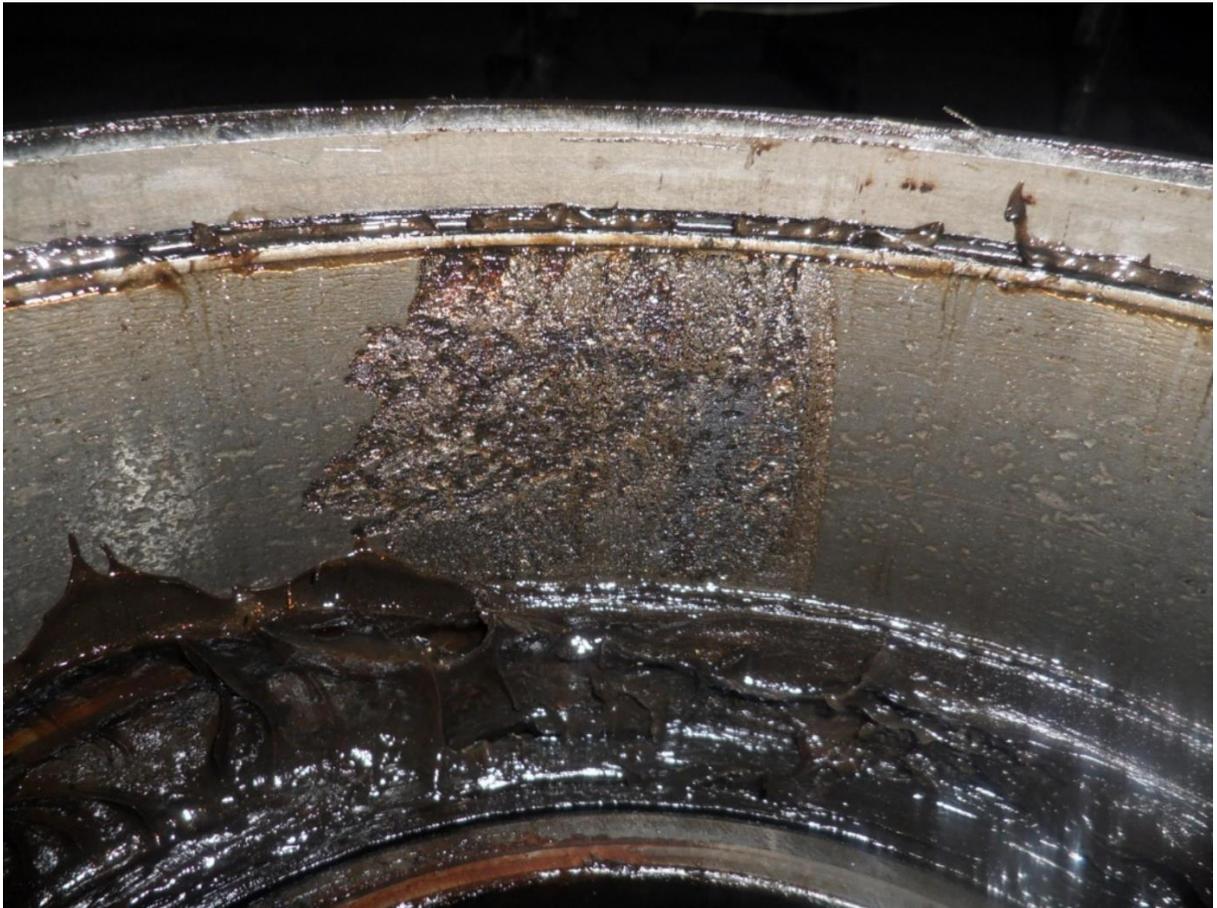
position was run a second time (denoted as 360°) to validate that the spall did not propagate throughout testing. Iterations for all defect positions were conducted with operating speeds of 40.2 km/h (25 mph), 72.4 km/h (45 mph), and 104.6 km/h (65 mph) under both unloaded and loaded conditions. Instrumentation included a V6 Boomerang, a wired version of A1 for reference, and another tri-axial accelerometer being tested as a possible replacement for the Boomerang's A1 accelerometer. Figure 27 depicts the mounting of the instrumentation to the adapter.

Figure 26: Cup spall used in index testing

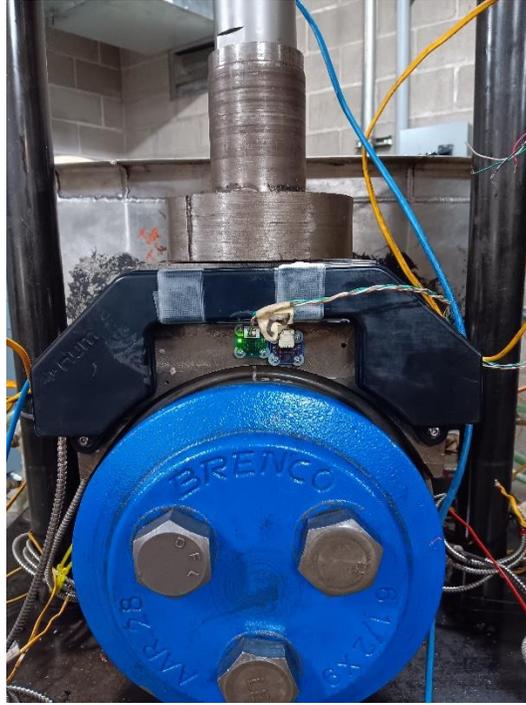
Figure 27: Instrumentation setup for index testing
