VIBRATION-BASED ALGORITHM FOR DIAGNOSTIC AND PROGNOSTIC CONDITION  
MONITORING OF RAILROAD BEARINGS AND WHEELS

A Thesis

Major Subject: Mechanical Engineering

The University of Texas Rio Grande Valley

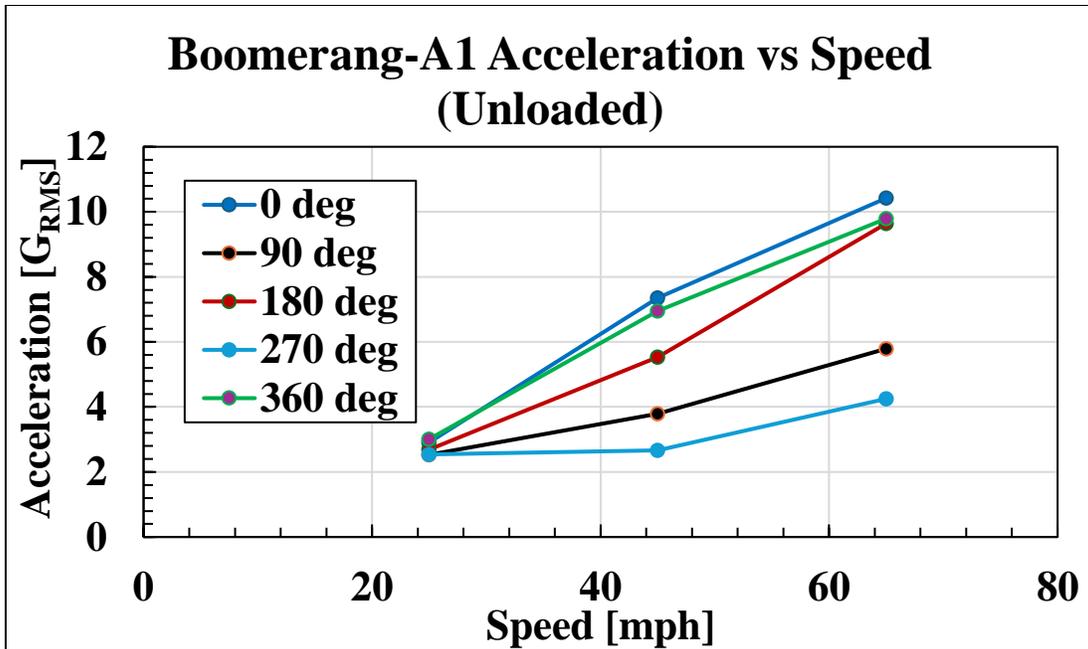
Figure 28 and Figure 29 present the Boomerang A1 acceleration as a function of speed at all defect positions for unloaded and loaded conditions, respectively. The data shows that the position of the cup spall has a significant effect on the measured acceleration with higher values generally being measured with the defect directly under the instrumentation (i.e.  $0^\circ$  or top-dead-center, which also coincides with the region of maximum applied load). The  $0^\circ$  and  $180^\circ$  positions produced similar trends at unloaded conditions as they shared the same primary axis of vibration in the vertical direction. However, lower acceleration was recorded when the bearing was fully loaded with the defect at the  $180^\circ$  position as compared to the  $0^\circ$  position. This can be explained by the increased loading compressing the cup, leading the spall to move further away from the rollers. This increased separation between the spall and the rollers decreases the vibration levels as the rollers impact the defect with a lower force.

Figure 28: Boomerang A1 acceleration vs speed at unloaded conditions (all defect positions)

Although it is evident that defect position has a measurable effect on bearing vibration levels, the algorithm can account for this utilizing the same method used to account for the propagation-induced variability. The algorithm retains the lowest BHI which corresponds to the highest measured acceleration value. Cup defects are most likely to initiate in the  $0^\circ$  position since this is the region that experiences the highest applied load. Therefore, even if the defect position shifts in the field due to indexing and the measured acceleration decreases, the algorithm will retain the lowest BHI calculated when the defect was located at top-dead-center. Moreover, if the defect propagates during indexing, then upon completing a full rotation, the acceleration values at the  $0^\circ$  position will be higher than in the previous cycle, resulting in a lower tabulated BHI. Thus, the algorithm can still provide reliable and accurate bearing diagnostics and prognostics even if the cup containing the spall (defect) indexes.

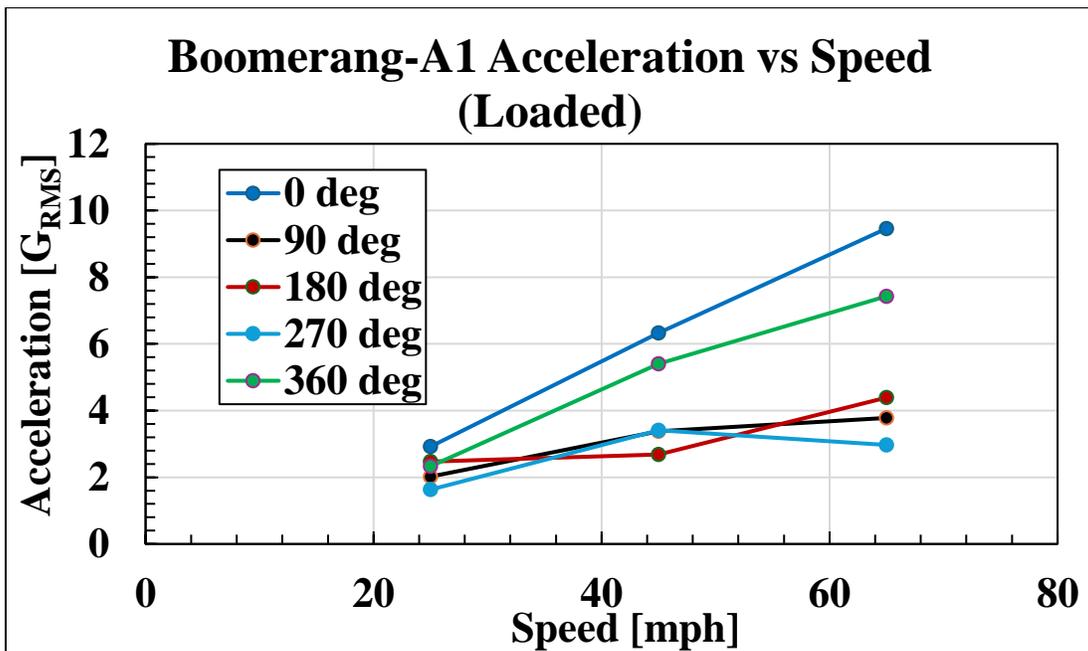
Figure 29: Boomerang A1 acceleration vs speed at loaded conditions (all defect positions)

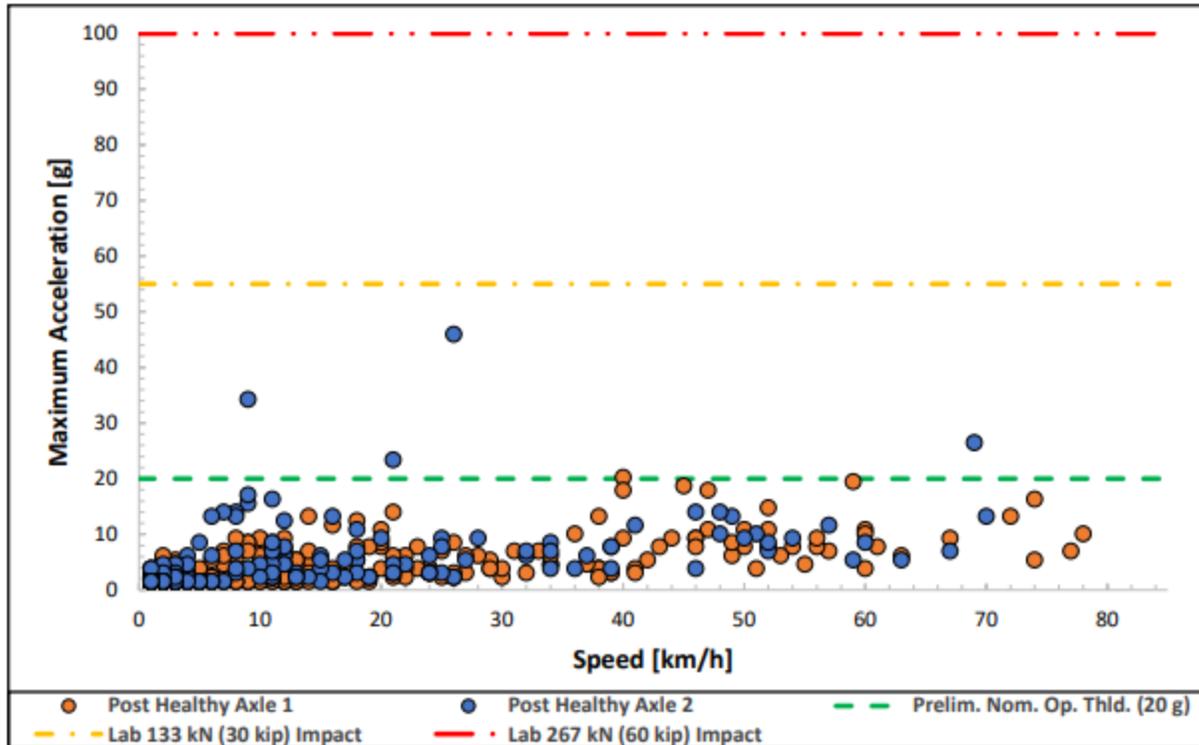
The first step of the algorithm is to determine whether the wheelset (also referred to as axle) assembly (consisting of the wheels, bearings, and axle) is defective. This is accomplished by analyzing the maximum acceleration data from the A2 accelerometer. The field test conducted by Barrera showed that the maximum acceleration measured by A2 of a healthy wheelset generally remains below a threshold of 20 g apart from a few outliers (likely track-related) [23]. Figure 30 presents the A2 data recorded from a newly installed, healthy wheelset on the railcar. From this data, it can be inferred that wheelsets with no defective bearings or wheels will generally exhibit acceleration values below the 20 g threshold. Therefore, to identify defective wheelsets, the algorithm applies the statistical filtering method described in Chapter IV to remove potential outliers, then calculates the percentage of data points that fall below the defined threshold. If less than 95% of the data is below the 20 g threshold, the algorithm flags that wheelset as most likely being defective and proceeds to the next step.

Figure 30: A2 acceleration data taken from a healthy wheelset [23]

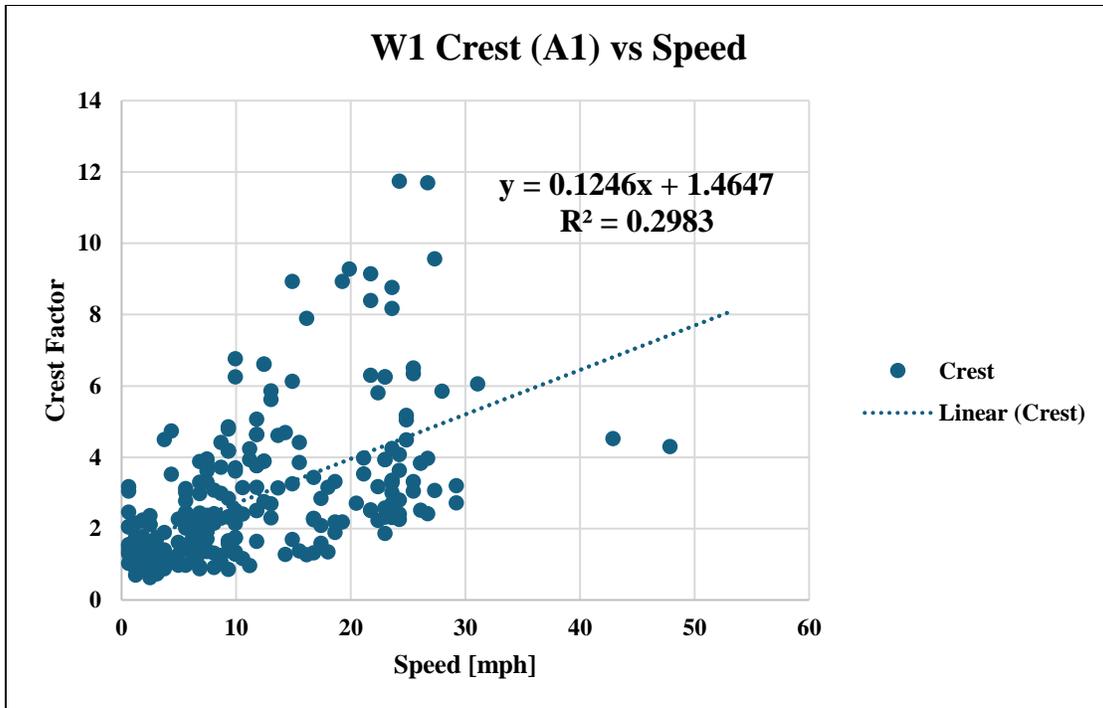
Once a defective wheelset has been identified, the next step is to determine whether the bearing or wheel is defective. This step is challenging as both of the Boomerang's accelerometers are capable of detecting vibration signatures characteristic of either component being defective. Hence, this process requires an in-depth analysis of historical data to identify patterns indicative of a defective bearing or wheel. As mentioned in Chapter IV, the Crest Factor is a good indicator of the presence of impacts. Analysis of Crest data as a function of train speed for two defective wheels identified in a field test revealed a pattern that could aid the algorithm in identifying defective wheels. Figure 31 and Figure 32 display the A1 Crest data as a function of speed for both defective wheels denoted as W1 and W2, respectively.

Figure 31: A1 accelerometer Crest vs speed for defective wheel W1 from field test

Linear regression analysis of the Crest data from the defective wheels reveals that the Crest tends to increase as a function of speed, indicating that higher speeds result in higher impact forces, which is expected. It should be noted that the majority of the data did not exceed the previously mentioned Crest threshold of 10. This is likely due to the impacts at lower speeds not generating enough force to push the Crest above the threshold. However, as the trendlines indicate, the Crest values would have crossed the threshold if the speed were to increase. Nonetheless, it is clear that defective wheels create a noticeable pattern in the Crest data. In contrast, laboratory experiments with defective bearings show that the Crest Factor is not influenced by operating speed. Figure 33 displays the vibration levels and Crest as a function of simulated distance travelled for two defective bearings running on the four-bearing test rig housed within the environmental chamber. The changes in the maximum threshold (red line) correspond to changes in operating speed. Note that the Crest values remain generally constant despite the presence of defects and changes in speed. Further analysis of five other experiments with defective bearings reveal similar patterns. Thus, analyzing Crest data as a function of speed can aid in the differentiation between defective bearings and wheels.

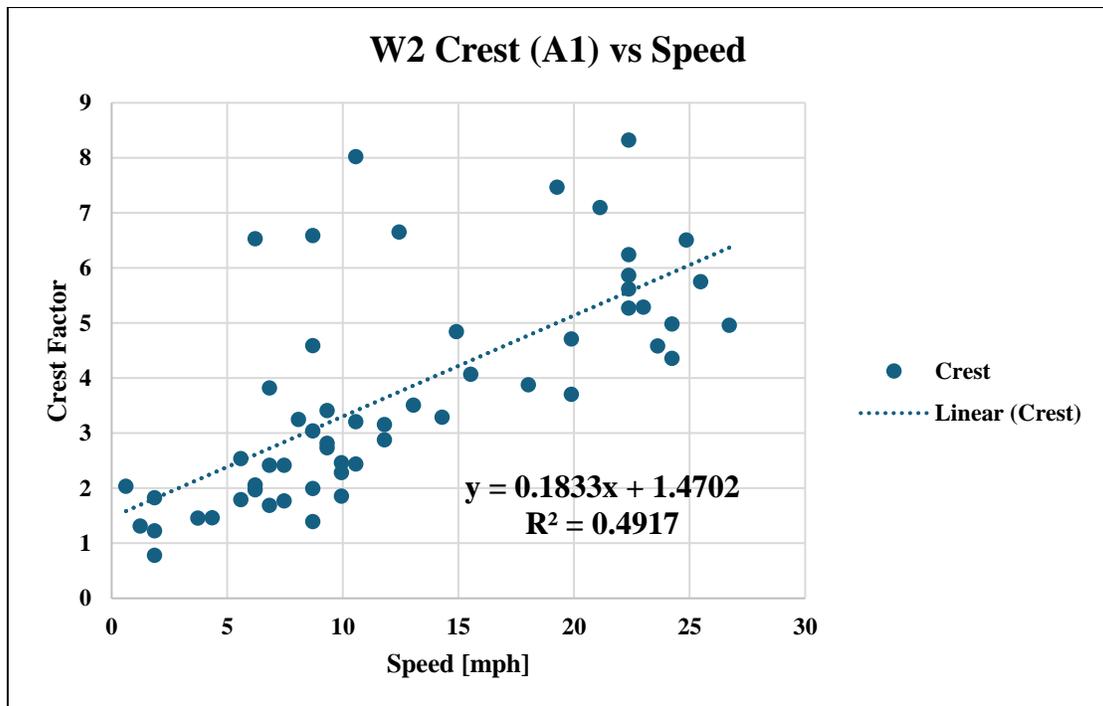
Figure 32: A1 accelerometer Crest vs speed for defective wheel W2 from field test

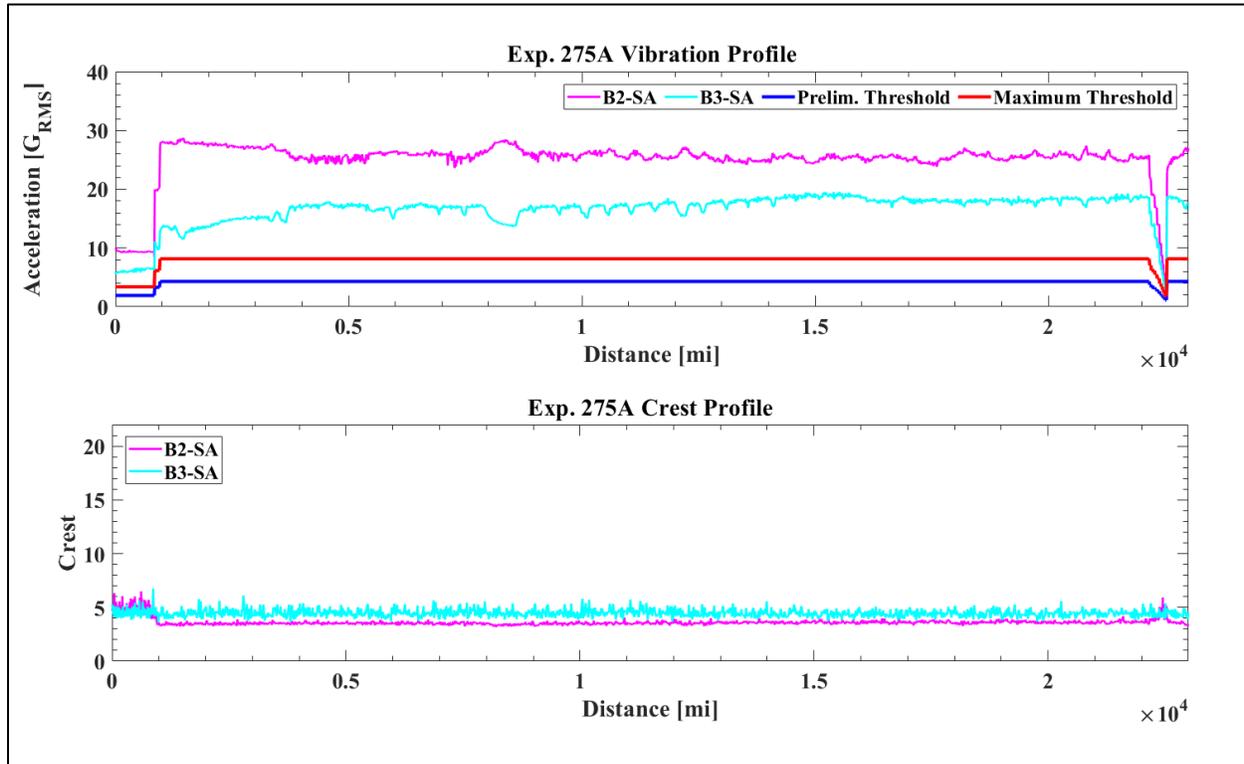
this is preliminary work based on limited data, and further field testing is needed to validate and analyze the Crest patterns for a wide variety of defect severities.

Figure 33: Laboratory vibration and crest profiles for two defective bearings

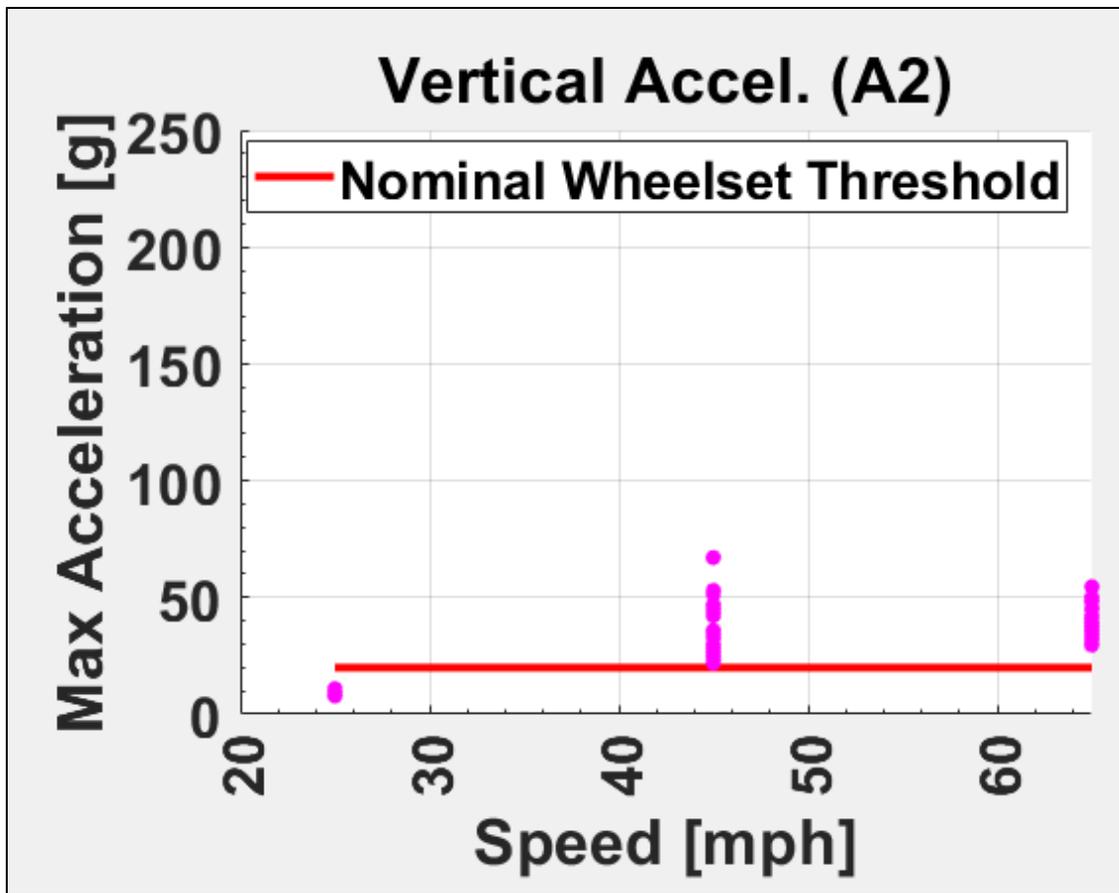
Figure 34 displays the unloaded and loaded maximum acceleration data from the Boomerang's A2 accelerometer. It can be seen that a significant amount of data is above the 20 g threshold. The algorithm calculated that 50.5% of the data was above the nominal wheelset threshold, thus designating the "wheelset" as being defective. This demonstrates that the algorithm is capable of identifying defective "wheelsets" in a laboratory setting.

Figure 34: A2 accelerometer maximum g acceleration data as a function of speed (unloaded and fully loaded)

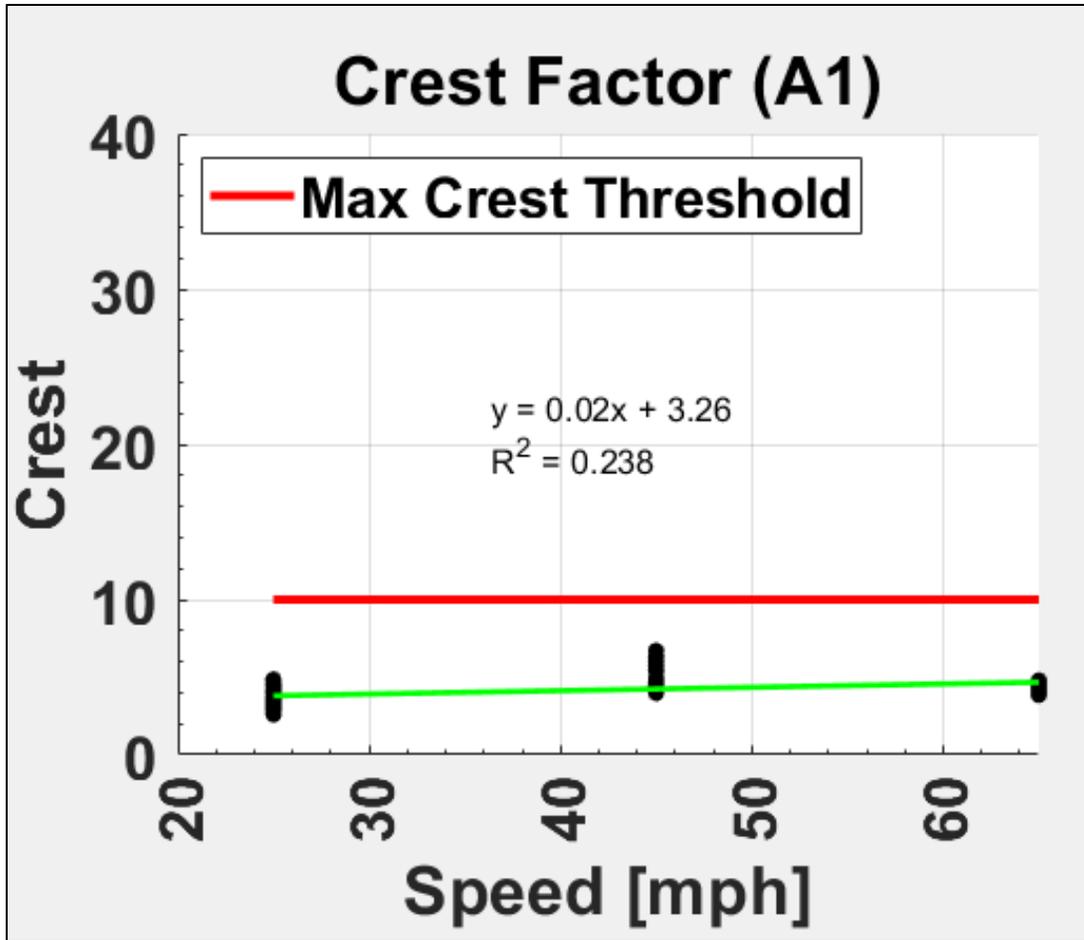
The next step of the algorithm is to determine the defective wheelset component through analysis of the A1 Crest data. Figure 35 shows the A1 Crest Factor as a function of operating speed. The algorithm calculated the correlation coefficient ( $R^2$  value) and slope of the trendline to be 0.238 and 0.02, respectively. Although the correlation coefficient is above the 0.1 criterion established in Chapter VI, the slope of the line is below the 0.1 criterion resulting in the algorithm correctly identifying the bearing as being defective.

Figure 35: A1 accelerometer Crest Factor as a function of speed (unloaded and fully loaded)

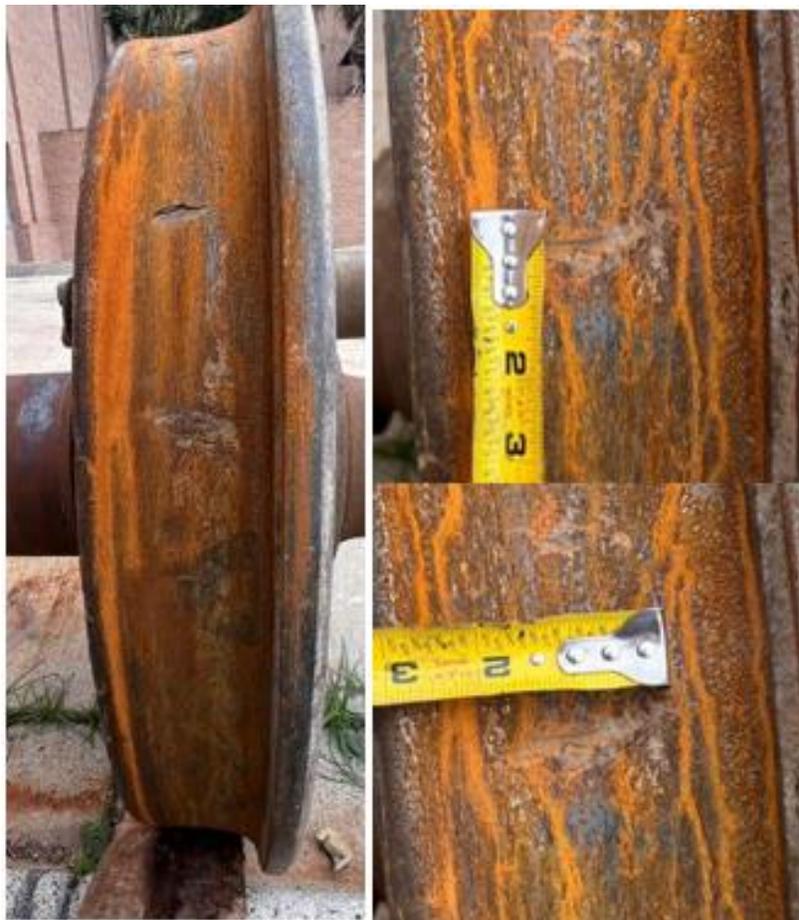
This section evaluates the performance of the FCMA in a field setting. The data used for this evaluation was taken from Boomerangs installed on railcars during a field pilot test on a freight rail short line. From this test, a wheel was identified as being defective. Figure 36 displays the defects found on the tread of wheel R2.

Figure 36: Shelling on R2 wheel tread

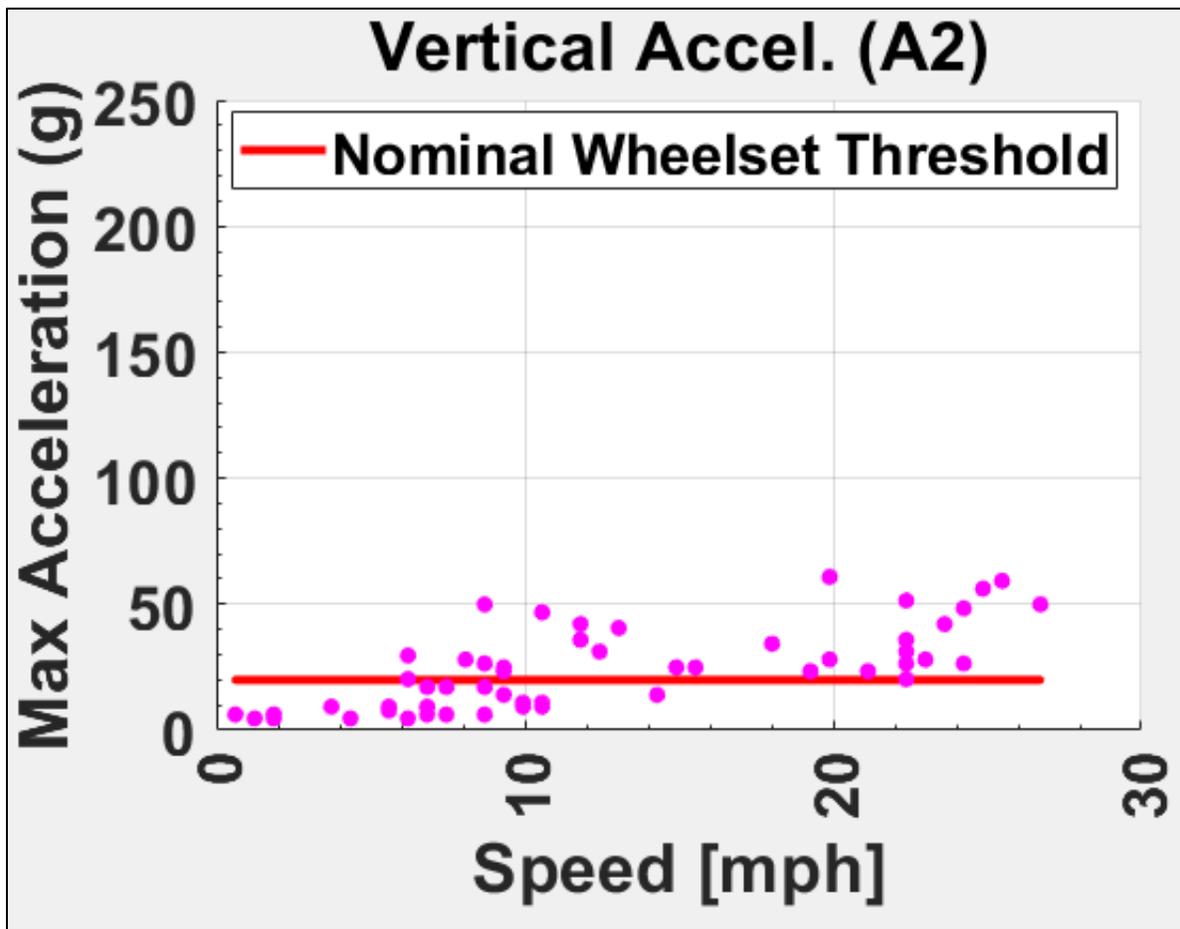
Figure 37 presents the A2 accelerometer maximum acceleration data as a function of speed for wheel R2. It is visually evident that a considerable portion of the data is above the nominal wheelset threshold. The algorithm calculated that 55.4% of the data was above the threshold, thus correctly identifying that a component of the wheelset is defective.

Figure 37: A2 accelerometer maximum acceleration data as a function of speed for wheel R2

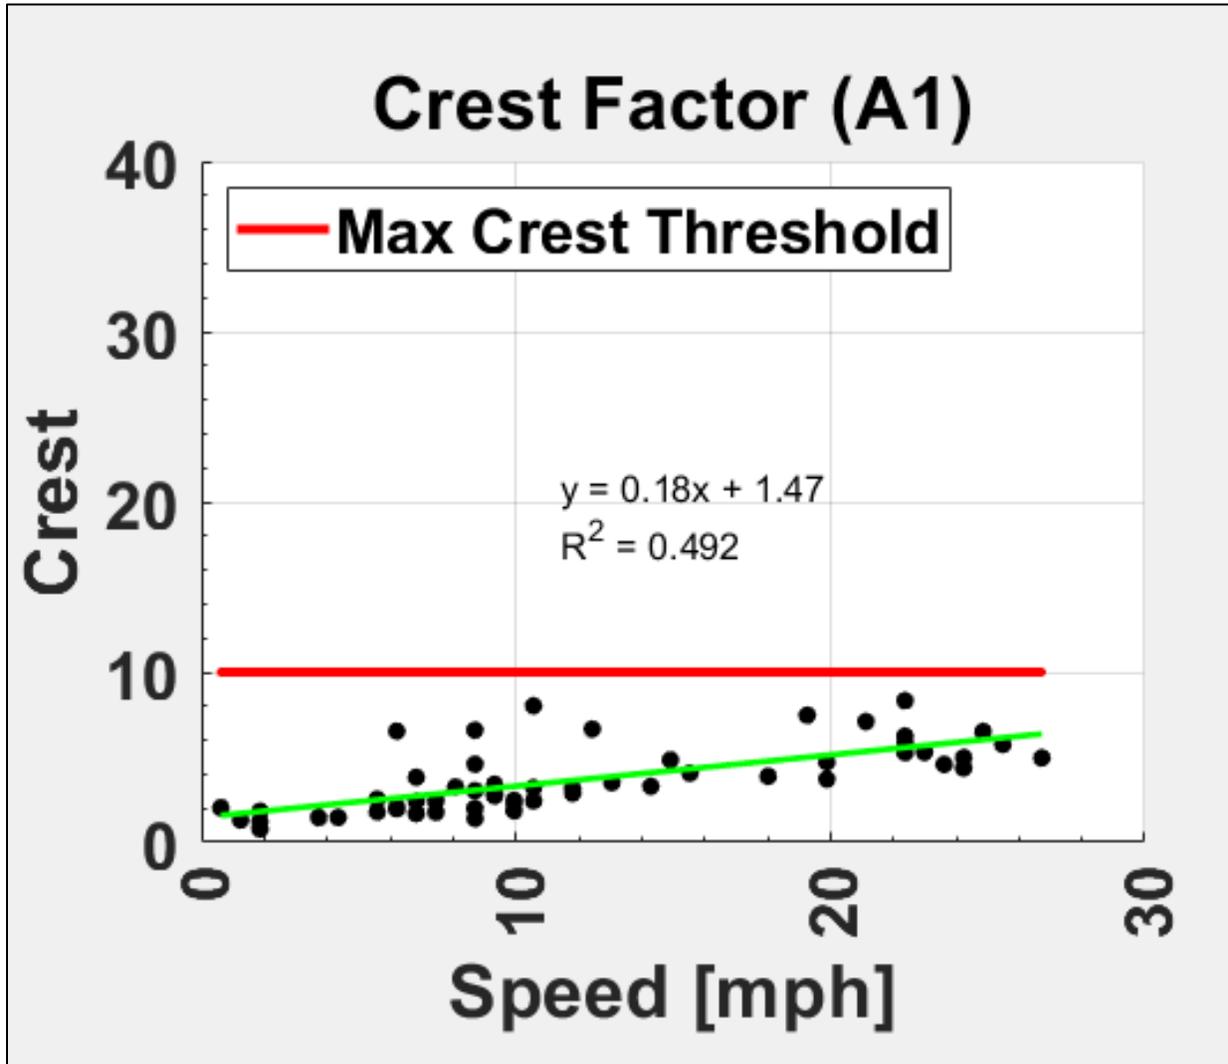
respectively, meeting both criteria needed to designate the wheel as defective. Therefore, the algorithm successfully identified the wheel as the defective component.

Figure 38: A1 Crest as a function of speed for wheel R2
