NONDESTRUCTIVE TESTING OF RAIL TUNNEL LININGS

A Thesis

Major Subject: Civil Engineering

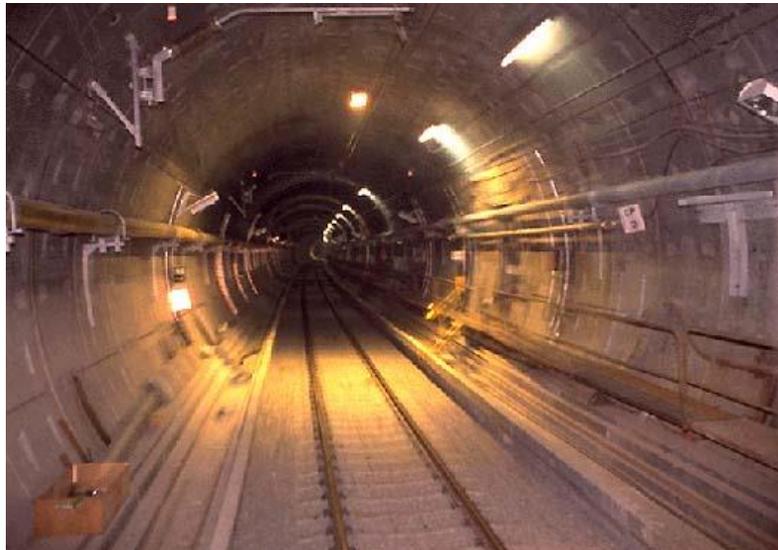
Figure 2.1. Rail tunnel with a precast segmental lining (www.railway-technology.com)

tunnel. As the tunnel is constructed, ribs constructed from steel, concrete, or timber are placed with blocking in-between the ribs for stability. Then poured concrete is placed between the ribs as the final stage of construction. If a tunnel boring machine is used in soft ground, the primary type of lining used is a segmental lining. Each segment is prefabricated out of steel, concrete, or cast iron and erected within the tail shield of the tunnel boring machine. The segments are then bolted together compressing gaskets to provide a water tight barrier. A precast concrete tunnel lining can be seen in Figure 2.1. Placed concrete linings are a final lining that can be placed on top of any of the other types of linings mentioned above. It can be a thin layer to give the tunnel a cover or to enclose a waterproofing membrane. The concrete layer can be structural or non-structural and with or without reinforcement (USDOT 2005). Due to the fact that concrete/shotcrete is a primary part of many lining types the research will focus on the testing of concrete.

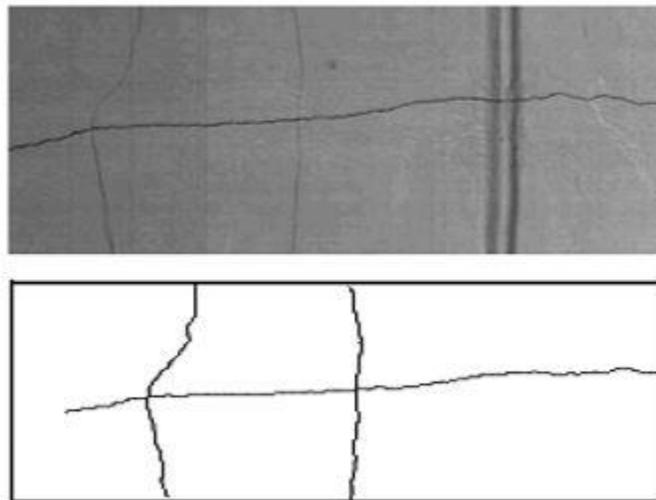
Figure 2.2. Image of cracks (top) Output of image analysis (bottom) (Ko et al. 2003)

Image acquisition uses a CCD line camera to take photos of the tunnel lining and then through analysis can find and measure cracks in the surface of the lining (Ko et al. 2003). This type of device is used to enhance and minimize the subjectivity of visual scans. The camera will not tire or be distracted and miss a crack or miss measure it. In the test done by Ko et al. (2003), they used the device in a subway tunnel to find cracks in its concrete lining. An example of the results can be seen in Figure 2.2. Their system had an error rate of 70% to 80% overall and the crack measuring error was 10% or less of all recognized cracks. Therefore, Ko et al. (2003) believes it could be a viable method but needs more development.

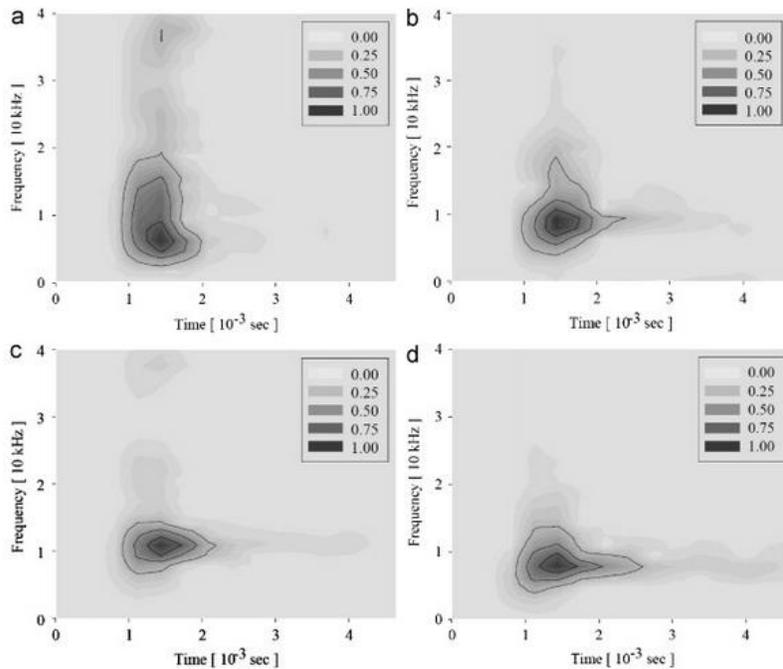
Figure 2.3. Time-frequency domain analysis results via STFT. (a) Fully bonded condition. (b) Debonded condition. (c) Void condition (shotcrete thickness = 18cm). (d) Void Condition (shotcrete thickness = 13cm) (Song and Cho 2009)

when only one side was accessible (McCann and Forde 2001). Previously the receiver needed to be applied to the opposite side of the concrete element being tested. The results are better interpreted in the frequency domain using the Fourier transform. Then a frequency response function (FRF) is determined for the system and peaks in the frequency spectrum indicate reflections or echoes of the compression wave created by the impulse hammer (McCann and Forde 2001). The peaks that occur in the data represent the resonant frequencies of flaws or thickness. Knowing the compression wave velocity in the material, the depth to the flaw or thickness can be calculated. However, the results can be ambiguous due to the three dimensional dispersion of the impact echo wave in concrete, frequency reduction of the signal caused by surface concrete crumbling, and insufficient sensitivity of the response transducer (McCann and Forde 2001). Impact echo has been shown useful in determining the bonding state of shotcrete linings (Song and Cho 2009). By analyzing the data in both the frequency domain and time-frequency, the condition of the shotcrete could be determined as fully bonded, debonded, or voided condition. These different conditions can be more easily seen by using time-frequency analysis calculated using the short-time Fourier transform (STFT). Figure 2.3 shows the different time-frequency analyses for each of the different conditions.

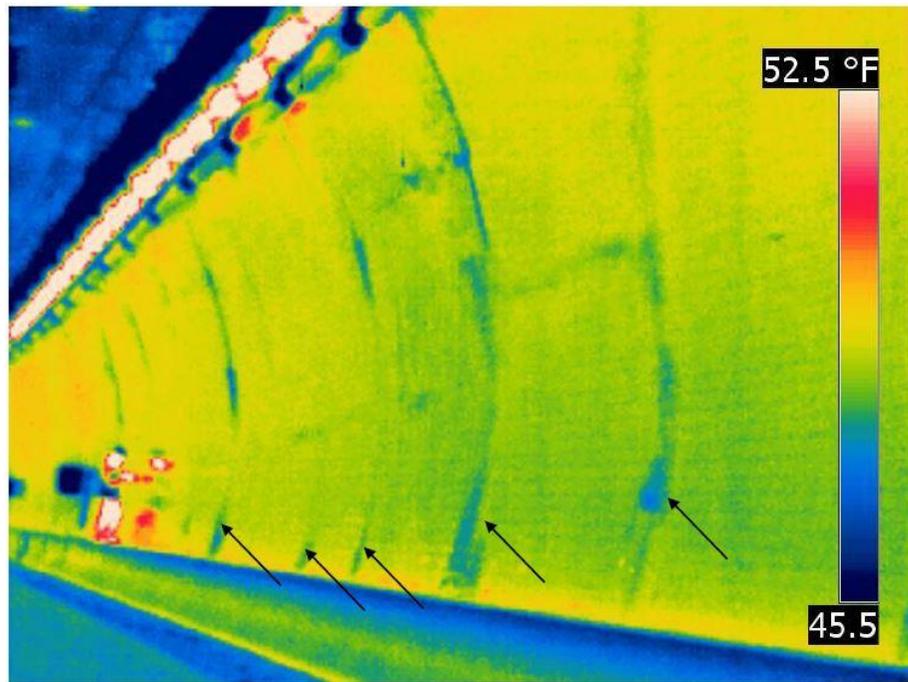
Figure 2.4. Infrared image of tiled tunnel. Areas in blue are areas of debonded tiles (Wimsatt et al. 2013)

Infrared thermography (IRT) uses specialized cameras that can convert heat at any temperature into a thermal image. Thermal images can be used to determine if concrete has any defects. If there are any cracks, delaminations, or voiding close to the surface, the concrete will heat and cool at a different rate than the surrounding concrete (McCann and Forde 2001). Therefore, a uniform image means that the concrete has no surface defects or shallow voids or delaminations, but if there are areas of differing temperature a defect could be present. The areas that are different temperatures can then be inspected closer. McCann and Forde (2001) state that infrared thermography has proven itself to be an effective preliminary survey tool to assess large buildings. In a lab test with controlled heating rates and constant ambient temperature, infrared thermography was able to detect defects up to 20 mm deep from the concrete surface (Kamoi et al. 2004). Wimsatt et al. (2013) showed that it works for tiles in road way tunnels, and one of their thermal images can be seen in Figure 2.4

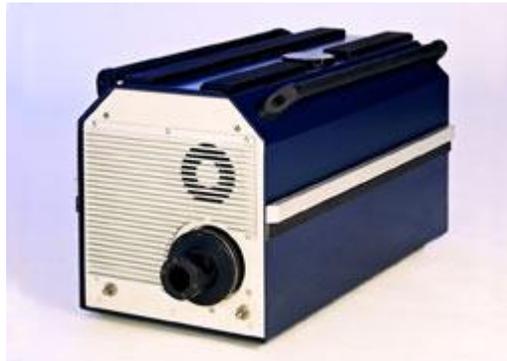
Figure 2.10. SPACETEC TS3 tunnel scanner (SPACETEC 2014)

SPACETEC is a German company that specializes in the evaluation of rail and highway tunnel linings. They develop all of their own equipment and software so that it will meet the needs of their work. Their surveys use three different noncontact methods of evaluation: image recording, distance measuring, and thermal recording (SPACETEC 2014). All of the methods are completed simultaneously as they go through the tunnel; their TS3 unit can be seen in Figure 2.10. The image recording is practically a visual recording of the tunnel which is then ran through software that can determine cracking. It can find cracks as small as 0.3 mm wide, and the cracks are found based on the slight color change of each pixel that the crack runs through. To find this small of a crack, the scan must be

done at its highest resolution of 10,000 pixels which is controlled by scanning speed. For this maximum resolution, the scan must be done at a maximum of 5 km/h (SPACETEC 2014). The distance measuring uses lasers to determine the profile of the tunnel. The lasers calculate the distance to the lining and the software creates an entire profile of the tunnel. This allows for the determination of sag, movement, or differential settlement and whether the clearance tolerances are still met. SPACETEC also uses thermal recording of the tunnel to find areas of abnormal temperature differences (SPACETEC 2014). All of the data collected is provided to the client along with the SPACETEC software so the data can be examined. All three of the different measurements can be viewed individually or together to better understand the data (White et al. 2014). Viewing the data together allows for a better understanding of what could be causing anomalies.

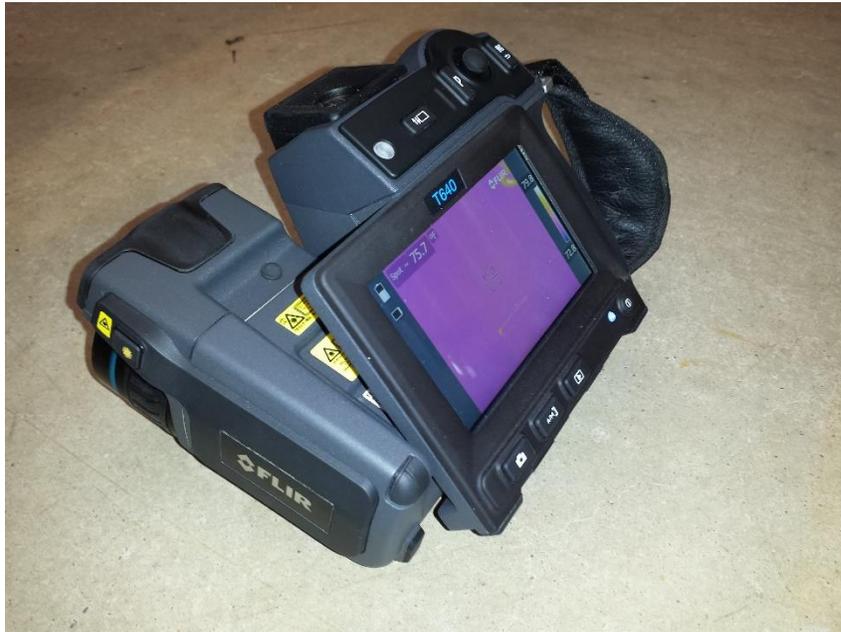
Figure 3.1. FLIR T640 thermal camera

The thermal device used for this research is the FLIR T640 which can be seen in Figure 3.1. It can be used for a temperature range of -40°F to 3632°F and is calibrated to an accuracy within +/- 2% of the reading. It can take individual images and video. When taking individual pictures it can be set to take a digital image along with the thermal so that the thermal image can be compared with the digital to see what is located where and if any objects would be affecting the temperature in that area. The frame rate for the camera is 30 Hz. The device will also be used in conjunction with the FLIR Tools+

program. The program allows for post processing of images and allows for video to be saved directly to a computer.

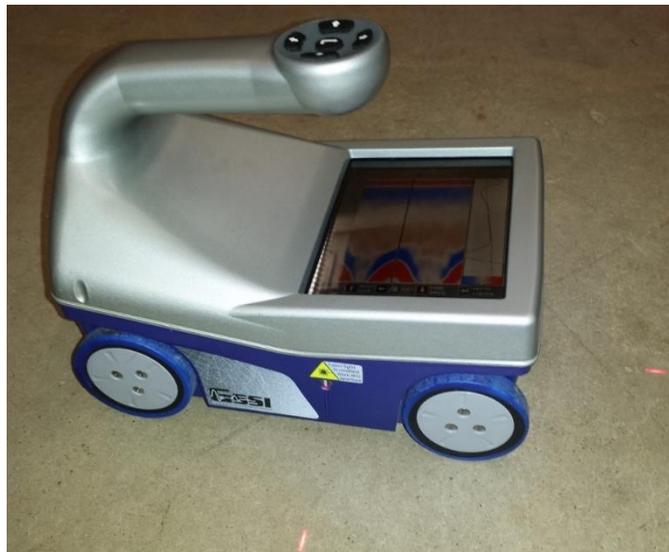
Figure 3.2. GSSI StructureScan Mini HR GPR device

The GPR device chosen for this research is the GSSI StructureScan Mini HR, seen in Figure 3.2. It has a frequency of 2600 MHz. This frequency allows it to penetrate up to

16 inches and provide high resolution. It is also a small handheld device that weighs 3.6 pounds making it easy to travel with and use for a tunnel lining. There are lasers on three sides of the unit that line up with the antenna so the user can know where the scan is located and can mark the area if needed. The device provides the ability to do individual 2D scans or to build a grid that can be developed into a 3D scan. It has preprogrammed grid sizes in the device that match provided grids or using the software, RADAN, provided by GSSI a custom grid can be used. The RADAN software also allows for post processing of the collected data.

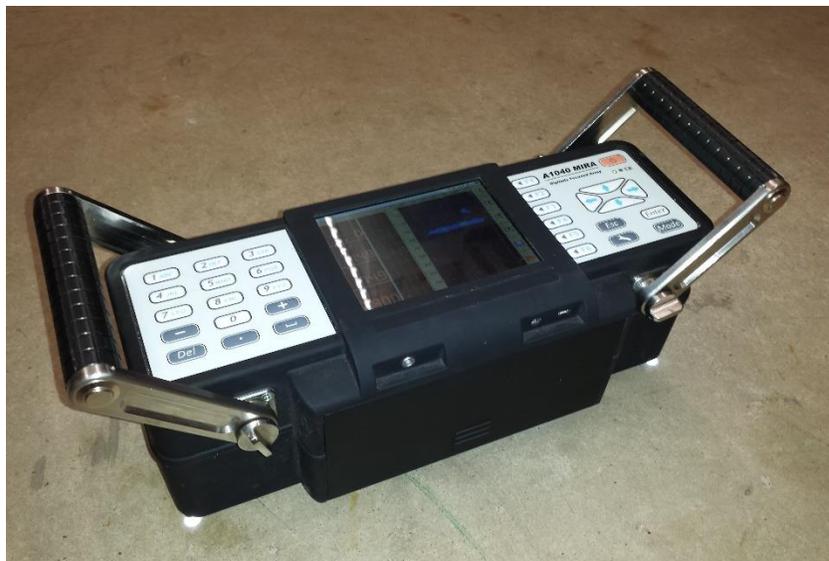
Figure 3.3. A1040 MIRA UST device

The unit used in the research was the A1040 MIRA device seen in Figure 3.3. It is small and light weight making it easy for travel and was developed for use on concrete structures. The device has 48 transducers that are aligned in twelve rows of four. The center frequency can be set at 25, 50, or 85 kHz. The device can be used to test on depth of 50 to 2000 mm. The software in the device uses the synthetic aperture focusing technique (SAFT) which allows the device to create a 2D image based on the transit time measurements. When the device is used on a grid a 3D image can be obtained by using the IDEALviewer software on a computer.

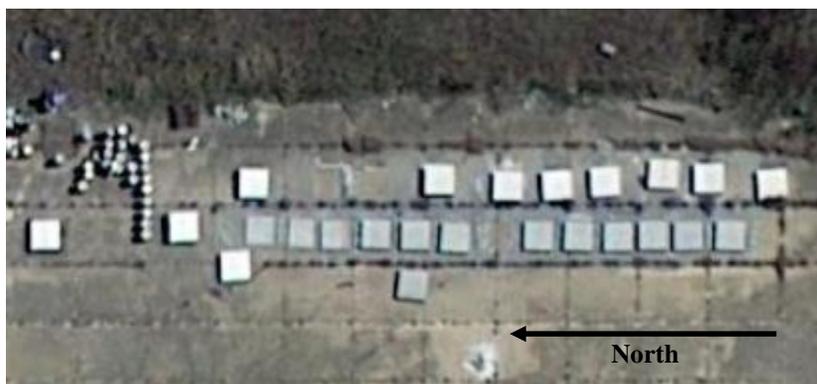
Figure 4.1. Overview of slabs

The 24 slabs were constructed with various voids, delaminations, and reinforcement so that testing methods could be verified. Therefore, this research project is using them for the same reason but the locations of the problems and reinforcement were unknown prior to testing and data analysis for this project. Concrete was used to construct 11 of the slabs, and 13 were shotcrete. They were all 6' x 6' and located at Texas A&M's Riverside campus, and an overview image of the slabs can be seen in Figure 4.1.

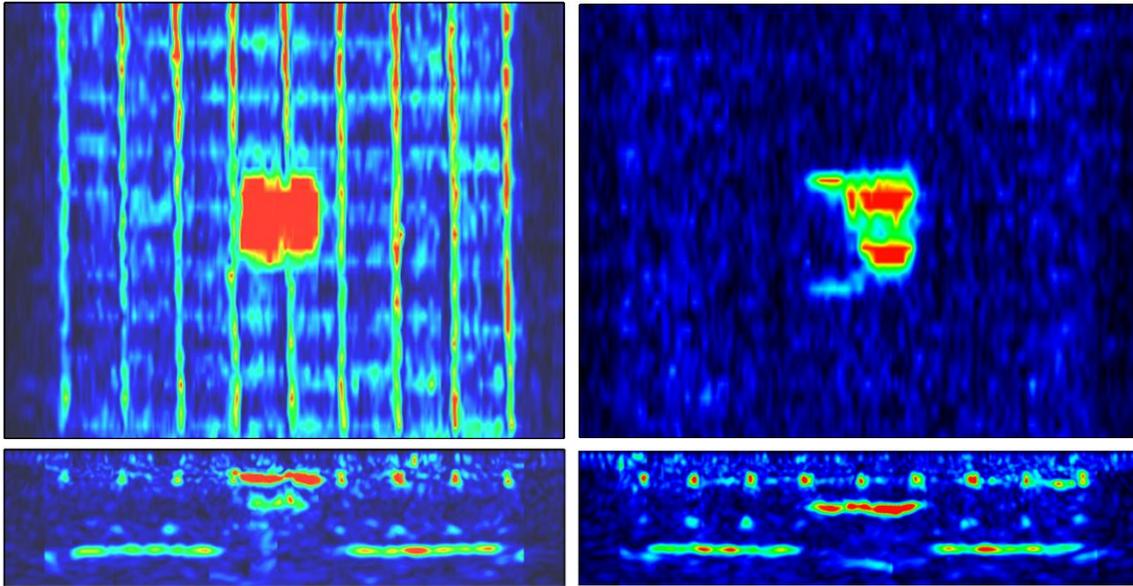
Figure 4.4. UST scans of concrete slabs: Specimen Theta with delamination C-scan at depth of 98 mm (top left), Specimen Theta B-scan at 850 mm (bottom left), Specimen Lambda with void C-scan at depth of 213 mm (top right), Specimen Lambda B-scan at 650 mm (bottom right)

The images produced by the A1040 MIRA are color coded based on the reflective intensity with dark blue being no reflection and red being high reflectivity. The green and yellow colors are in between the blue and red. This device worked well in determining all the various defects that were in the concrete and shotcrete slabs. Figure 4.4 shows a C-scan and B-scan of a delamination and void in concrete slabs, and Figure 4.5 is the same but in shotcrete slabs.

The UST images for the concrete slabs are clearer than the ones for the shotcrete. This is likely due to poor construction of the shotcrete slabs due to the placement method. The top area did not get vibrated properly resulting in groups of air pockets which resulted in the images having a green spotting at the top of the B-scan. Also, the back wall can be seen in the B-scans, but the back wall does not show up in the scan beneath the defect area because the shear waves cannot pass through the defects. Another area to note is the almost black sections on the left and right edges of the images, these are due to the MIRA device hanging off the edge of the slab. This provides a reference for the edge of the slab.

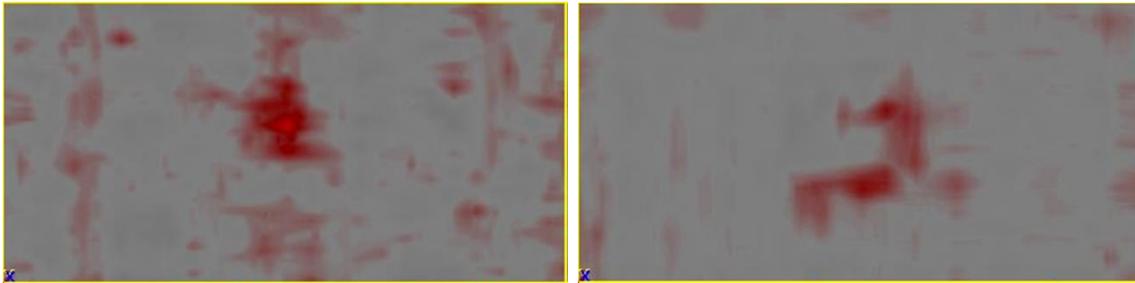
Figure 4.6. GPR C-scans of concrete slabs: Specimen Iota with delamination (left) Specimen Kappa with void (right)

The GPR worked well for finding rebar and some of the voids and delaminations. It only found two of the delaminations in the concrete slabs and one definitively in the shotcrete slabs, and they were difficult to find. The UST data was looked at first and then the GPR data so that there would be a reference and an area to look in. The images for the GPR are color coded with grey meaning no reflection and the red color gets darker with more reflectivity. Also if the reflectivity is very high it will turn yellow and go through multiple colors with white being the highest. Figure 4.6 shows C-scans for two concrete slabs, one with a void, and one with a delamination. Figure 4.7 is the same type of image but for shotcrete slabs and with B-scans.

The B-scans are not shown for the concrete slabs because they do not show anything but the rebar similar to the B-scan of Specimen L. The parabola in the B-scan of Specimen L is the girder reinforcement used in the shotcrete slabs. However, the void in Specimen F can be seen in the B-scan which is due to the shallowness of the void. The void in Specimen G which is at the same depth as Specimen F's void can also be seen in the B-scan but is not shown here.

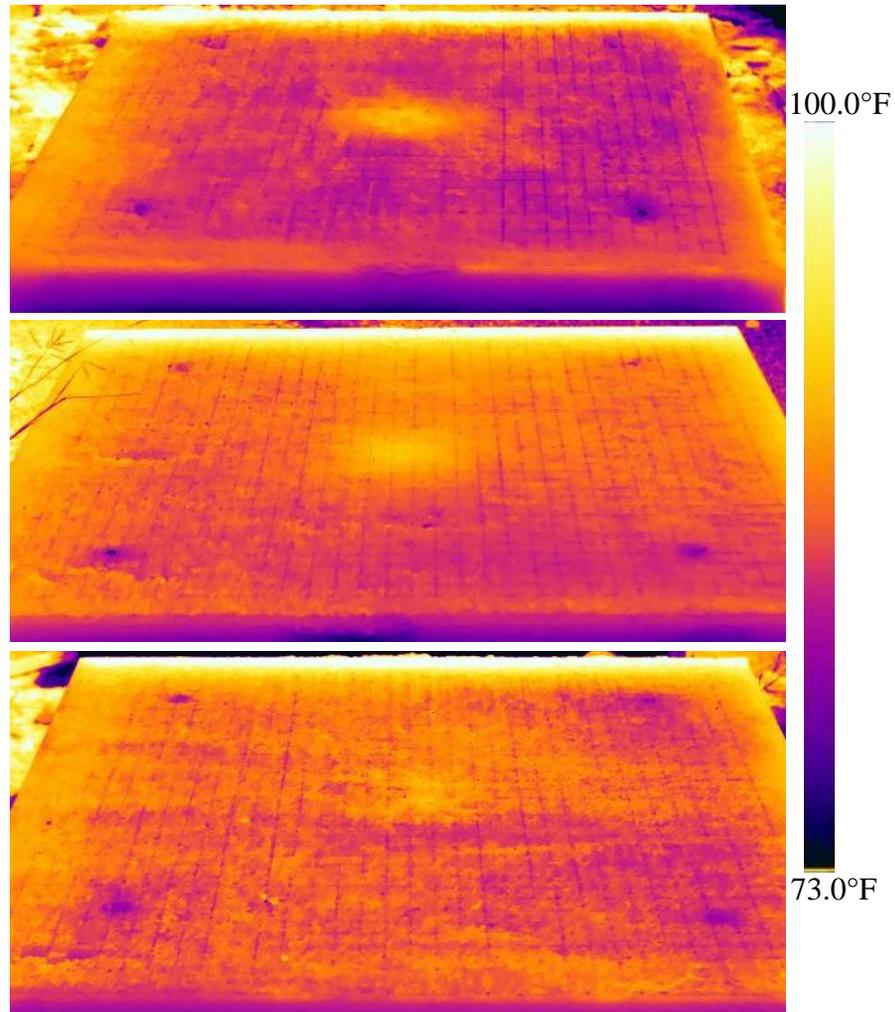
Figure 4.8. IRT images: Specimen F (top), Specimen G (middle), and Specimen L (bottom)

Specimen F is cooler in the middle where the void is located. The ambient temperature has not warmed enough at that point in the morning so the differential cooling is still evident. Specimens L and F look like there may be something showing but it is not definitive. In Figure 4.10 which is two hours later, the temperatures have evened out so that there is no evidence of a defect on any slab.

Infrared thermography worked well for the shallow defects in the shotcrete slabs. During the initial scan, it detected a possible issue in 3 of the 13 shotcrete slabs but none in the concrete slabs. This is believed to be due to the difference in the slab's color. The concrete slabs are lighter than shotcrete slabs; therefore, the concrete slabs do not absorb as much light and heat from the sun. The three infrared images showing problems can be seen in Figure 4.8.

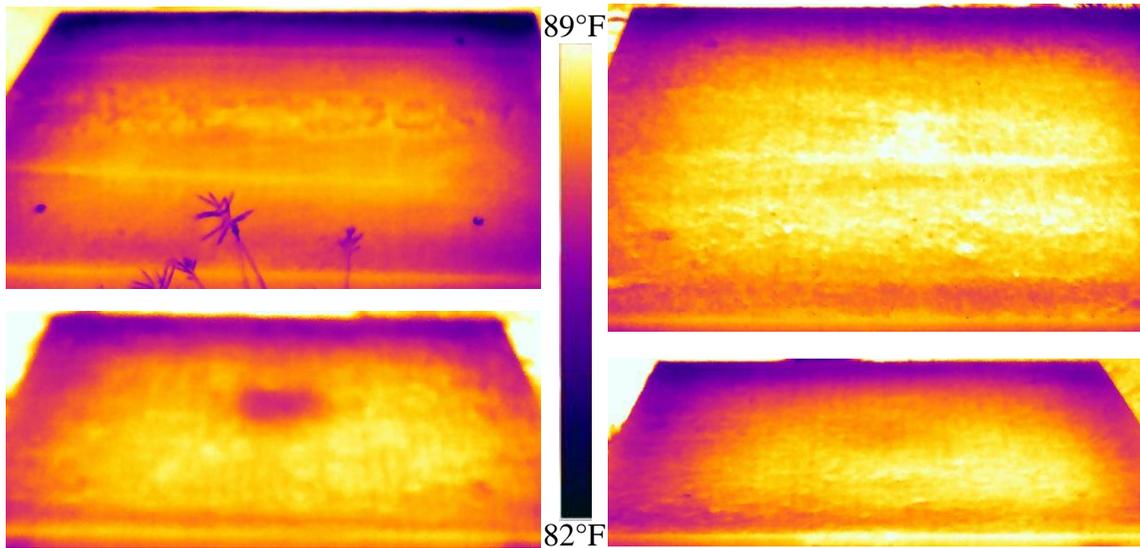
Figure 4.9. 9:00 AM Thermal images: Specimen Iota (top left), Specimen L (top right), Specimen F (bottom left), Specimen G (bottom right)

The second IRT testing was done at various times throughout the day on Specimens Eta, Iota, Kappa, Lambda, F, G, K, and L. Only one slab showed anything at the first scan at 9:00 AM. At 11:00 AM, nothing was visible on any of the slabs. From 12:00 PM to 2:00 PM, defects started to be able to be seen with four being detected at 2:00 PM. This testing allowed for one of the defects in a concrete slab to show up in the image. It was Specimen Iota which has a delamination at a depth of 25 mm. Table 4.4 lists the conditions at the various times of testing, and Figure 4.9 through 4.13 shows the four slabs that a defect was detected in at each testing time.

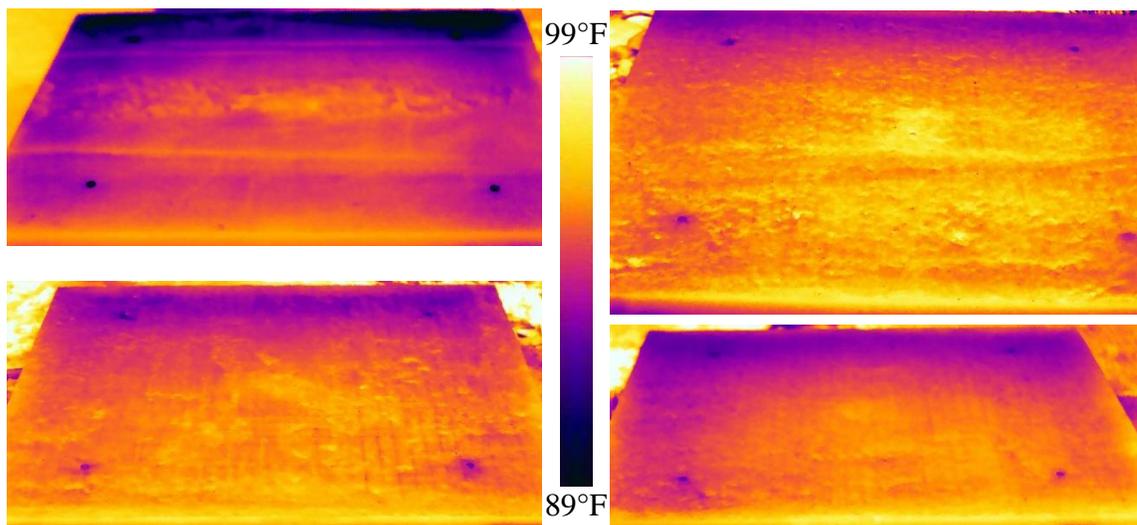
Figure 4.11. 12:00 PM Thermal images: Specimen Iota (top left), Specimen L (top right), Specimen F (bottom left), Specimen G (bottom right)

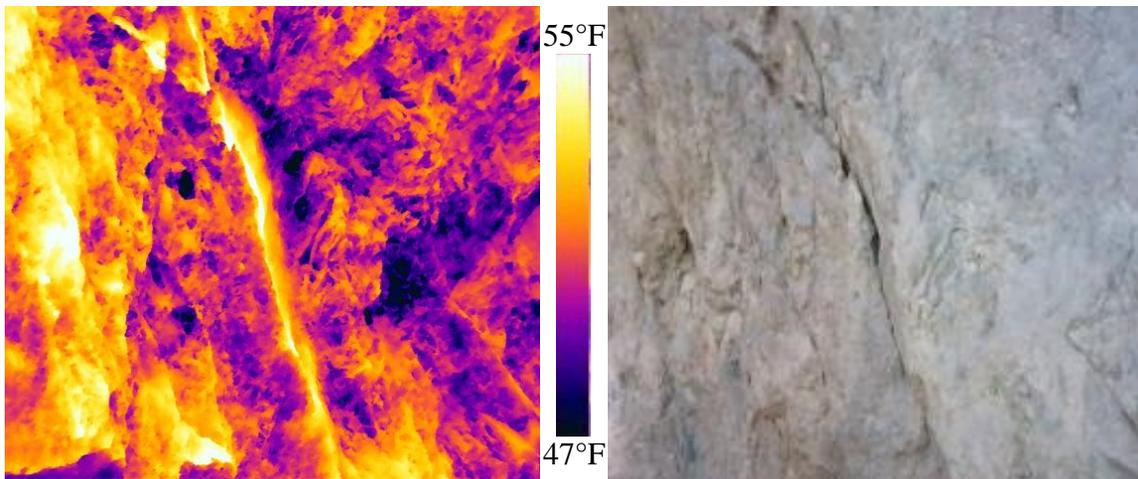
Figure 5.8. Images of crack: Thermal (left) and visual (right)

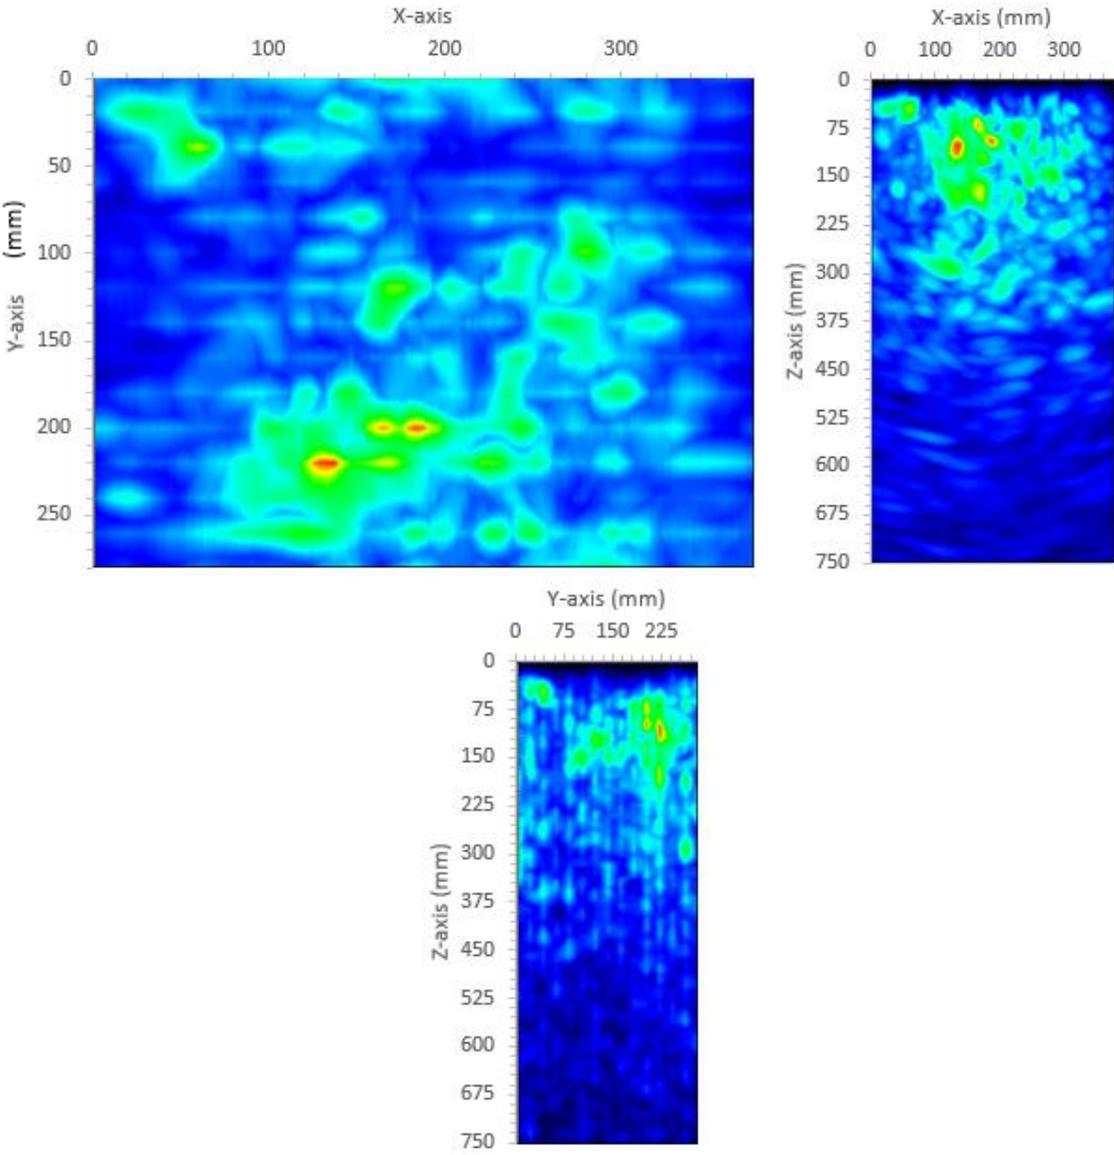
Figure 5.9. UST images: C-scan (top left), B-scan (top right), and D-scan (bottom)

is typical of all the other scans done. The figures show the full thickness on all the scan types so they are not at a certain depth or point on the axis not shown. The UST shows some red but it is within a large cloud of greens which makes it look erroneous. It is either a layer boundary or an area of non-homogeneity.

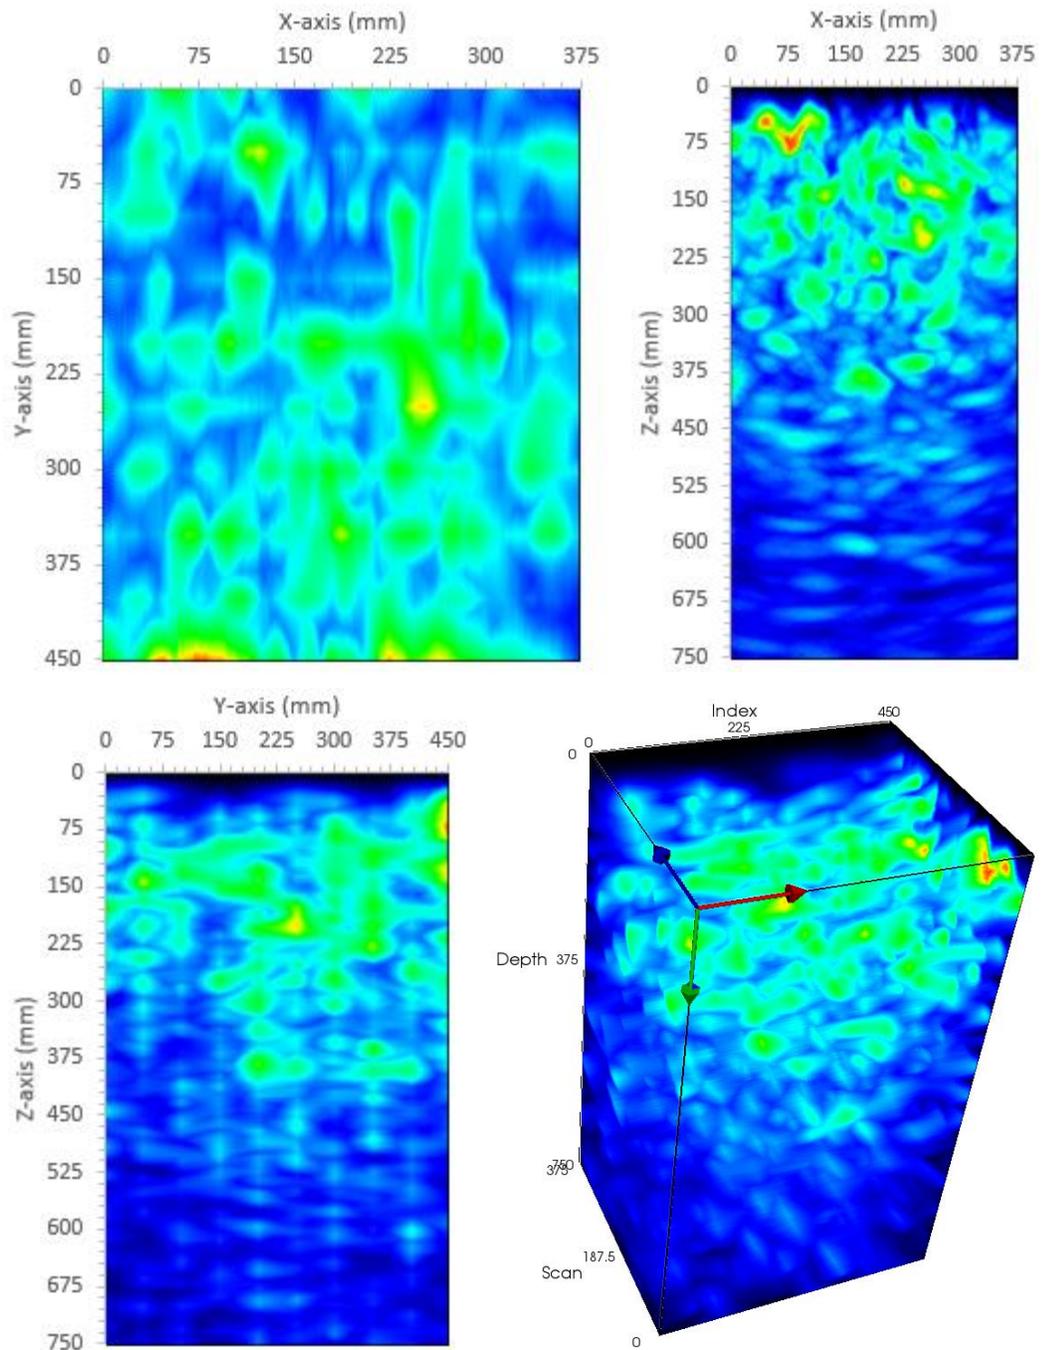
Figure 5.10. UST images: C-scan (top left), B-scan (top right), D-scan (bottom left), and 3D volume (bottom right)

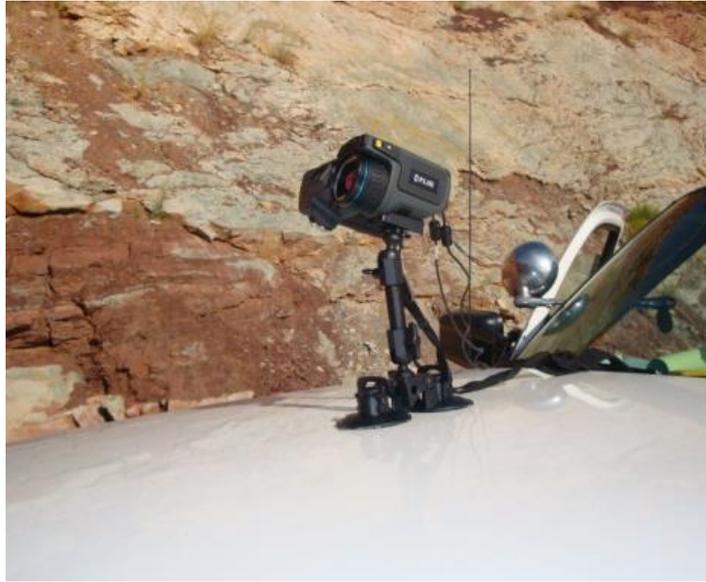
Figure 6.3. Thermal camera set-up on high rail truck

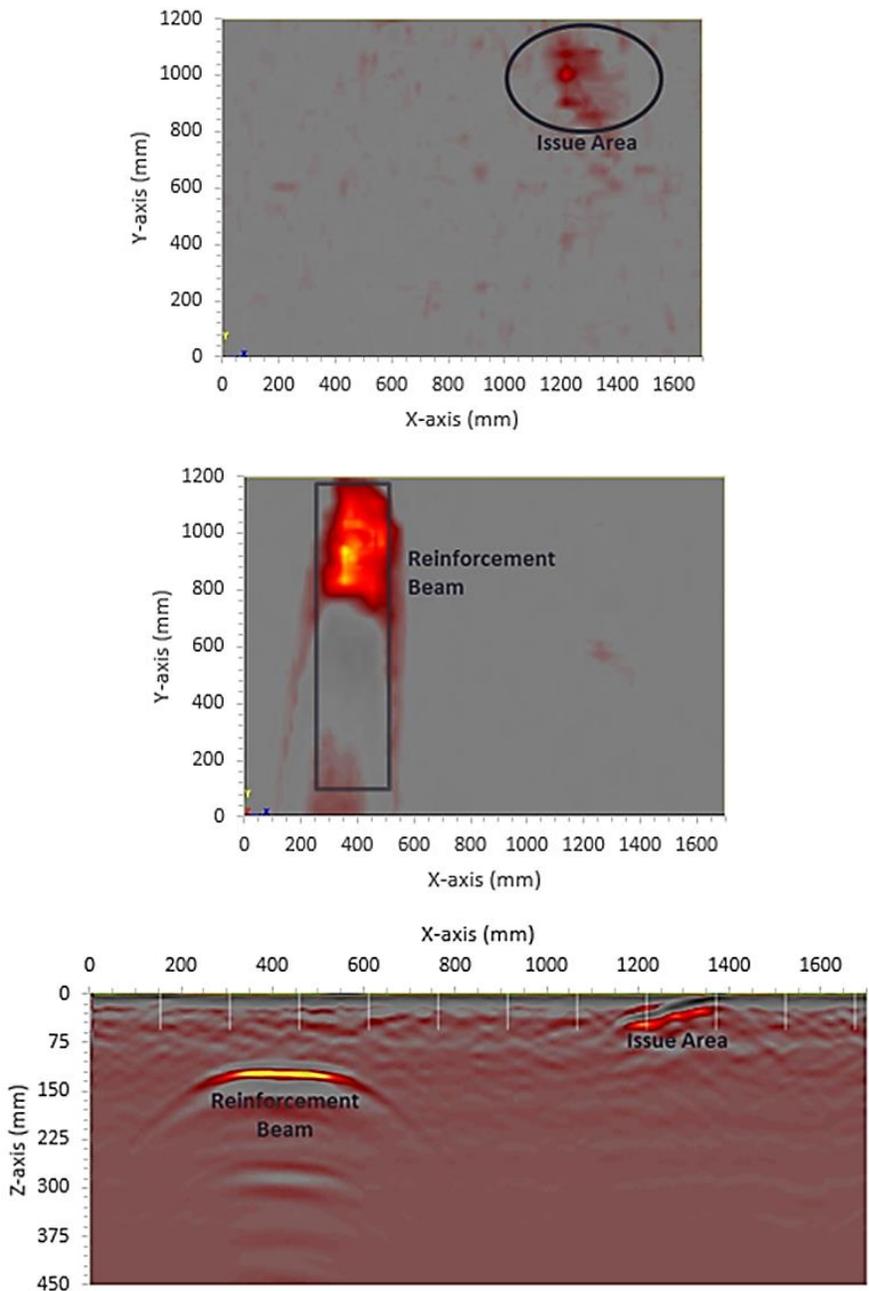
Figure 6.8. GPR scans of Grid 1: C-scan at 64.5 mm (top), C-scan at 135.5 mm (middle), and B-scan at 1000 mm (bottom)

be seen in the B-scan of Figure 6.8. The UST shows a cloudy area with some high reflections similar to what the voids detected during the slab testing.

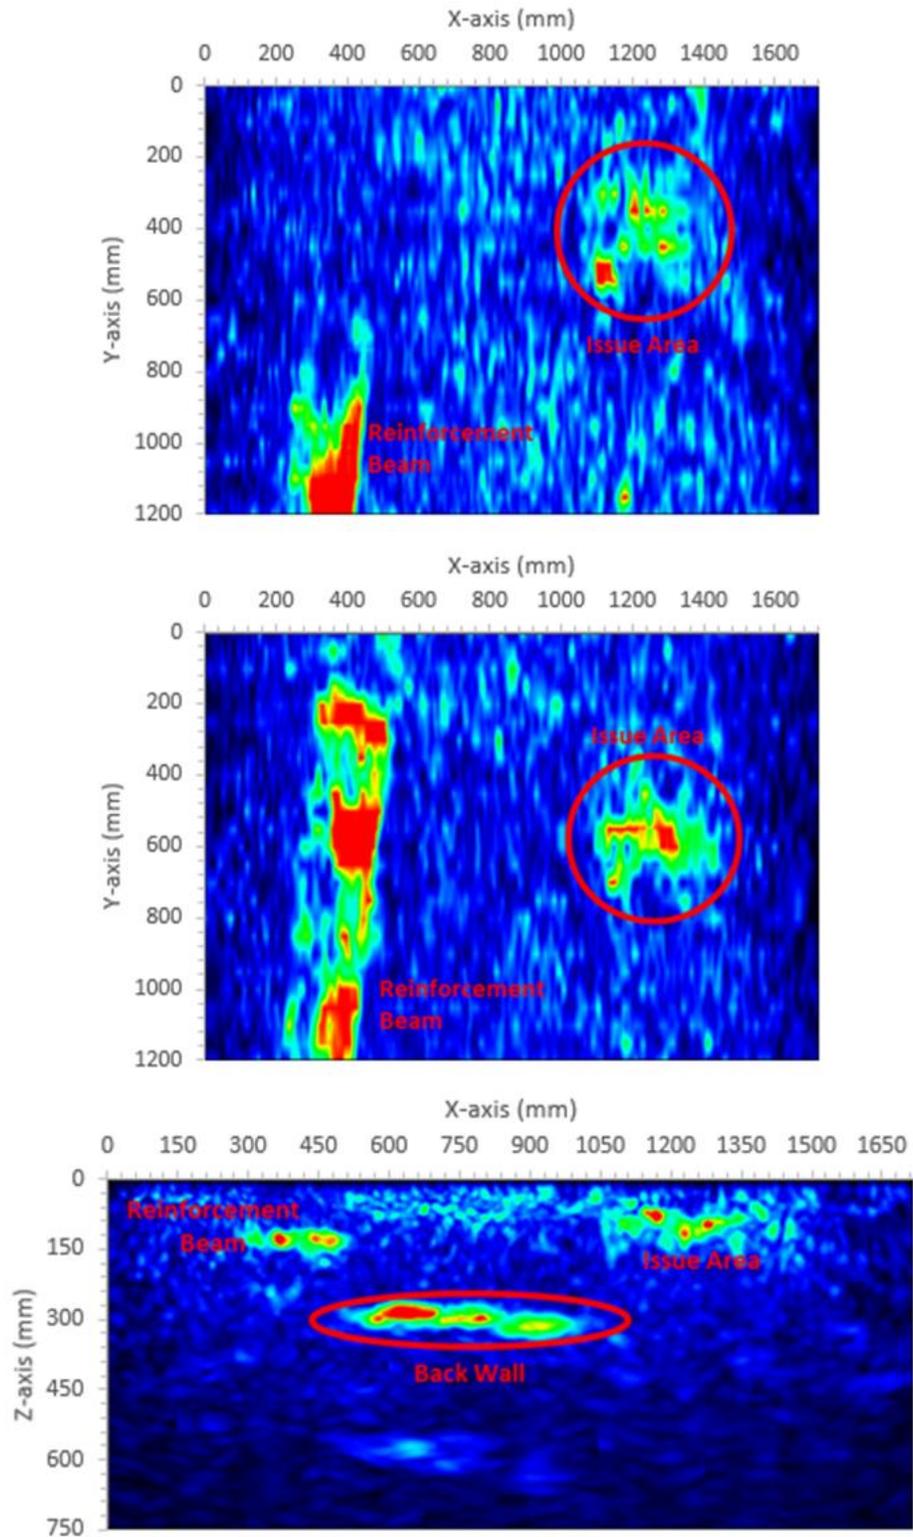
Figure 6.9. UST scans of Grid 1: C-scan at 90.5 mm (top), C-scan at 125 mm (middle), and B-scan at 450 mm (bottom)

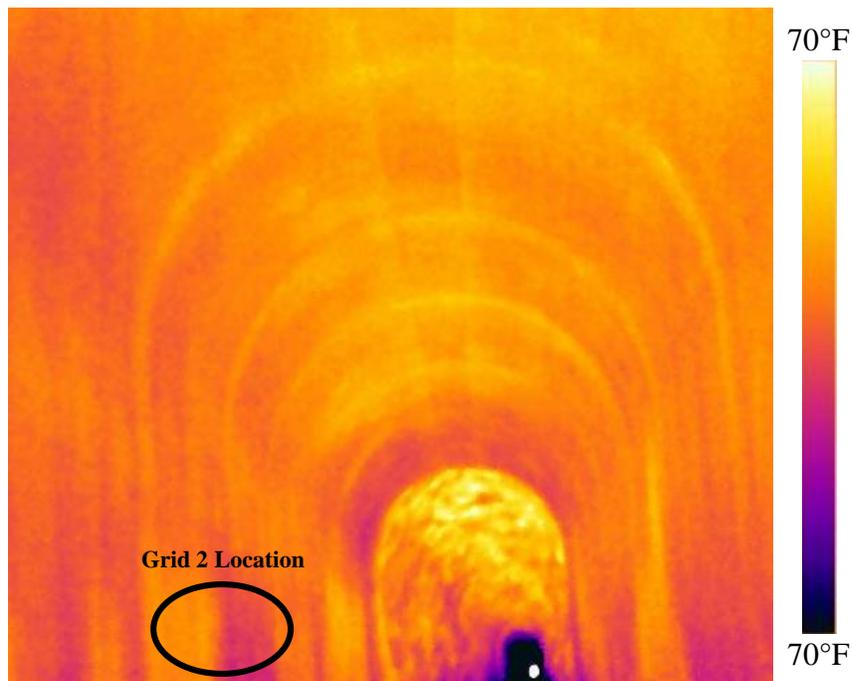
Figure 6.10. Run 2 image of Segment E

Grid 2 was placed on the side wall of Segment E based on the thermal videos. The area was chosen based on the temperature change and that the change did not occur across a construction joint. There are other similar areas in this segment but the one chosen looked the most drastic based on all the videos. Figure 6.10 shows the chosen area from the thermal video taken during run 2.

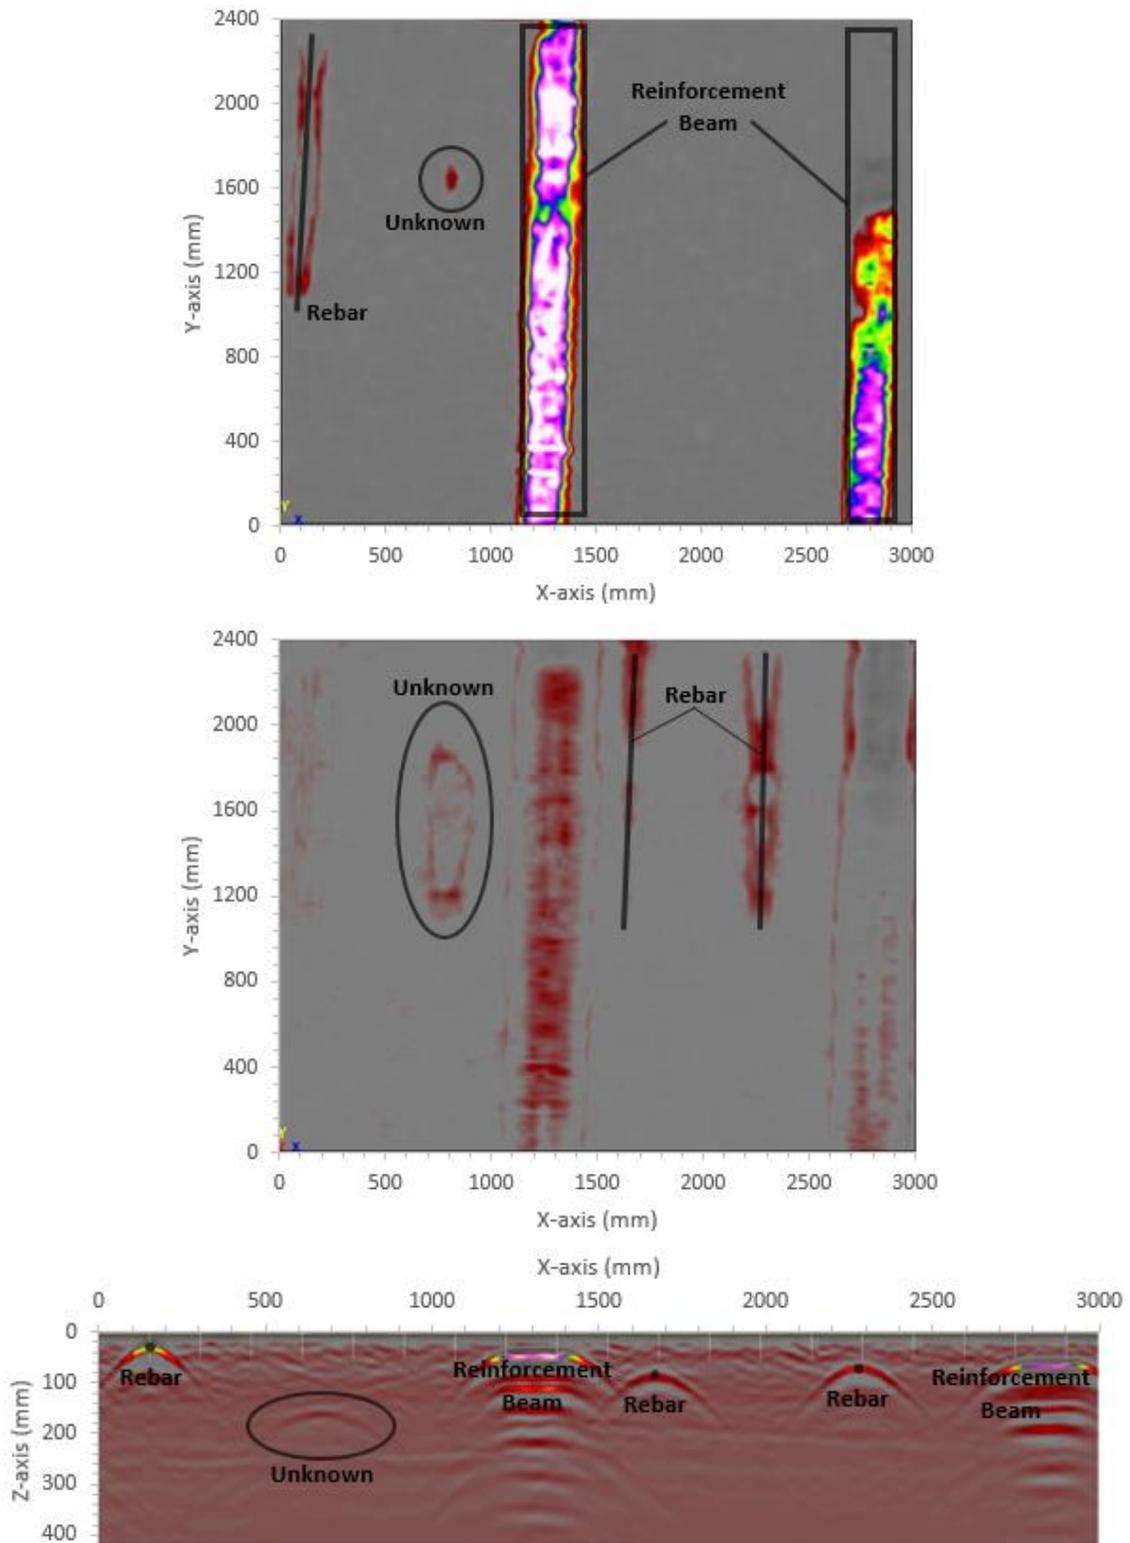
Figure 6.11. GPR data from Grid 2: C-scan at 61.5 mm (top), C-scan at 103 mm (middle), and B-scan at 2200 mm (bottom)

The GPR of this grid provided a lot of information on the construction of the tunnel lining. Since the grid was so large, many different features were found such as rebar in both directions and the spacing of the reinforcement beams. Figures 6.11 and 6.12 show

No anomalies were discovered that would have caused the temperature variation detected with the thermal camera. The detection of the back wall seemed to correspond to the location of the temperature change, yet that difference would be too deep for the thermal camera to detect. The temperature difference was either due to environmental factors or undetected properties with the lining.

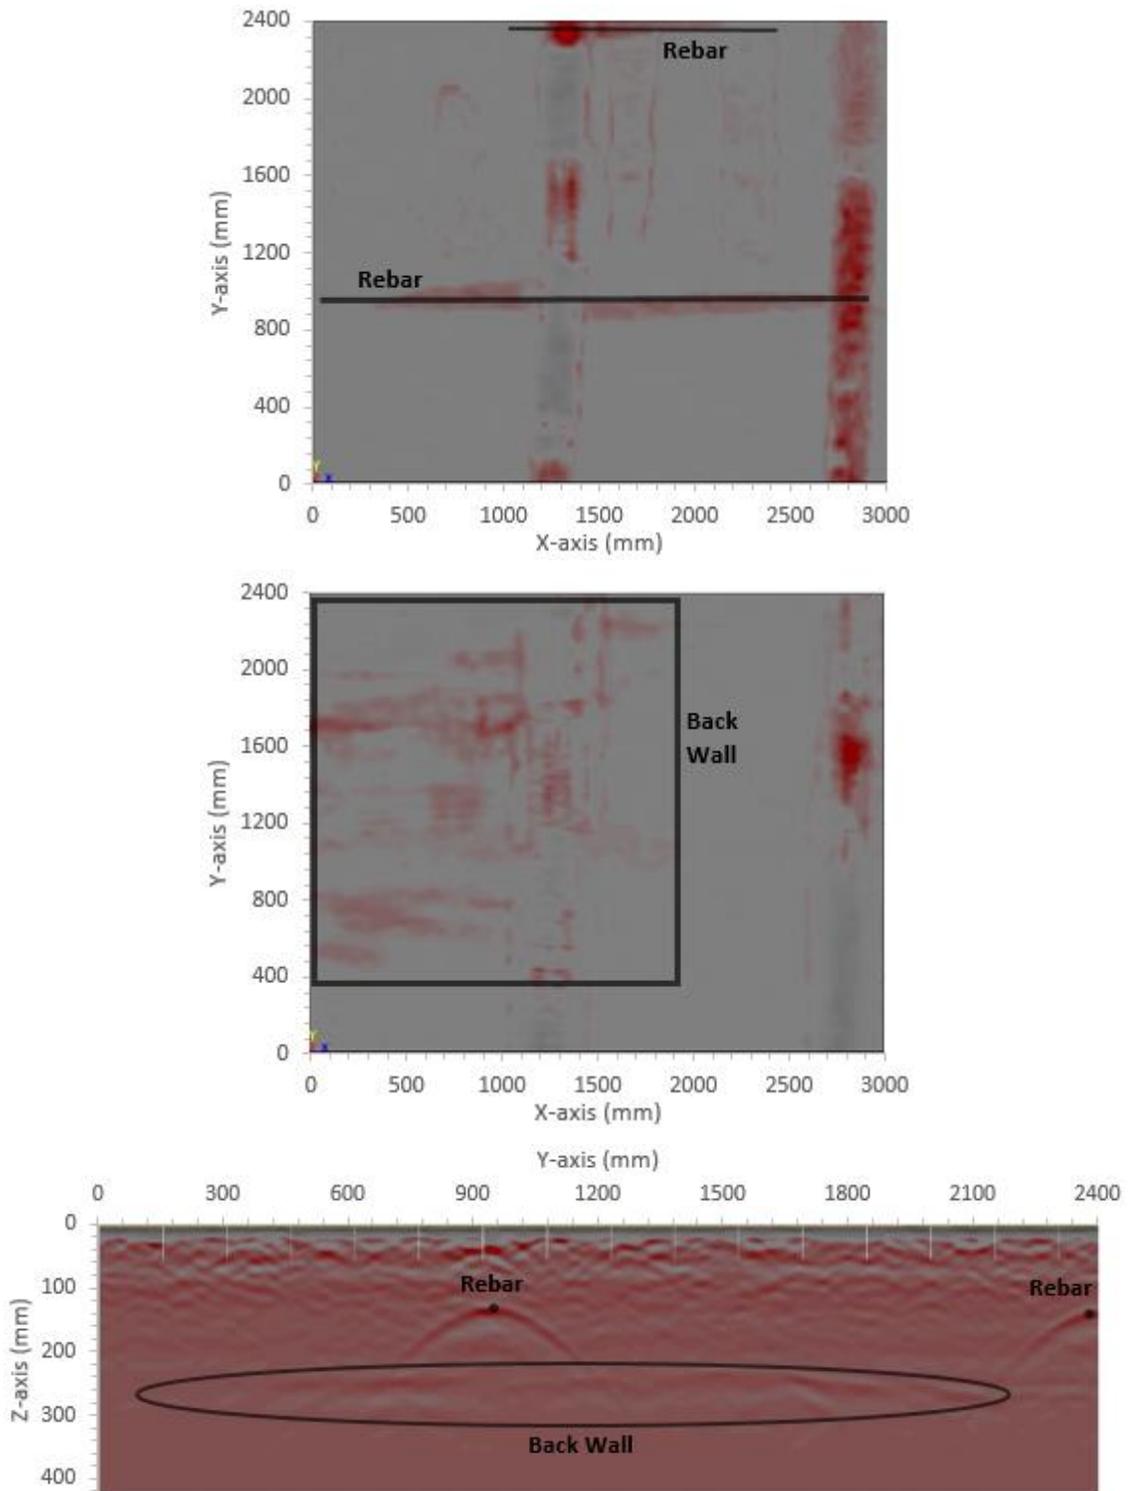
Figure 6.12. More GPR data from Grid 2: C-scan at 145 mm (top), C-scan at 274 mm (middle), and D-scan at 350 mm (bottom)
