NONDESTRUCTIVE TESTING OF RAIL TUNNEL LININGS

A Thesis

Major Subject: Civil Engineering

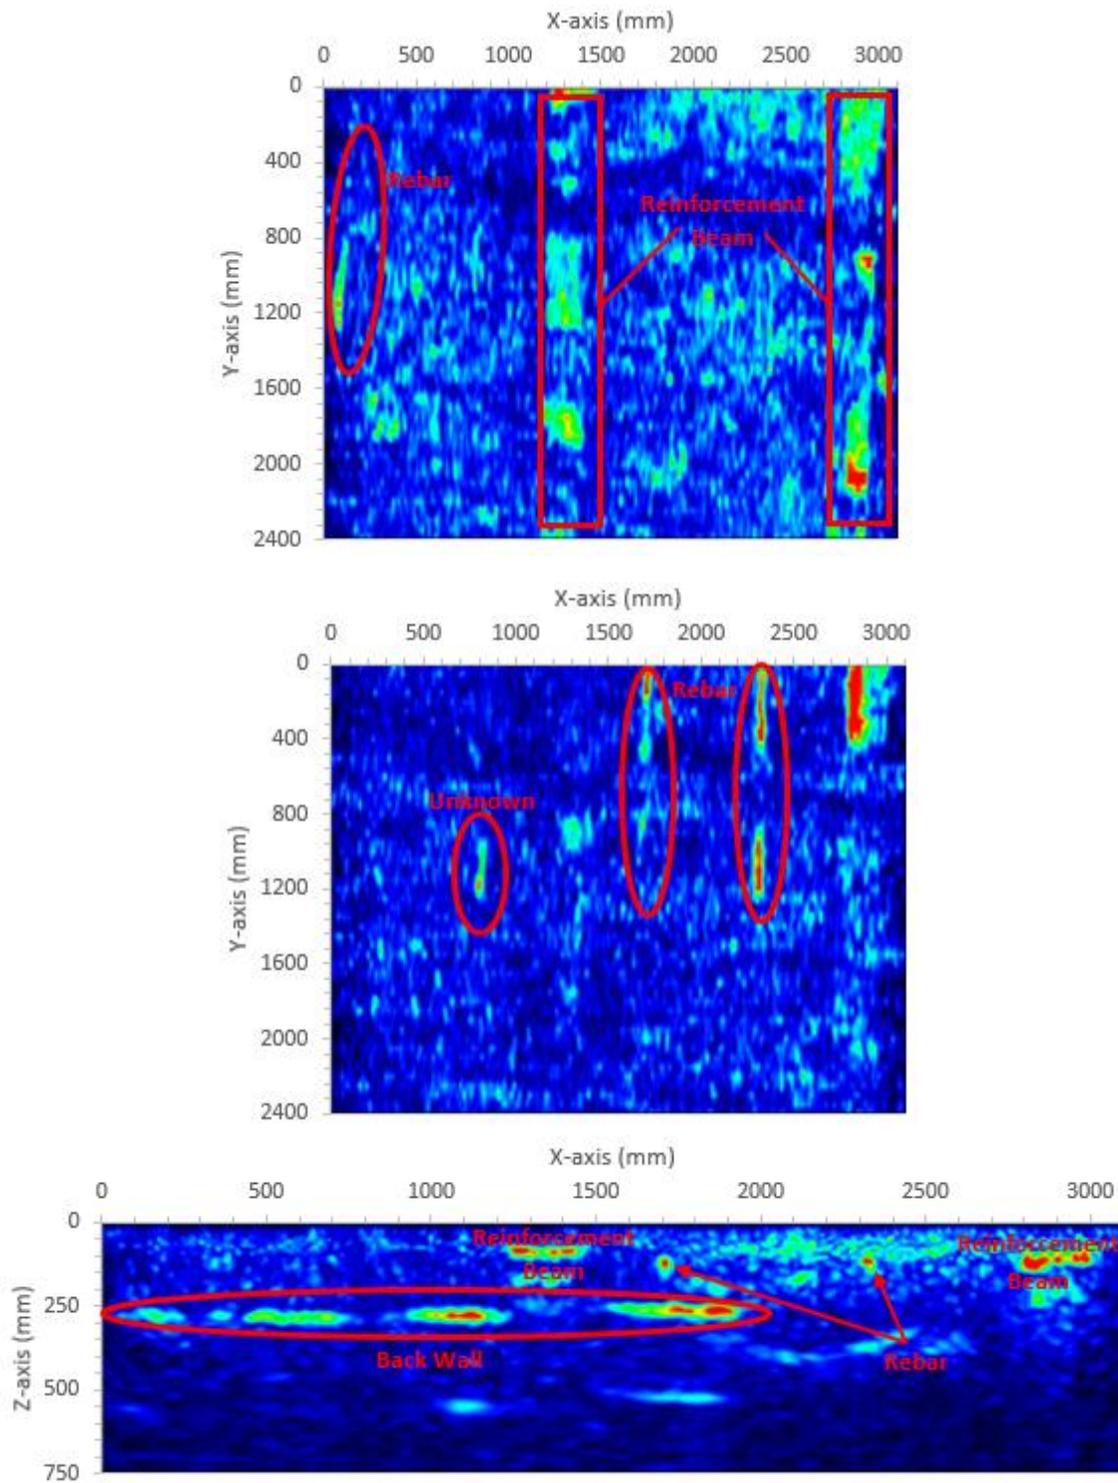
Figure 6.13. UST oriented horizontal data from Grid 2: C-scan at 80 mm (top), C-scan at 124 mm (middle), and B-scan at 850 mm (bottom)

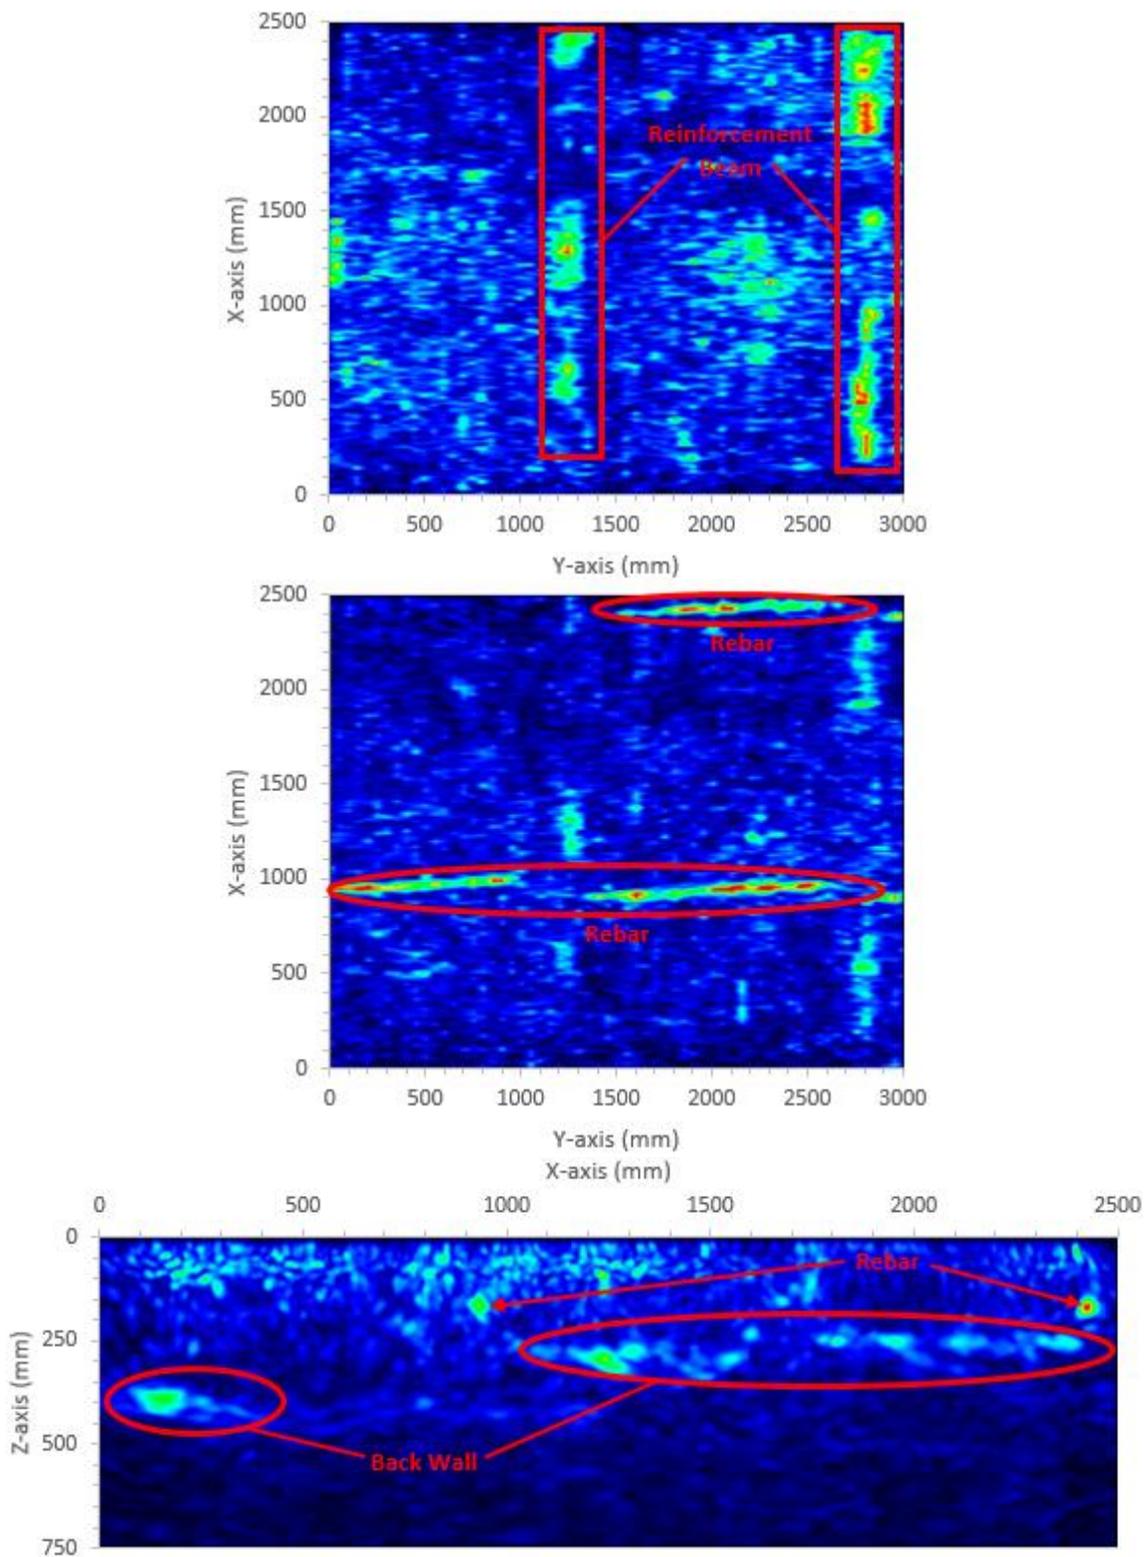
Figure 6.14. UST oriented vertically data from Grid 2: C-scan at 90.5 mm (top), C-scan at 172 mm (middle), and B-scan at 1900 mm (bottom)

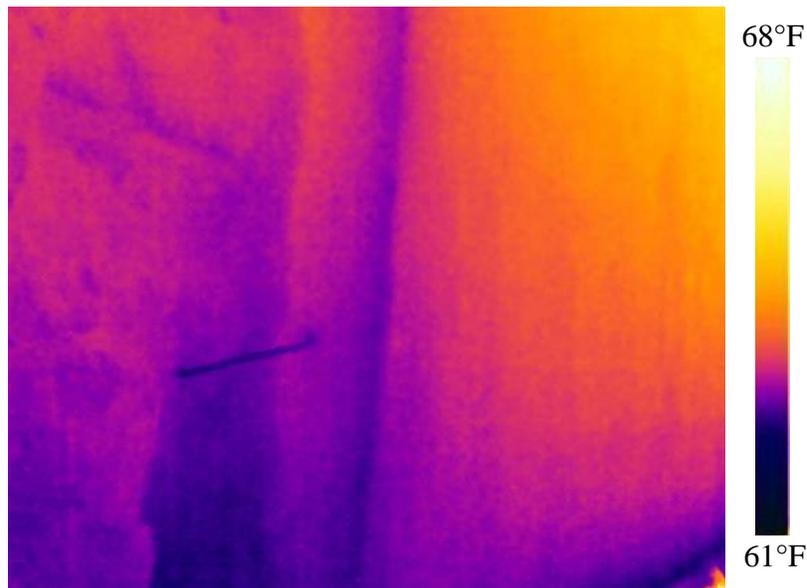
Figure 6.15. Infrared image of the exposed rebar at Grid 3

Grid 3 was used to determine the capabilities of the devices to detect rebar and how accurate their dimensions are. Since the rebar was exposed, the cover was known and could be compared to the detected depth. The measured cover of the rebar was 290 mm. Figure 6.15 shows that the exposed section of the rebar was detected with the thermal camera; however, this grid was primarily for the UST and GPR methods.

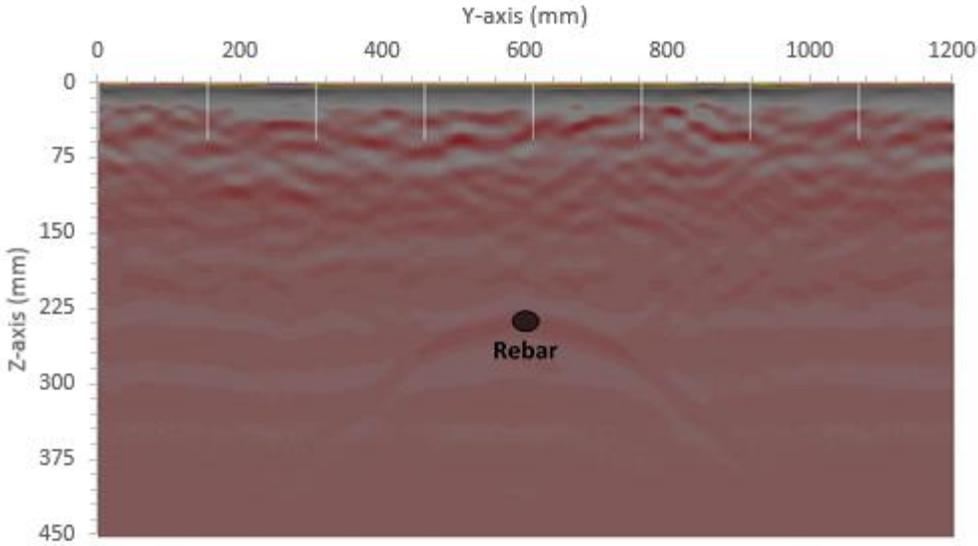
Figure 6.16. GPR of rebar at Grid 3

GPR found the rebar at a depth of 240 mm within the lining. This distance was 50 mm shallower than the measured cover which is an error of 17%. The UST detected the bar with more accuracy at a depth of 260 mm resulting in an error of 12.5%. The accuracy of both devices can be improved by using more precise values for the dielectric constant

in GPR and the wave velocity in UST. Figure 6.16 and 6.17 show the GPR and UST data from this grid. The reflections from the electromagnetic and shear waves were more faint due to the depth of the rebar which could effect the accuracy of the devices as well.

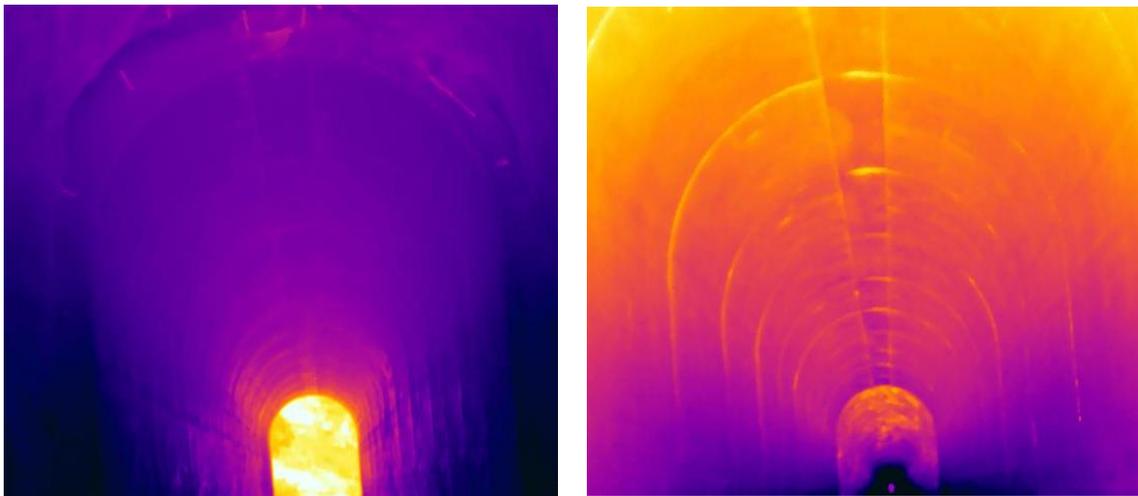
Figure 6.18. Thermal images of the east portal (Segment G): Image from Run 2 (left) and image from Run 4 (right)

A major result from the infrared testing on the Moab Tunnel is that runs need to go in both directions through the tunnel. It provides two perspectives on all the surfaces and makes the biggest difference at the ends of tunnels. When the end of the tunnel is reached the thermal video is altered due to the heat from the sun shining through the portal. Figure 6.18 compares the thermal video from each direction on the east portal. The details of the portal can be seen better in the image from the video starting at the east portal which was Segment G.

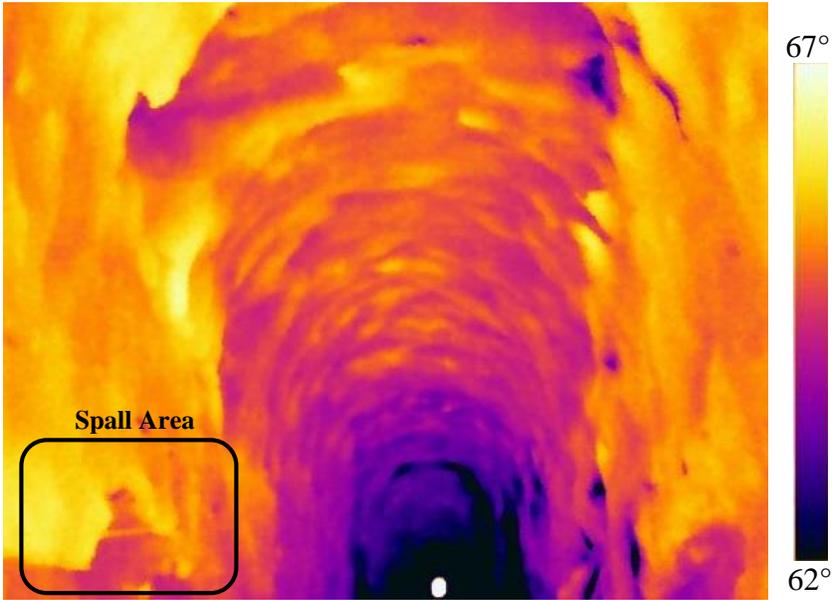
Figure 6.19. Thermal image from Run 4 of the spall in Segment F

A failure of the shotcrete lining within the rock Segment F. It was first noticed visually and then the thermal video was checked to see if it was noticeable. Figure 6.19

and 6.20 show the image from the thermal video and a thermal image and photo. A large chunk of rock had fallen off at the location along with the shotcrete.

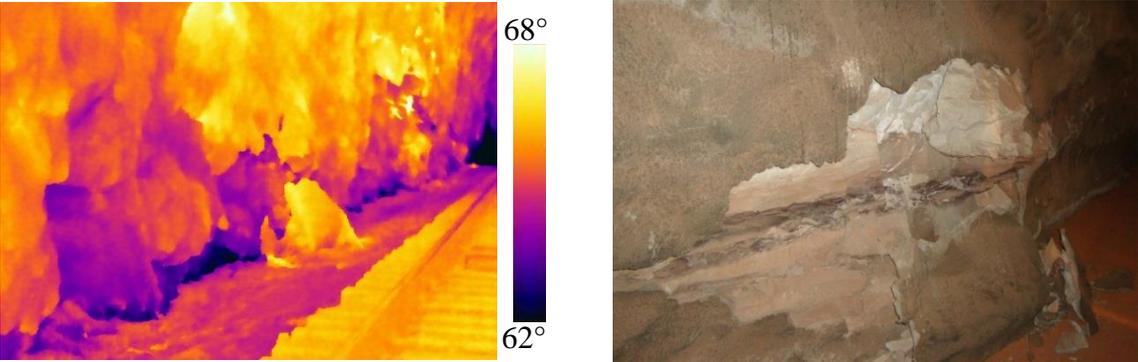
Figure 6.20. Thermal image and photo of the spall in Segment F

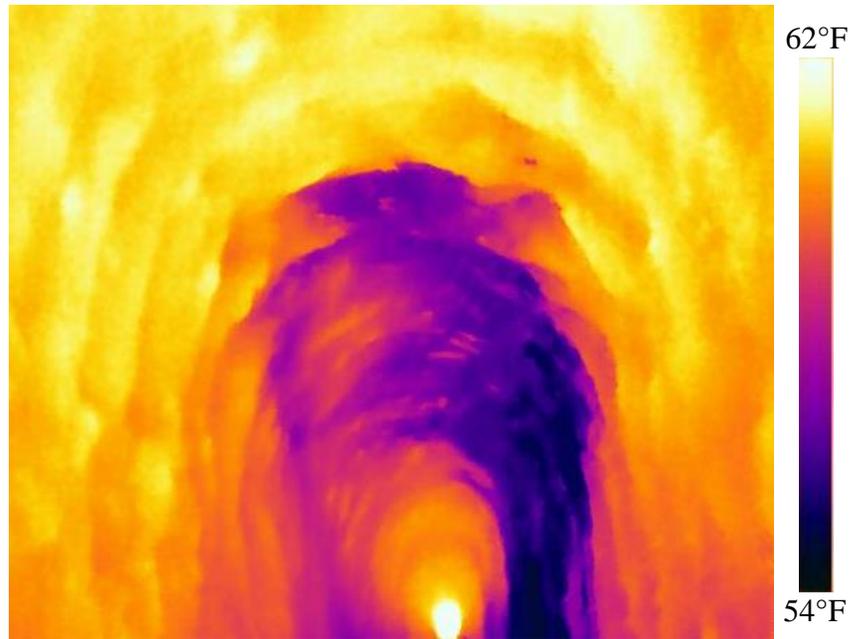
Figure 6.21. Thermal image of water infiltration

The thermal videos also worked very well for detecting water infiltration in the rock sections. Figure 6.21 is a thermal image showing a large area of water with in the rock Segment F. Water found within a concrete section would be an indication of other problems. The thermal camera detected the rock bolts as well. They could be seen in the thermal image in many locations when they were not visible. Figure 6.22 shows rock bolts that were located on the ceiling of the tunnel which would be difficult to see visually. The metal bolts heat and cool differently than the concrete and create more surface area for heat flux.

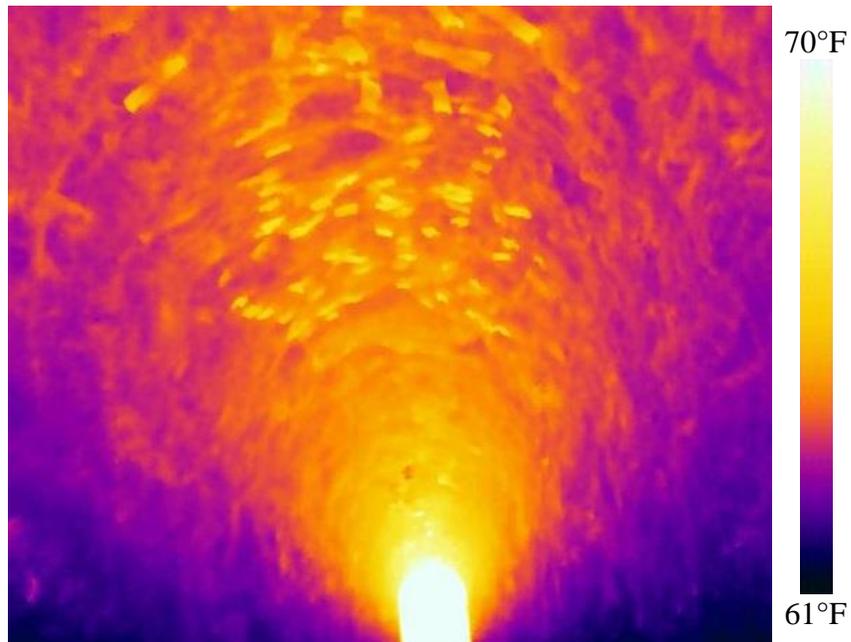
Figure 6.22. Thermal image of rock bolts on the ceiling of the tunnel

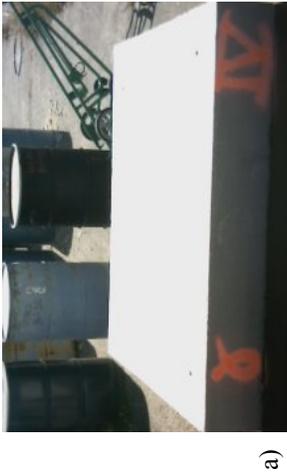
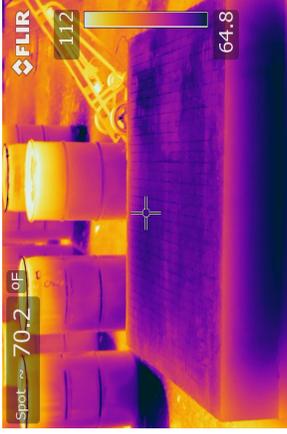
Figure A.3. Specimen Gamma with no defect: a) Image, b) Thermal image, c) GPR B-scan, d) GPR C-scan, e) UST B-scan, and f) UST C-scan

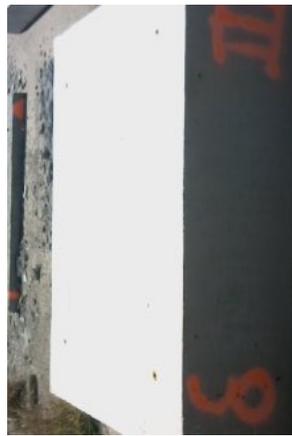
Figure A.4. Specimen Delta with no defect: a) Image, b) Thermal image, c) GPR B-scan, d) GPR C-scan, e) UST B-scan, and f) UST C-scan

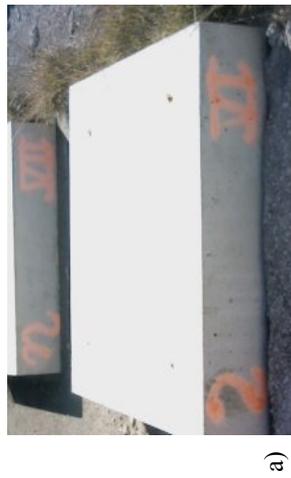
Figure A. 6. Specimen Zeta with no defect: a) Image, b) Thermal image, c) GPR B-scan, d) GPR C-scan, e) UST B-scan, and f) UST C-scan

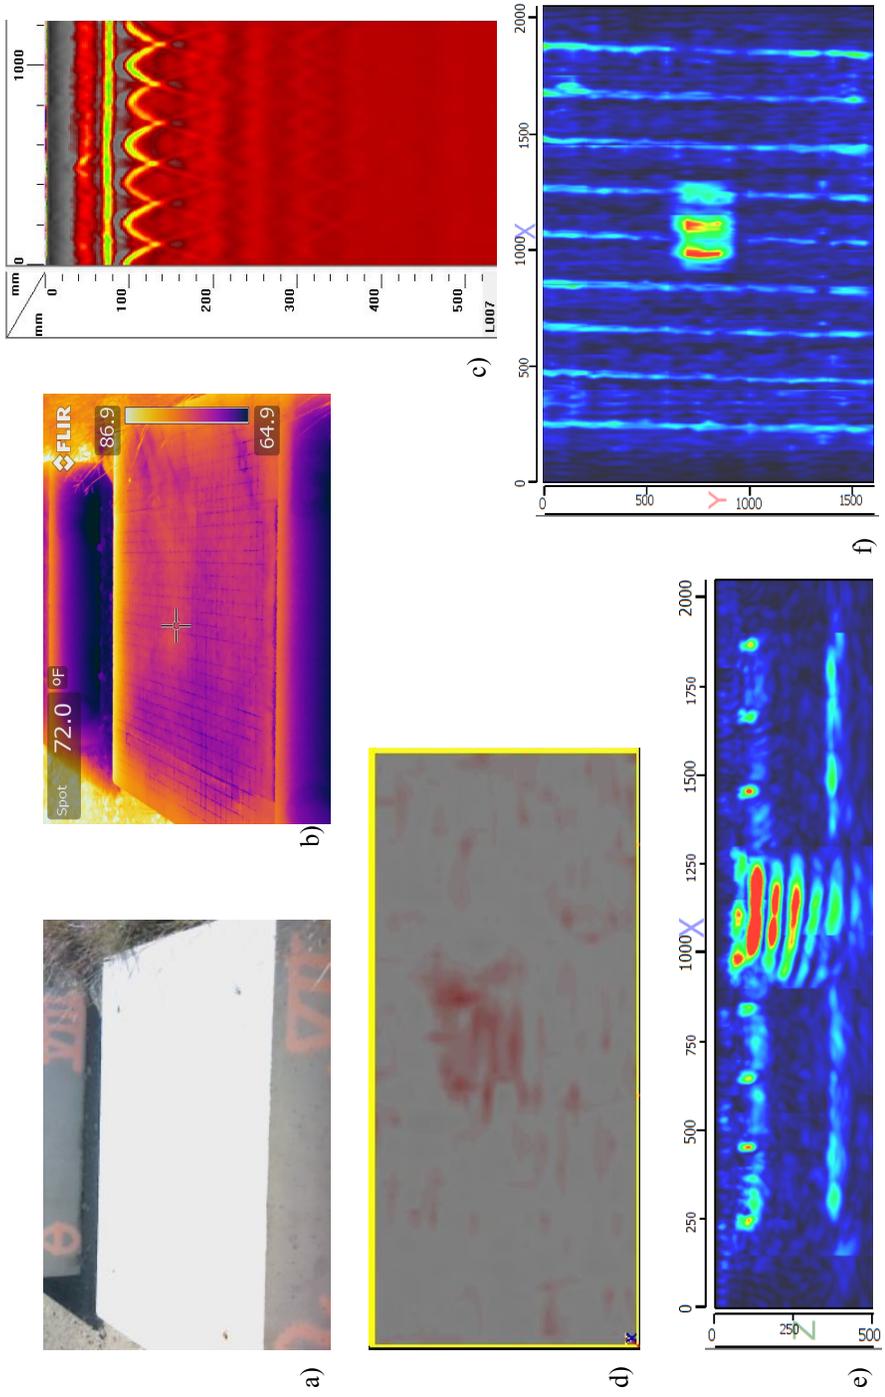
Figure A.7. Specimen Eta with a delamination at 72 mm: a) Image, b) Thermal image, c) GPR B-scan, d) GPR C-scan, e) UST B-scan, and f) UST C-scan

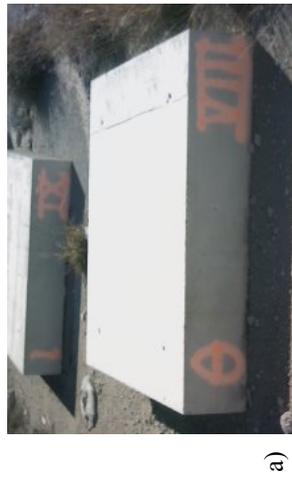
Figure A.8. Specimen Theta with a delamination at 98 mm: a) Image, b) Thermal image, c) GPR B-scan, d) GPR C-scan, e) UST B-scan, and f) UST C-scan

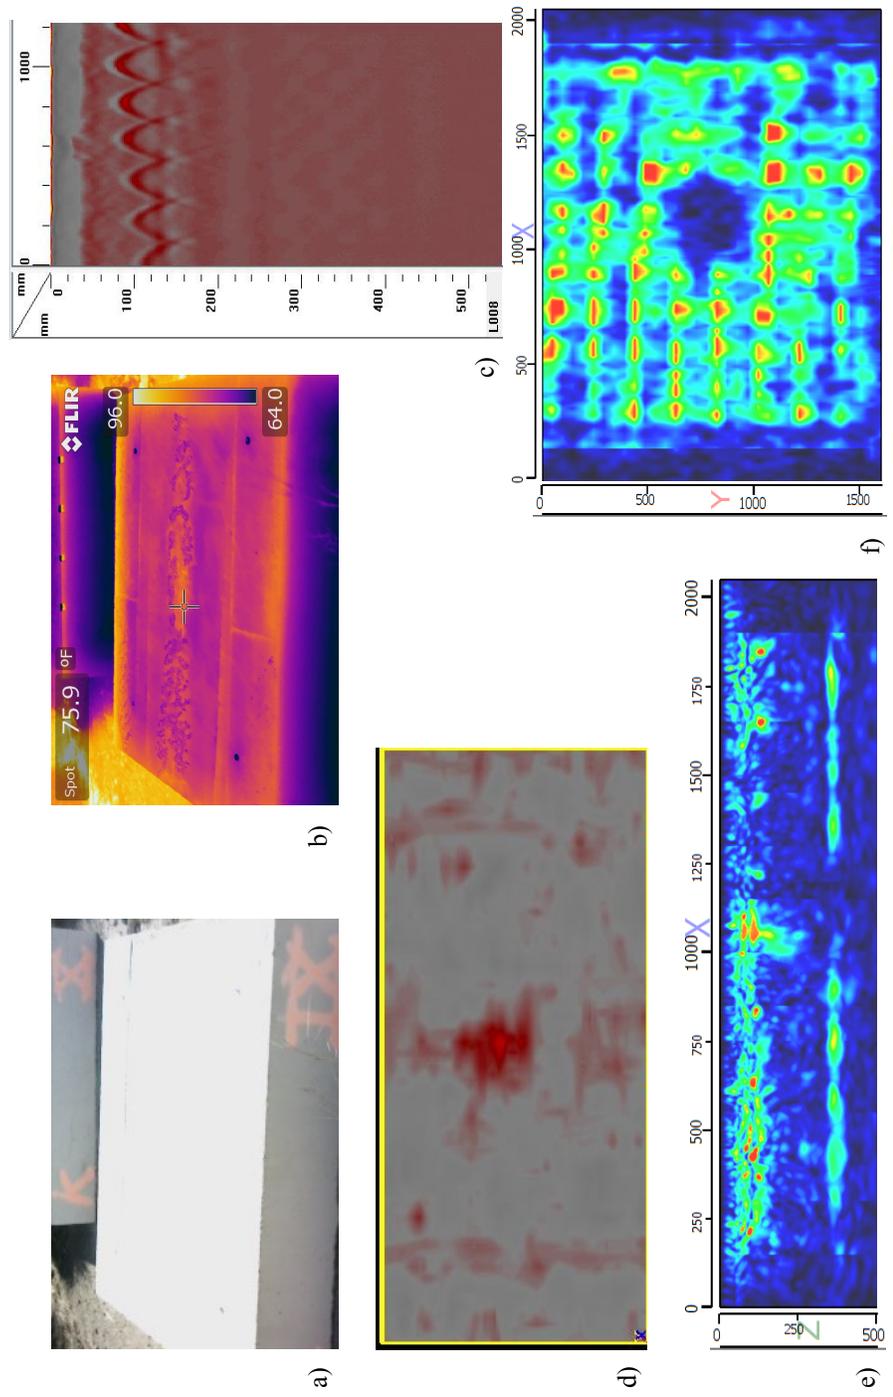
Figure A.9. Specimen Iota with a delamination at 34 mm: a) Image, b) Thermal image, c) GPR B-scan, d) GPR C-scan, e) UST B-scan, and f) UST C-scan

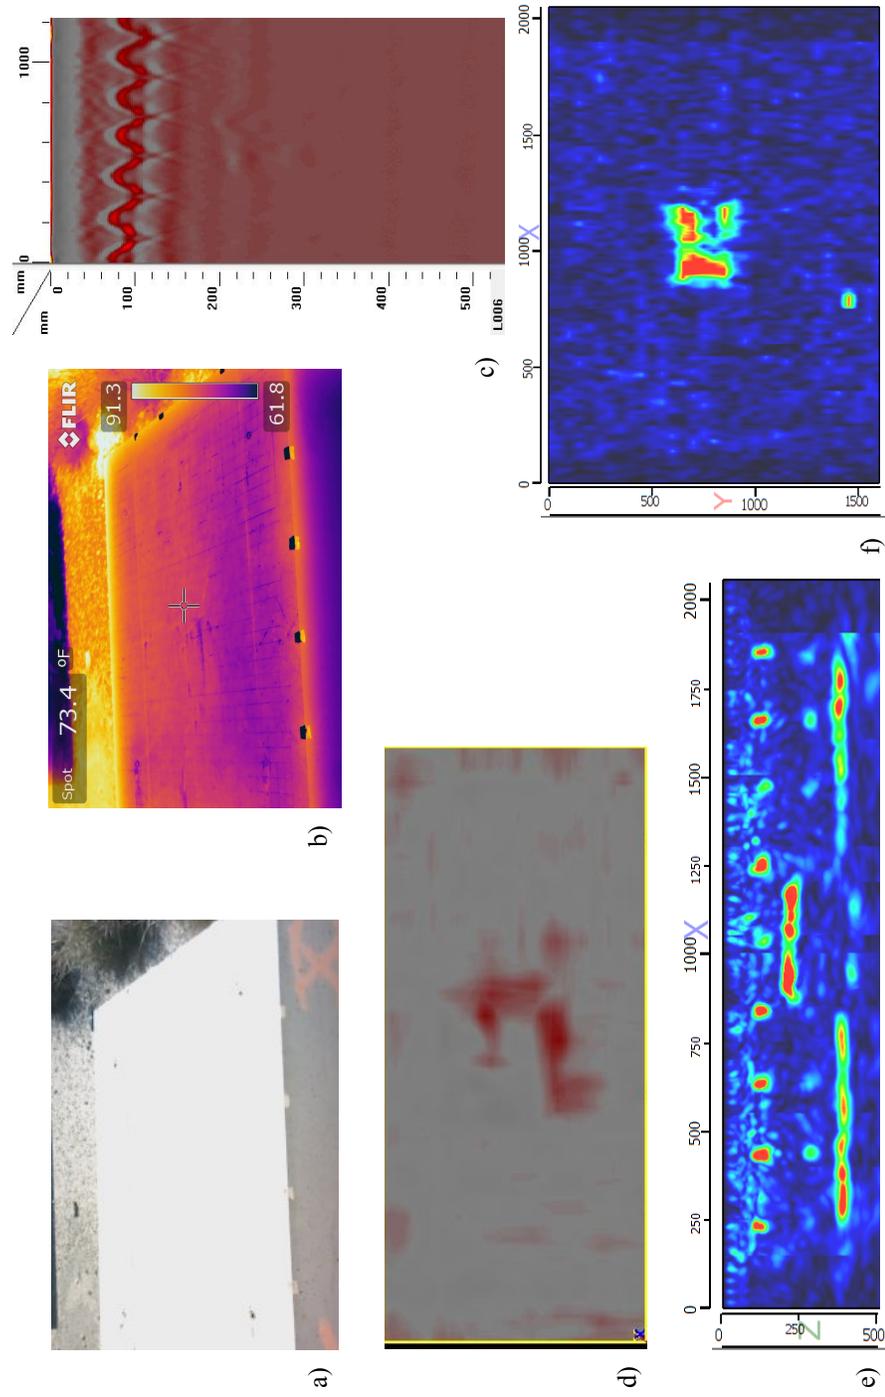
Figure A.10. Specimen Kappa with a void at 210 mm: a) Image, b) Thermal image, c) GPR B-scan, d) GPR C-scan, e) UST B-scan, and f) UST C-scan

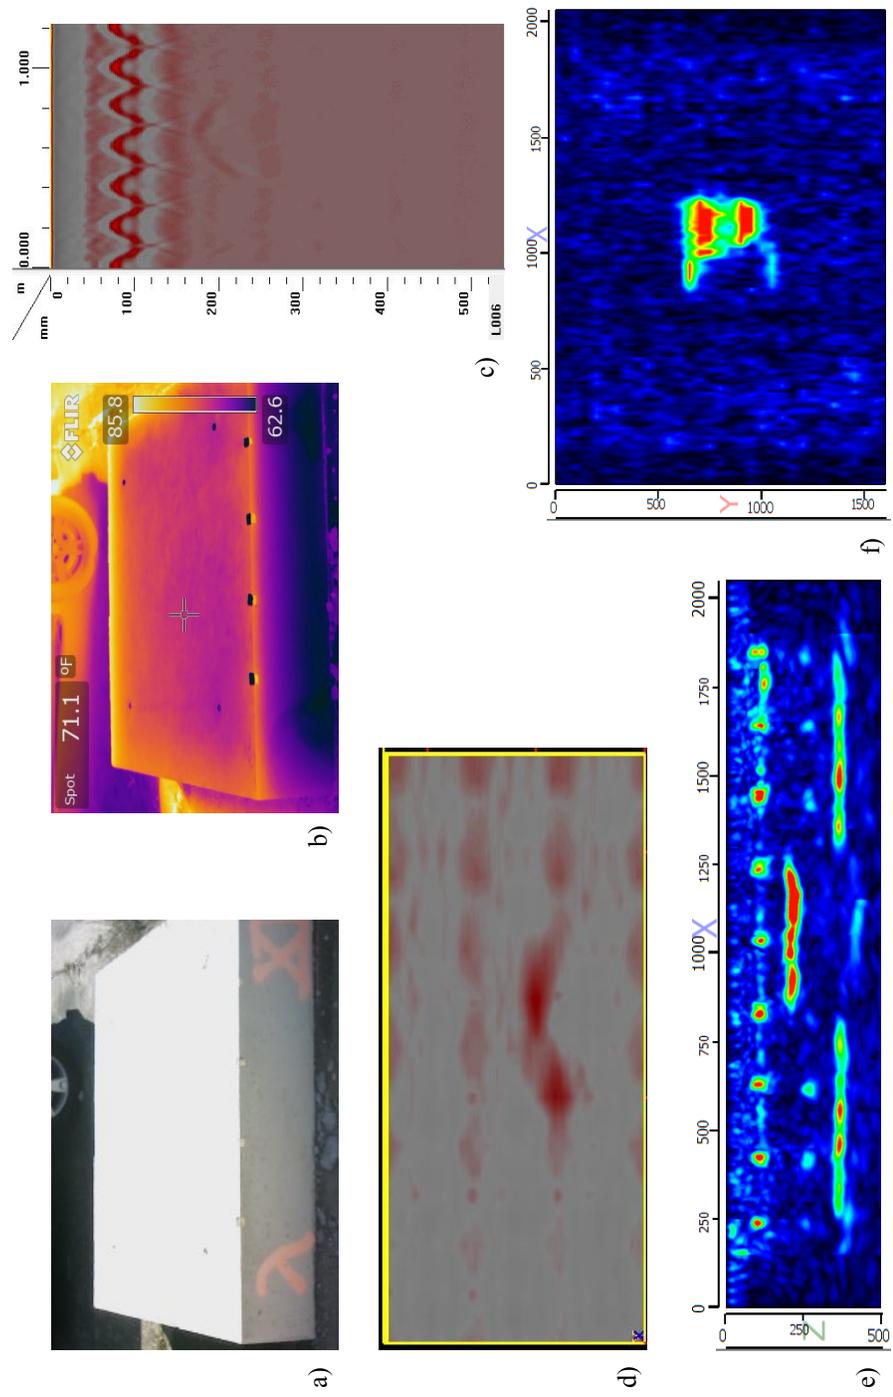
Figure A.11. Specimen Lambda with a void at 213 mm: a) Image, b) Thermal image, c) GPR C-scan, d) GPR B-scan, e) UST B-scan, and f) UST C-scan

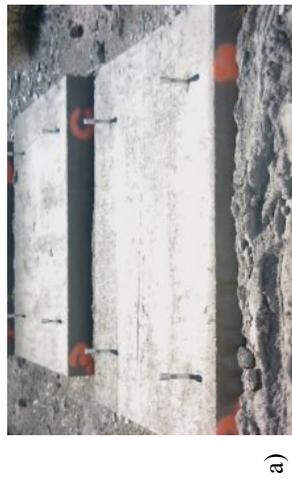
Figure A.13. Specimen B with no defect: a) Image, b) Thermal image, c) GPR C-scan, d) GPR B-scan, e) UST B-scan, and f) UST C-scan

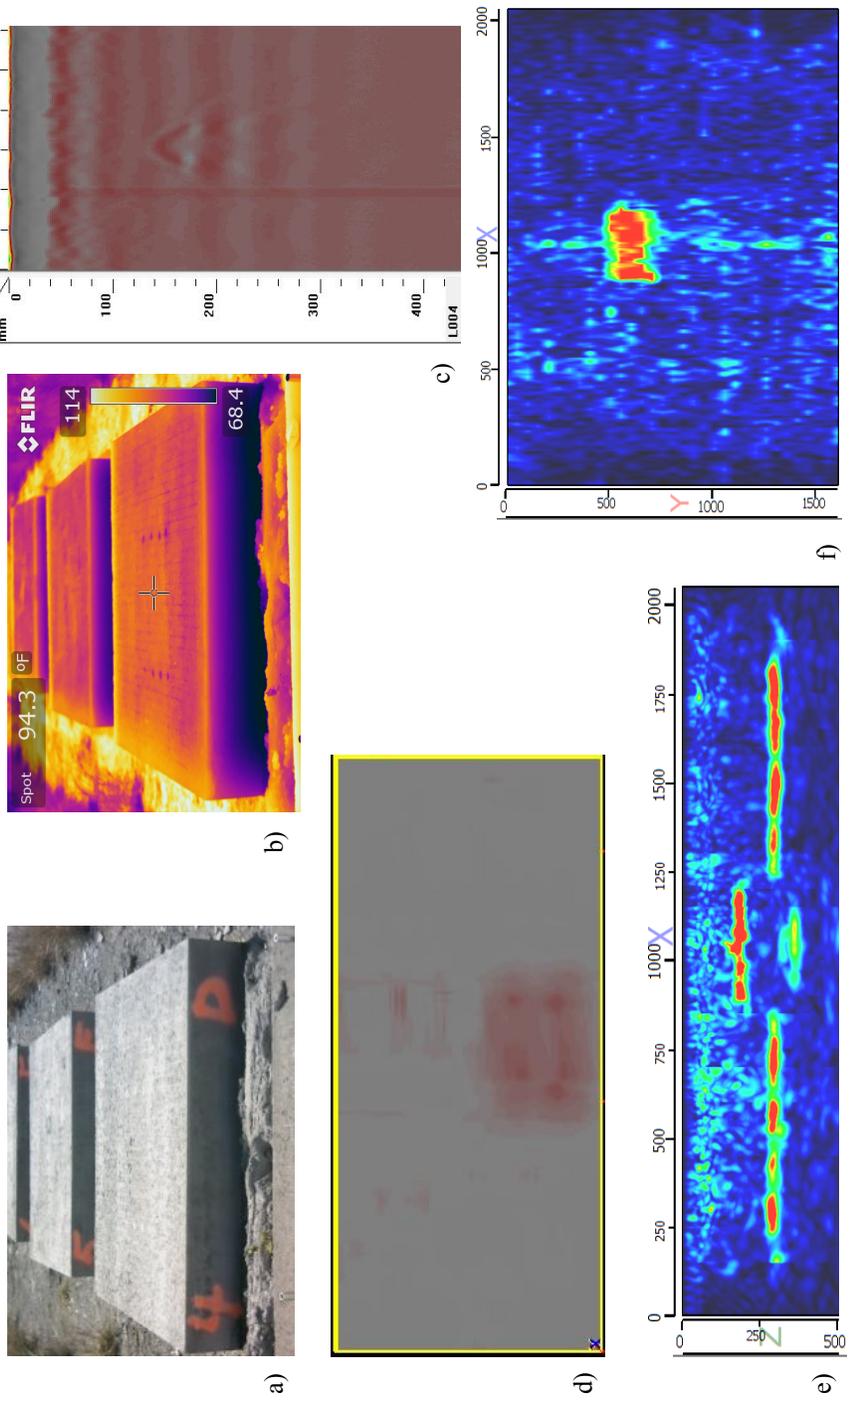
Figure A.15. Specimen D with a void at 182 mm: a) Image, b) Thermal image, c) GPR B-scan, d) GPR C-scan, e) UST B-scan, and f) UST C-scan

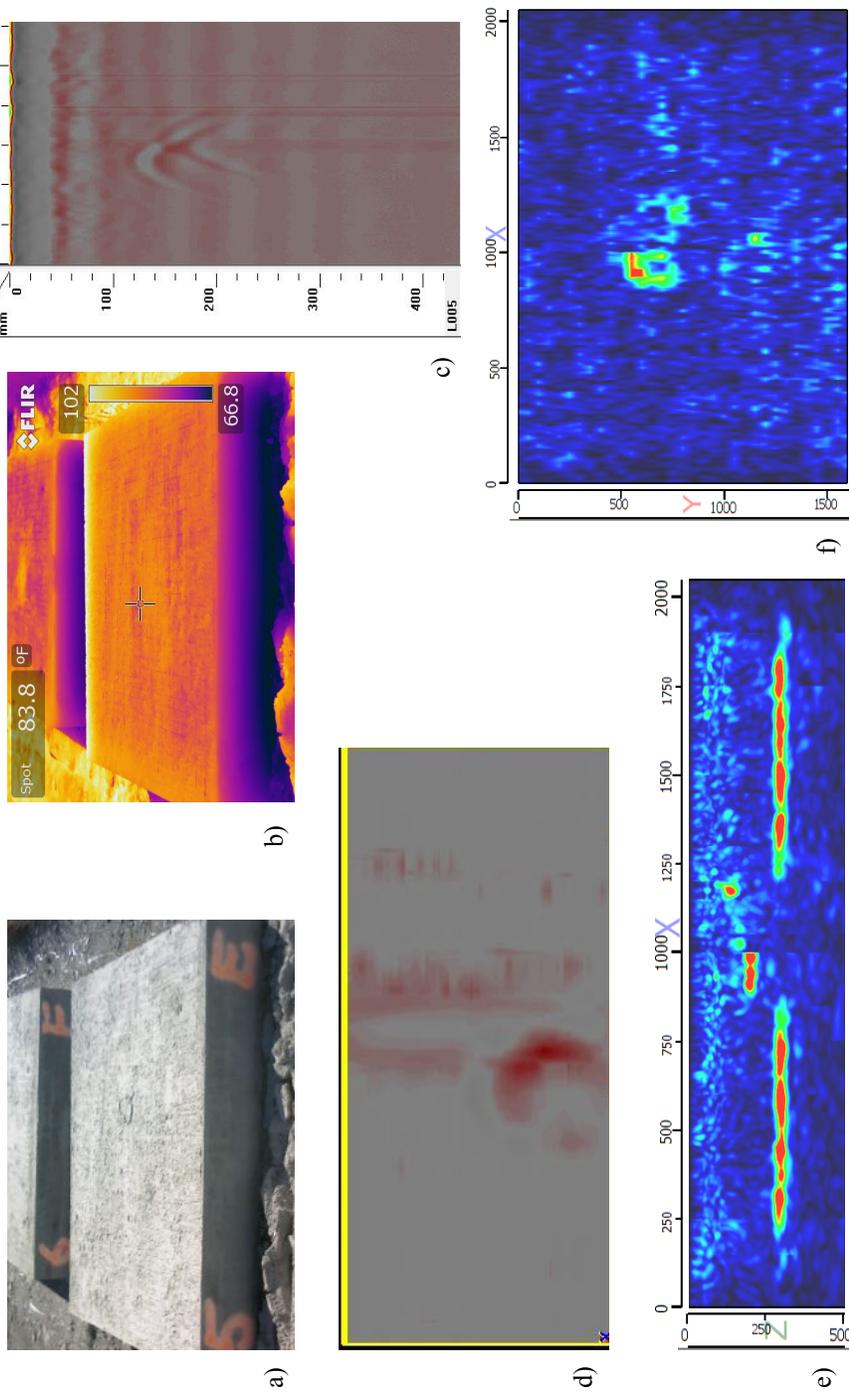
Figure A.16. Specimen E with a void at 196 mm: a) Image, b) Thermal image, c) GPR B-scan, d) GPR C-scan, e) UST B-scan, and f) UST C-scan

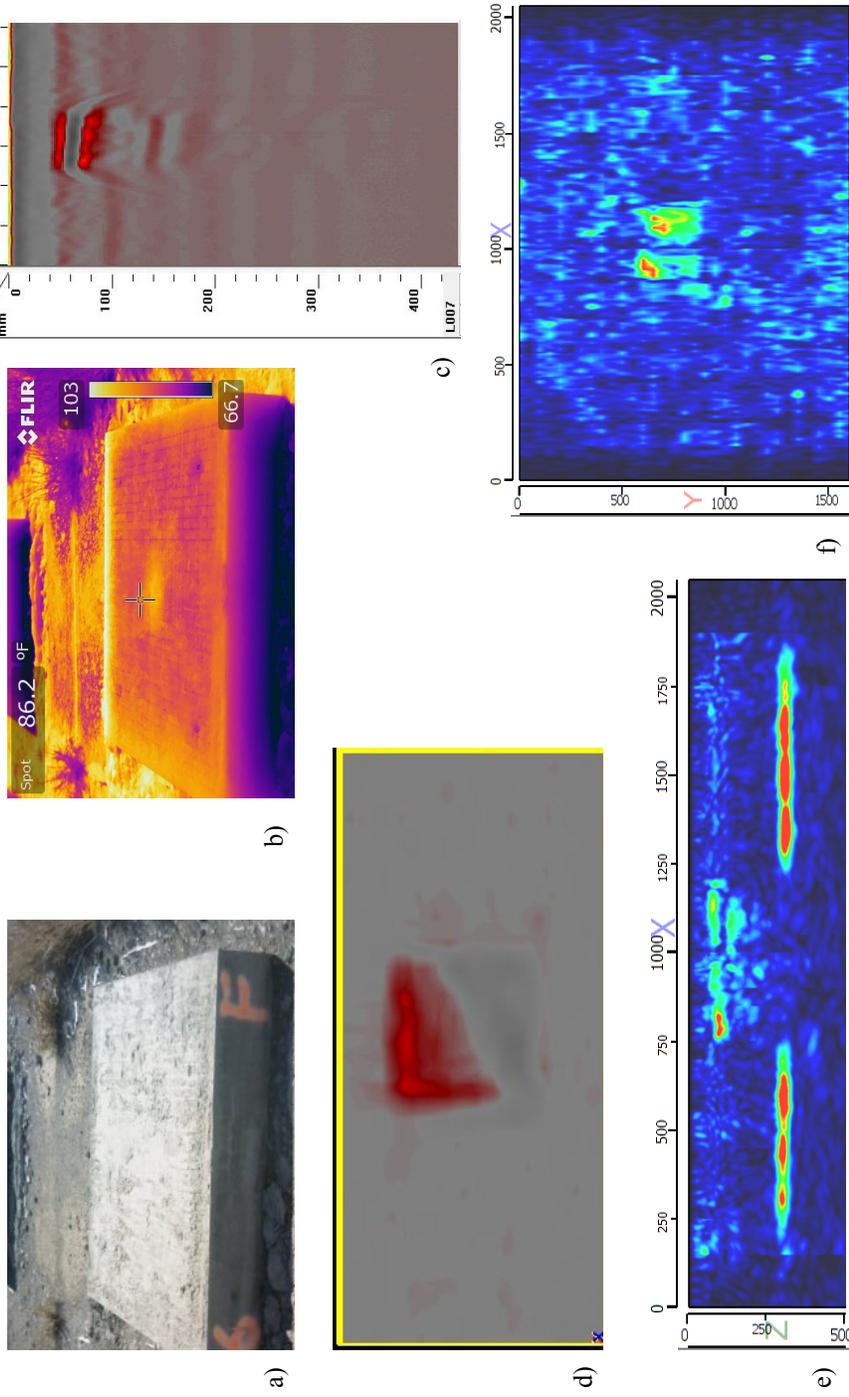
Figure A.17. Specimen F with a void at 78 mm: a) Image, b) Thermal image, c) GPR B-scan, d) GPR C-scan, e) UST B-scan, and f) UST C-scan

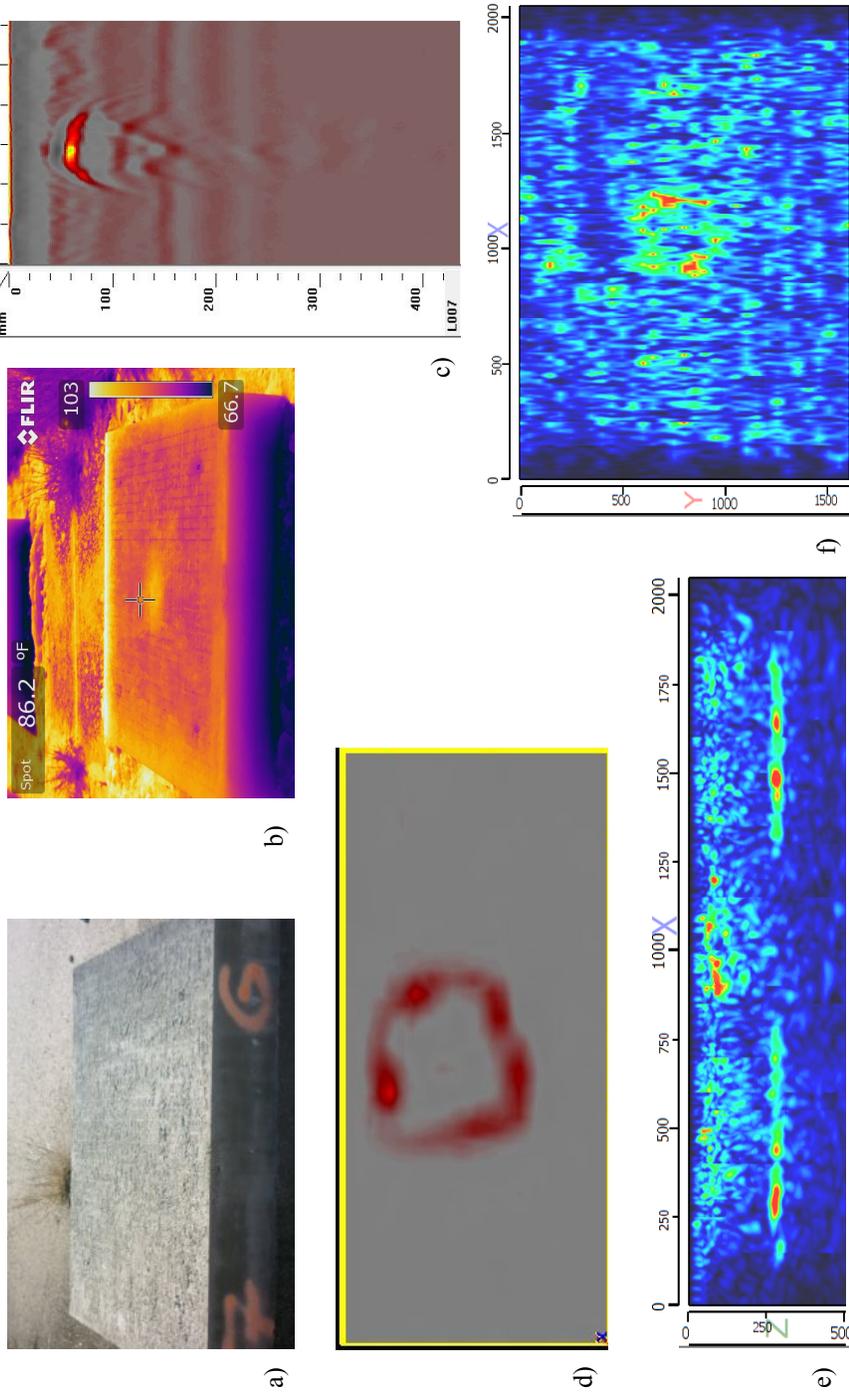
Figure A.18. Specimen G with a void at 83 mm: a) Image, b) Thermal image, c) GPR B-scan, d) GPR C-scan, e) UST B-scan, and f) UST C-scan

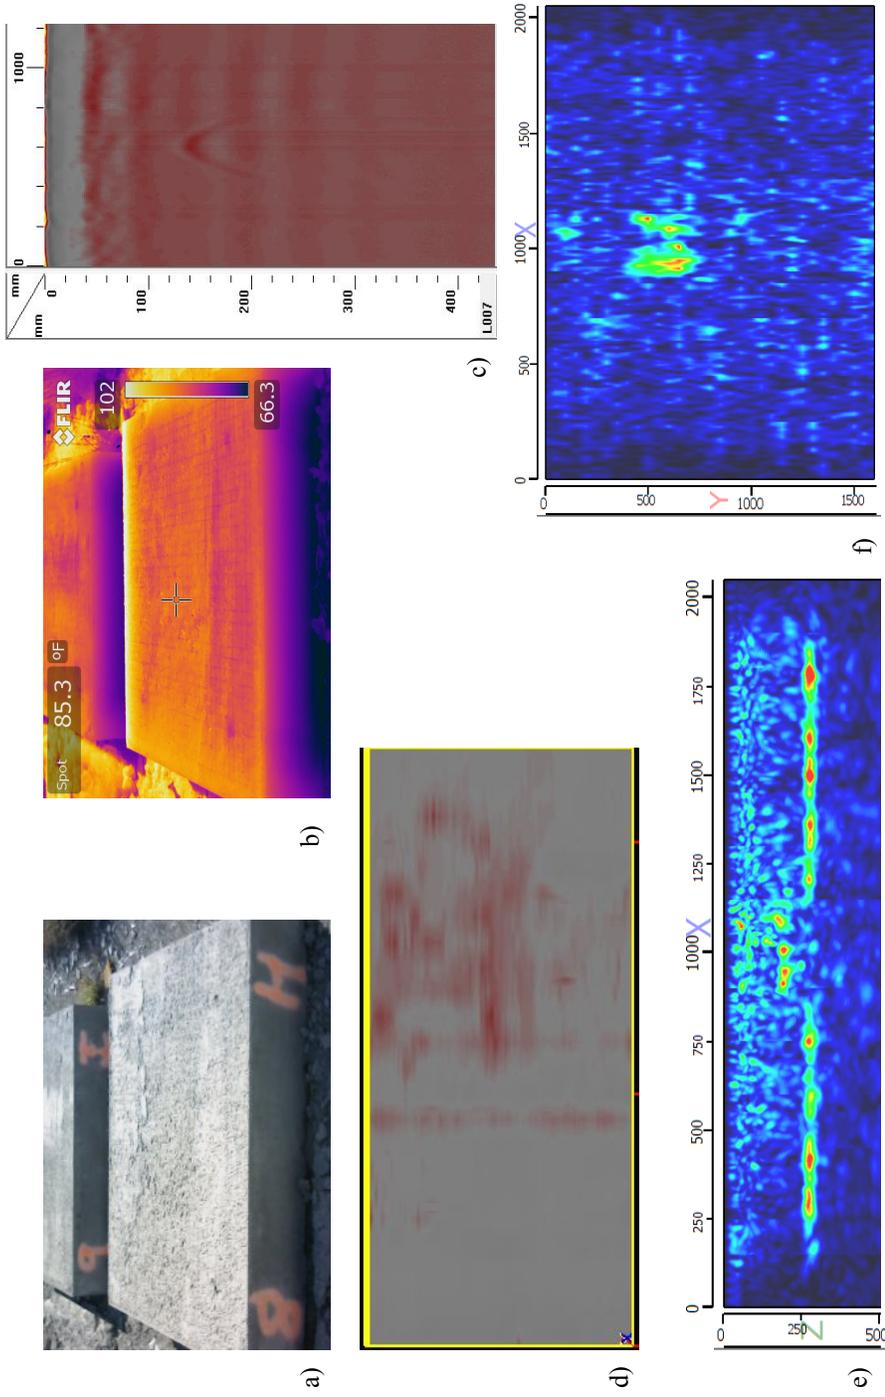
Figure A.19. Specimen H with a delamination at 190 mm: a) Image, b) Thermal image, c) GPR B-scan, d) GPR C-scan, e) UST B-scan, and f) UST C-scan

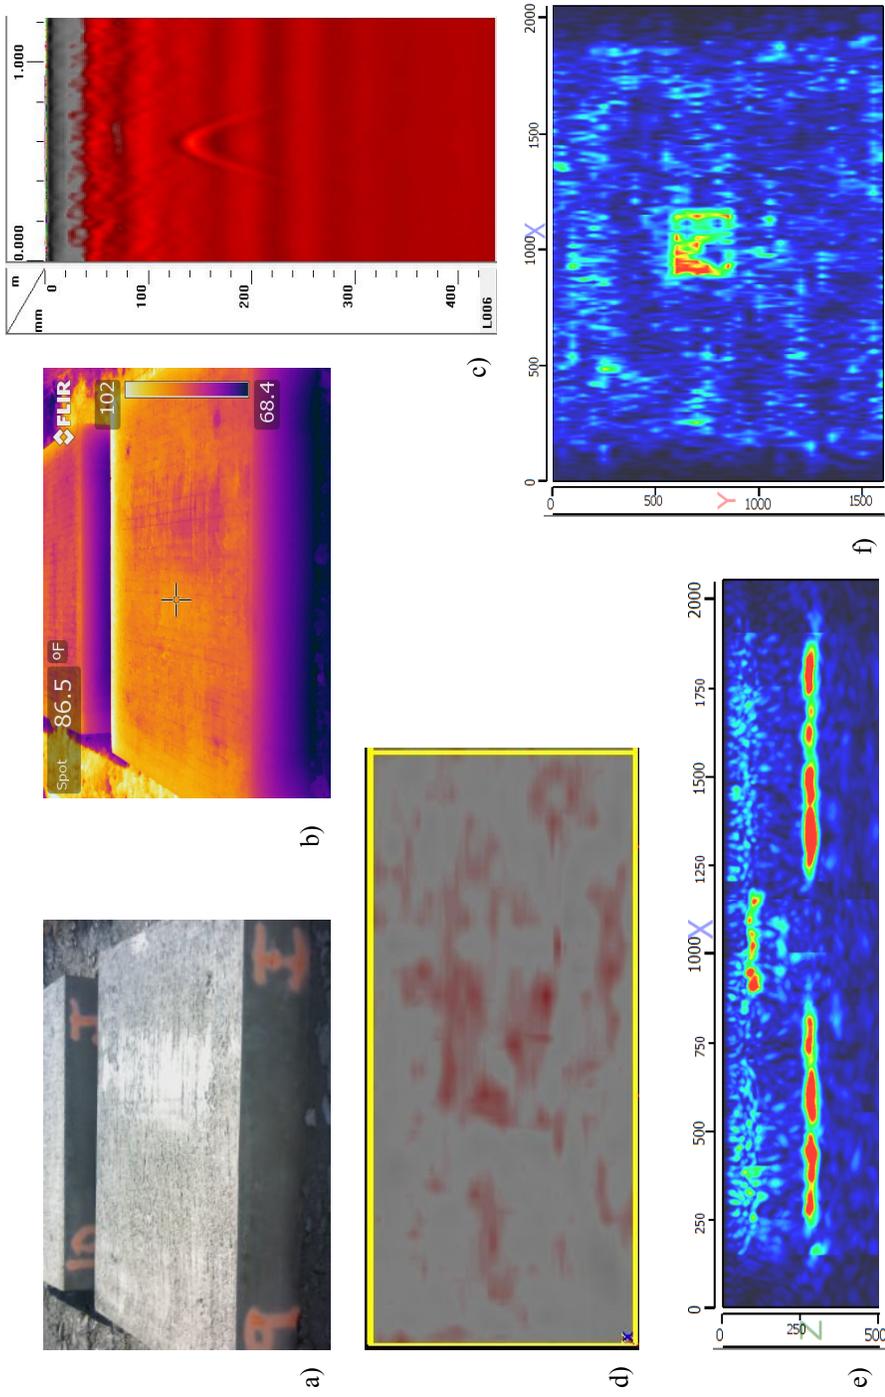
Figure A.20. Specimen I with a delamination at 95 mm: a) Image, b) Thermal image, c) GPR C-scan, d) GPR B-scan, e) UST B-scan, and f) UST C-scan

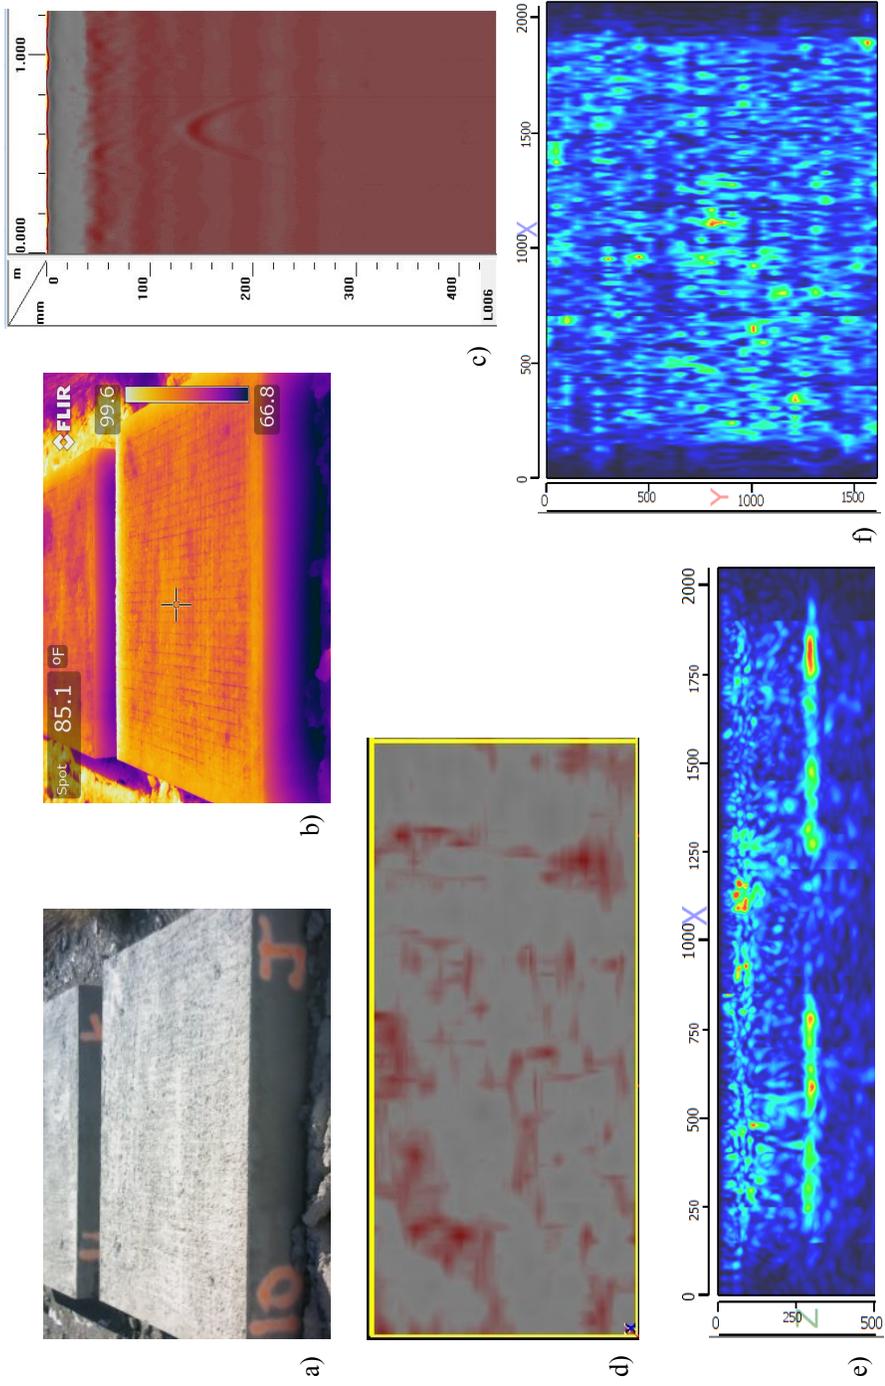
Figure A.21. Specimen J with a delamination at 83 mm: a) Image, b) Thermal image, c) GPR B-scan, d) GPR C-scan, e) UST B-scan, and f) UST C-scan
