NONDESTRUCTIVE TESTING OF RAIL TUNNEL LININGS

A Thesis

Major Subject: Civil Engineering

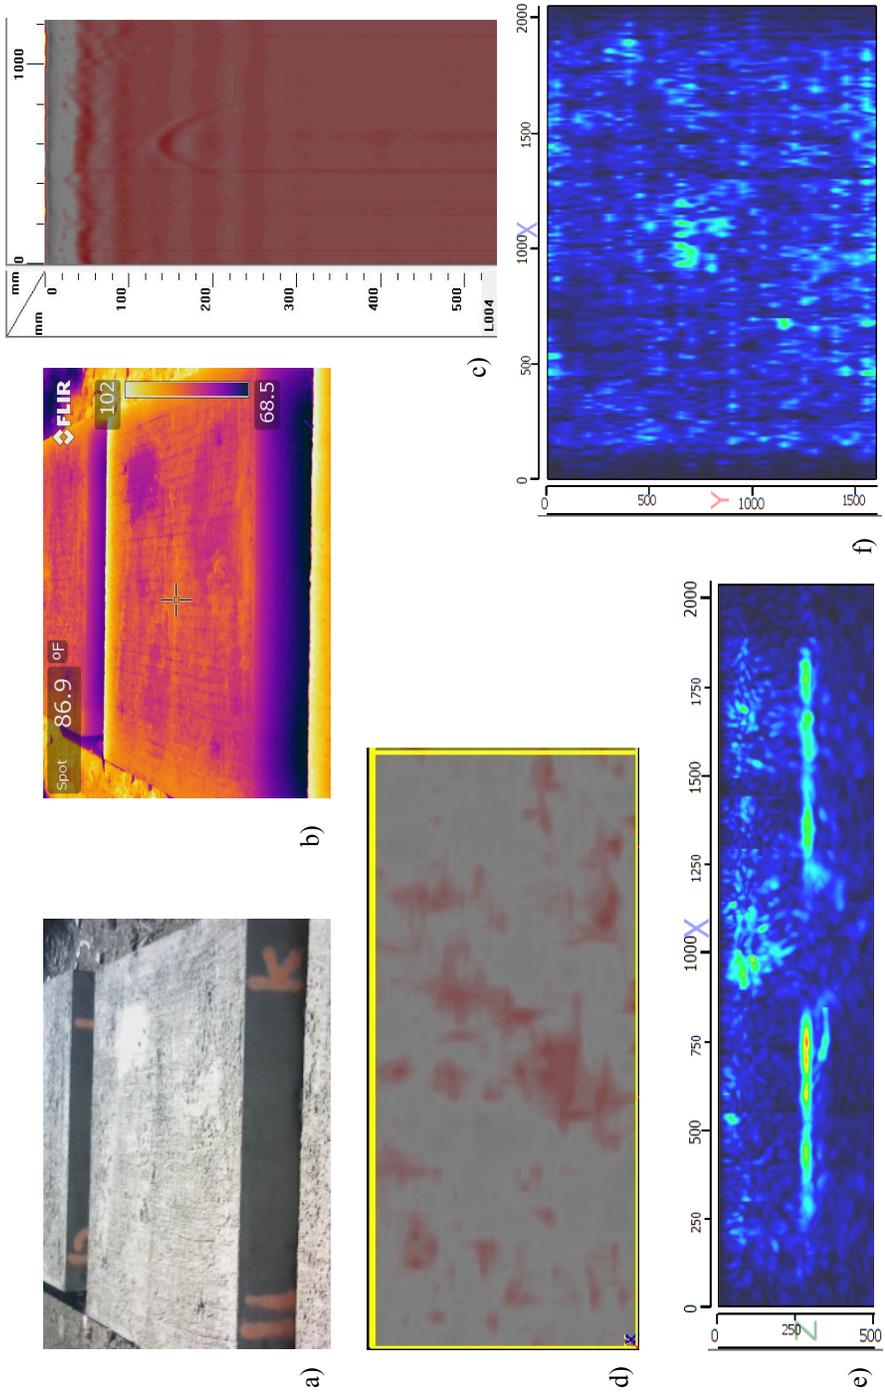
Figure A.22. Specimen K with a delamination at 68 mm: a) Image, b) Thermal image, c) GPR B-scan, d) GPR C-scan, e) UST B-scan, and f) UST C-scan

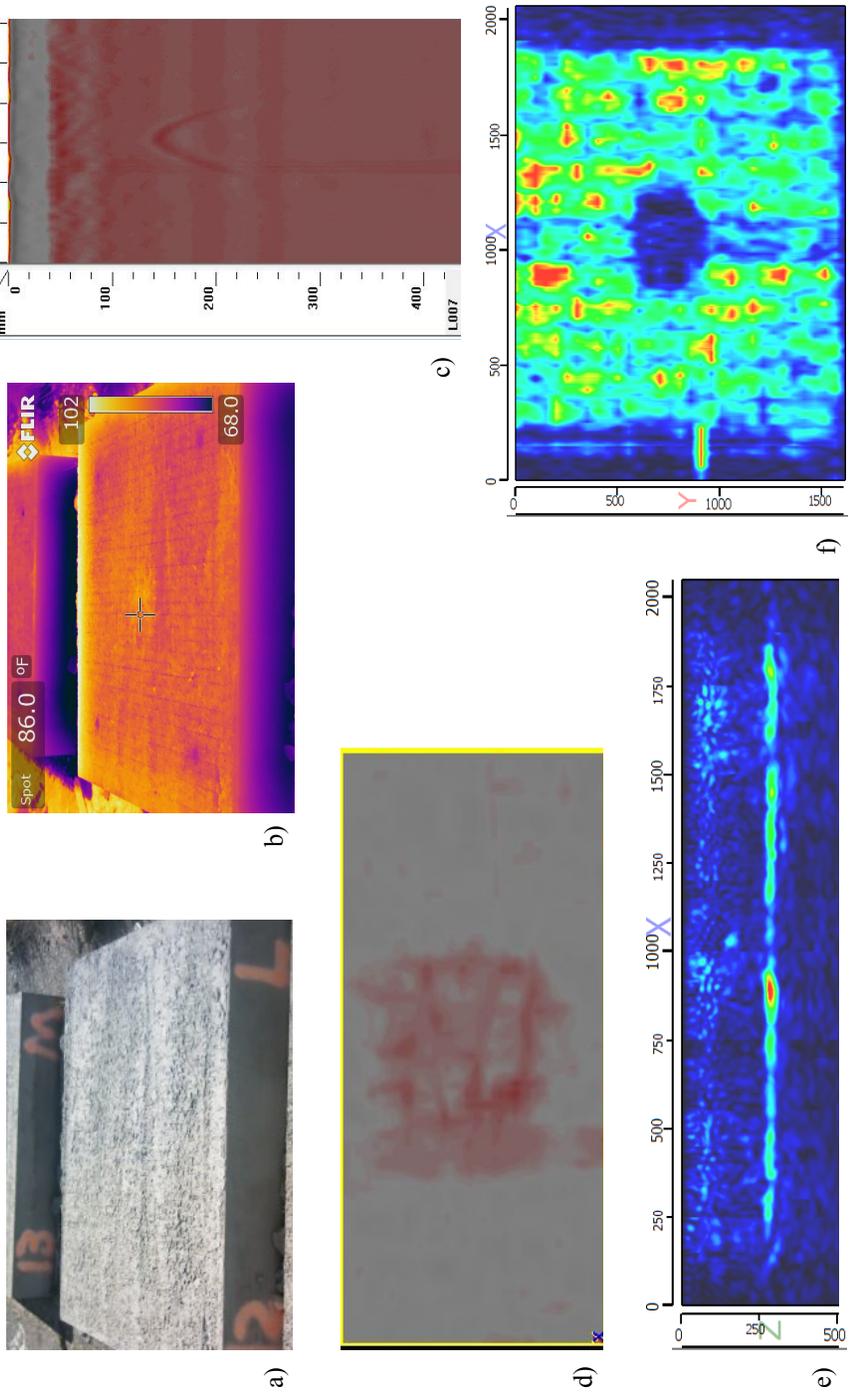
Figure A.23. Specimen L with a delamination at 15 mm: a) Image, b) Thermal image, c) GPR B-scan, d) GPR C-scan, e) UST B-scan, and f) UST C-scan
