PERFORMANCE ASSESSMENT OF RECONDITIONED FREIGHT
RAIL BEARINGS USING EDDY CURRENT ARRAY FOR
ENHANCED NONDESTRUCTIVE INSPECTION

A Thesis

EDUARDO MIRANDA

The University of Texas Rio Grande Valley
December 2025

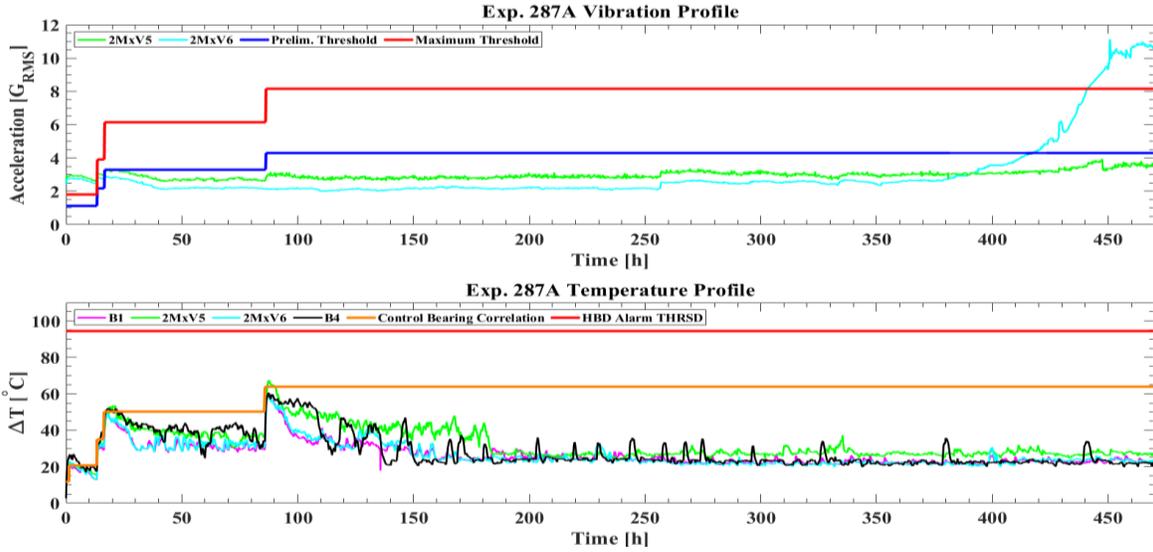
Figure 22: Vibration and temperature profiles for Experiment 287A

The vibration and temperature profiles for the test bearings are provided in Figure 22. The temperature data presents no characteristics associated with those of bearings in distress as the operating temperature of the defective bearing exhibited normal operating conditions at

100% load and 85 mph (137 km/h). In fact, the operating temperature for the 2MxV6 bearing, which averaged around 21.5°C (38.7°F) above ambient, was well below the average temperature for healthy bearings operating at the same load and speed conditions (indicated by the control bearing correlation in Figure 22), and significantly lower than the recommended AAR Hot-Bearing Detector (HBD) alarm threshold, which is 94.4°C (170°F) above ambient. The control bearing correlation is a statistical average temperature for a healthy bearing at those operating conditions as determined by prior work at the UTCRS [31]. It should be noted that experiments were stopped when the defect detection algorithm used would indicate that a defect had developed. The HBD alarm threshold is usually exceeded after significant damage has developed within the bearing, which may not allow for early intervention to mitigate catastrophic bearing failure.

The acceleration (G_{RMS}) levels of 2MxV6 displayed control bearing conditions at the beginning of the experiment. Nearing the 380 hour-mark (32,725 mi or 52,666 km), the defect detection algorithm indicated that a defect had initiated. The acceleration values exceeded the preliminary threshold, signifying that a possible defect had initiated. Within the following 6,000 mi (9,656 km), the acceleration surpassed the maximum threshold meaning that a spall had fully developed on one of the components of the bearing. Vibration analysis enables detection of early-stage defects through correlations to the empirical defined thresholds [2]. As for the 2MxV5 bearing, the acceleration values were below the preliminary threshold, implying that it was still healthy at this point.

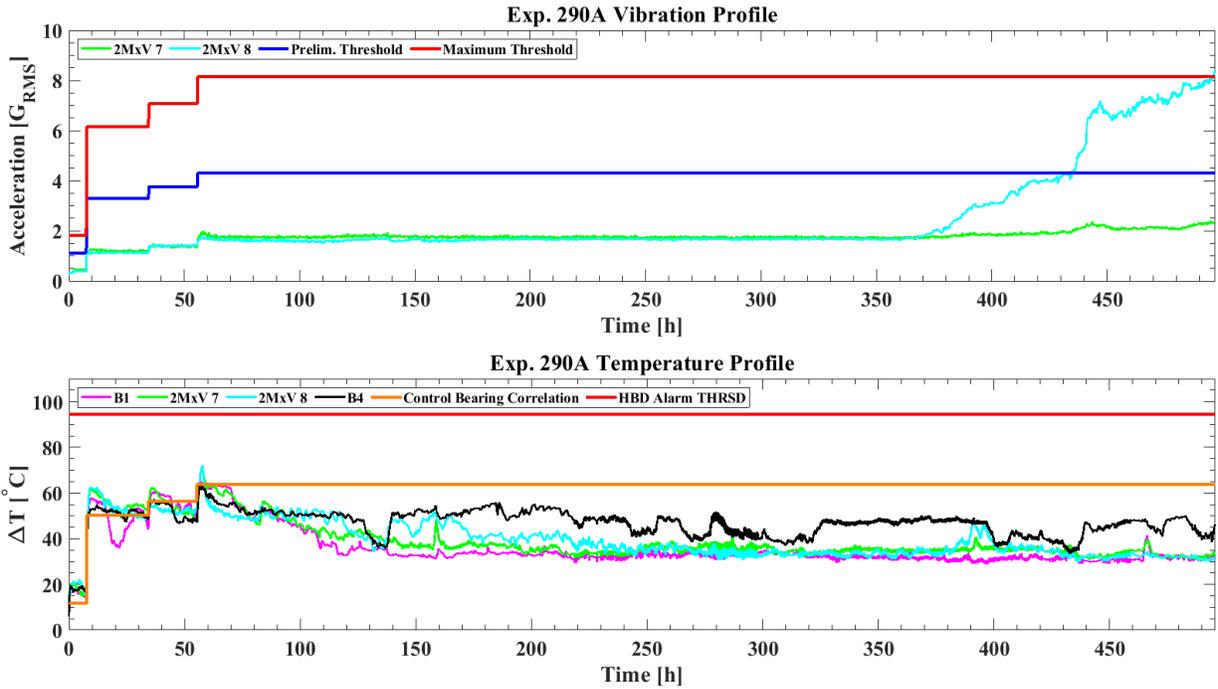
Figure 26: Vibration and temperature profiles for Experiment 290A

Plots representing the vibration and temperature profiles of these two test bearings are given in Figure 26. The operating temperatures for both test bearings, which averaged around 39.0°C (70.2°F) above ambient, remained below the control bearing correlation for the majority of the experiment, and well below the HBD alarm threshold. The acceleration (G_{RMS}) levels for 2MxV7 ran steady and below the preliminary threshold, exhibiting healthy bearing conditions for the duration of the experiment. However, the acceleration levels for the 2MxV8 bearing started to steadily increase around the 370 hour-mark, crossing the preliminary threshold at hour 434 (31,025 mi or 49,930 km) of the experiment, thus signifying a possible defect initiation, and eventually exceeding the maximum threshold at the 41,151 mi (66,226 km) mark, which

confirmed that a defect had developed on that bearing.

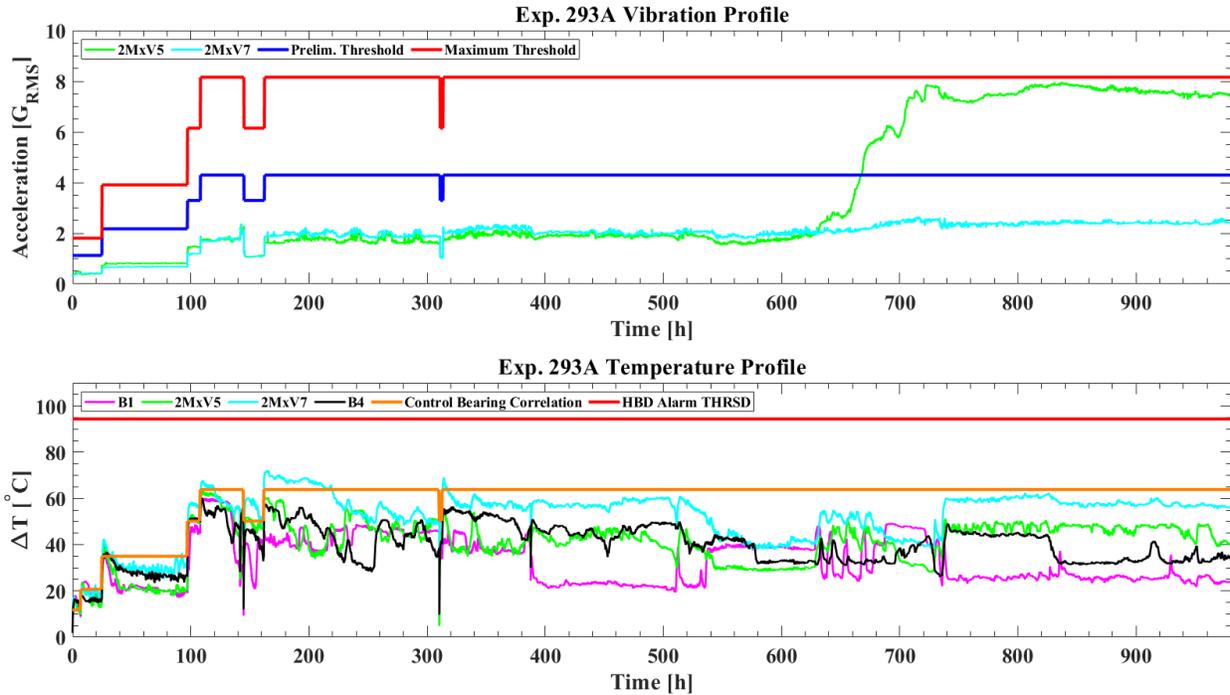
Figure 32: Vibration and temperature profiles for Experiment 293A

The vibration and temperature profiles for these two test bearings are plotted in Figure 32. The operating temperatures for both test bearings, which averaged around 46.9°C (84.4°F) for 2MxV5 and 61.2°C (110.2°F) for 2MxV7 above ambient, remained below the control bearing correlation for the majority of the experiment, and well below the HBD alarm threshold. The acceleration for 2MxV7 ran steady and below the preliminary threshold, signifying that it remained a healthy bearing for the duration of the experiment. However, the acceleration levels for the 2MxV5 bearing started to steadily increase around the 630 hour-mark (118,879 mi or 191,317 km) of the experiment. The vibration levels approached the maximum threshold and remained just below that threshold. The G_{RMS} values that are between the preliminary threshold (blue line), and the maximum threshold (red line) signify that the bearing is potentially defective. However, the steady increase in the G_{RMS} value exhibited by the 2MxV5 bearing is usually indicative that a spall has initiated and propagated.

The propagated defect for 2MxV5 was approximately 0.5 in (1.27 cm) wide and spanned across the width of the cup raceway. The size of this spall measured approximately 1.51 in² (9.74 cm²). This area exceeds the maximum allowable defect size (0.14 in² or 0.90 cm²) for repair, making it unsuitable for the reconditioning process. Referring to the vibration profile of Figure 32, it can be seen that the spall on bearing 2MxV5 started developing after running a total

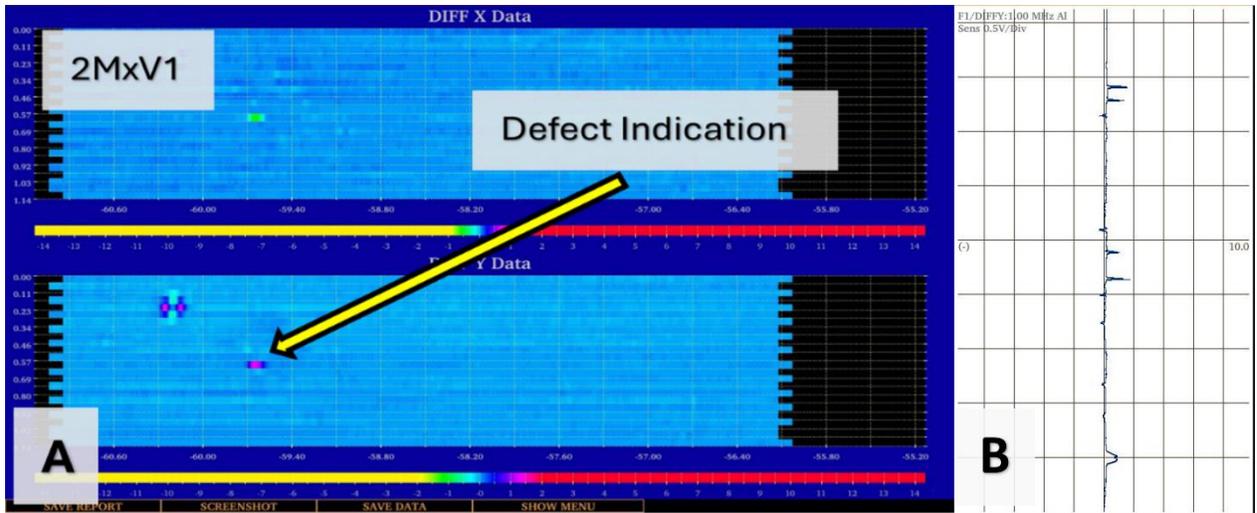
Figure 37: (A) Magnified C-scan of 2MxV1, (B) A-scan for 2MxV1

2MxV1 displayed multiple anomalies as pictured in Figure 37(A). This image provides a magnified C-scan to better visually represent the indications output by the ECA scanner. The C-scan displays two high amplitudes on the image but one represents a man-made dimple that was located on the surface. To validate whether the indications correspond to defects, A-scans were generated via the use of a pencil probe as shown in Figure 37(B). The A-scan output by the ECA for 2MxV1 exhibited small peaks that were mainly seen on the right-hand side of the scan, implying that the anomaly is a defect.

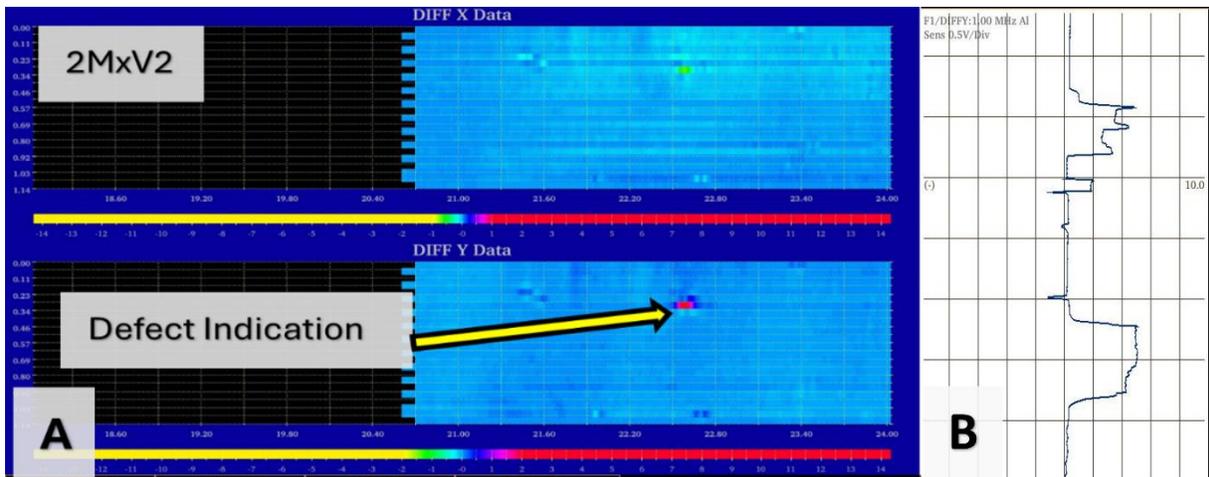
Figure 38: (A) Magnified C-scan of 2MxV2, (B) A-scan for 2MxV2

Figure 38(A) provides a magnified image for 2MxV2 to better represent the indication. Only one indication was displayed on the C-scan image for 2MxV2. To validate whether the indication corresponded to a defect, an A-scan was generated via the use of a pencil probe, as shown in Figure 38(B). Larger peaks can be observed on the right-hand side, meaning that the indication is a defect. To reiterate, the change in impedance is not a measure of the severity of the defect but rather denotes the existence of one near the surface.

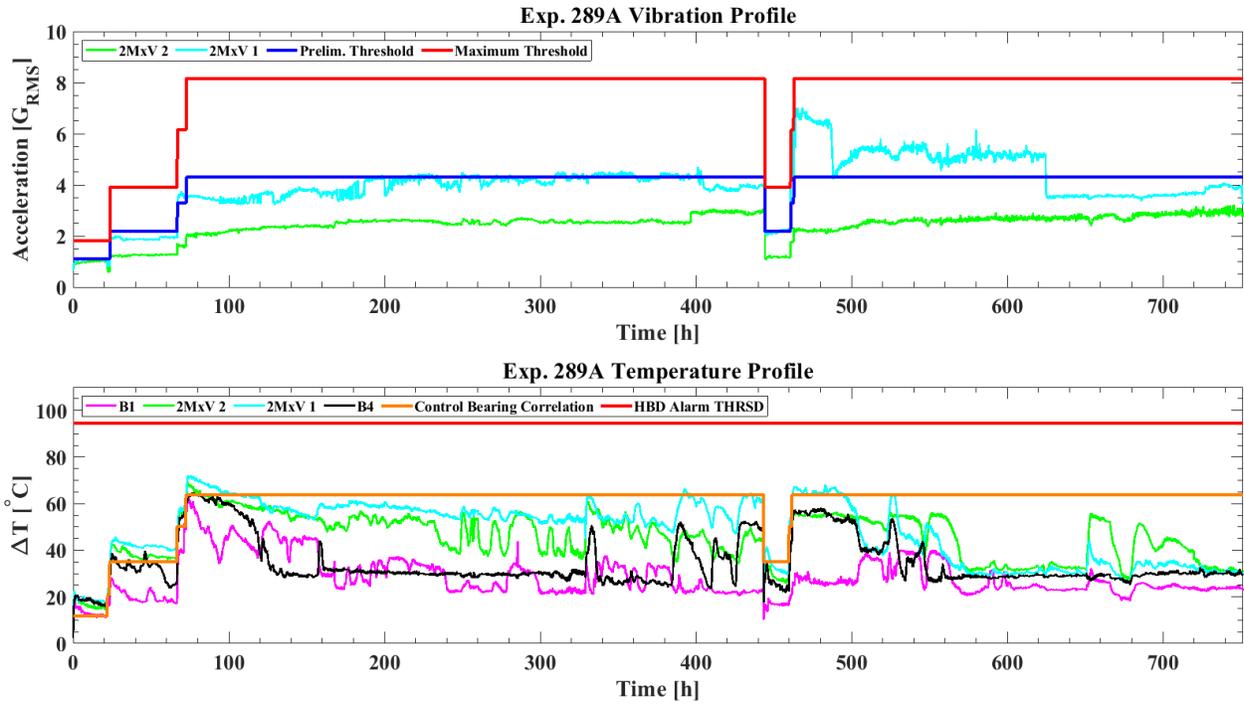
Figure 39: Vibration and temperature profiles for Experiment 289A

Similar procedures to those carried out in the previous experiments were followed with the bearings set up on the 4BT. Again, the ECA indicated regions on the bearing cups were placed directly under the applied load (i.e., top-dead-center position). Accelerated service life testing conditions of 85 mph (137 km/h) and full railcar load (34,400 lbs or 153 kN per bearing) were utilized for this experiment. This experiment was terminated after 2MxV1 and 2MxV2 ran for a total of 60,496 mi (97,359 km), reaching the halfway mark. Plots representing the vibration and temperature profiles of these two test bearings are given in Figure 39. The operating temperatures for both test bearings, which averaged around 48.7°C (87.7°F) for 2MxV1 and 53.5°C (96.3°F) for 2MxV2 above ambient, remained below the control bearing correlation for the majority of the experiment, and well below the HBD alarm threshold. The acceleration levels for 2MxV2 ran steady and below the preliminary threshold, exhibiting healthy bearing conditions for the duration of the experiment. However, the acceleration levels for 2MxV1 increased to the preliminary threshold and remained at that level, signifying that the bearing is potentially defective. The acceleration then experienced an impulse due to electrical issues that occurred during the experiment.

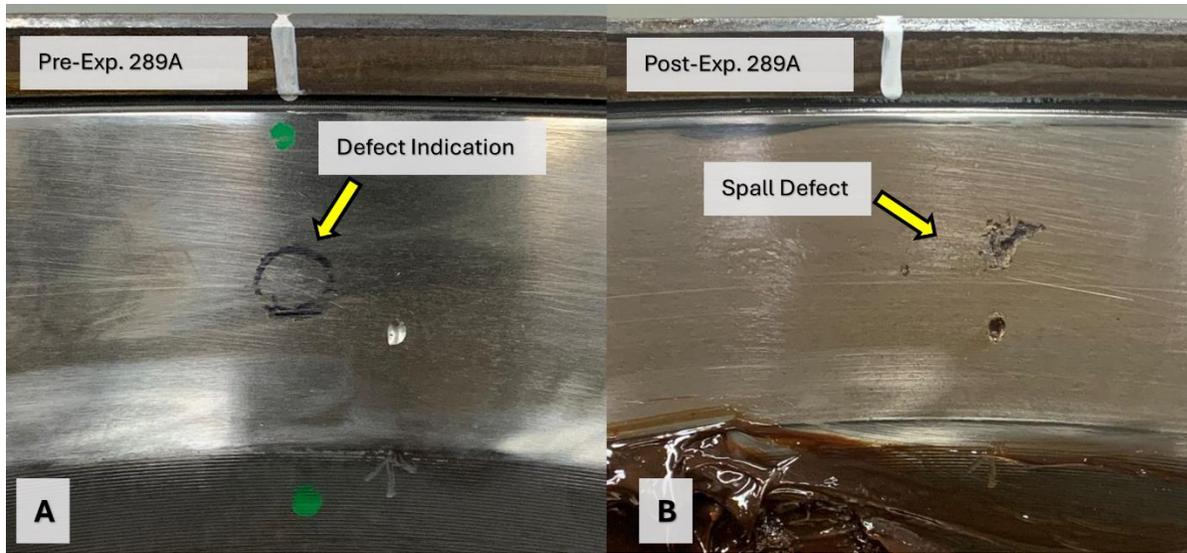
Figure 40: 2MxV1 (A) Pre-test inspection for 2MxV1, (B) Post-test inspection

The output of the Level 2 analysis supports the indication from the ECA scan as it confirmed that the defective components were the cups. A full teardown and visual inspection were then conducted for both bearings. Pre- and post-images of the 2MxV1 bearing for this experiment are depicted in Figure 40(A) and Figure 40(B), respectively. A small defect can be observed on the surface of the raceway. Moreover, the post-test image for the 2MxV2 bearing, shown in Figure 41(B), also shows that a very small defect in its early stages of development has initiated in the region where the C-scan identified a defect.

Both bearings developed a defect, albeit small, in the regions indicated by the ECA scans. The resulting defect size for 2MxV1 measured approximately 0.08 in^2 (0.52 cm^2). 2MxV2 developed a defect that measured approximately 0.01 in^2 (0.06 cm^2). Both these defects are below the maximum allowable defect size (0.14 in^2 or 0.90 cm^2) for repair, however, it should be noted that the ECA scans were still able to detect suspect regions on the cup raceways that are susceptible to defect initiation. Both bearings developed these spalls after running for 60,496 mi

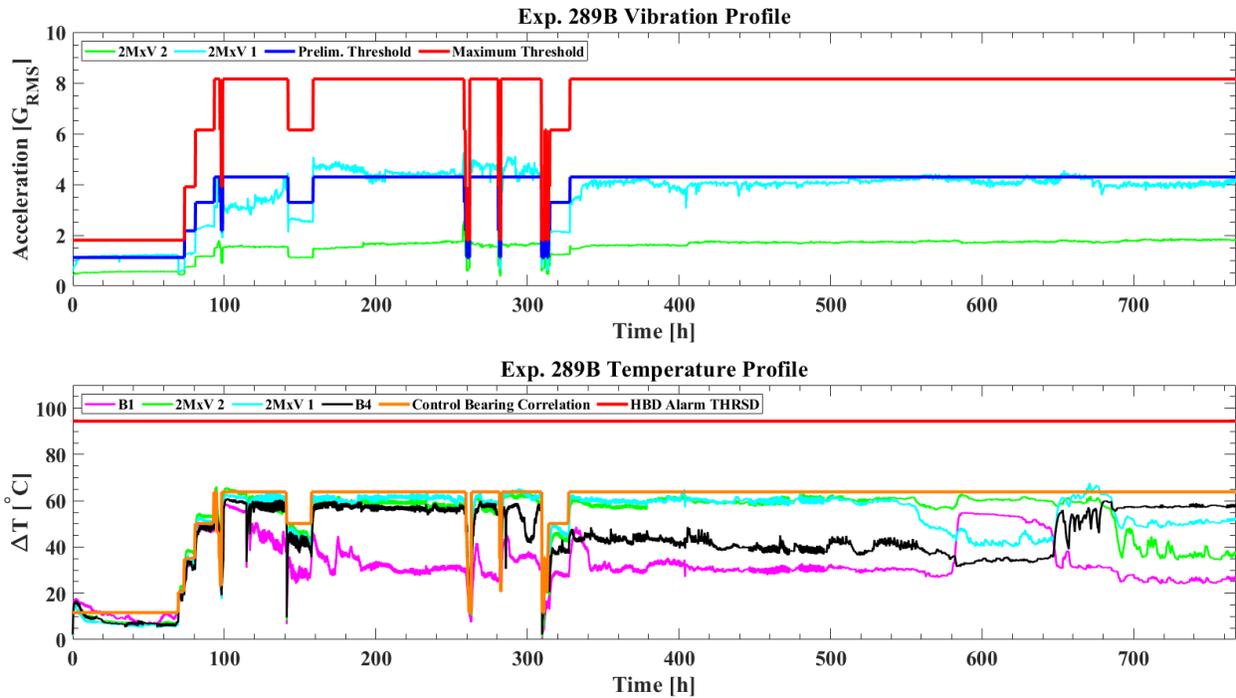
Figure 42: Vibration and temperature profiles for Experiment 289B

The experiment was stopped after the bearings had run for a total of 120,258 mi (193,536 km), reaching the target mileage. Figure 42 presents the vibration and temperature profiles for this experiment. The operating temperatures for both test bearings, which averaged around 50.3°C (90.5°F) for 2MxV1 and 54.8°C (98.6°F) for 2MxV2 above ambient, remained below the control bearing correlation for the majority of the experiment, and well below the HBD alarm threshold. The acceleration levels for 2MxV2 were steady and below the preliminary threshold, exhibiting healthy bearing conditions for the duration of the experiment. The acceleration levels for 2MxV1 remained around the preliminary threshold.

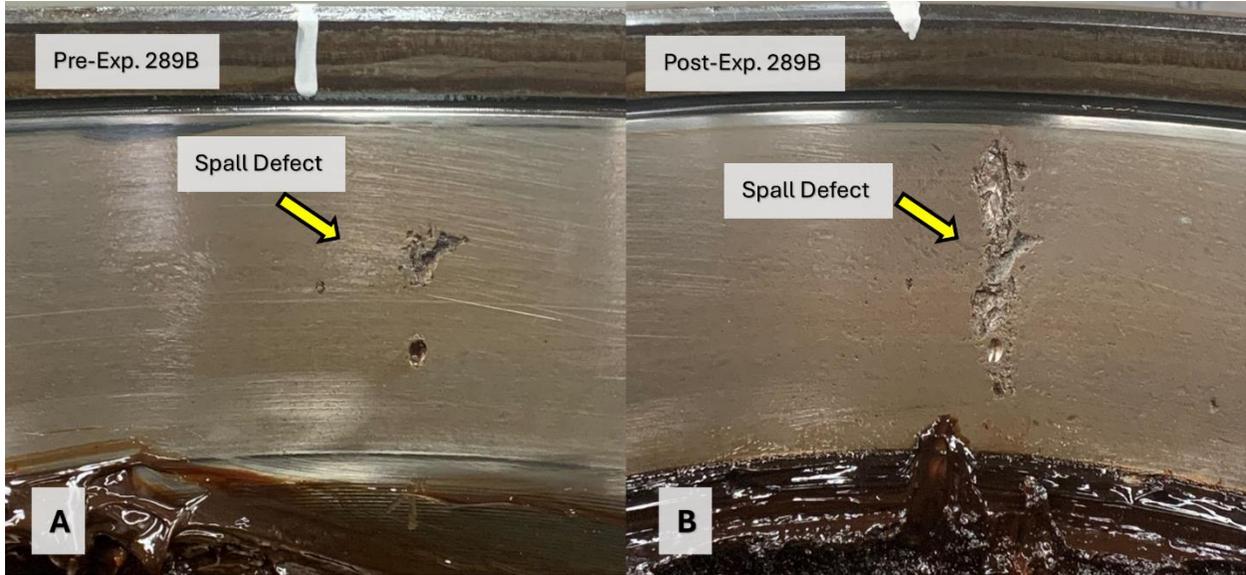
Figure 43: 2MxV1 (A) Pre-test inspection, (B) Post-test inspection

A full teardown and visual inspection ensued after both bearings reached the mileage goal of 120,258 mi (193,536 km) to see if the defects have grown in surface area. Images of pre- and post-test for 2MxV1 are depicted in Figure 43. Looking at Figure 43(B), it can be seen that the spall on the 2MxV1 bearing exhibited growth toward the upper shoulder and towards the repair dimple. This behavior is typical of spall growth on cup raceways where any defects that initiate in the middle region of the raceway tend to grow across the raceway width before expanding circumferentially. The spall area after this iteration measured approximately 0.36 in² (2.06 cm²), which represents an increase in surface area that is four times its previous size (0.08 in² or 0.52 cm²). Figure 44 presents the defect from both iterations for 2MxV2. The picture

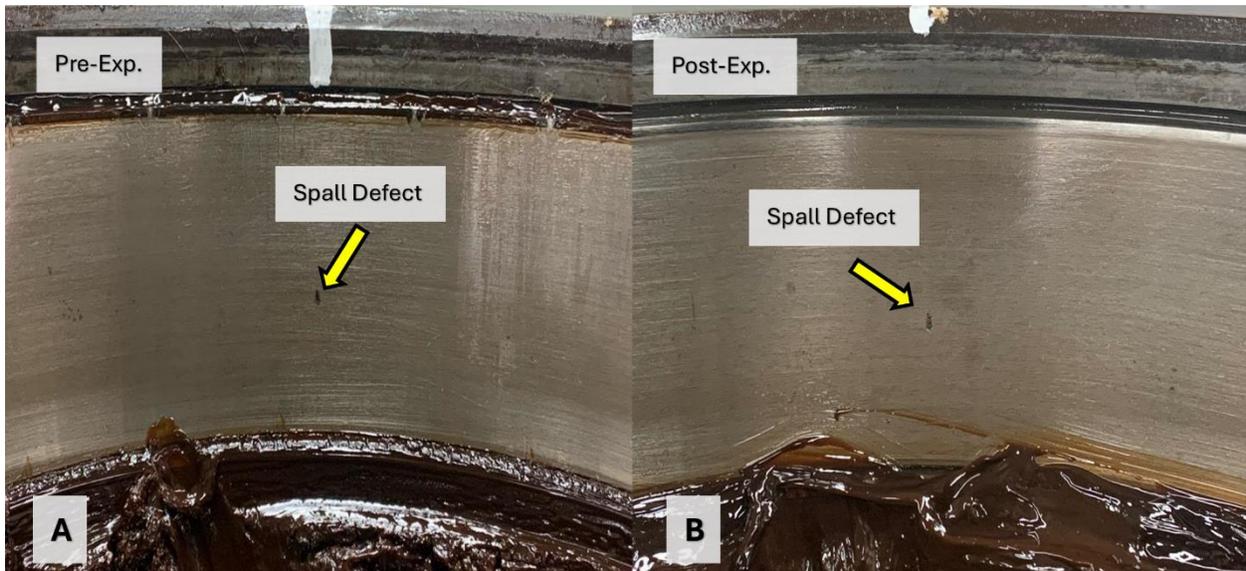
Figure 44: 2MxV2 (A) Pre-test inspection, (B) Post-test inspection

shows that the spall area remained at the same size after both iterations and measured approximately 0.01 in² (0.06 cm²).

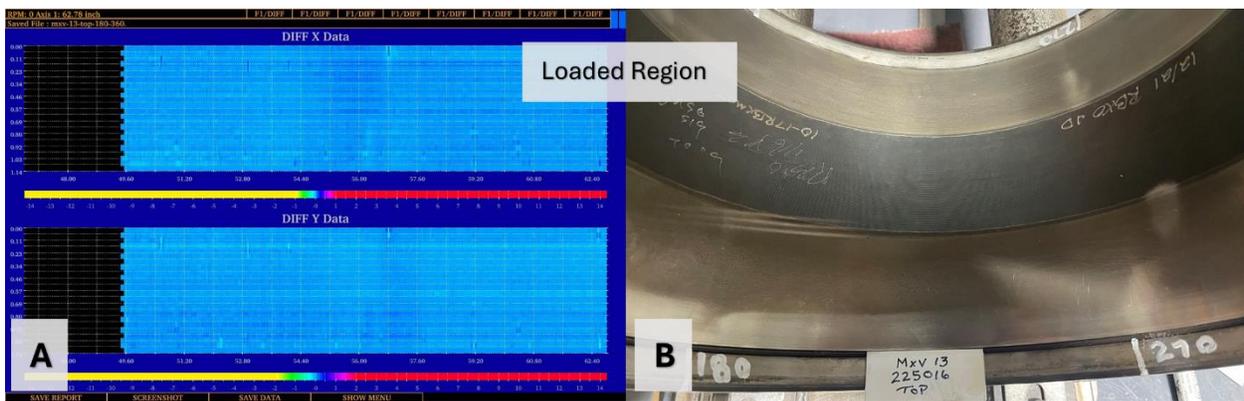
Figure 46: (A) C-scan image of the raceway of 2MxV13, (B) Visual inspection of the raceway of 2MxV13

Experiment 297B featured two bearings, 2MxV12 and 2MxV13. The ECA scanner output C-scan images of these two cups can be seen in Figure 45(A) and Figure 46(A), respectively. No defects were identified by the ECA, signifying that the eddy current was not disrupted and there were no subsurface defects in this focal depth. Pictures of the visually inspected surfaces of the reconditioned bearing cups are displayed in Figure 45(B) and Figure 46(B) for bearings 2MxV12 and 2MxV13, respectively. No defects were visible on the surface of the cups.

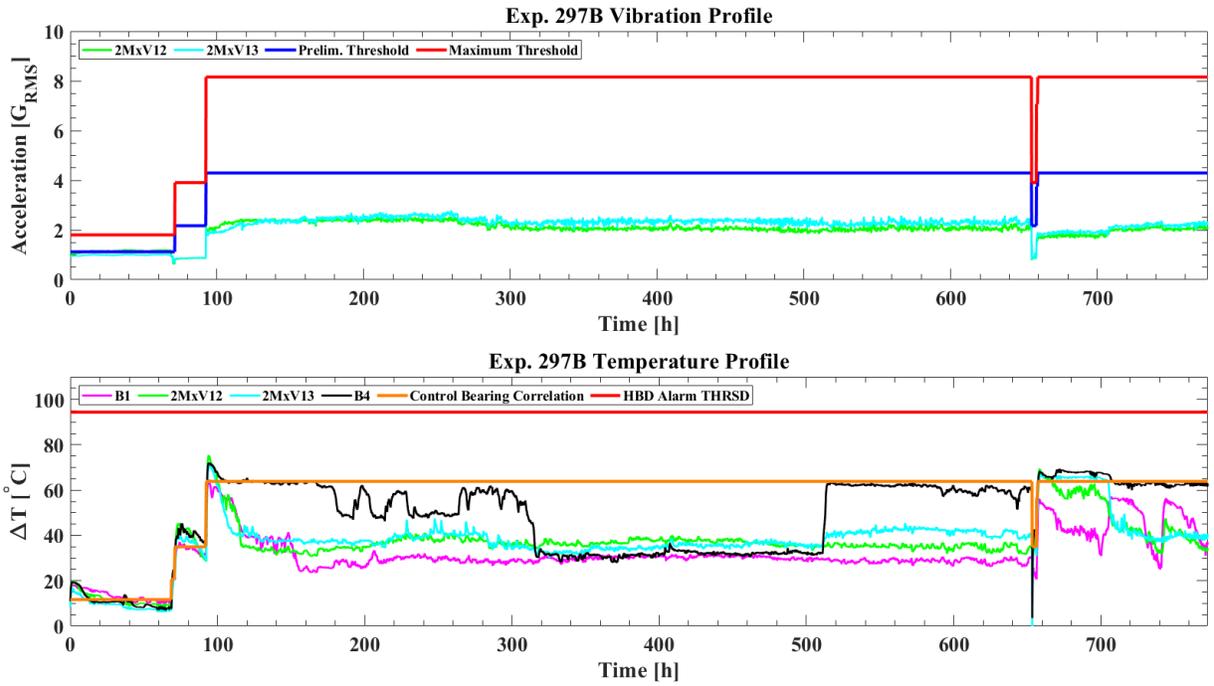
Figure 47: Vibration and temperature profiles for Experiment 297B

The vibration and temperature profiles of the two test bearings for the last 60,000 mi of operation are provided in Figure 47. The operating temperatures for both test bearings, which averaged around 42.6°C (76.7°F) for 2MxV12 and 46.9°C (84.4°F) for 2MxV13 above ambient, remained below the control bearing correlation for the majority of the experiment, and well below the AAR Hot-Bearing Detector (HBD) alarm threshold. The acceleration (G_{RMS}) levels for

both bearings also displayed healthy conditions, running below the preliminary threshold. A full teardown and visual inspection were conducted after both bearings reached the mileage goal. The pre- and post-test images are pictured in Figure 48 for 2MxV12 and Figure 49 for 2MxV13, and show no defects or any discernible damage on the cup raceways other than normal wear after running 120,000 mi.

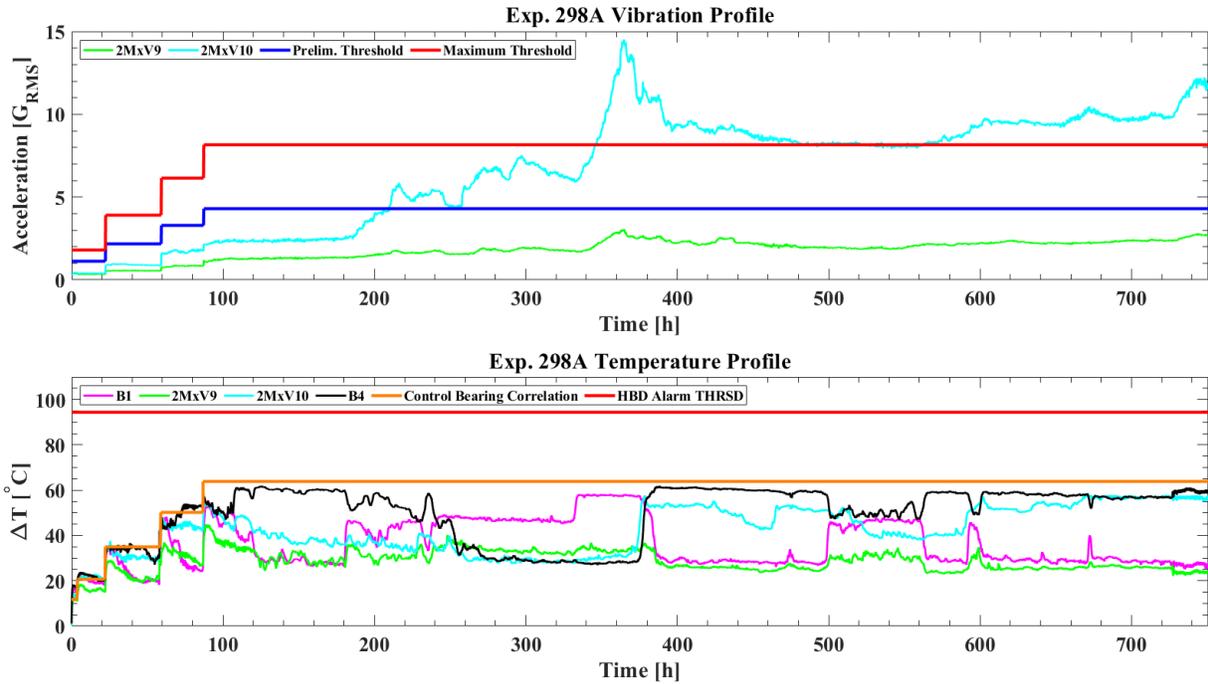
Figure 51: Vibration and temperature profiles for Experiment 298A

Plots representing the vibration and temperature profiles of the two test bearings are given in Figure 51. The operating temperatures for both test bearings, which averaged around 35.6°C (64.1°F) for 2MxV9 and 45.9°C (82.6°F) for 2MxV10 above ambient, remained below the control bearing correlation for the majority of the experiment, and well below the HBD alarm threshold. The acceleration levels for 2MxV9 demonstrated healthy bearing conditions, running below the preliminary threshold. However, the acceleration levels for the 2MxV10 bearing started to increase around the 190 hour-mark (12,470 mi or 20,068 km) of the experiment, thus signifying a possible defect initiation, and eventually exceeding the maximum threshold, confirming that a defect had developed. To avoid unnecessary stoppage to this test, it was

decided to allow this experiment to run until the 2MxV9 bearing reached the halfway mark mileage before performing a full teardown and visual inspection.

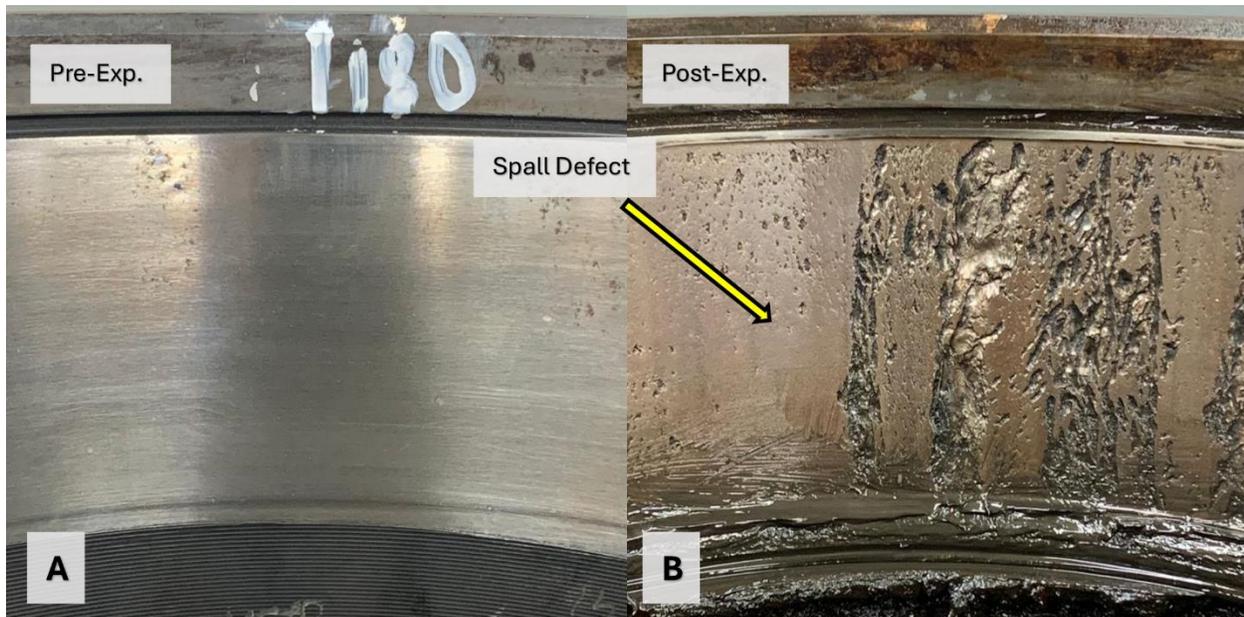
Figure 52: (A) Pre-test inspection, (B) Post-test inspection

A full teardown and visual inspection were conducted after both bearings reached the halfway mark. The visual inspection revealed no defects on the 2MxV9 bearing, so it was reassembled in accordance with suggested AAR guidelines and paired with another non-indicated bearing for continued testing. Figure 52(B) displays a post-test image of the loaded zone with the developed defect on the surface of 2MxV10. The pre-test image of that same surface is illustrated in Figure 52(A) and shows no discernible damage.

The defect propagated across the entire width of the cup raceway and measured approximately 3.11 in² (20.06 cm²) in area, as seen in Figure 53. This spall exceeded the maximum allowable defect size (0.14 in² or 0.90 cm²) for repair, making it unsuitable for the reconditioning process. This defect was located around the 180° mark of the bottom raceway (refer to Figure 54) and was not detected by the ECA scans. However, the research team at QUISP provided ultrasonic scans that were able to detect that defect, as depicted in Figure 54 [32]. This reiterates the point that NDE technology can detect this defect but was likely missed due to the focal zone or the lack of overlapping scans of the ECA. That is, there is a chance that the defect was not properly scanned given that the scanning profiles from the ECA scanner were taken from approximately 0° to 180° and from 180° to 360° and that the defect initiated around the 180° region. Implementing scanning profiles taken from 90° to 270° and from 270° to 90° alongside the original scans would provide overlapping that would minimize the likelihood of this potential false negative. This practice would also ensure that the ECA scanned the entire raceway, for a total of eight scans per bearing cup (four per raceway).

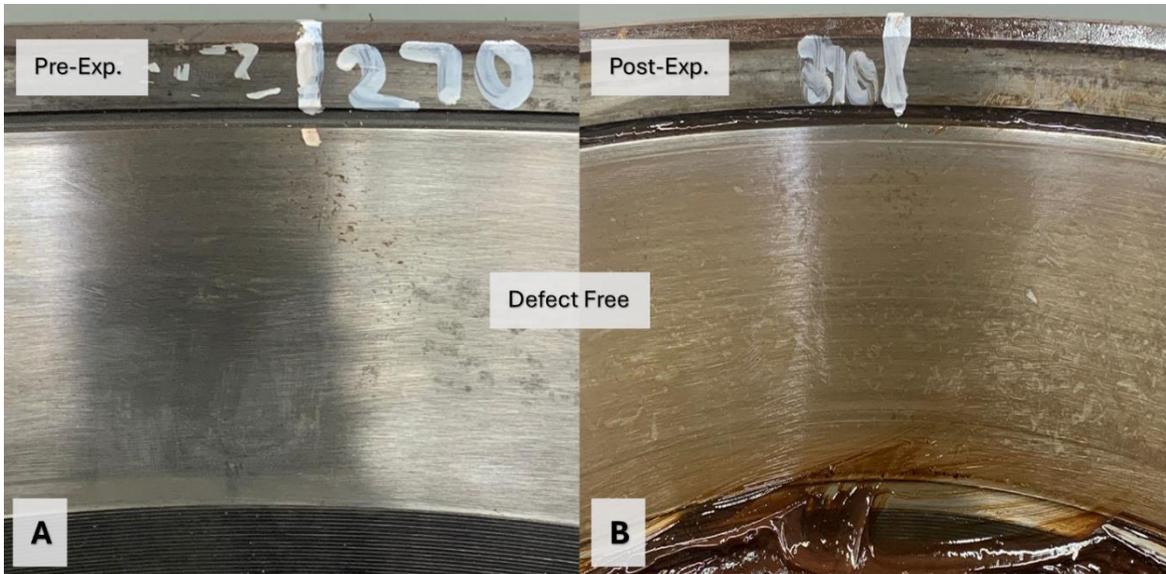
Figure 57: 2MxV9 (A) Pre-test inspection, (B) Post-test inspection

The visual inspection revealed that no defects developed on the 2MxV11 bearing, so it was reassembled in accordance with suggested AAR guidelines and paired with another non-indicated bearing for continued testing. Pre- and post-test images for the 2MxV9 bearing are depicted in Figure 57, showing that no defect(s) had developed on the cup raceway. The minor abrasions that can be seen are likely due to the small metal fragments introduced to the raceway from the spalled roller(s). To confirm this observation, the cone assembly was cleaned and disassembled to enable the visual inspection of the rollers.

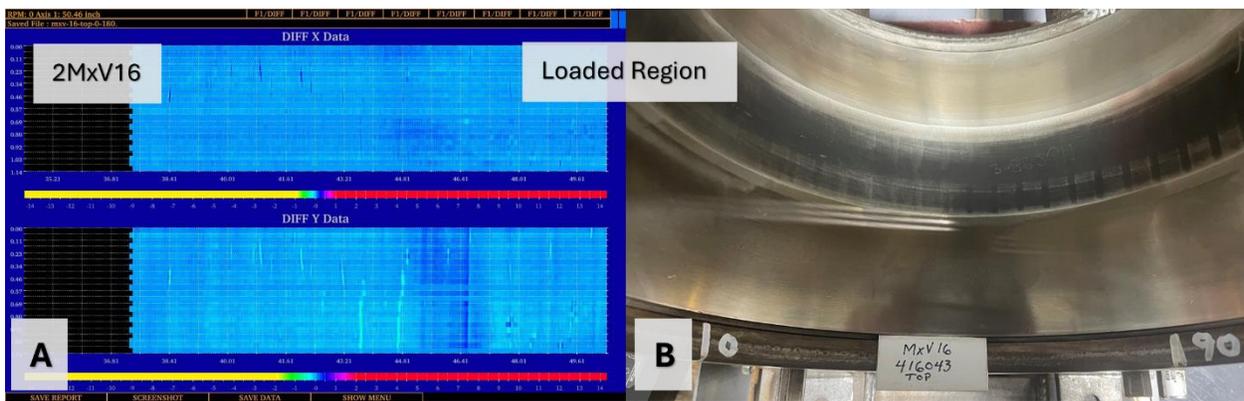
Figure 59: (A) C-scan of the raceway of 2MxV15, (B) Visual inspection of the raceway of 2MxV15

Experiment 300B featured two bearings, 2MxV15 and 2MxV16. The ECA C-scan images of these two cups can be seen in Figure 59(A) and Figure 60(A), respectively. The ECA scans detected no potential defects on these cups. Pictures of the visually inspected surfaces of the reconditioned bearing cups are displayed in Figure 59(B) and Figure 60(B), for bearings 2MxV15 and 2MxV16, respectively. It should be noted that surfaces of the cups looked clean and free from any damage.

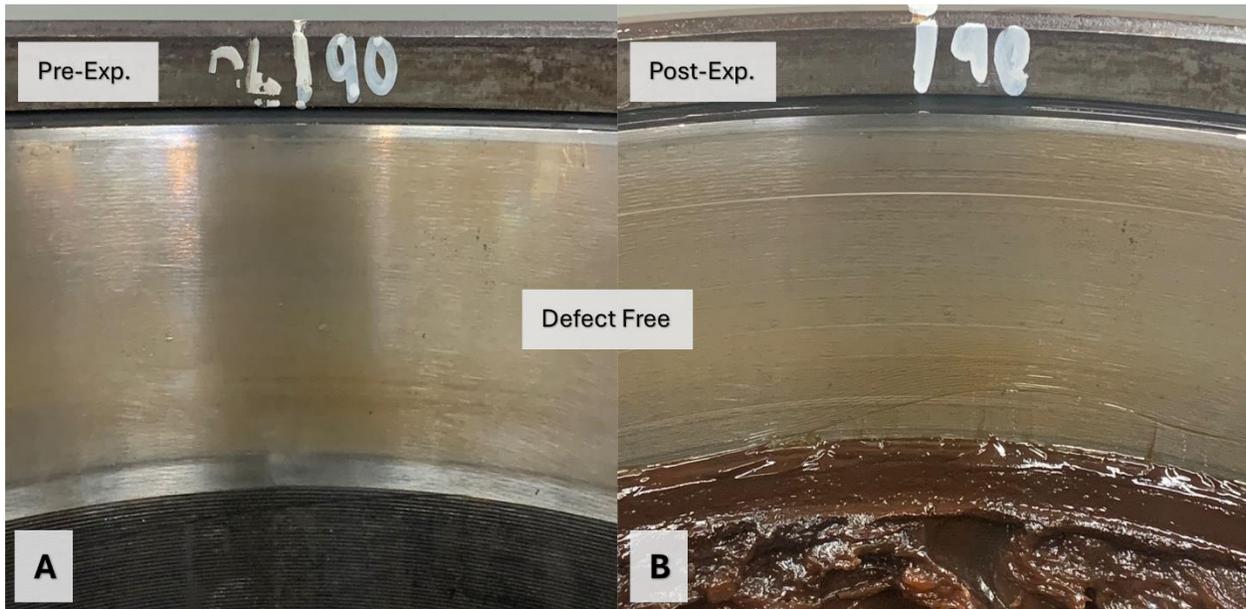
Figure 62: 2MxV15 (A) Pre-test inspection, (B) Post-test inspection

by the vibration profile of the 2MxV15 bearing was caused by minor electrical interference issues that occurred during the experiment. A full teardown and visual inspection were conducted after both bearings reached the mileage goal. The pre- and post-test images are depicted in Figure 62 for 2MxV15 and Figure 63 for 2MxV16, and show no defects or any discernible damage on the cup raceways other than normal wear after running 120,000 mi.
